**NATIONAL REGISTER OF HISTORIC PLACES
REGISTRATION FORM**

HISTORIC NAME: Harris Drug Store
OTHER NAME/SITE NUMBER: Westerman Drug Store

STREET & NUMBER: 114 South Chadbourne Street
CITY OR TOWN: San Angelo
STATE: Texas **CODE:** TX **COUNTY:** Tom Green **CODE:** 451 **ZIP CODE:** 76903
NOT FOR PUBLICATION: N/A
VICINITY: N/A

Harris Drug Store
San Angelo, Tom Green County, Texas

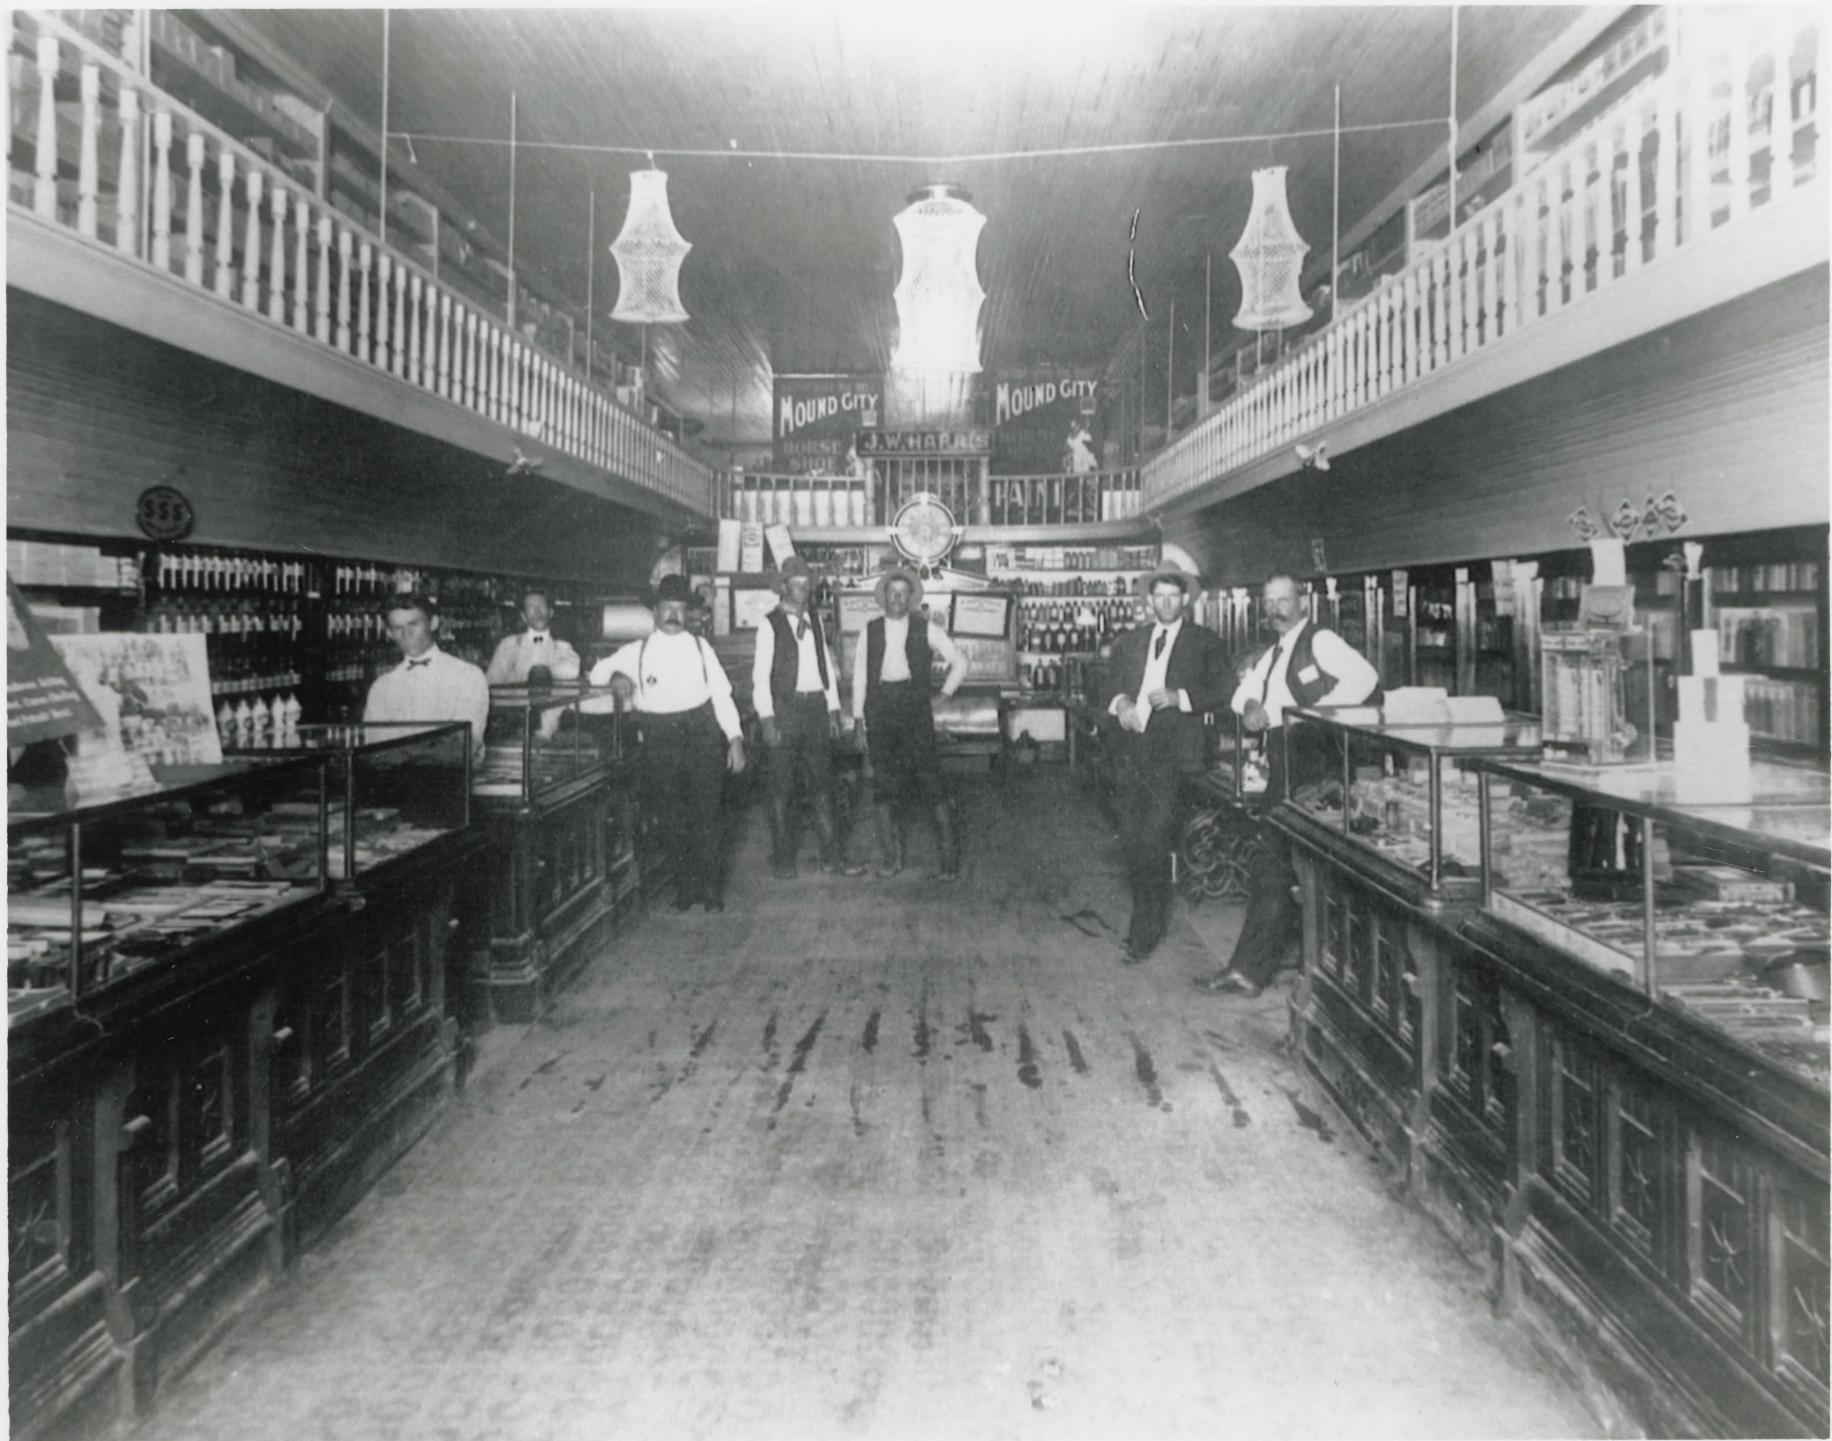
PHOTOGRAPH 12 of 20

Photo 12 of 20
c. 1890s interior (hatless J.W. Harris wearing vest on right side of picture)
Camera facing east from the front door
