NATIONAL REGISTER OF HISTORIC PLACES
REGISTRATION FORM

HISTORIC NAME: Winters-Wimberley House
OTHER NAME/SITE NUMBER: N/A

The ca. 1856 Winters-Wimberley House occupies a five-acre site on a high bluff overlooking Cypress Creek, at the northern periphery of Wimberley, a small but growing Hill Country town in southwestern Hays County. Although set back about 100' feet to the east of Ranch Road 12, the house is visible from the road which connects the town of Wimberley to the county seat of San Marcos, about 10 miles to the southwest. The five-acre site contains the main house, several outbuildings, a fenced garden and other agricultural features, and a network of dirt roads that once led to the mill and other family work sites. The house is a vernacular 1-story, side-gabled limestone dwelling with matching limestone chimneys centered on the gable ends. An attached 3-bay porch supported by turned posts stretches across most of the front facade and matching pilasters are affixed to the wall. Multiple frame additions extend to the rear. Although its symmetrical 3-bay appearance suggests a center-passage plan, physical evidence indicates that the original house was built as a simple, 2

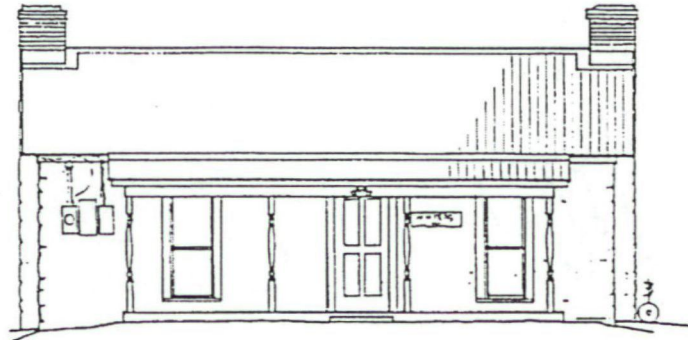
SOUTH ELEVATION existing
scale: 1/8"=1'-0"

Figure 1: South (Primary) Elevation, Existing Appearance, Winters-Wimberley House, drawn 1998

The original two-room section of the house (Figure 1, Photo 1- South Elevation; Figure 5-Plan 1, Rooms 1 A and 1 B) is built of random, 18" thick ashlar limestone blocks cemented with lime-based mortar. Stone footings provide a base for the masonry walls while the interior floor and walls are supported by pier and beam foundation. A new side-gabled metal roof covers the rectangular main building; it replaced an earlier metal roof that in turn replaced the original cedar shingles sometime within the historic period. Stone chimneys for wood-burning fireplaces in each of the two rooms extend from the gable ends. Matching 1/1 light double hung windows flank each of the chimneys.

A single entry door near the center of the primary (south) facade is surrounded by 1/1 light double hung windows. The windows were probably installed in the 1920s and likely replaced multi-light windows of a 6/6 configuration. An attached 3-bay porch extends almost full-width across the front facade, shading the entrance and front, south-facing windows. It is supported by turned posts and matching pilasters that appear to date to the turn of the century. A concrete porch floor poured in the 1930s has been replaced with a simple wood plank floor that is probably similar to the original. The primary facade gives an overall impression of symmetry; the door appears centrally placed, flanked by identical, equally spaced windows, enframed by a centered porch and capped on both ends by matching chimneys.

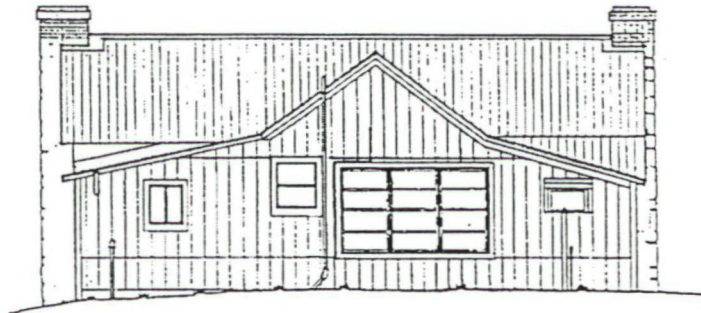
NORTH ELEVATION existing
scale: 1/8"=1'-0"

Figure 2: North (Rear) Elevation, Existing Appearance, Winters-Wimberley House drawn 1998
Source: Jeffrey H. Kester & Associates, *Master Plan for the Restoration of the Historic Winters- Wimberley House*

The rear (north) elevation contains a gabled core section that defines the termination of the earliest addition extending from the center of the original house (Figure 2, Photo 3-North Elevation). Shed-roofed wings slope from both sides of the gabled roof, covering the later additions on either side. The rear elevation is covered with a variety of siding materials and window types, reflecting the different building campaigns and the secondary importance of this facade. Its original windows were replaced and the openings greatly altered by the installation of horizontal aluminum sash in the 1960s or 1970s.

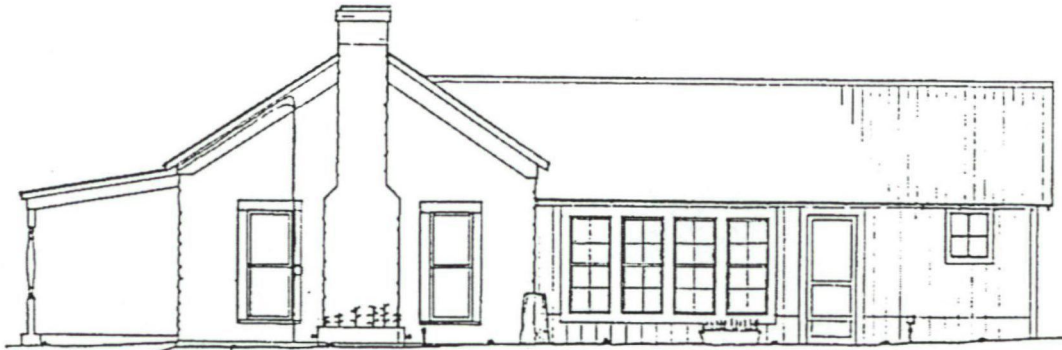
EAST ELEVATION

Figure 3: East Elevation, Existing Appearance, Winters-Wimberley House, drawn 1998

Side elevations reveal both the original stone construction and the later frame additions (Figures 2 & 3 -East and West Elevations, Photos 4 & 6). The south end of the east elevation is defined by a side-gabled roof that covers the original limestone wall. Matching 1/1 light windows are spaced on either side of the stone chimney which is centered on the ridgeline. Attached to the north end of the stone wall is a long, shed-roofed wing that extends to the north.

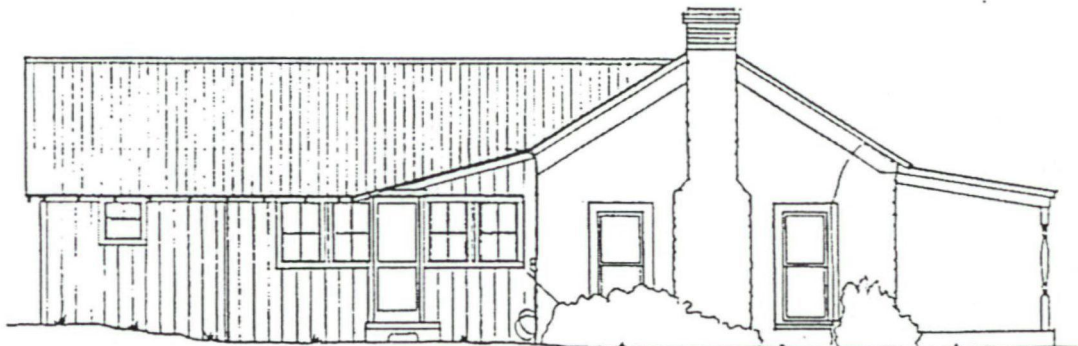
WEST ELEVATION

Figure 4: West Elevation, Existing Appearance, Winters-Wimberley House drawn 1998
Source: Jeffrey H. Kester & Associates, *Master Plan: Restoration of the Historic Winters- Wimberley House*

The south side of the west elevation is identical to the east side; it encompasses the side-gabled stone portion of the original house with a central limestone chimney flanked by matching 1/1 light double hung windows (Photo 6-West Elevation). Like the east elevation, a long, side-gabled frame wing extends to the north.

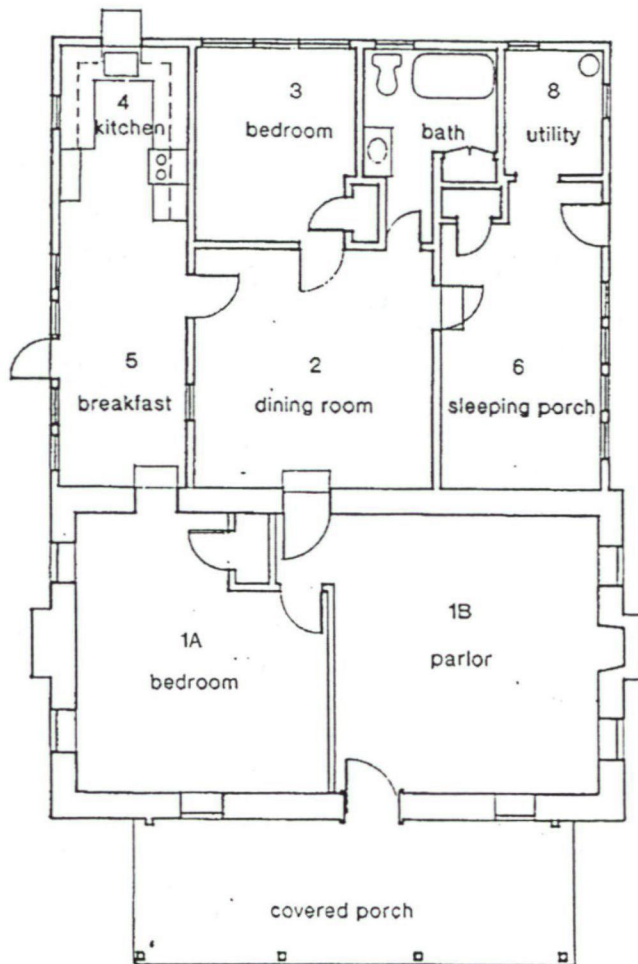
FLOOR PLAN
scale: 1/8"=1'-0"

Figure 7: Existing Floor Plan, Winters-Wimberley House, drawn 1998

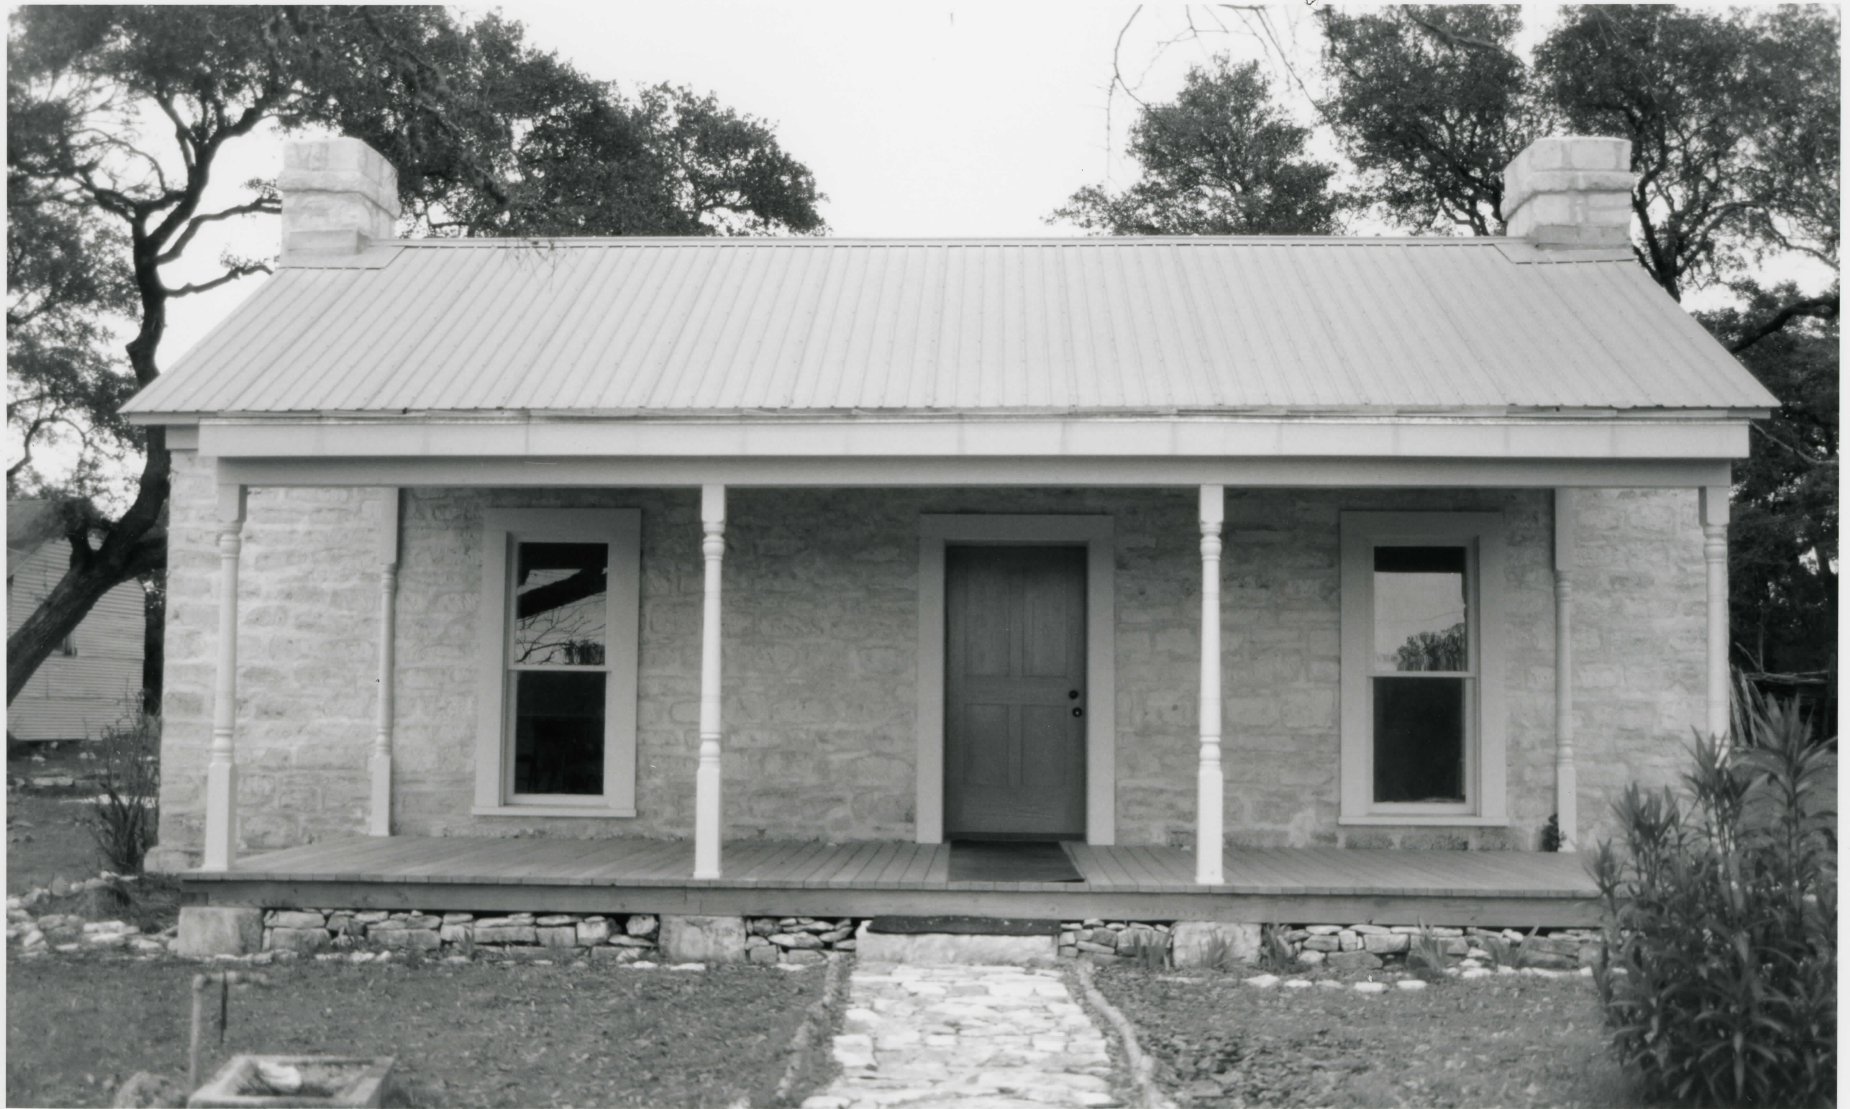
Photo No. 1 of 6

South (primary) Elevation
camera facing north

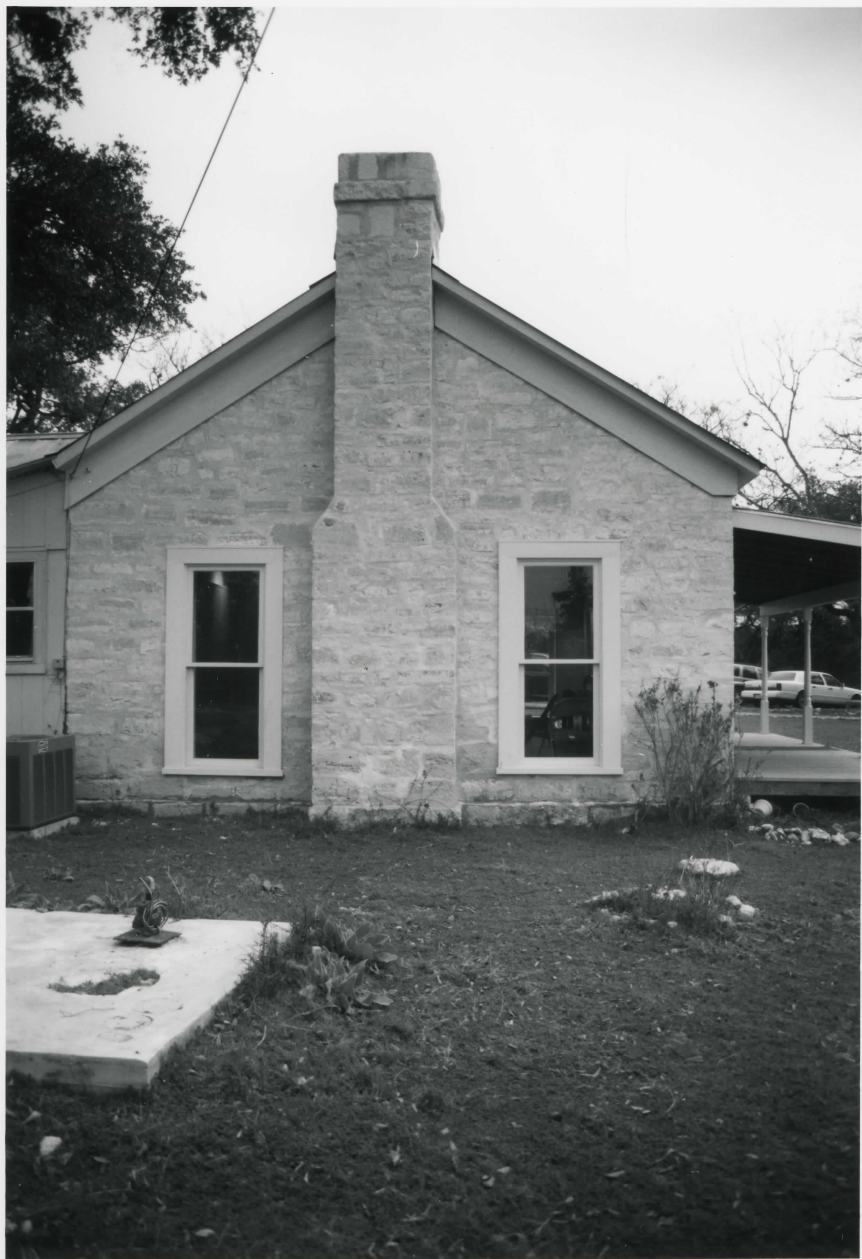
WINTERS-WIMBERLY HOUSE
14070 RANCH ROAD 12
WIMBERLEY, HAYS CO., TEXAS
PHOTOGRAPH 5 of 6

Photo 5:
West elevation
Camera facing east
