**NATIONAL REGISTER OF HISTORIC PLACES
REGISTRATION FORM**

HISTORIC NAME: Carlock Building
OTHER NAME/SITE NUMBER: New Cotton Exchange Building

Carlock Building
Lubbock, Lubbock County, Texas

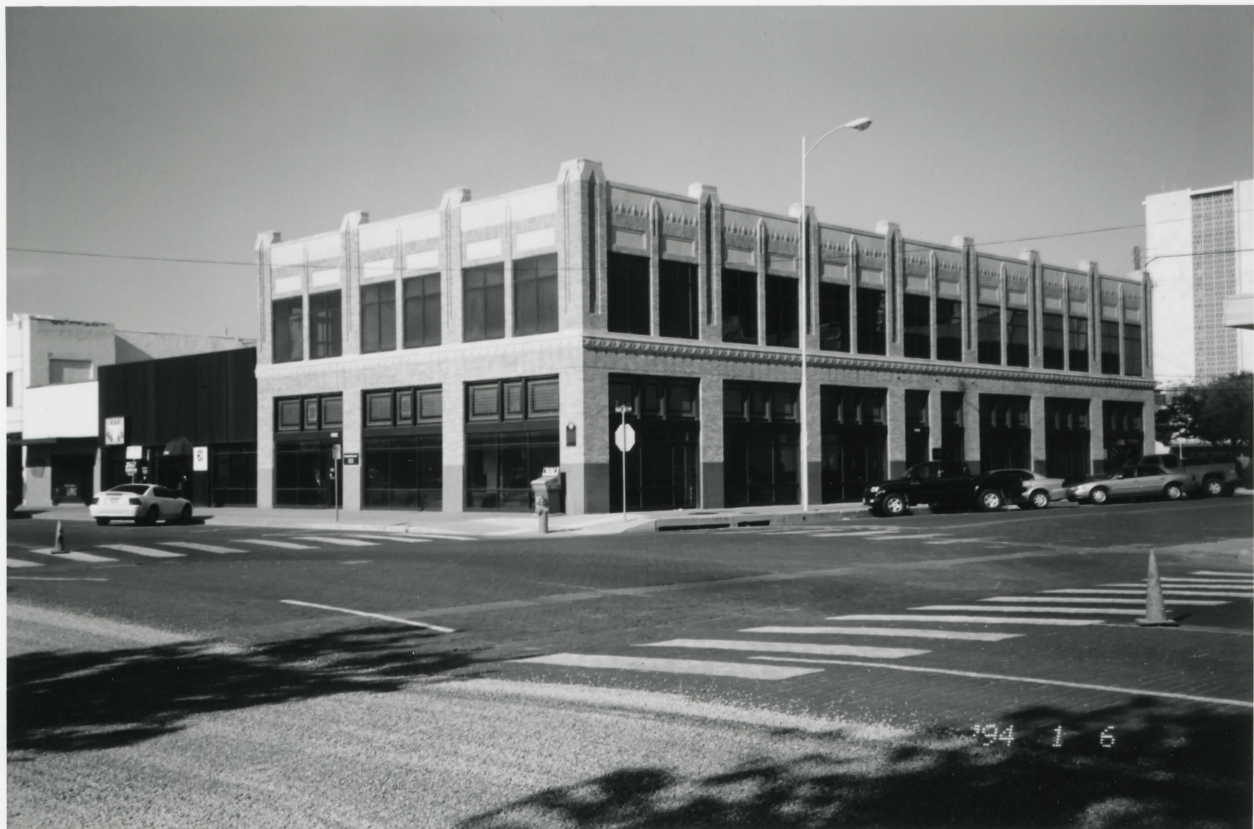
PHOTOGRAPH 1 of 5

Northeast oblique
Camera facing southwest
Photo 1 of 5
