NATIONAL REGISTER OF HISTORIC PLACES  
REGISTRATION FORM

HISTORIC NAME: Allen Water Station  
OTHER NAME/SITE NUMBER: H&TC Railway Water Station

Allen Water Station  
Allen, Collin County, Texas

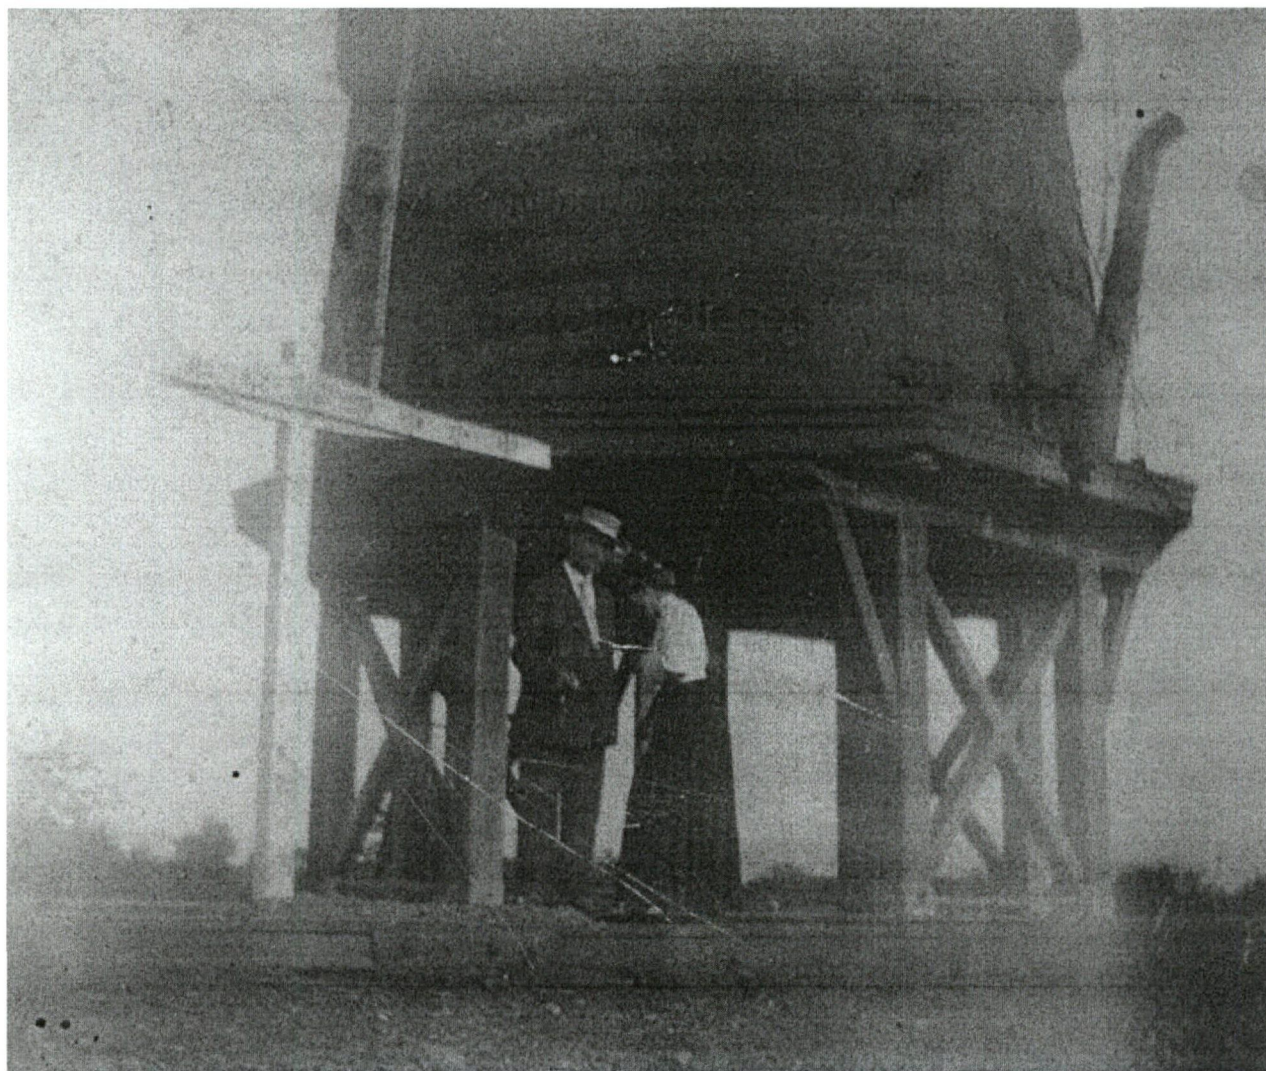
An early twentieth century photograph of the Allen water tank showing the gooseneck delivery spout and wooden support piers with cross braces. View looking southeast from the west side of the railroad tracks (photo courtesy of the Allen Heritage Guild).

Today, only the 12 stone piers remain. From the stone piers, it is estimated that the diameter of the tank's tub was 25 to 26 feet in diameter. The entire structure is estimated to have been 28 to 35 feet tall, based upon plans for late 19<sup>th</sup> century water tanks (Berg 1893:117).

The remains of twelve stone piers in three rows that once supported a circular water tank tub are located 168 feet west of the dam. Documentary information of water tank construction and design are well documented in Berg's *Buildings and Structures of American Railroads: A Reference Book*, 1893. Octagonal shapes were commonly used to make floors and roofs for round water tanks. The Allen tank photograph shows an octagonal base holding the large wooden tub. The spacing of iron hoops on the Allen tank was designed much like many of the ones depicted in late nineteenth century illustrations or photographs and was a very common design for iron hoops on a wooden water tank.

Historical photographs reveal that the tank was a circular wooden water tank tub with slightly conical sides rather than a true cylinder making the tub's base wider than its top. The tub sat on an octagonal wooden platform supported by large wooden posts with cross braces. The tub featured at least ten wrought iron hoops holding its wooden staves together. The hoops were spaced more closely together at the bottom of the tub to handle the additional weight. The historic photograph does not depict the top of the water, but the goose-neck delivery spout for the tank is clearly visible and was probably about ten feet long and stood about 12 feet above the tracks. The simple lever system opened an internal valve in the tub to let water flow down the goose-neck spout and into tender cars (from Berg 1893: 119).

The stone piers at the site of the water tank today provide a reasonable method to estimate the diameter of the tank. They suggest that the water tank's tub was probably 25 to 26 feet in diameter. This is evident from examining other water tank plans where their outer most piers are generally seated squarely beneath the outer edge of the tub. Common heights from tub plans for late 19th century water tanks are about 16 feet tall (Berg 1893: 117). The roof on the Allen station tank probably added another 5 feet making the entire structure between about 28 to 35 feet tall.

The stone piers are about 26 inches square and covered by 30 inch square capping stones seated on top. The piers vary from 6 inches to more than 3 feet above the gravel slope of the raised embankment currently maintaining the rail tracks. The embankment and tracks undoubtedly have been raised in the last 90 years. The elevation of the tops of the stone footings is 640.1 feet. Above them would have been the wooden brace posts and beams that supported the super structure

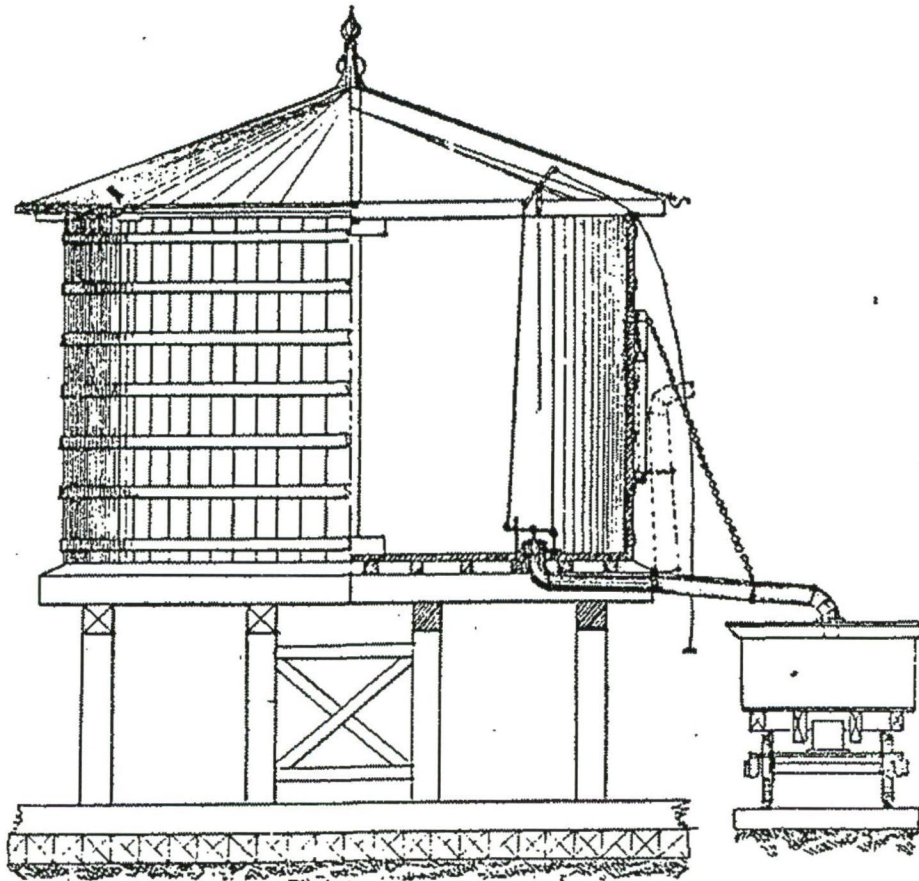
Illustration of an 1880's railroad water tank common for warmer climates and showing internal workings of the gooseneck delivery spout and interior levered lid-valve for letting water flow down the spout (from Berg 1893: 119). Berg (1893:117) notes that wooden water tank tub diameters in general use were 16, 18, 20, 22, 24 and 30 ft. The heights of their staves were typically 14, 15, and 16 ft. and the floor of the tubs typically stood about 12 to 15 feet above the tracks. Foundations were frequently wooden trestle-bents. They would have an intake supply pipe, a discharge pipe connected to a goose-neck delivery spout and a water level indicator so that operators could tell how much water was in the tank upon approach.

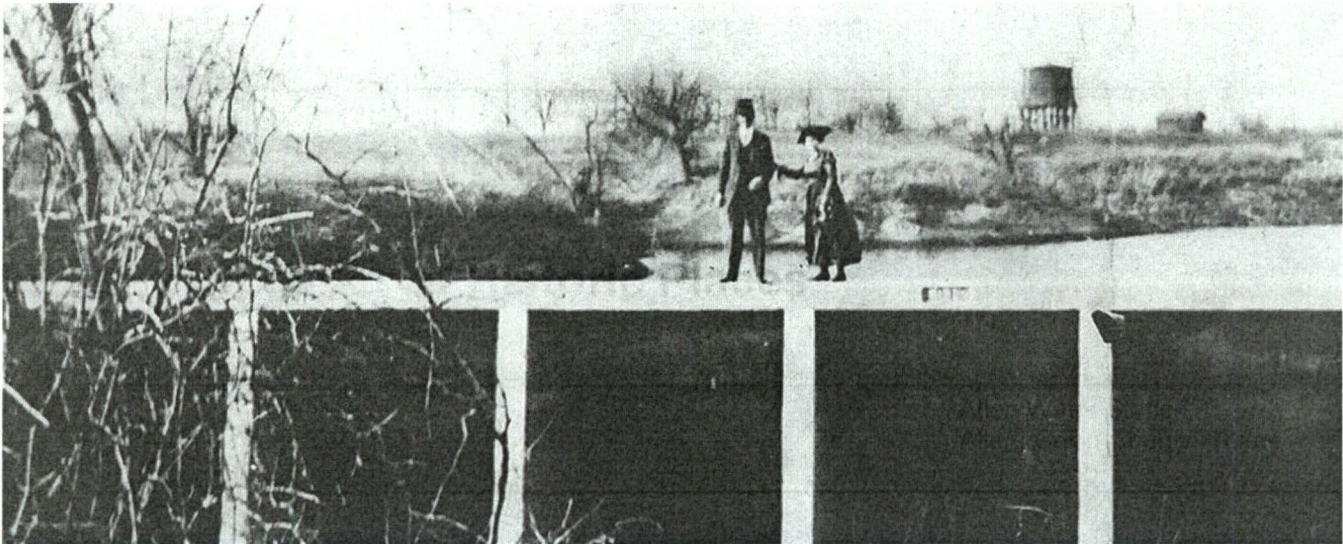
1912 concrete dam constructed by Southern Pacific Railroad with Water Tank and Section House in background (photo courtesy of Allen Heritage Guild). View is from southeast to northwest. The reservoir created by the 1912 dam submerged the 1874 stone dam and created the local recreational swimming hole for local youth. The 1912 dam was breached in the 1960s and demolished in the 1990s.

In 1912, the Southern Pacific Railroad constructed a larger reinforced concrete and rubble fill dam to the south of the 1874 dam. The rubble consisted of pink granite mixed with concrete to construct parts of the lower foundation of the dam. It consisted of a sloping poured cement bulkhead about 15 to 20 feet tall with support buttresses about every 15 feet on the downstream side. The 1912 dam had been breached in the 1960s and was demolished when Exchange Parkway was constructed between S.H. 5 and U.S. 75 in the 1990s.

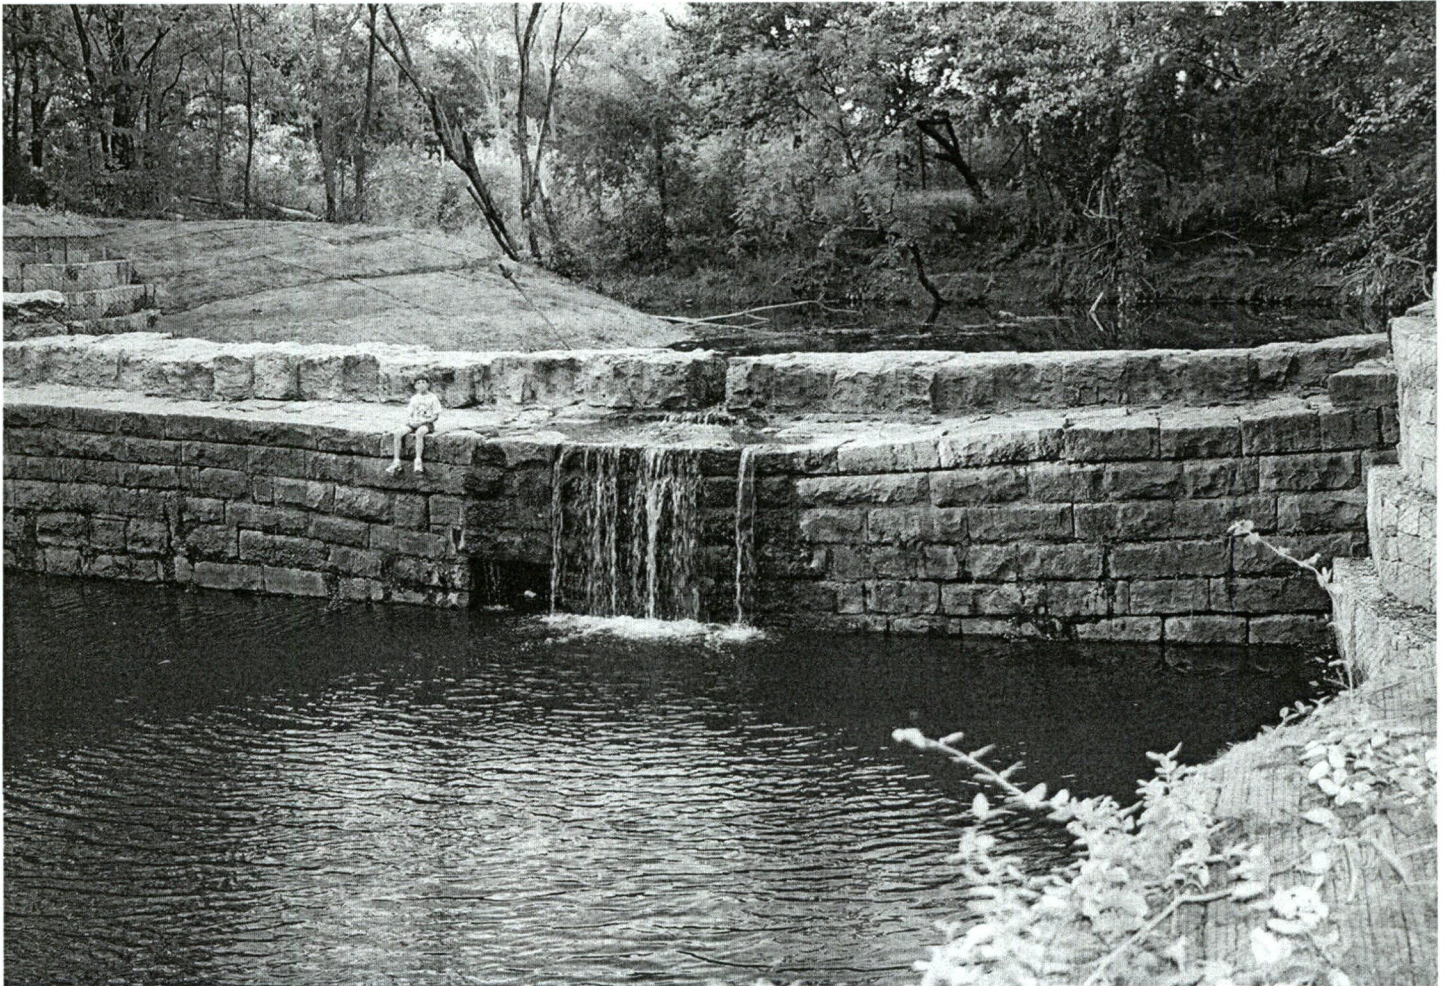
View southeast to northwest.

On left and right, photo shows erosion control gabions installed in 2002 / 2003 after 1999 study by Randal W. Moir, Ph.D., Historic Preservation Consulting Services. Angling upward from the reservoir is the sluice gate metal rod, extending approx 6' above the stone dam.

The dam has a sluice gate that was used to keep sediment from filling in the upstream pool too quickly. The sluice gate's tunnel is visible from downstream and is five feet wide near the center of the dam. The tunnel runs about eleven feet through the core of the dam and was accessed from the upstream side after a gate was opened. Its roof stands approximately two feet above the thrust pool and its floor is approximately two feet below the plunge pool water level. The sluice gate mechanism apparently was operated by a tall iron rod which rose about six feet above the dam. It had been bent slightly by major floods and appears to date from the 1870's. It is a solid iron rod about three inches in diameter and is threaded along its upper-most end. The rotted ends of two wood braces which formed the outer frame of

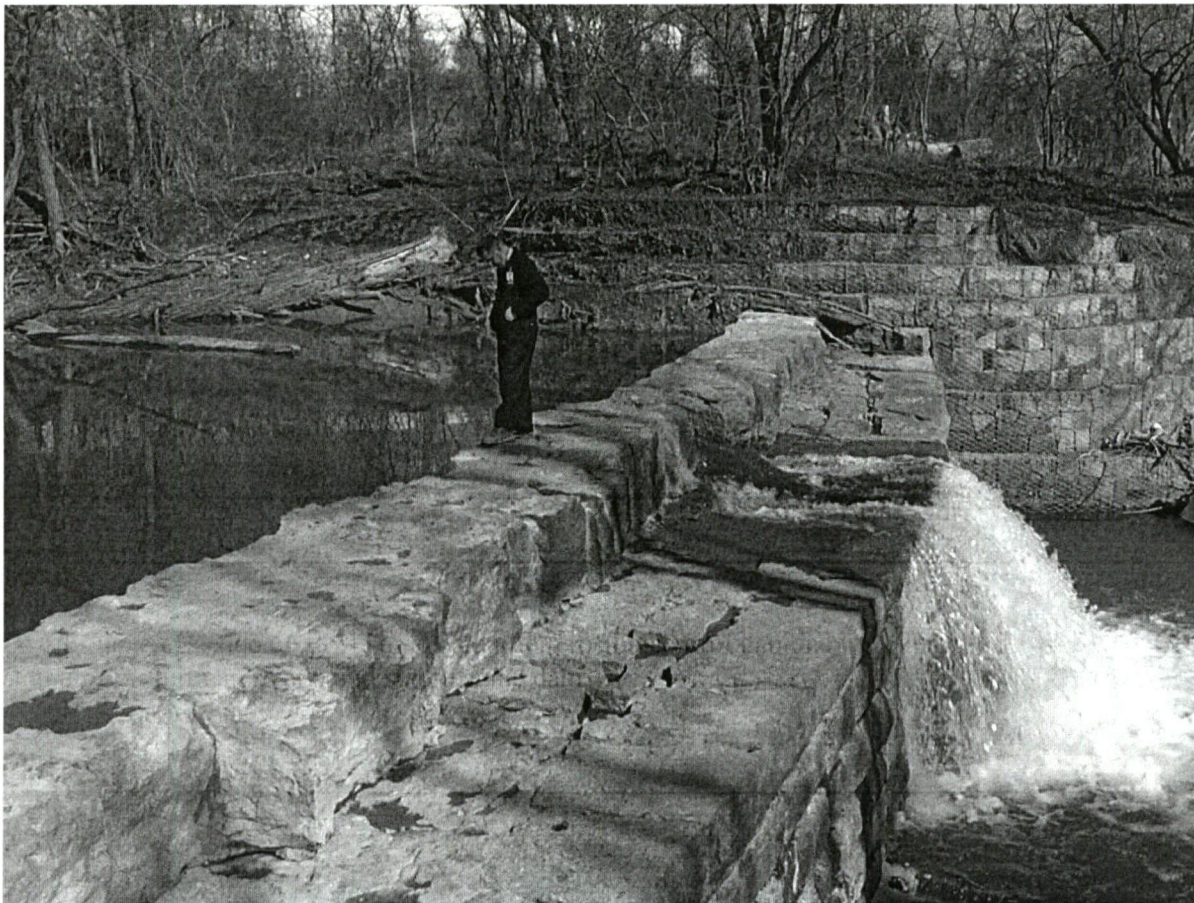
View from west side to east side of 1874 stone dam after erosion control gabions were installed by the City of Allen in 2002 / 2003 to prevent further erosion and stabilize the dam.

The dam appears to consist of two stages of masonry construction. Most of it is made from large roughly shaped sandstone blocks about 15 inches thick used to construct the bulkhead. There are six courses of these blocks showing above the plunge pool's waterline. On top of the dam is a single row of large and thicker blocks, called capping stones that were used to raise the height of the dam sometime after it was originally constructed. These blocks form a straight topped crest while the more massive section of the dam was sloped to drain toward the center. One of the capping stones was removed years ago and the water flowing over the dam in these photos is passing through this gap in the capping stones.

The 1874 stone dam probably was the largest structure on the immediate water station premises until the 1912 dam (demolished) was built by Southern Pacific Railway. The central section of the 1874 dam is about 69 feet long and 10 ft 8 inches wide at its widest part. It forms a large bulkhead made from six courses of large stone blocks currently above the water level of the plunge pool. The courses raise the dam about 8.5 ft above the plunge pool at its flanks and only about 7.8 ft in center, indicating that the broad top of the structure slopes inward toward the middle.

The dam displays evidence of a second phase of construction consisting of minor modification. It has a single course of large, rough-cut stone blocks set on top of its broad flat crest, added after the main part of the structure was constructed. The added blocks are not the same shape as the main part of the dam, and are set with Portland cement, whereas the other stones in the dam were set using soft mortar. The eastern flank of the dam shows the alteration where the added capping stones have filled in the older shape of the dam. These added blocks (also known as capping stones) raised the height of the dam by two feet and increased the capacity of the small reservoir upstream. The capping blocks are not identical in size and shape although they all are crudely rectilinear. They are generally about 50 inches deep and 22 to 25 inches high, with lengths varying from 48 to 53 inches. In comparison to the rest of the masonry work, the capping blocks are less uniformly finished and much thicker, and are taller toward the center of the dam. When one views it at eye level from down stream, it looks as if the dam has sagged in the middle since its six stone courses are not horizontal but bow about nine inches downward towards the middle of the dam. The purposely engineered slope draws water to the center of the structure. When very high flows occur, the entire crest of the dam is topped and creates a waterfall about 65 feet wide. A major flood would submerge the entire dam along with its flanking abutments. The greatest threat of erosion occurs along the dam's flanks when moderate flood levels are present (Moir 1999).

The dam has a notch in the capping stone course that allows water to flow through it when the pool behind the dam is below its crest. This notch was created late in the use of the dam and it shows evidence that it was formed by physical force. A crack has formed in the adjacent capping stone just on the east side of the notch and evidence of concrete is adhering to the stone on the west side. The notch might have been added for holding the iron intake pipe when the 1912 reservoir was built.

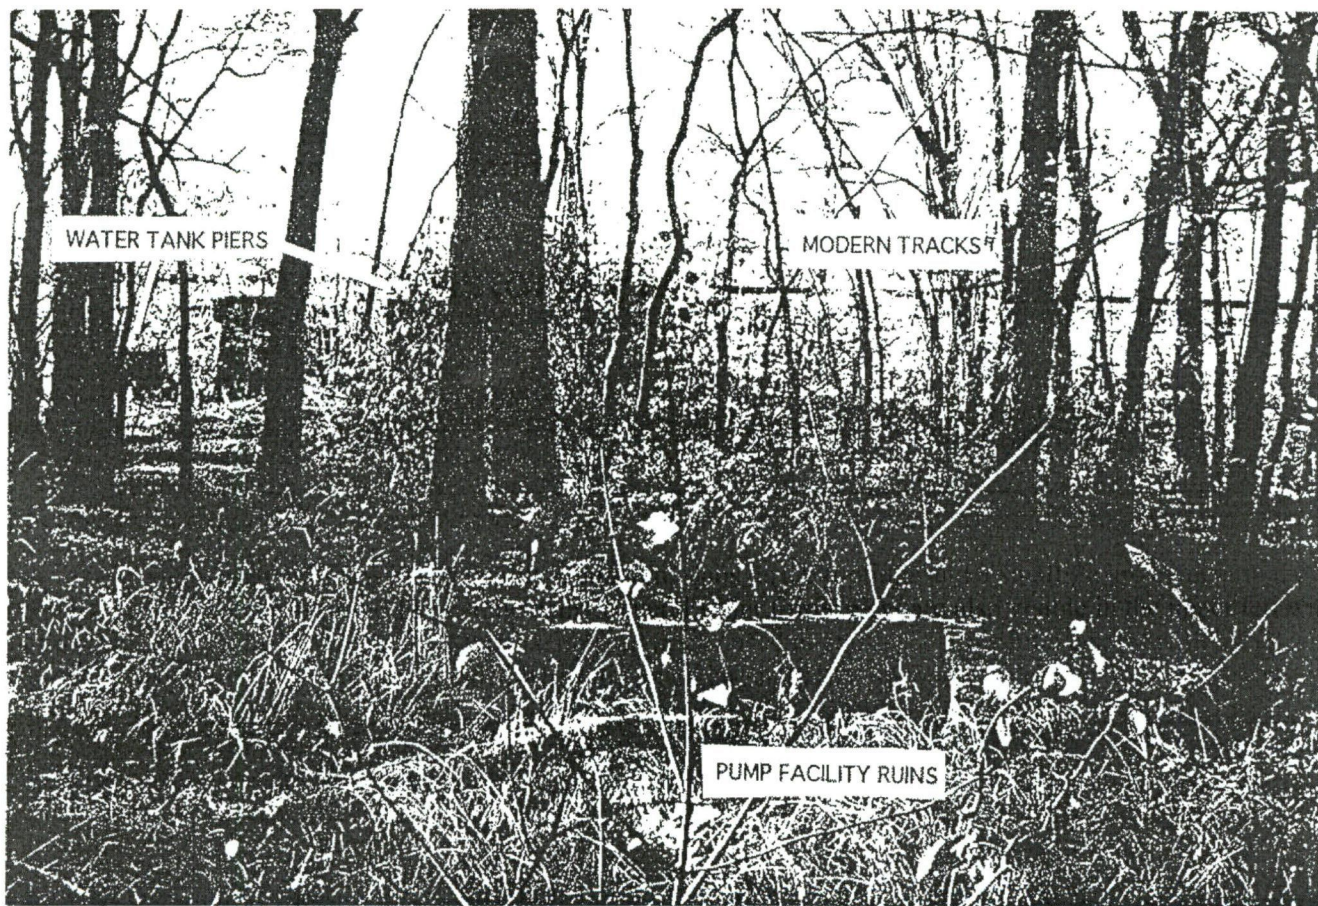
Remains of the Allen water station's pump facility's concrete slabs, brick footings and a small pit are evident in the foreground about 120 feet west of the 1874 stone dam. Several water tower piers are also visible in the upper left with the current tracks across the top of the photo. Machine pressed bricks used to construct part of the pump facility suggest that the facility may have been extensively upgraded when the much larger 1912 dam was constructed downstream.

Located 113 feet west of the dam are the ruins of a pump house facility. It consists of concrete slabs and brick and cement footings covering a 10 by 20 foot area. A small depression about 6 by 5 feet is very evident on the eastern side of the ruins. The age of the bricks used in the foundation of one section of the ruins date from after 1900. This suggested that the visible ruins were possibly from the 1912 water system when the larger dam was constructed downstream. It is likely that the railroad upgraded the pump facility when they increased the reservoir's capacity by at least a factor of fifteen. An iron intake pipe was probably installed about the same time that the pump facility was upgraded. By 1999, the eastern section of the iron intake pipe had fallen into the plunge pool as erosion re-exposed the western half of the 1874 stone dam buried beneath post-1912 sediment. The iron intake pipes have been removed are now in storage for future exhibit.

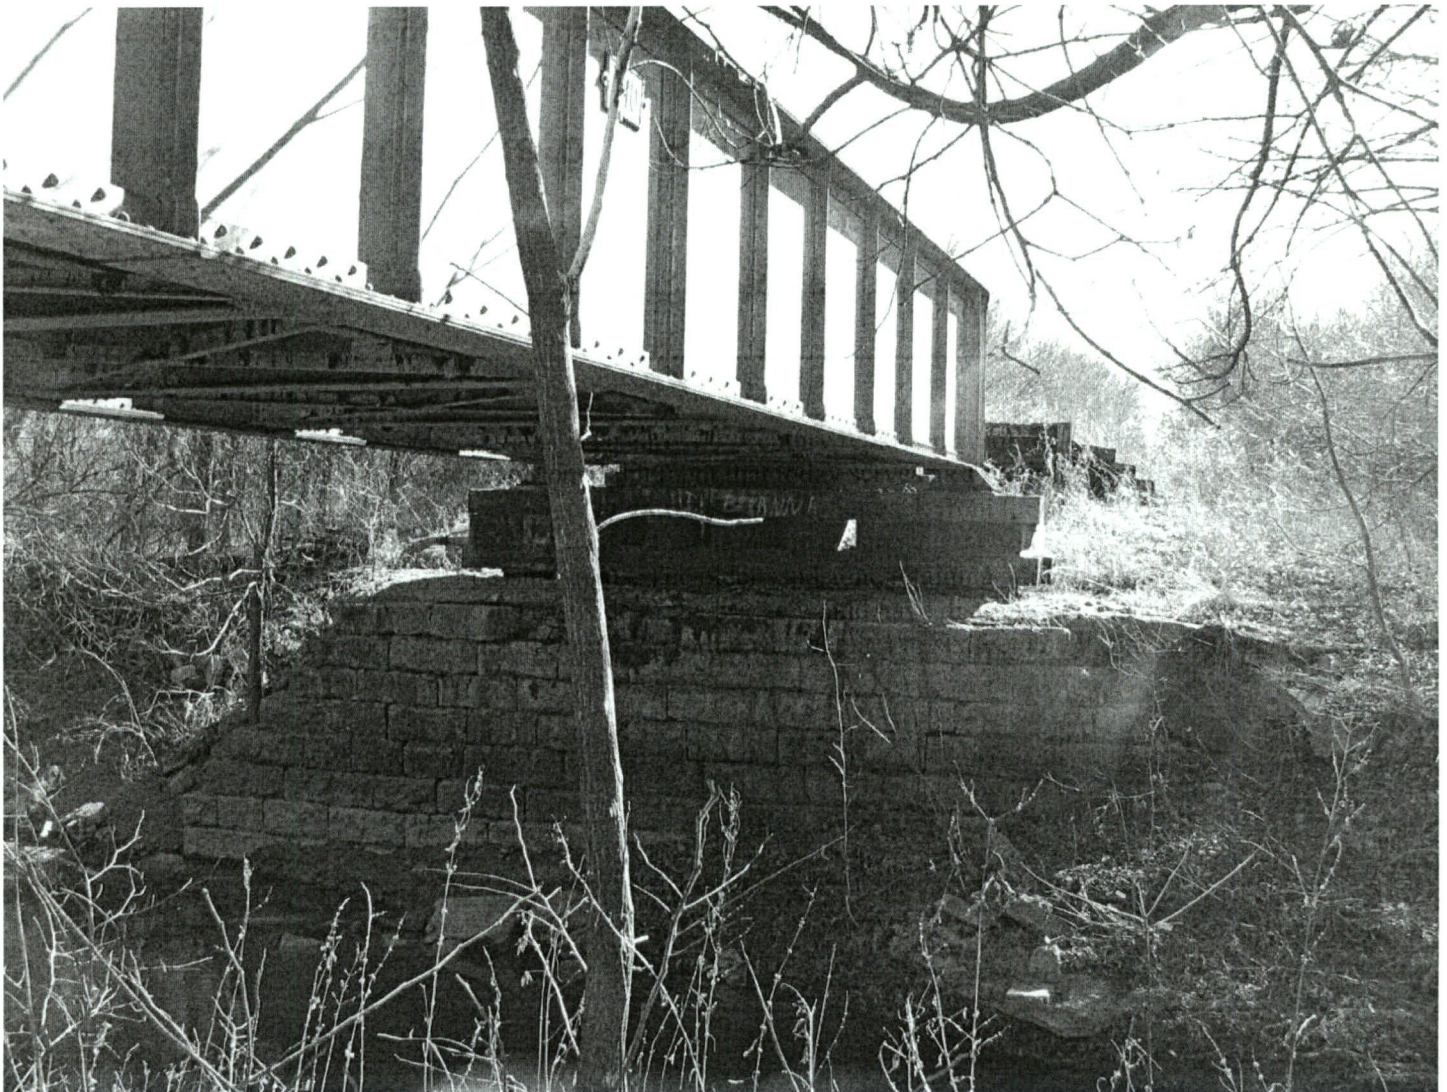
1910 rail bridge over Cottonwood Creek. This is an early 20<sup>th</sup> century replacement of the original H&TC rail bridge. View north to south. Note the older stone masonry abutment that today serves as a retaining wall. The top of the wall and adjacent ground surface were covered by concrete to prevent erosion. Set back from the edge of the wall are large wood timbers and wooden blocks used to seat the south end of the iron bridge carrying the tracks. Three courses of specially stacked timbers distribute the weight of passing trains. The older sandstone retaining wall shows some major fractures that can be traced through five courses where the east side of the bridge would have distributed its load when the bridge sat on top of the wall. Today the bridge is set back from the top of the wall about 4 to six feet and its weight is redistributed over the concrete surface well back from the stone abutment.

Signage on the steel plate girder bridge identifies the manufacturer as the American Bridge Company of New York as well as the manufacture date of 1910. The steel bridge is apparently an early 20<sup>th</sup> century upgrade by Southern Pacific. To the immediate north of the steel bridge is a short wooden approach trestle most likely built after 1940. On the south side of the creek is a much older masonry abutment that serves as a retaining wall. The top of the wall and adjacent ground surface have been covered by concrete to prevent erosion. Set back from the edge of the wall are large wood timbers and wooden blocks used to seat the south end of the iron bridge carrying the tracks. There are three courses of specially stacked timbers to distribute the weight of passing trains. The older sandstone retaining wall shows some major fractures that can be traced through five courses where the east side of the iron bridge would have distributed its load when the bridge sat on top of the wall. Today, the bridge is set back from the edge of the wall about four to six feet, and its weight is redistributed over the concrete surface well back from the stone abutment.

The sandstone blocks in the older abutment on the south side are similar in shape and material to the stones in the 1874 dam, supporting the premise that the masonry abutment is part of the original construction of the H&TC rail line, although the abutment shows more uniformity in the stone blocks. The selection of shorter and more uniform rocks in the bridge abutment is probably an engineering consideration to avoid causing fractures through blocks as the wall shifted over time due to train traffic and bearing loads. There are seven courses evident above the creek bottom and there should be several more buried to give the abutment a firm foundation.
