United States Department of the Interior
National Park Service
National Register of Historic Places Registration Form

Historic Name: King-Woods Farmstead
Other name/site number: King-Woods Farmstead
Name of related multiple property listing: NA

Street & number: 920 E Court Street
City or town: Seguin State: Texas County: Guadalupe
Not for publication: [] Vicinity: []

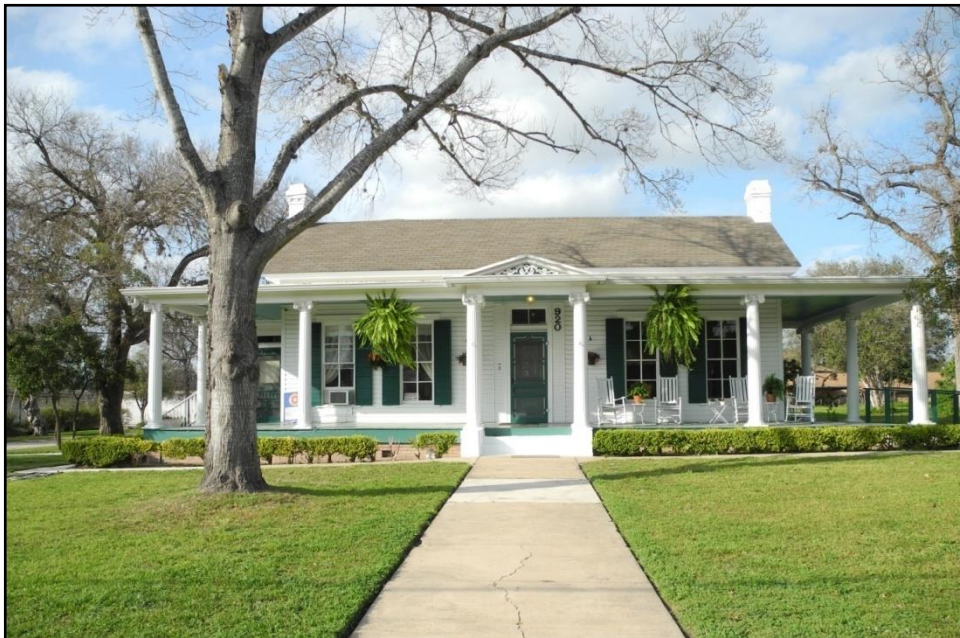
PHOTO 1: King-Woods House, south elevation, facing north (February 1, 2017).

The front façade has a symmetrical AABAA arrangement with a central entrance flanked by two window openings on each side. The entrance contains a single entry door topped by a two-light transom window. Vertical bead board panels used as infill are found to either side of the door, suggesting that the door opening was reduced in size—likely in 1893 when the house was remodeled to its Neoclassical appearance. The door and transom openings are framed with flat trim. The door itself is highly elaborate, with a bottom panel containing a decorative intaglio carving and a large window with etched glass in its center and leaded and stained glass lights in a 3” rectangular border around its edges (Photo 10). On either side of the window and bottom panel are carved spindles with alternating cylindrical and blocky shapes. Delicate sawtooth trim underlies the window, and the knob backplate is cast iron with carved floral motifs. A plain, historic-age wood screen door is attached to the exterior. The four window openings on this primary façade have tall, narrow, 4/4 double hung wood windows, louvered shutters, and wide wood trim with a molded strip along the top. The siding on the front elevation is wood drop siding with a thin decorative bead between each lap.

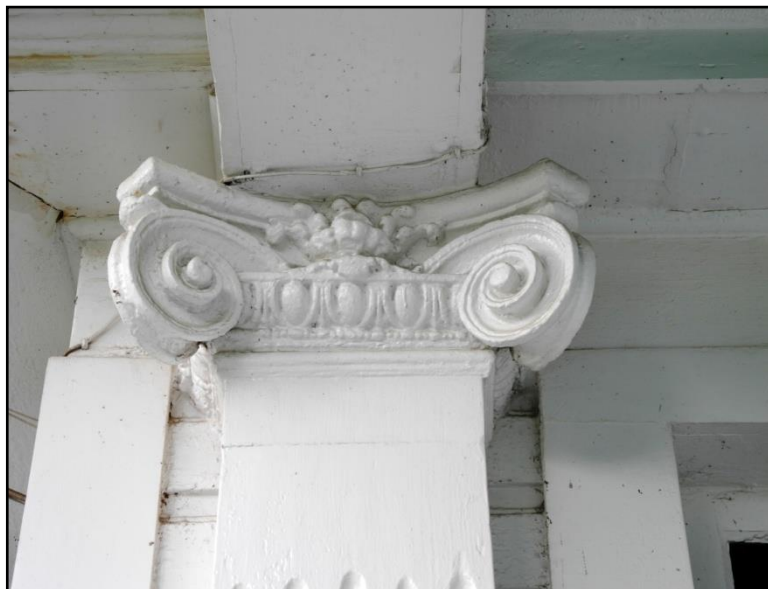
PHOTO 8: King-Woods House, capital on pilaster (west elevation), facing east (February 1, 2017).

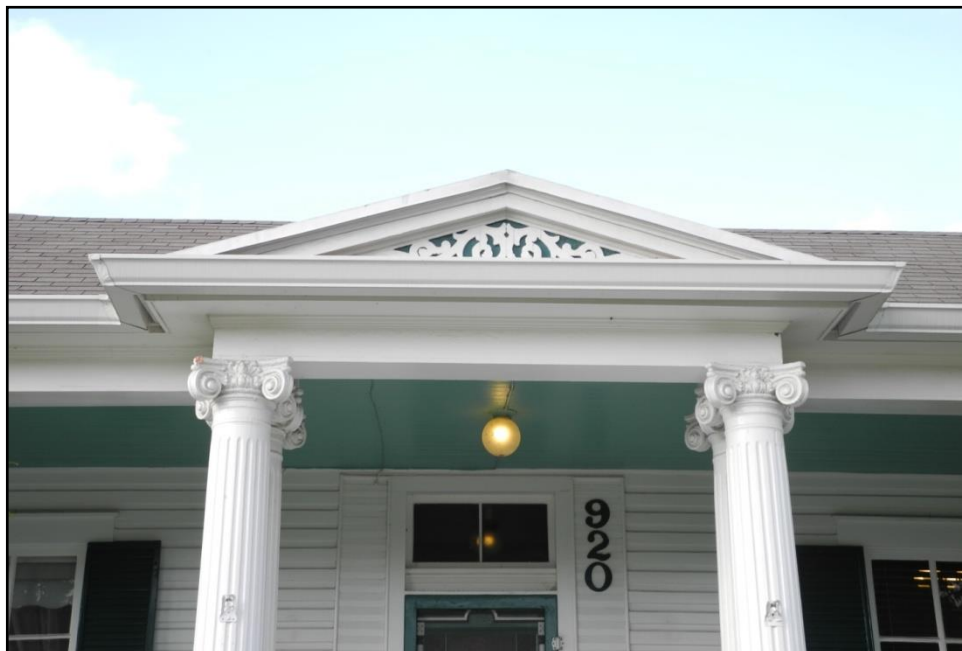
PHOTO 9: King-Woods House, pediment at entrance, south elevation, facing north (February 1, 2017).

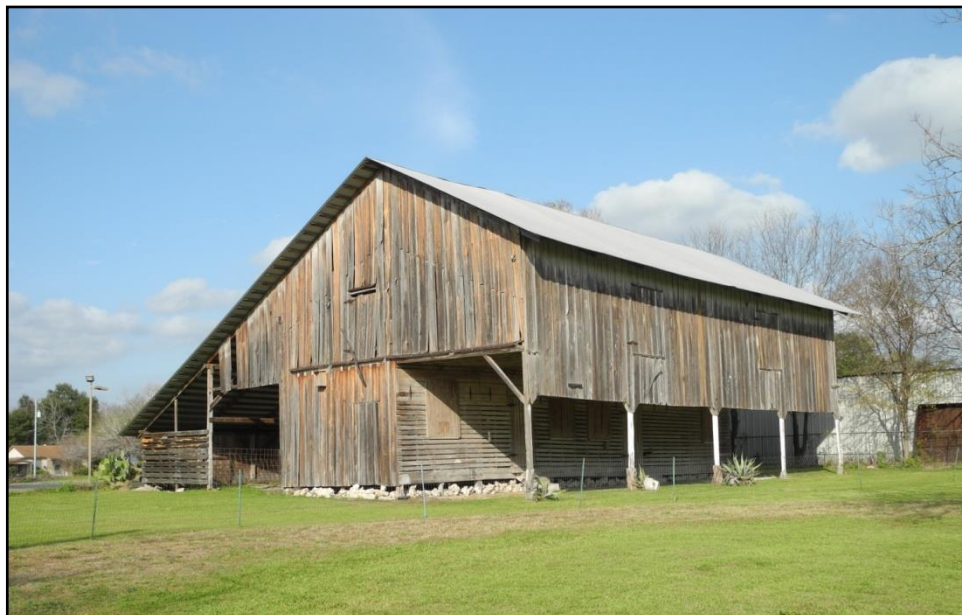
PHOTO 11: King-Woods Multi-purpose Barn, c. 1895, west and south elevations, facing northeast (December 10, 2016).

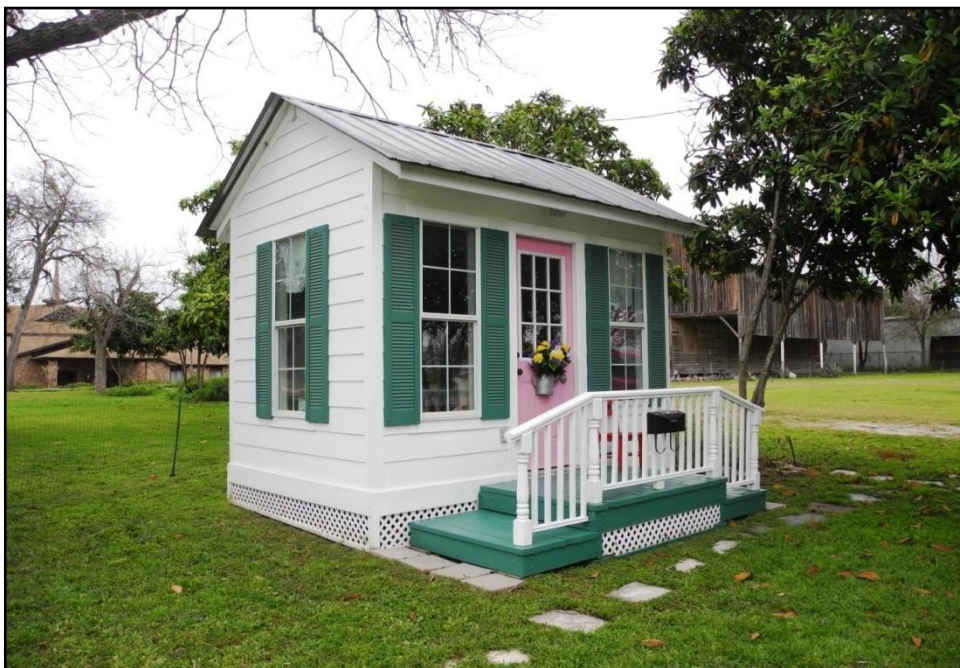
PHOTO 18: King-Woods Playhouse, 1947, west and south elevations, facing northeast (April 23, 2017).

The playhouse is located approximately 35 feet east of the house near the yard's decorative kumquat trees. It is a small wood frame side-gabled building with a footprint measuring approximately 10 by 8 feet (Photo 18). Its siding is asbestos and its roof is standing seam metal. Exterior walls have plain fascia and corner boards and flat window and door trim. The narrow bargeboards on the gabled side elevations have small wood "keystone" details. The building sits on a slightly raised foundation and its front elevation has a "Charleston" porch with wide, low steps accessing both sides. Along the front of the porch is a balustrade with turned and square banisters. The foundation is skirted with lattice.

The front elevation is symmetrical, with a central door flanked by two windows. The door is a non-historic replacement with two panels in the lower section and nine rectangular lights in the upper section. The west side elevation has a single window opening. All three windows have fixed wood shutters, replacement vinyl sash, and metal screens. The east side elevation and rear are windowless. Inside, the playhouse has a single room with a vaulted ceiling that follows the roof form. The floor is wood and the walls are smooth and painted.
