NATIONAL REGISTER OF HISTORIC PLACES
REGISTRATION FORM

HISTORIC NAME: Chapman House
OTHER NAME/SITE NUMBER: NA

Chapman House
Austin, Travis County, Texas

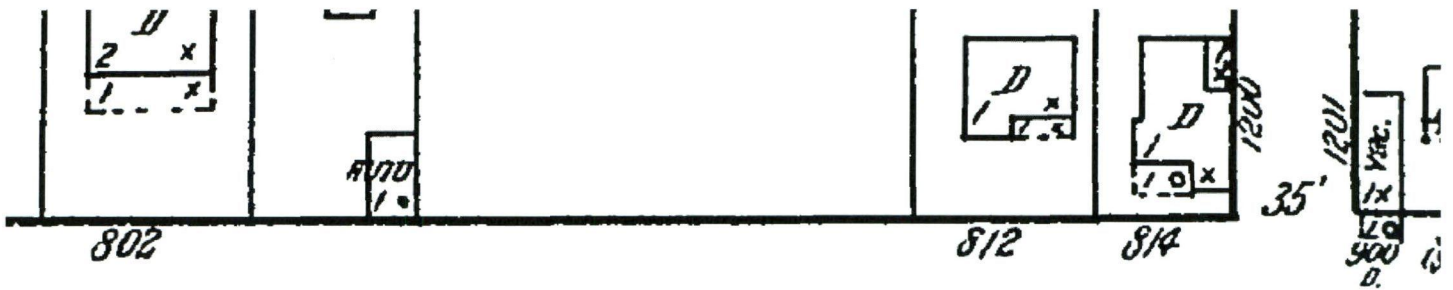
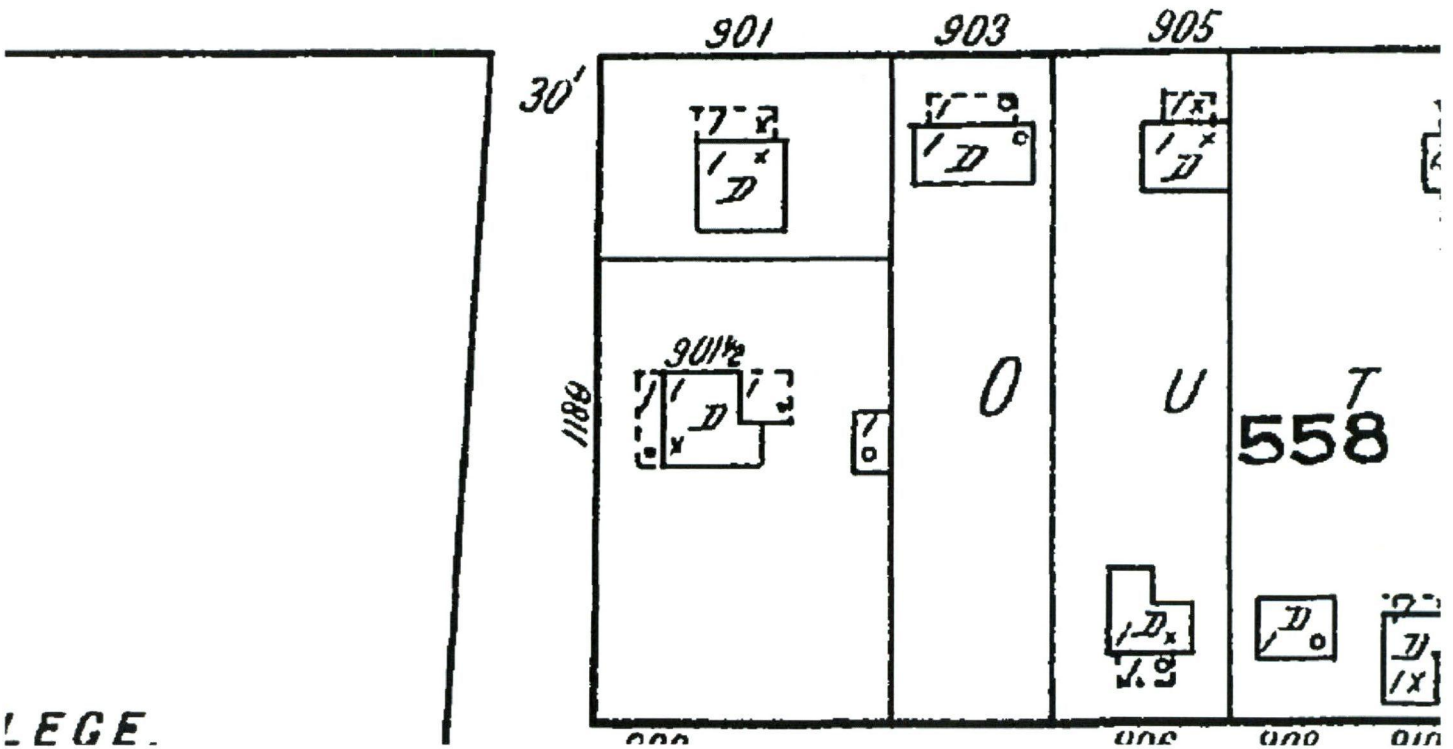
1922 Sanborn Fire Insurance Map. Chapman House at 901 E. 12th Street.

Comparison of buildings on 1901 and 1935 maps indicates that the 1922 scale is not accurate.

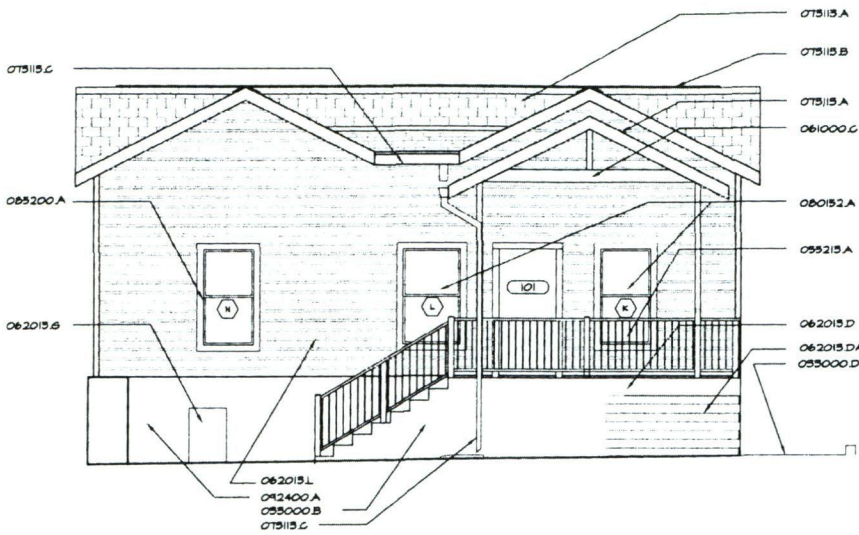
② SOUTH ELEVATION
SCALE 1/8" = 1'-0"

South and North Elevations (from rehabilitation drawing by Carter Design Associates, 2006). No Scale

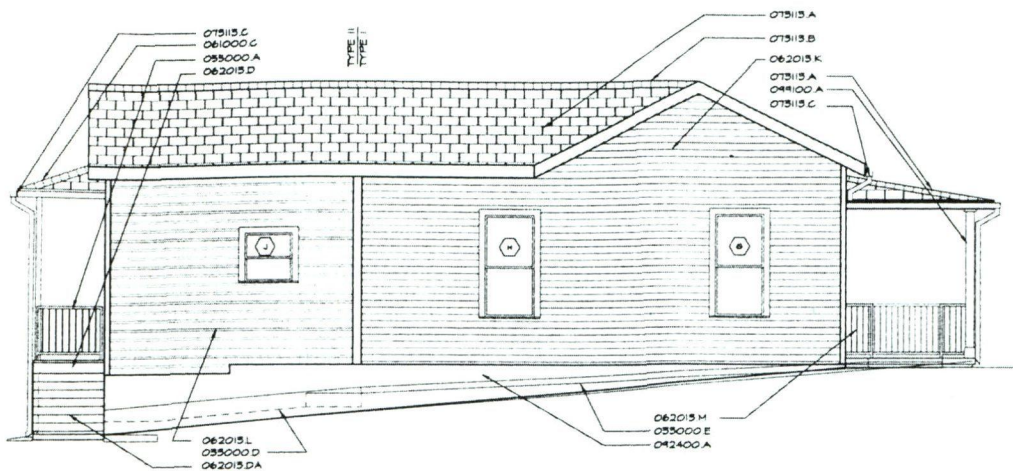
2 EAST ELEVATION
SCALE 1/8" = 1'-0"

East and West Elevations (from rehabilitation drawing by Carter Design Associates, 2006). No Scale

The west and east elevations reveal the original gable-end form of the house, with an addition extending to the south. On the west side, an original one-over-one window in the north portion of the building is located off center towards the front of the house. A visible seam in the siding delineates the front portion of the house from the rear additions to the south. Two smaller windows indicate the location of a rear bedroom (identified as an open porch on the 1901 Sanborn map), and the kitchen. The east elevation also features three windows: a six-over-six window centrally placed under the gable at the front of the house, an identical six-over-six window providing light to a central bedroom, and a small bathroom window. The rear (south) elevation of the building features the twin gable ends of the additions and an off-center door accessed by a small flight of stairs and a small entry porch covered by a hipped roof. The porch features the same boxed columns and turned wood banister as the front porch. An at-grade door leading to the crawlspace is located between the foot of the stairs and the southwest corner of the building.

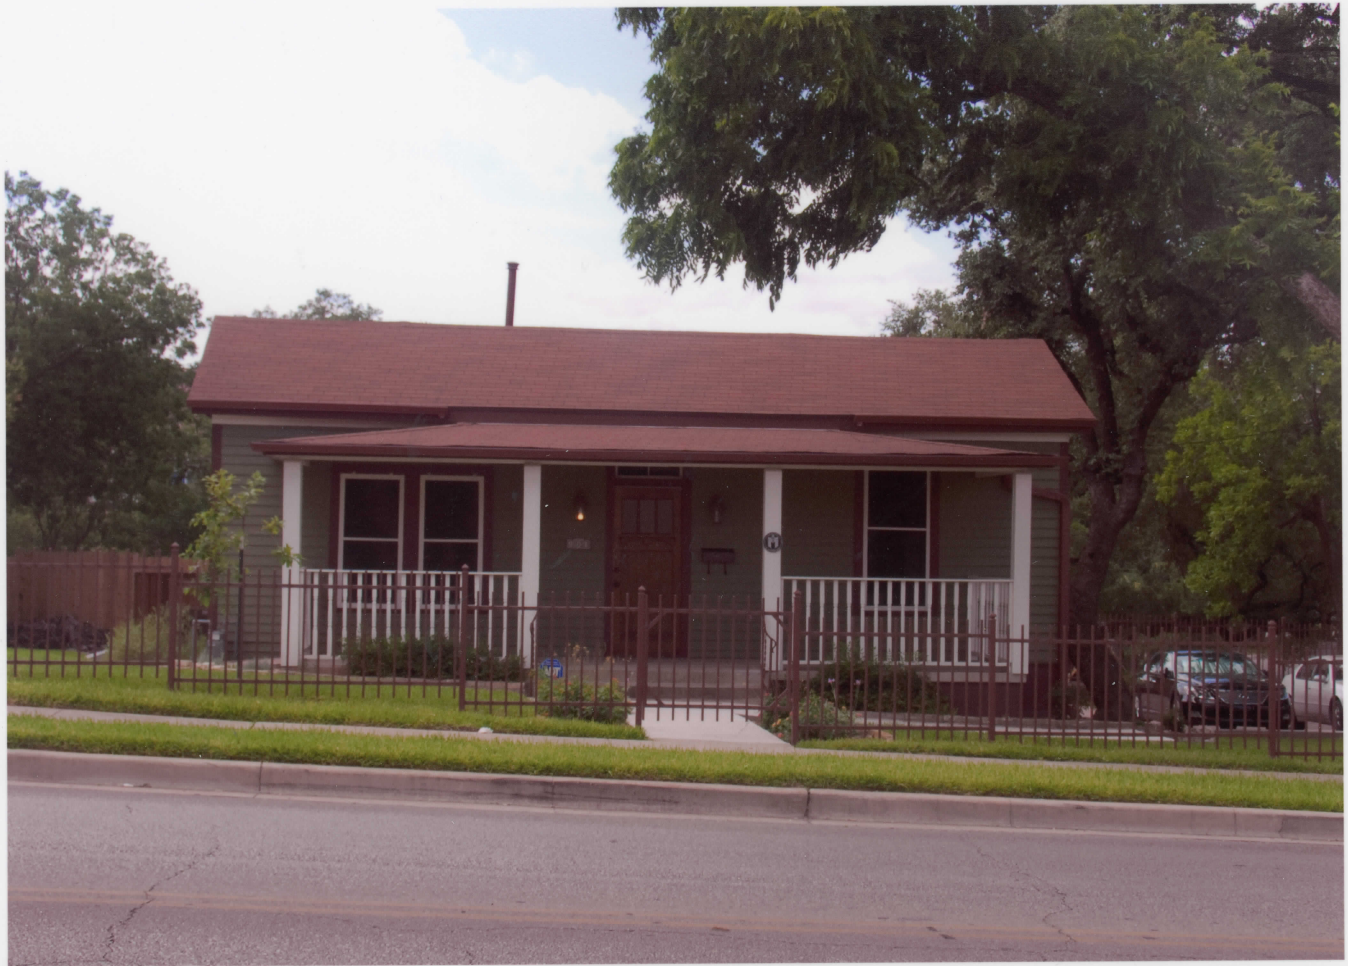
Chapman House
Austin, TRAVIS. Co. TX
photo 1

Photo 1
North elevation
Camera facing south

The primary (north) elevation features a nearly full-width porch with a gabled roof, supported by wood box columns. The porch is enclosed by a wood rail with turned wood balusters. The columns and railing replaced the mid-20th century decorative metal porch supports during the recent rehabilitation. The building is accessed through a single central door topped by a two-light operable transom. The stained and varnished door features a large single panel and three vertical lights, and most likely dates to the early 20th century. Fenestration of the north elevation is not symmetrical: the east side features paired one-over-one double-hung sash windows, while the western half features a single one-over-one window. The west window is taller than the paired windows and top of the screen and trim is partially covered by the angled porch roof. The porch has a concrete deck, and appears to replaced a much narrower porch prior to 1935.

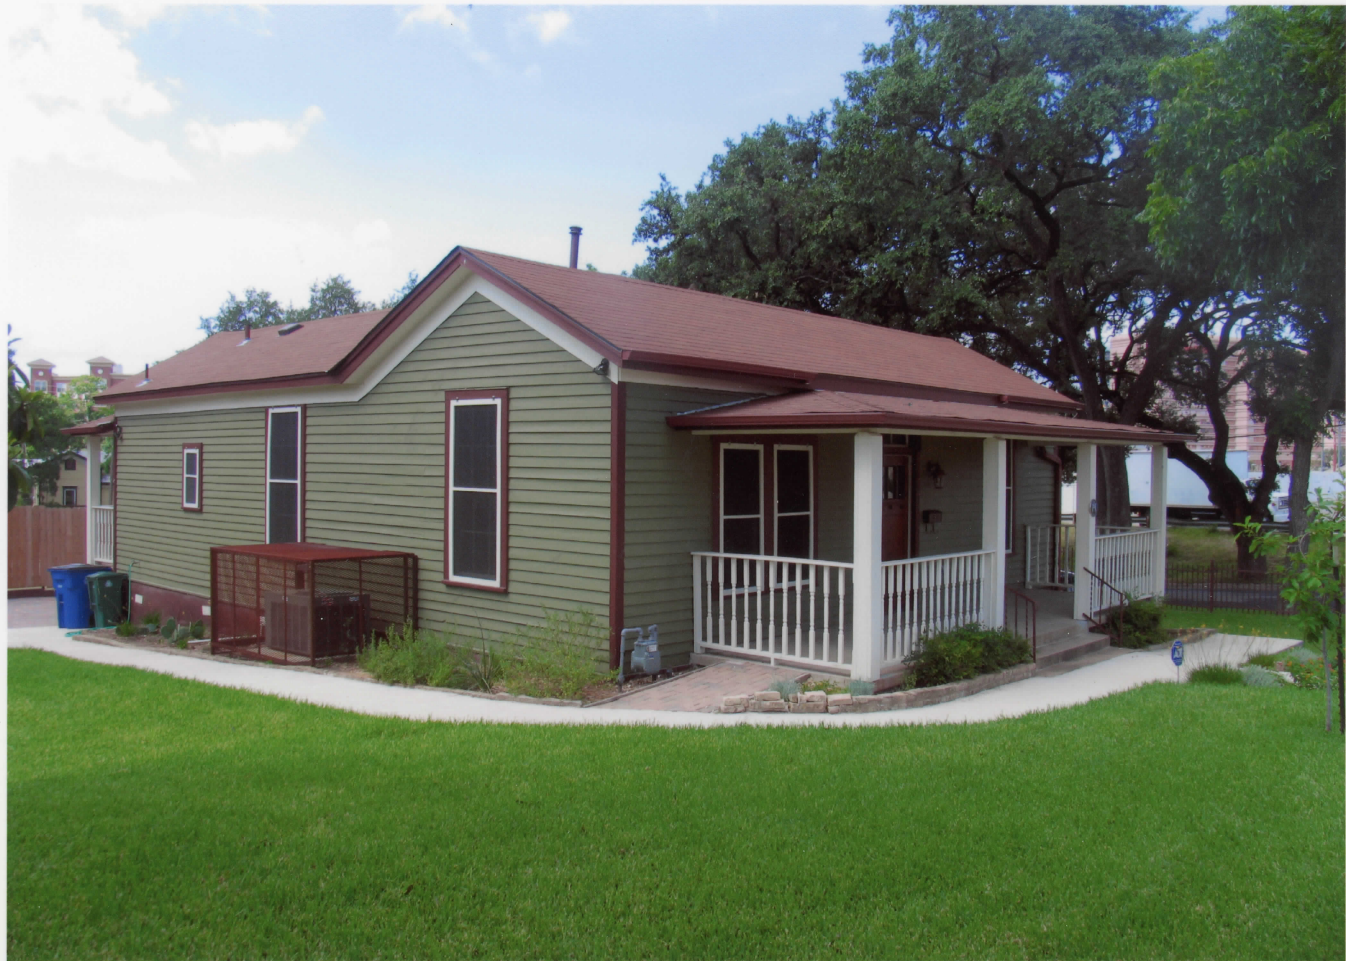
Chapman House
Austin, Travis Co. TX
photo 2

Photo 2
Northeast oblique
Camera facing southwest

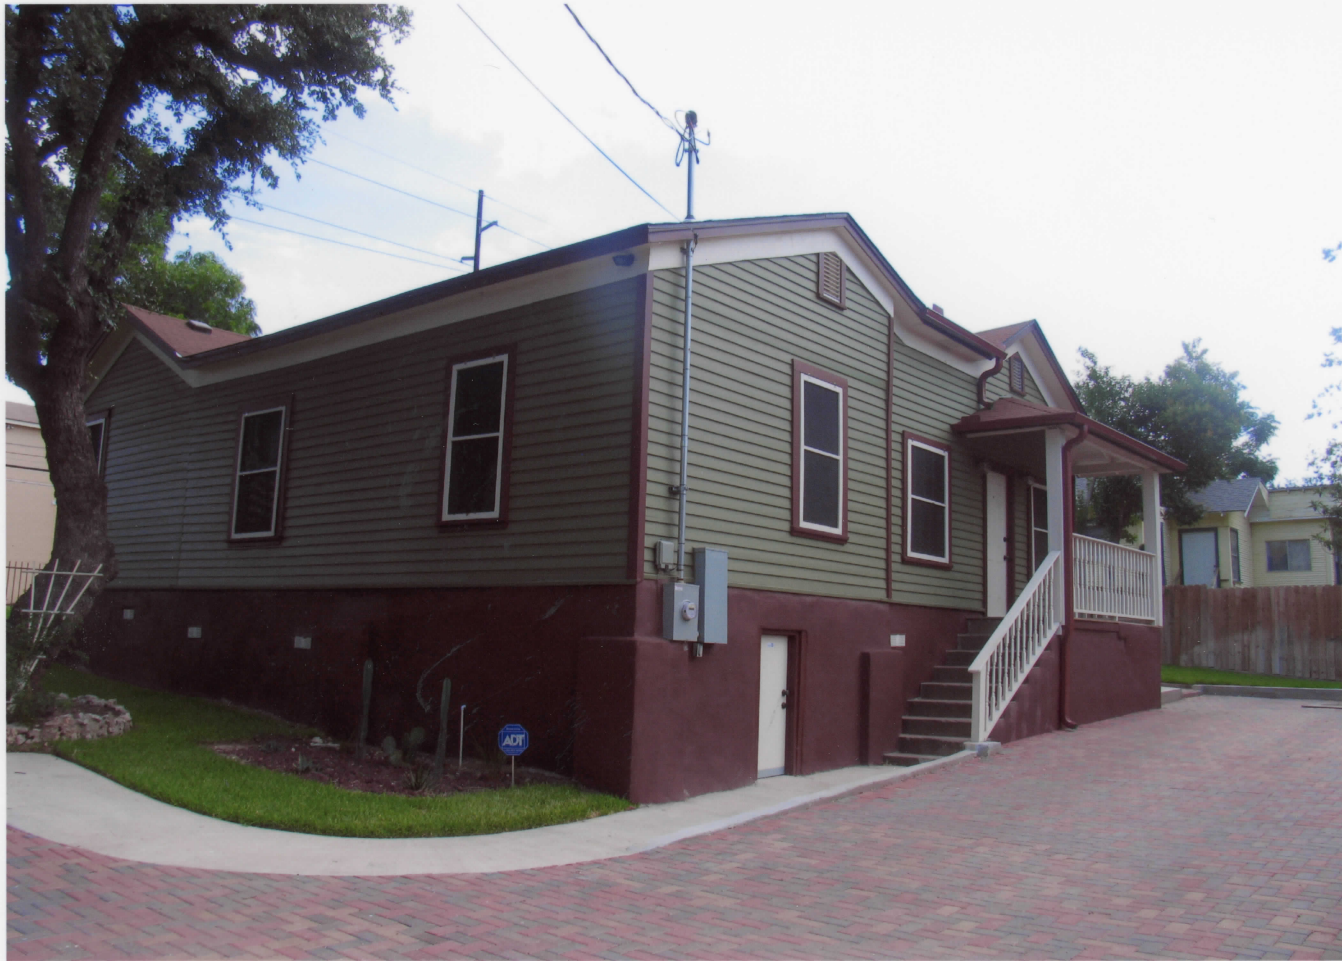
Chapman Hoose
Austin, TRAVIS Co. TX
photo 3

Photo 3
Southwest oblique
Camera facing northeast

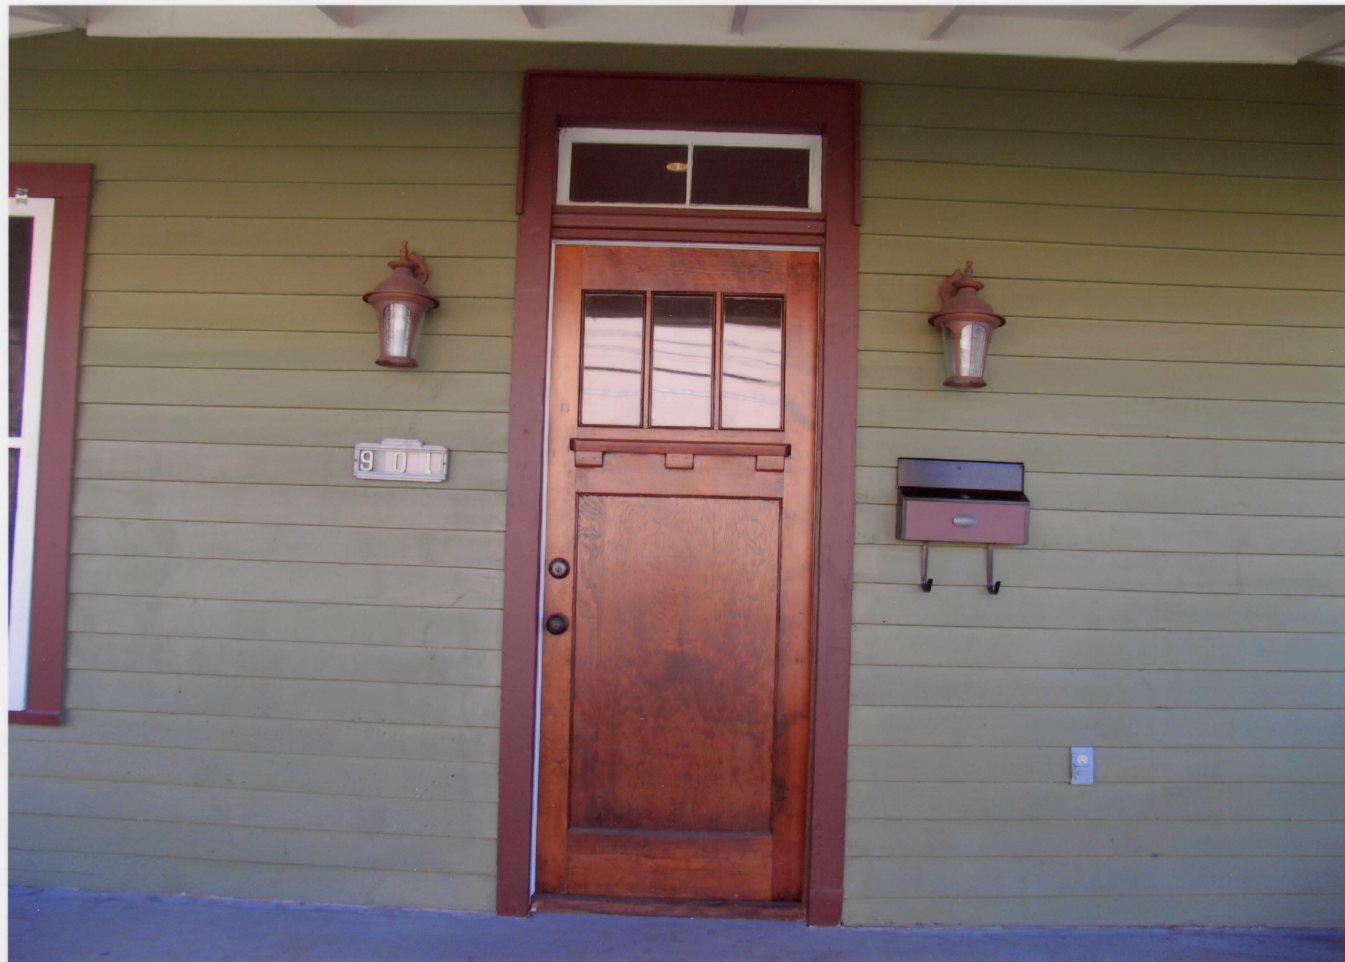
Chapman House
Austin, TRAVIS Co. TX
photo 4

Photo 4
Front door, north facade
Camera facing south
