United States Department of the Interior
National Park Service
National Register of Historic Places Registration Form

Historic Name: Comanche Downtown Historic District

Street & number: Roughly bounded by West College Avenue, North Pearl Street, Oak Avenue, and the rear property line along North Mary Street

City or town: Comanche

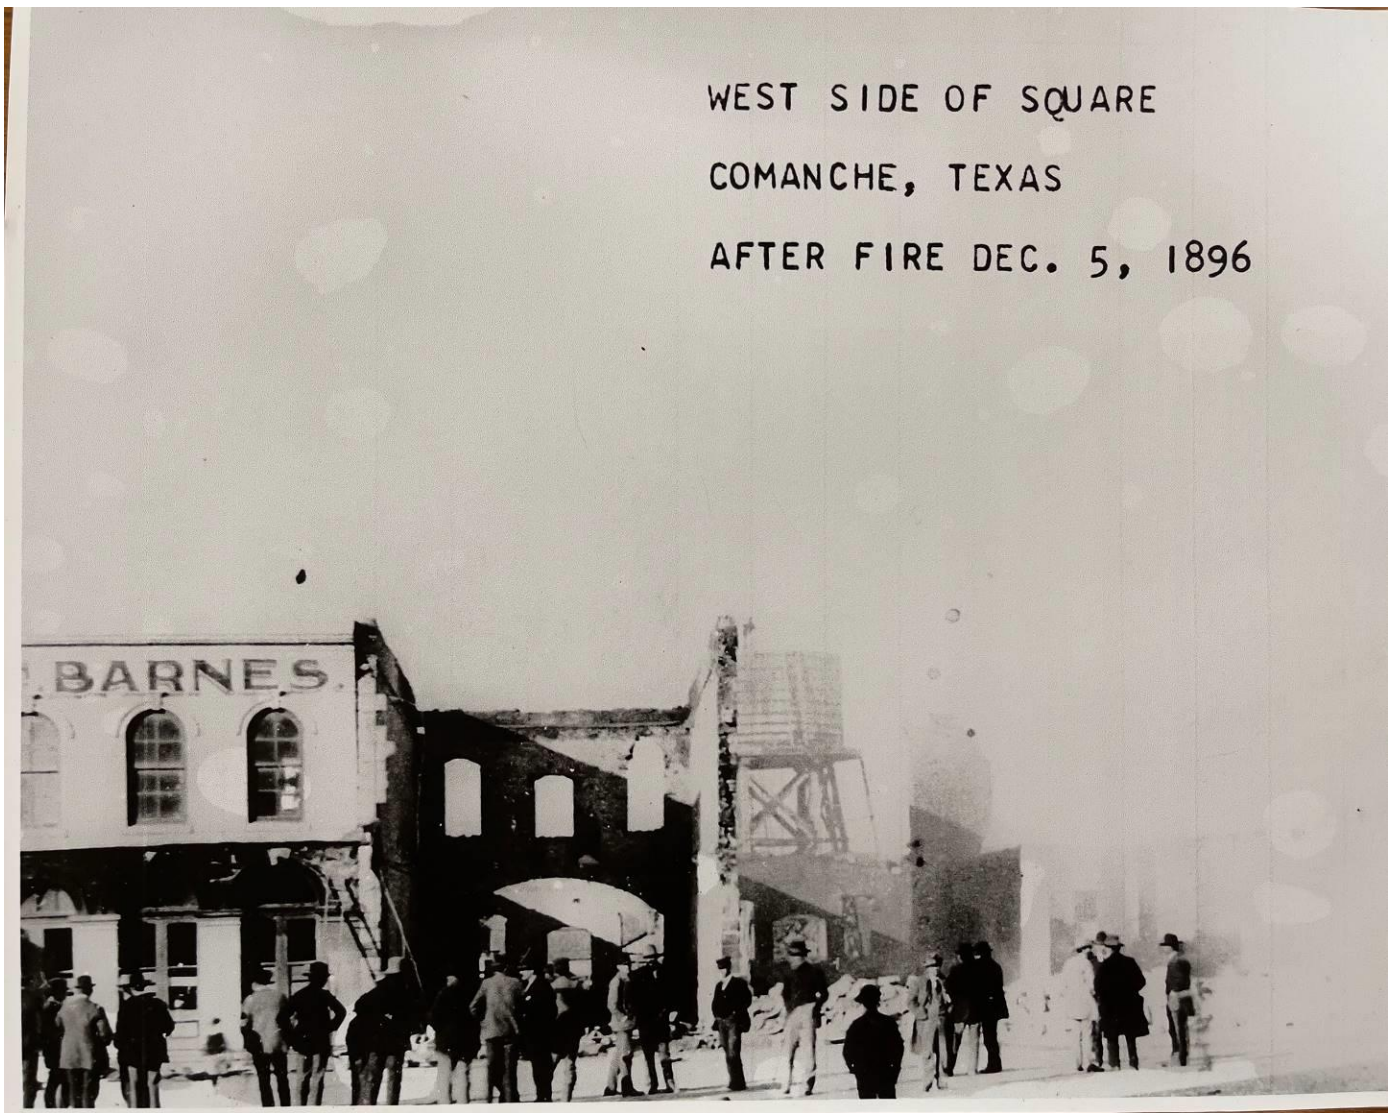
Figure 7 - Northwest corner of the square after the December 1896 fire.
Comanche County Historical Museum

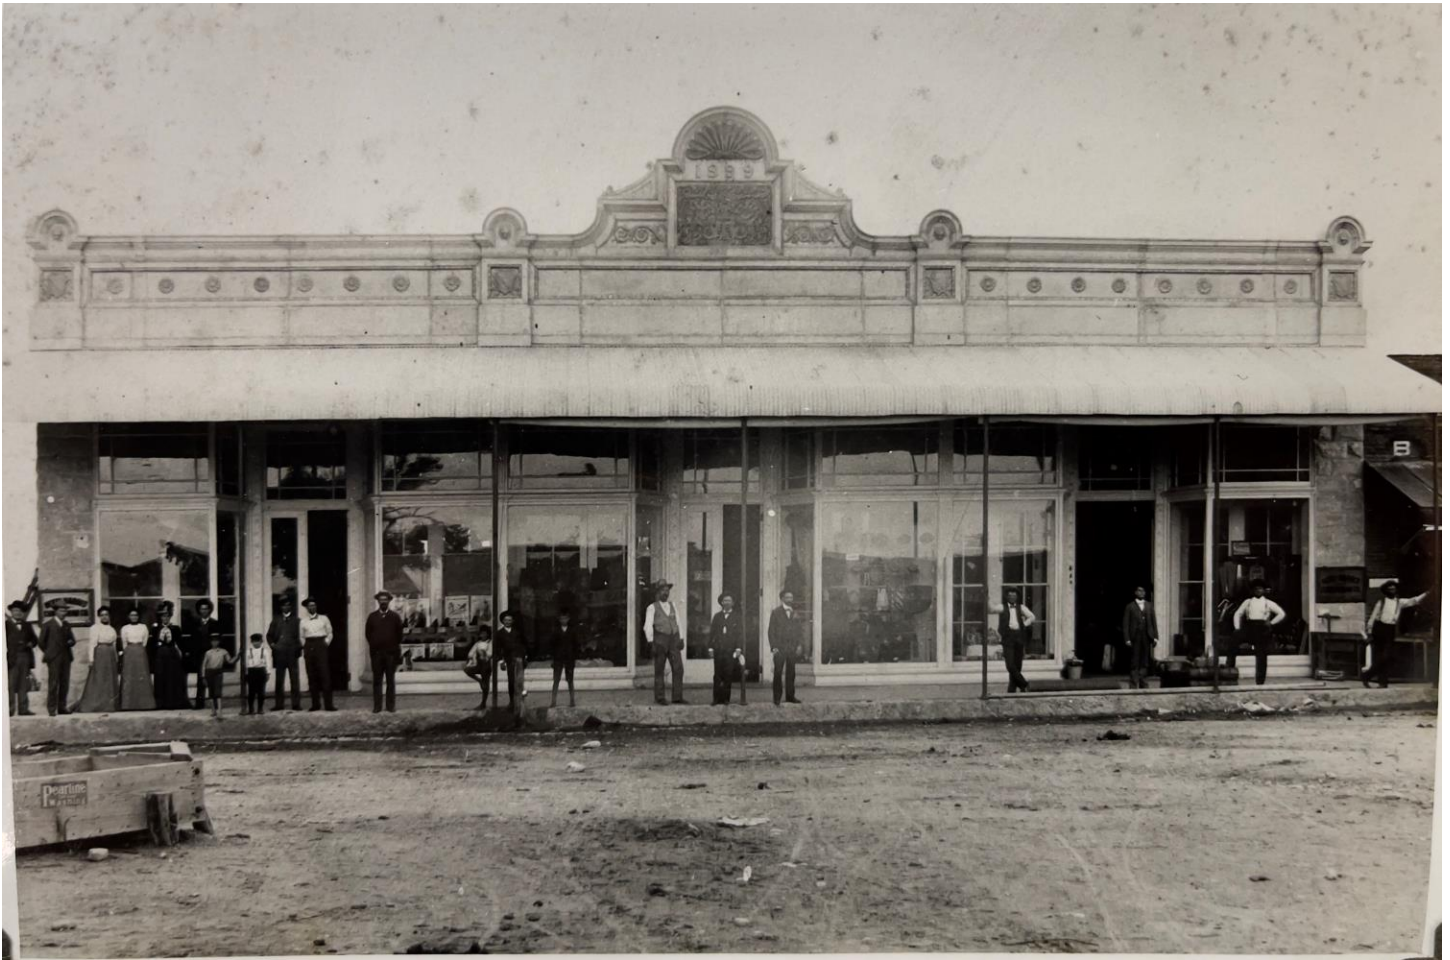
Figure 9 – Neely Harris Cunningham (Resource 24) c.1900
Comanche County Historical Museum

Comanche Chief.³¹ All of these were replaced by one story stone buildings completed in about April of 1897 (Figures 3, 8, 12, 13).³² These were accompanied by a large new general merchandise store for Neely-Harris-Cunningham at the southwest corner of the square in 1900 (Resource 24; Figures 9, 10).³³

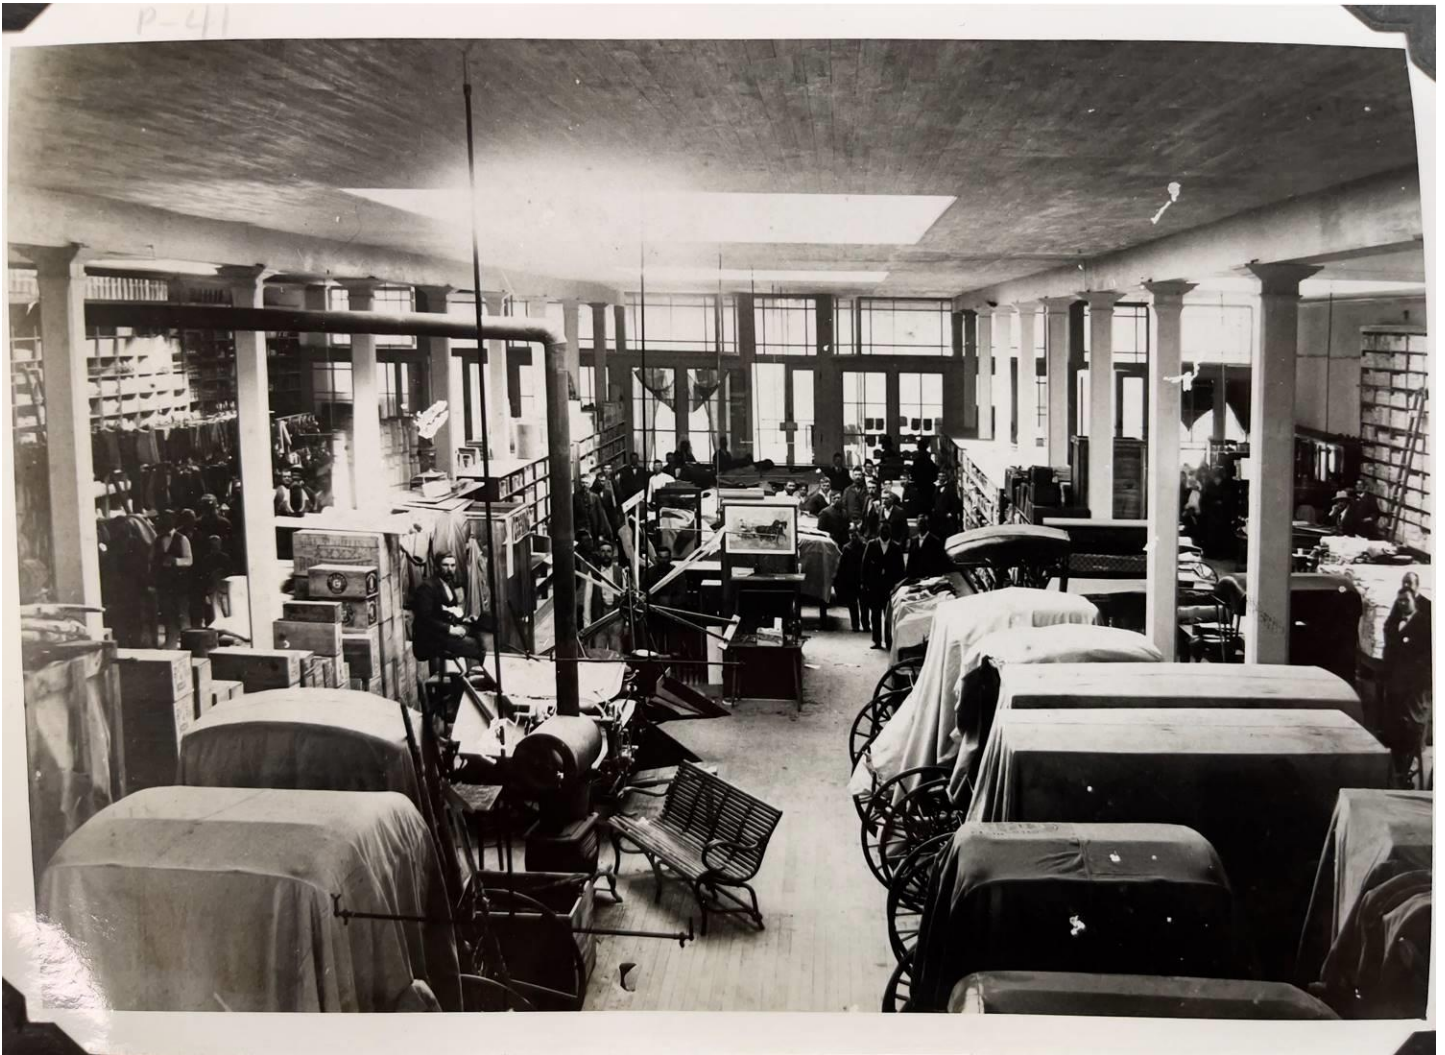
Figure 10 – Neely Harris Cunningham interior (Resource 24) c.1900
Comanche County Historical Museum

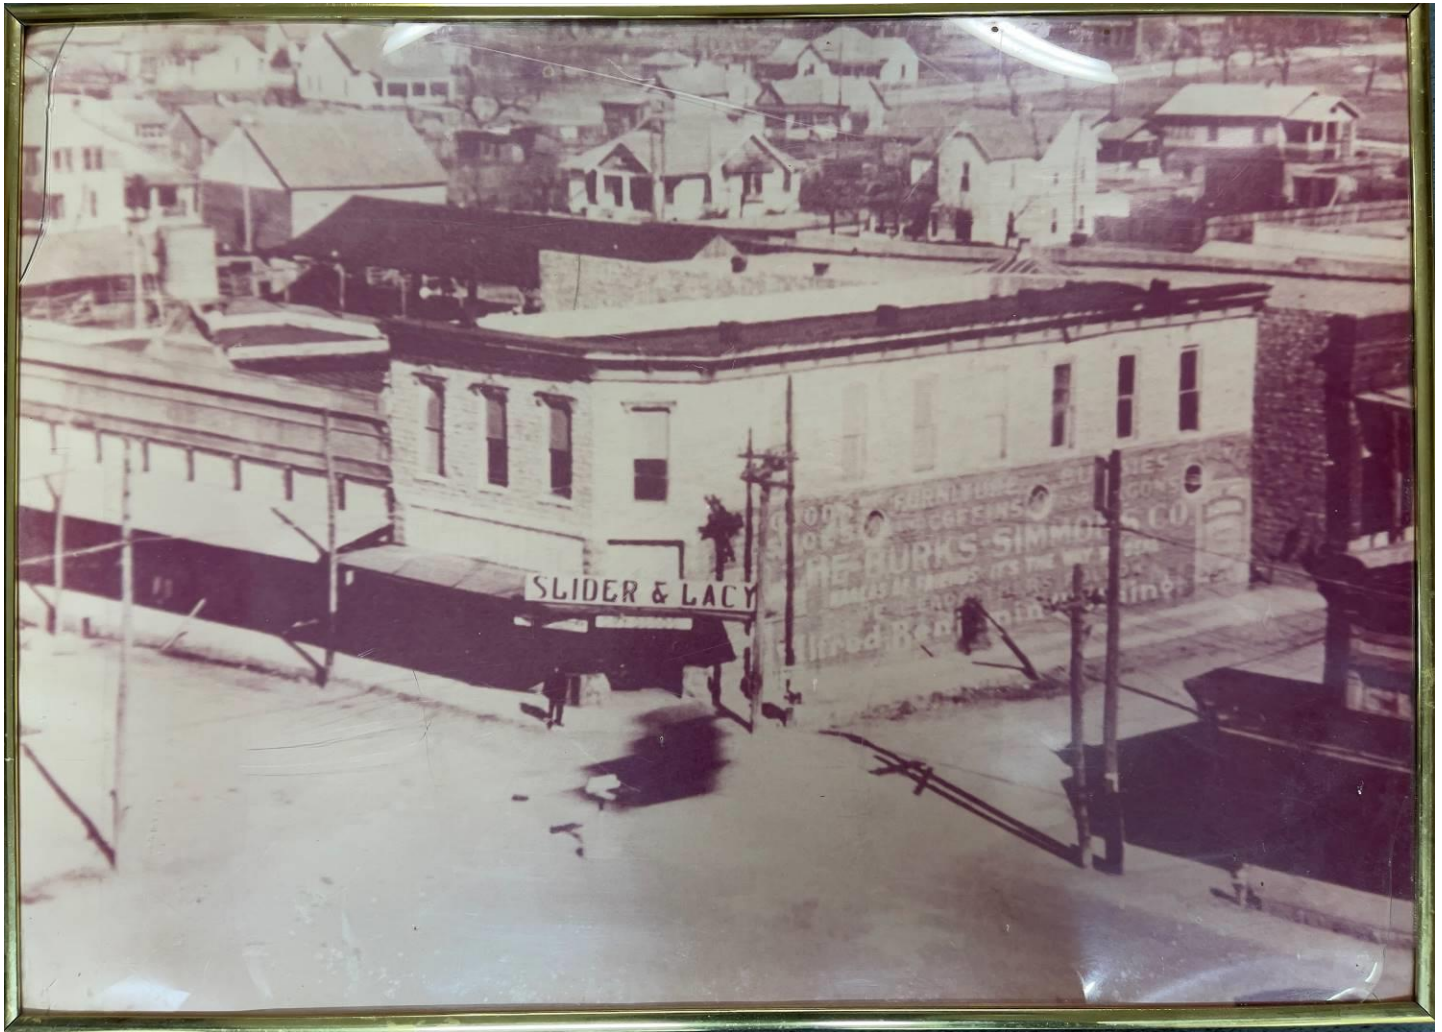
Figure 14 – Brightman Building (Resource 32) c.1905
Comanche County Historical Museum

In the northwest corner of the square are the 2-part Brightman Building (Resource 32; Figure 14; Photograph 29) completed in 1891 and *The Comanche Chief* Building (Resource 31; Photograph 35) completed in c.1900 and remodeled in 1960. Brightman is a 2-part building of heavy limestone construction. The metal ornamentation at the second-floor windows and cornice is missing and the storefront is heavily modified, but it still conveys its historic design. *The Comanche Chief* newspaper occupied the building next door in 1960 and the 1-part primary elevation of stucco with simple ornamentation reflects that period.

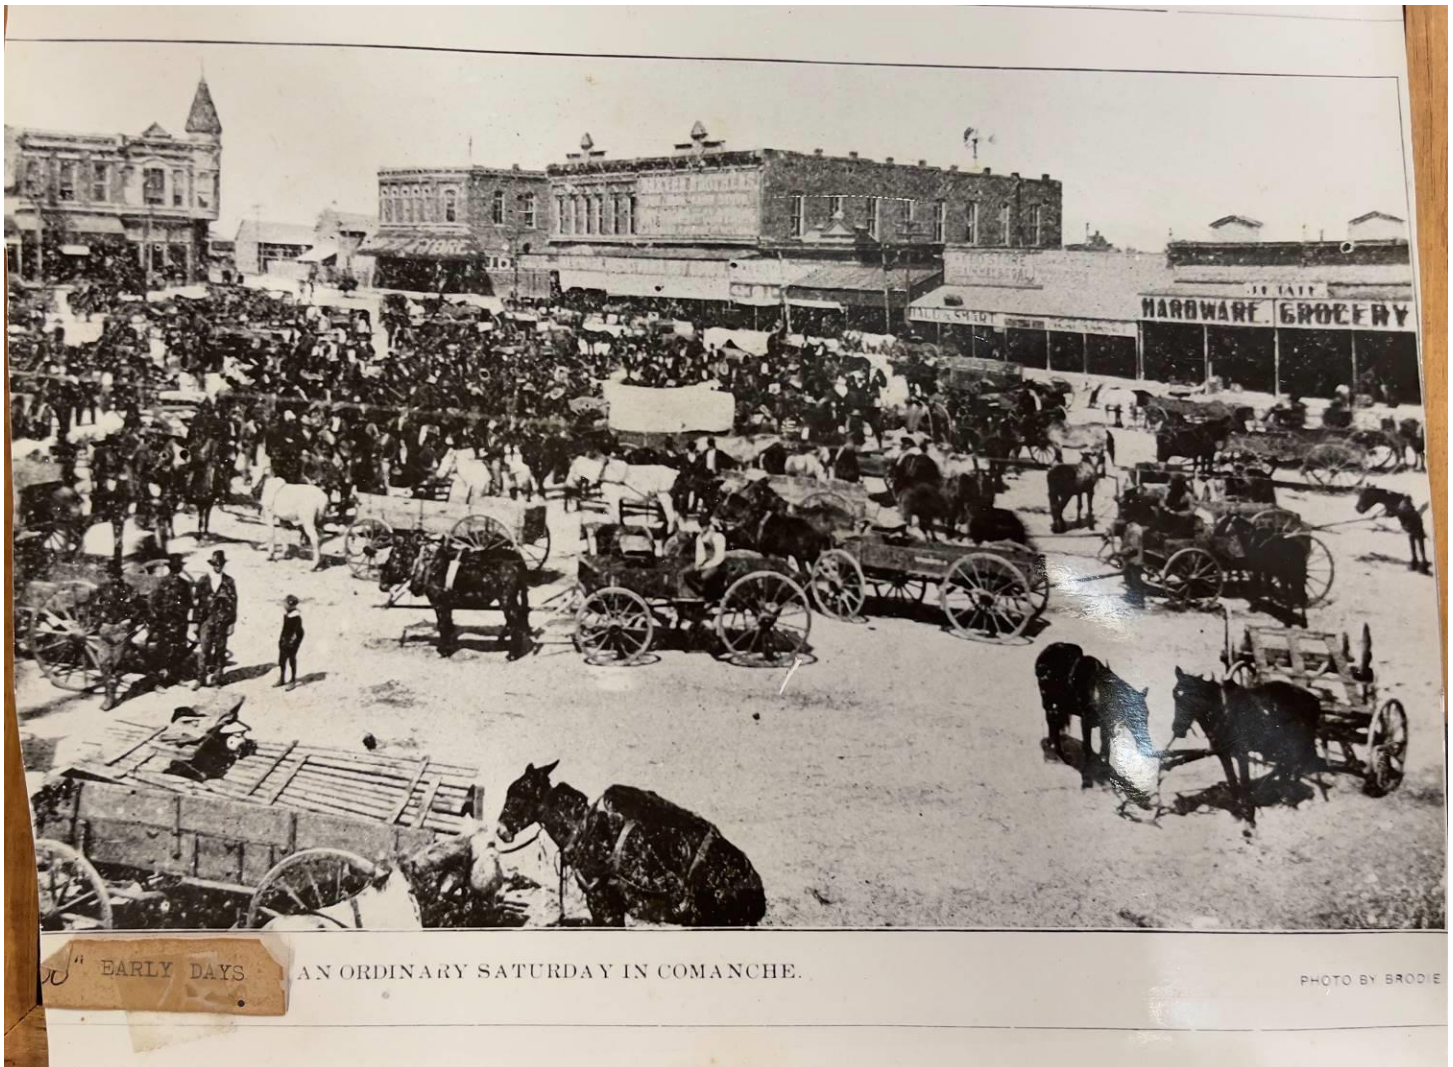
Figure 23 – Photo by Brodie Studio showing the east side of the square c 1900. The two-story building at top center housed the Comanche Opera House before being destroyed by fire in 1912. First National Bank (Resource 23) is visible on the left.

Disaster struck again in January 1900 when an explosion destroyed two buildings on the west side of the square and damaged many others. Dynamite stored in the Barnes Building detonated, destroying it and the R. O. Levi store adjoining it. Most buildings on the west side suffered some level of damage to their buildings or stock, and all the west side windows of the courthouse were blown out.³⁴ The west side of the square was struck by fire again in 1901 when three buildings belonging to William Reese and containing his drug store, the Huffman Saloon, and Tom's Restaurant were all destroyed (Figure 3).³⁵ With these losses, between 1896 and 1901 every original building on the west side of the square had been destroyed. More was to come. In January 1902 four frame businesses on the south side of the square were destroyed by fire.³⁶ In 1907 a fire destroyed five frame buildings on the east side including the Levisay Restaurant, Brodie Studio, Jones Barber Shop, and a confectioner.³⁷ In June another fire heavily damaged the E. W. Harris Building.³⁸ In 1912 on the east side of the square the Neely Building was destroyed by a gasoline explosion originating in J. E. Deeley's tailor shop. Also lost were the J. E. Long Studio and Henry Huff Jewelers. In August of 1912, a massive fire destroyed several two-story buildings at the north end of the block. Lost were the Lindsey Building and the Harris Building along with the opera house (Figure 23) and Knights of Pythias Hall. (Figures 4 & 23)³⁹

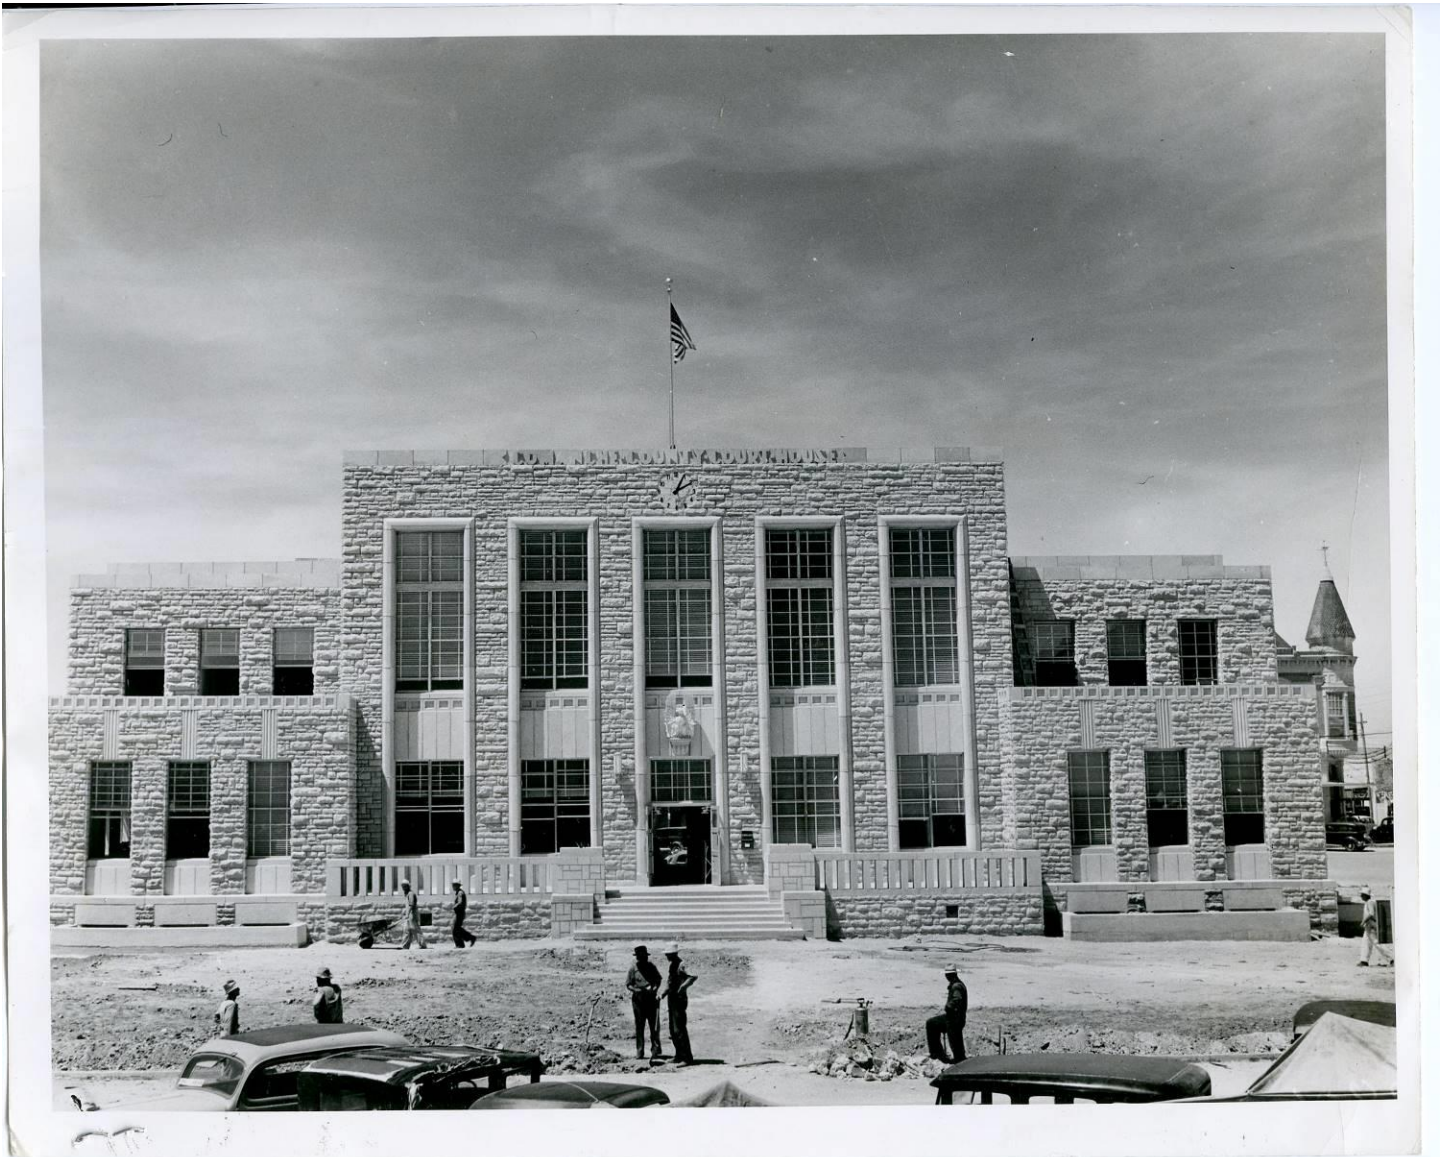
The most prominent building in the district is the Comanche County Courthouse (Resource 2; Figure 30, Photographs 1, 12) at the center of the courthouse square. The Modern Classical building was designed by renowned Fort Worth architect Wyatt Hedrick and completed in 1941 with the assistance of the Works Progress Administration (WPA). It replaced the 1856, 1860, 1879 and 1891 county courthouses. The two-story building is constructed of reinforced concrete and locally quarried ashlar stone and has a flat roof. Two wings flank a central mass which serves as the location of the main entrance. Original windows and doors seem to be intact on the primary and rear elevations. This was one of several WPA projects that benefitted Comanche including widespread street paving, new natural gas infrastructure, and the completion of the 1938 Comanche City Hall and Fire Station (Resource 50; Figure 29; Photograph 7). The two-story building is located on Austin Street one block north of the courthouse and is characterized by a fossil stone veneer over a concrete and steel structure. Other historic government buildings include the 1926 U.S. Post Office (now Comanche Police Department), which displays both Spanish Colonial Revival and Mission Revival design characteristics (Resource 58; Photograph 19) located on East Grand, and the old 1903 Comanche County Jail and Annex (Resources 22 and 23; Photograph 33) at 301 West Central.² All these government buildings in Comanche retain a high degree of integrity except for the jail. The jail's fortress-like Romanesque Revival design was simplified in 1948 with decorative elements above the cornice line removed and the roof flattened. It remains a contributing resource.

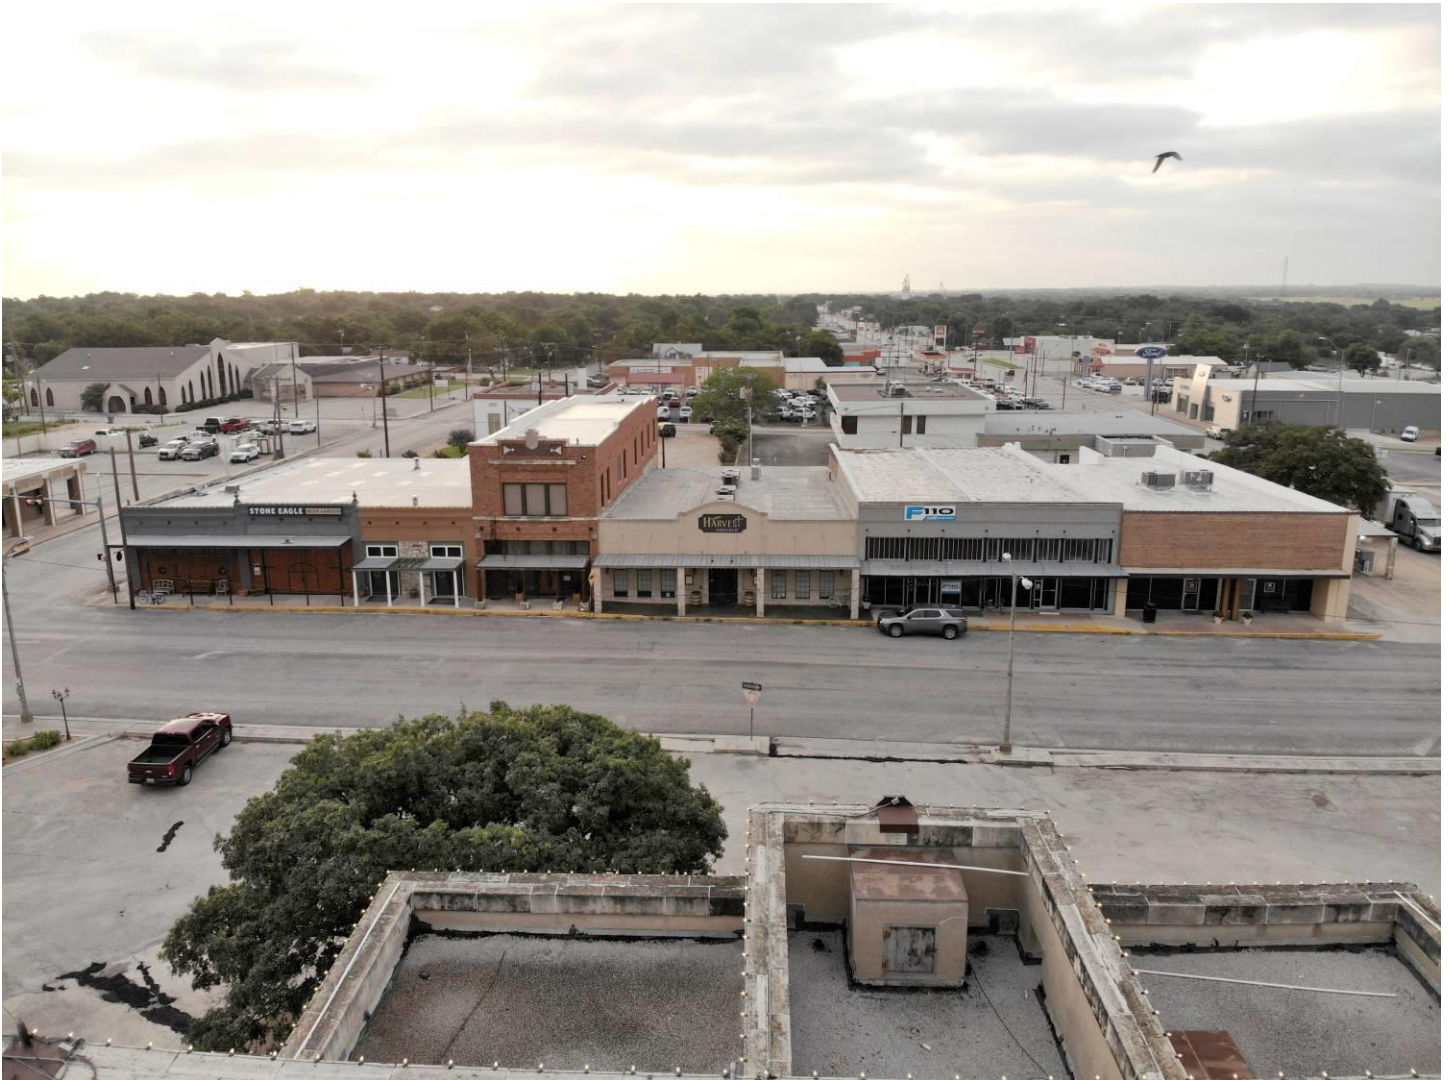
Photograph 2 - East square facing east. Camera facing east.

The east side of the square (Figure 23; Photograph 2) along Austin Street includes three contributing buildings, all of which replaced earlier construction destroyed by fire. The 1-part building at 108-110 N. Austin (Resource 62; Photograph 3) was completed c.1910 and is of stone construction with a brick primary elevation. While the original canopy is missing, the decorative cast iron columns, multi-light transoms, and corbeled brick cornice remain intact. The Knights of Pythias Building at 120 N. Austin (Resource 60; Photograph 4) was completed in 1913 after a major fire in 1912 destroyed the 2-story buildings at the north end of the block. It is among the most intact of the district's 2-part buildings and displays the typical characteristics of the type but with more formal early 20th-century brick detailing and second-floor windows that are grouped tightly together in a central bay. The George W. Tate Building at 124 N. Austin (Resource 59; Photograph 5) replaced the other buildings destroyed in the 1912 fire but was not completed until 1920. It is a broad 1-part building with three storefront bays, the center bay emphasized with a slightly raised parapet. The front elevation is composed of brick with recessed panels, brick corbelling, and replacement storefronts. Now housing a single business, it historically provided lease space to multiple tenants and was home to a wide variety of Comanche businesses including dry goods, a department store, restaurants, a confectionery, a bowling alley, and a movie theater.

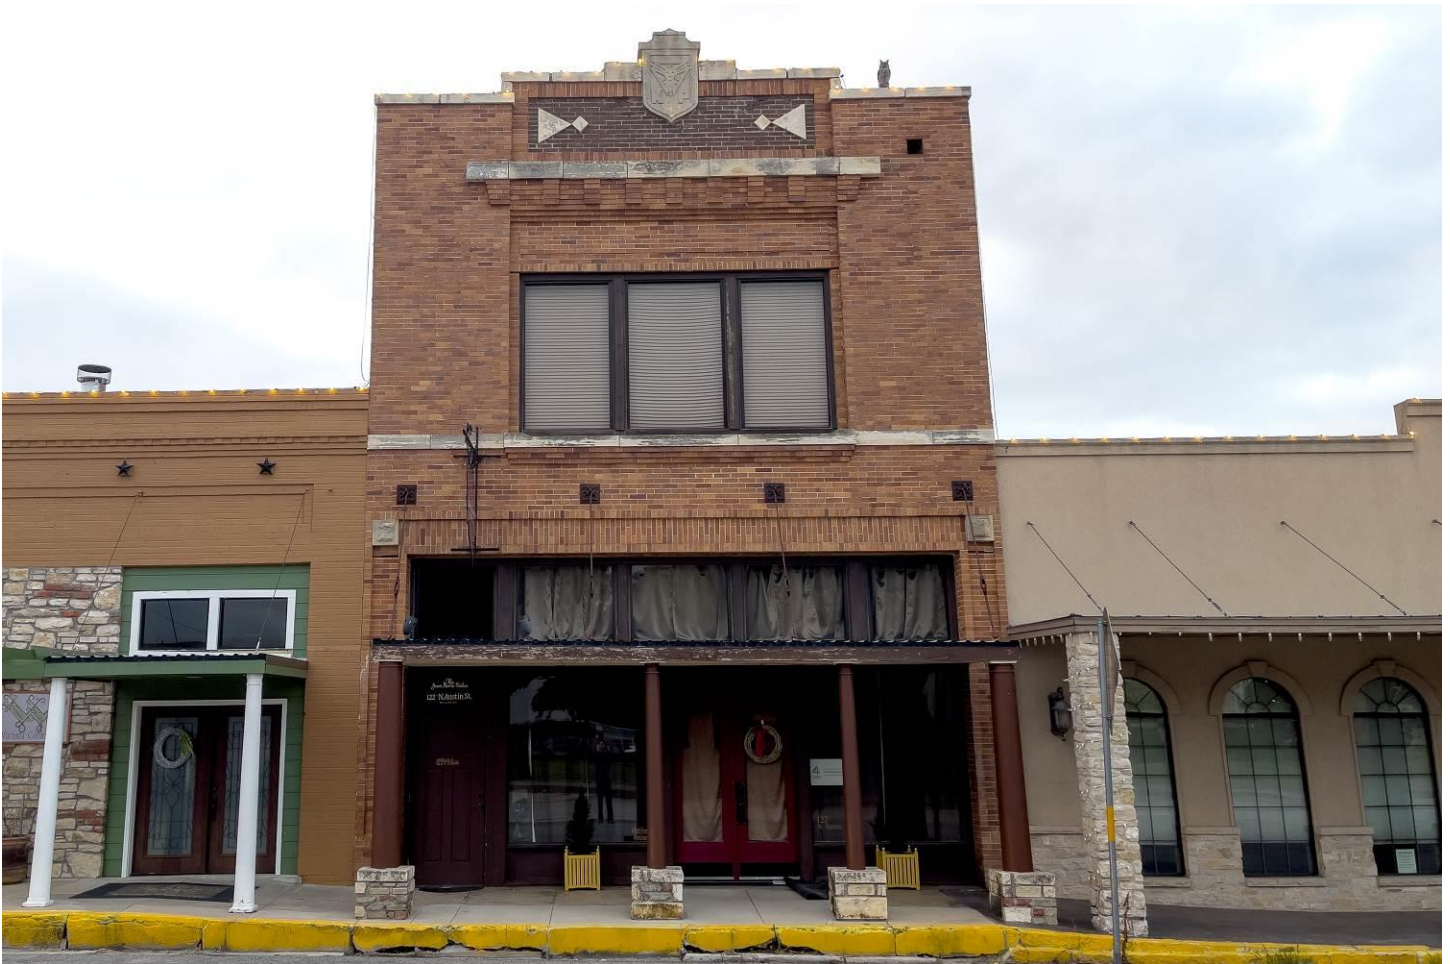
Photograph 4 - 120 N. Austin St. (Resource 60, Contributing). Camera facing east.

60	120	N	Austin	C	Knights of Pythias Lodge	2-part	1913	In 1912 a massive fire destroyed the block of two-story buildings on the northeast corner of the square. Among those lost was the Knights of Pythias Lodge. The replacement was completed in 1913. Albin Julius Olsson (Olson) of Cisco was the contractor. The 2-part composition has a double door entry with plate glass storefronts on either side. A single door on the north end of the storefront provides access

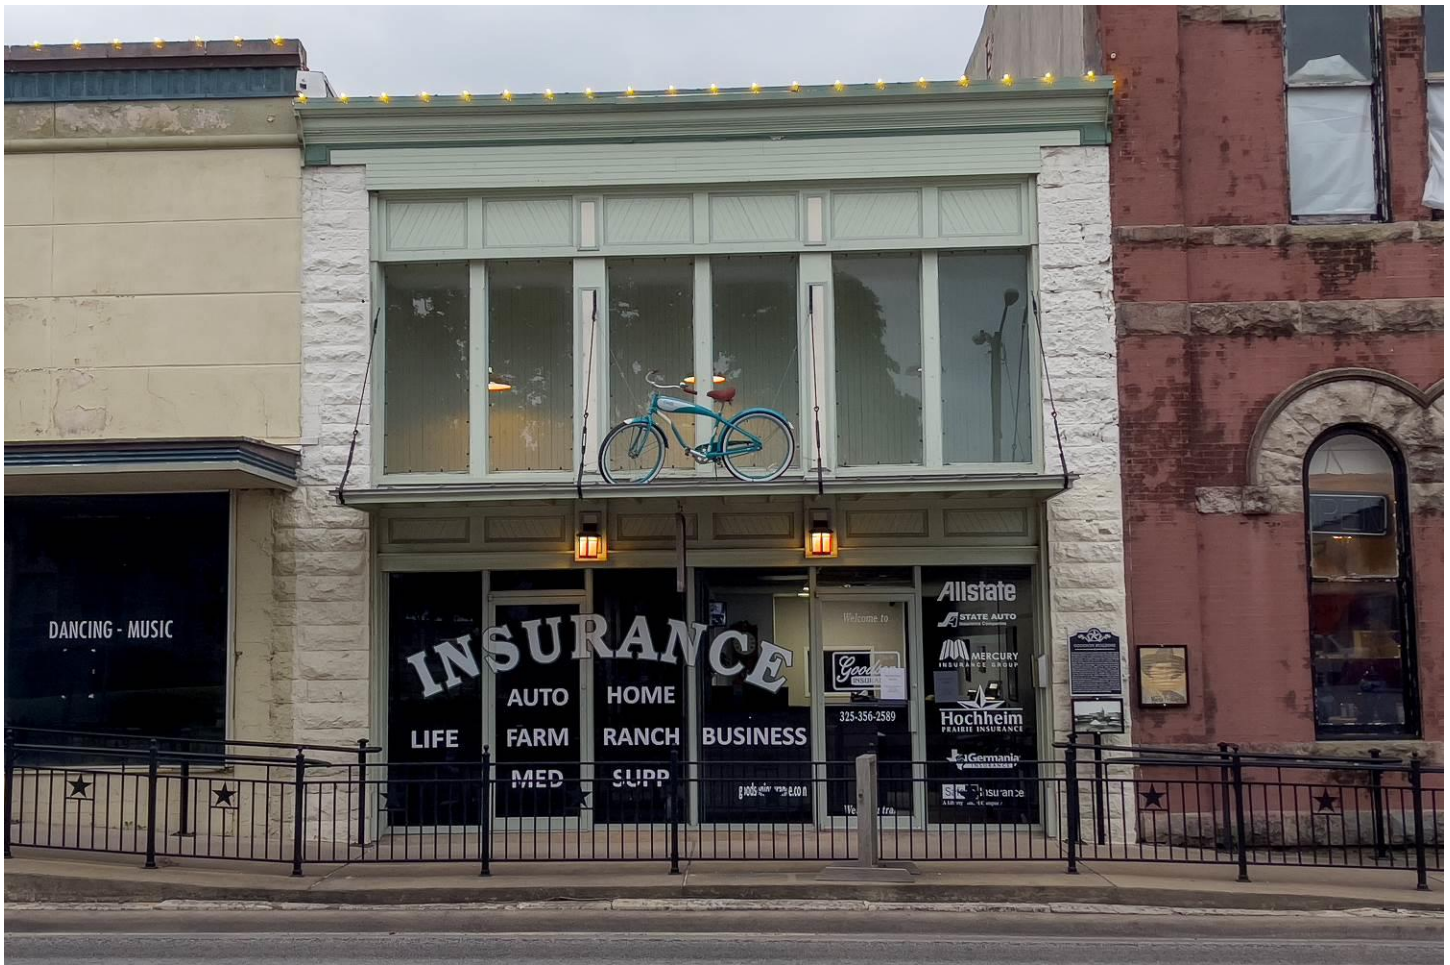
Photograph 16 - 132 W. Central Ave. (Resource 17, Contributing). Camera facing south.

17	132	W	Central	C	Fleming Meat Market	Enframed window wall	c.1890	Sanborn maps indicate this building was completed in about 1890. Unique to the district this enframed window wall has rusticated stone piers and a metal cornice. The first floor has plate glass storefronts. Above a rod-supported canopy are tall, fixed windows that provided light to the interior gallery. Recently restored as part of the Texas Main Street Program.
18	134A	W	Central	C	Comanche National Bank	2-part/Romanesque Revival influences	1892	The Comanche National Bank was organized in December 1889 with a beginning capital of \$50,000. The primary organizer was John B. Chilton, who met with other local businessmen in his second-floor downtown living quarters to establish the bank and elect a board of directors. The first elected officers were J.B. Chilton, President; T.J. Holmsley, Vice President; W.B. Cunningham, Cashier; and R.V. Neely, Assistant Cashier. Opened to the public in March 1890, the Comanche National Bank saw immediate success, as Comanche was poised for economic growth by the early 1890s. The railroad arrived in 1891, the same year in which the county constructed a new courthouse. Also in 1891, the bank directors purchased the lot on the southwest corner of the courthouse square and constructed this building. Remodeled in 1939, it served the bank's operations until 1969. It was constructed by the same contractors who built the 1891 courthouse. This brick building with locally quarried sandstone trim has Romanesque Revival influences. The original pyramidal tower is missing.

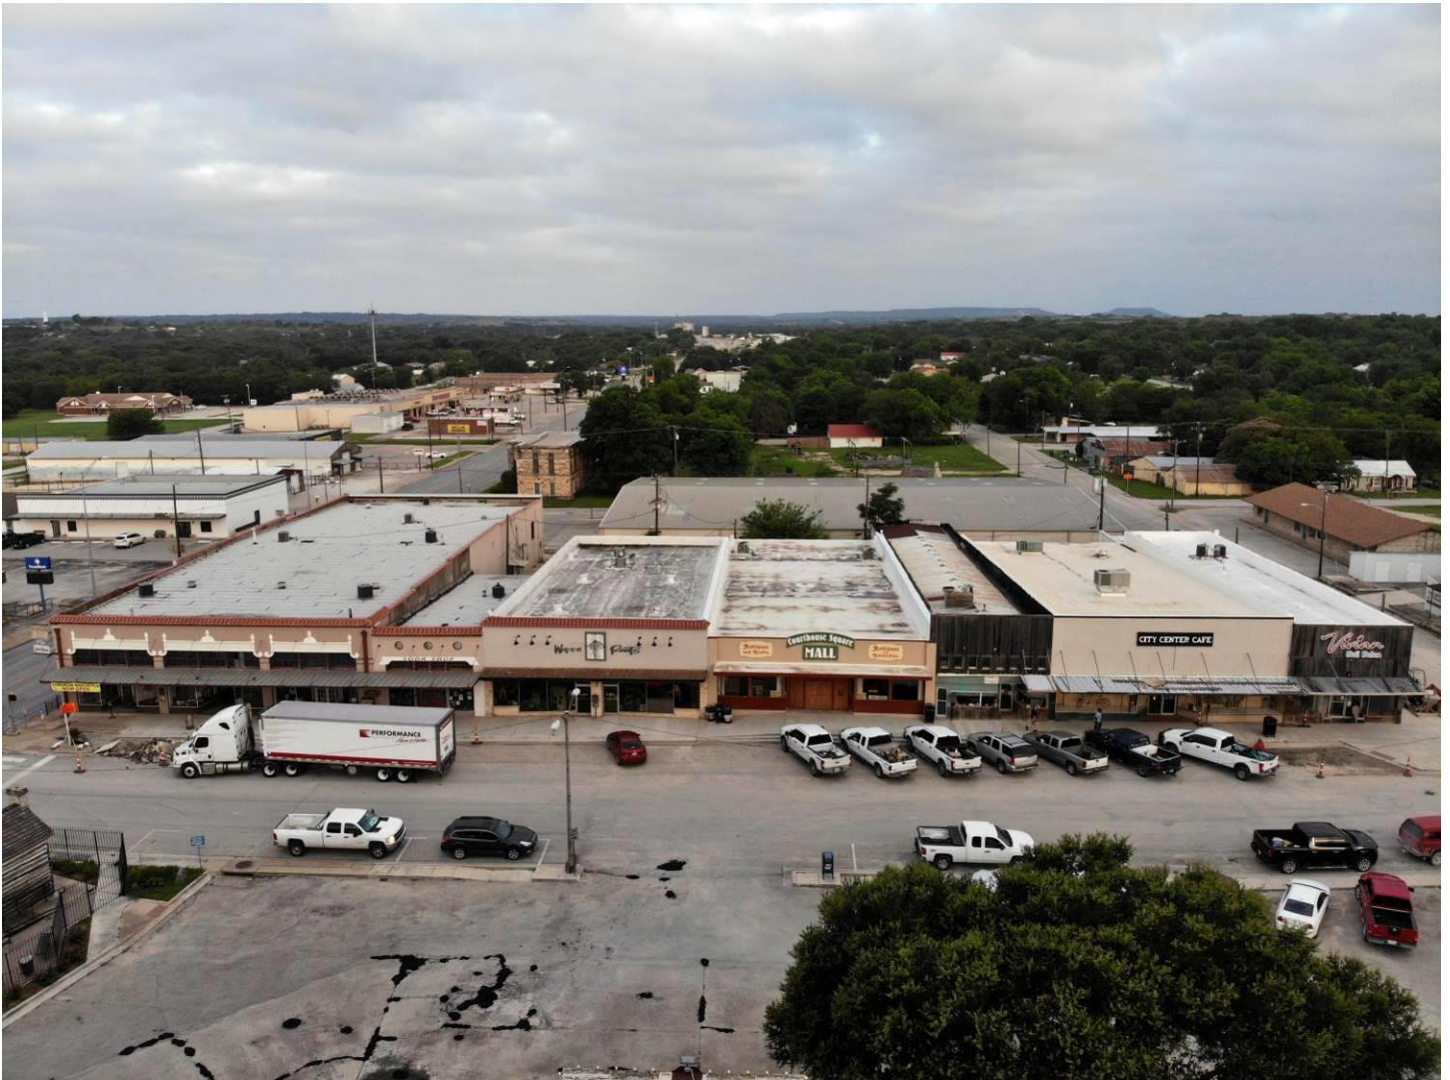
Photograph 25 - West square facing west. Camera facing west.

The west side of the square (Figures 5, 8, 12, 13; Photograph 25) was the first to be populated with permanent stone buildings. The oldest block at the north end was destroyed by fire and replaced with the three existing 1-story structures. The Majestic Theater/Ritz Theater (Resource 28) and Green-Huett (Resource 30; Photograph 28) are now covered with modern materials and are considered non-contributing. Green-Huett and the theater both appear to have been clad with Carrera Glass at some point, but it is unclear how much of these historic materials or those from earlier periods remain behind the existing wood. The Chilton-Harelik Building (Resource 29) had its wood slipcover removed exposing the 1948 façade and is considered contributing. At the center of the block is a 1-part brick building (Resource 27) that replaced two earlier buildings after 1949. Newspaper accounts indicate the current composition was completed for Ben Franklin's in 1963. The three remaining 1-part buildings on the west square share some unifying details indicating they were remodeled over time to give them a more cohesive appearance. After fire destroyed the Higginbotham Brother's building at the corner in 1930, the company constructed a beautiful new building with Spanish Colonial Revival detailing (Resource 24; Figures 9, 10, Photograph 27). It appears at least some of the original exterior walls were retained as part of the new building. The small building to the north (Resource 25) was constructed c.1910 and remodeled to resemble its neighbor. The William Reese/Durham's Pharmacy Building next door at 111 N. Houston (Resource 26) was completed in 1903 but also remodeled. All three buildings have parapets capped with red barrel tile and pent roofs.

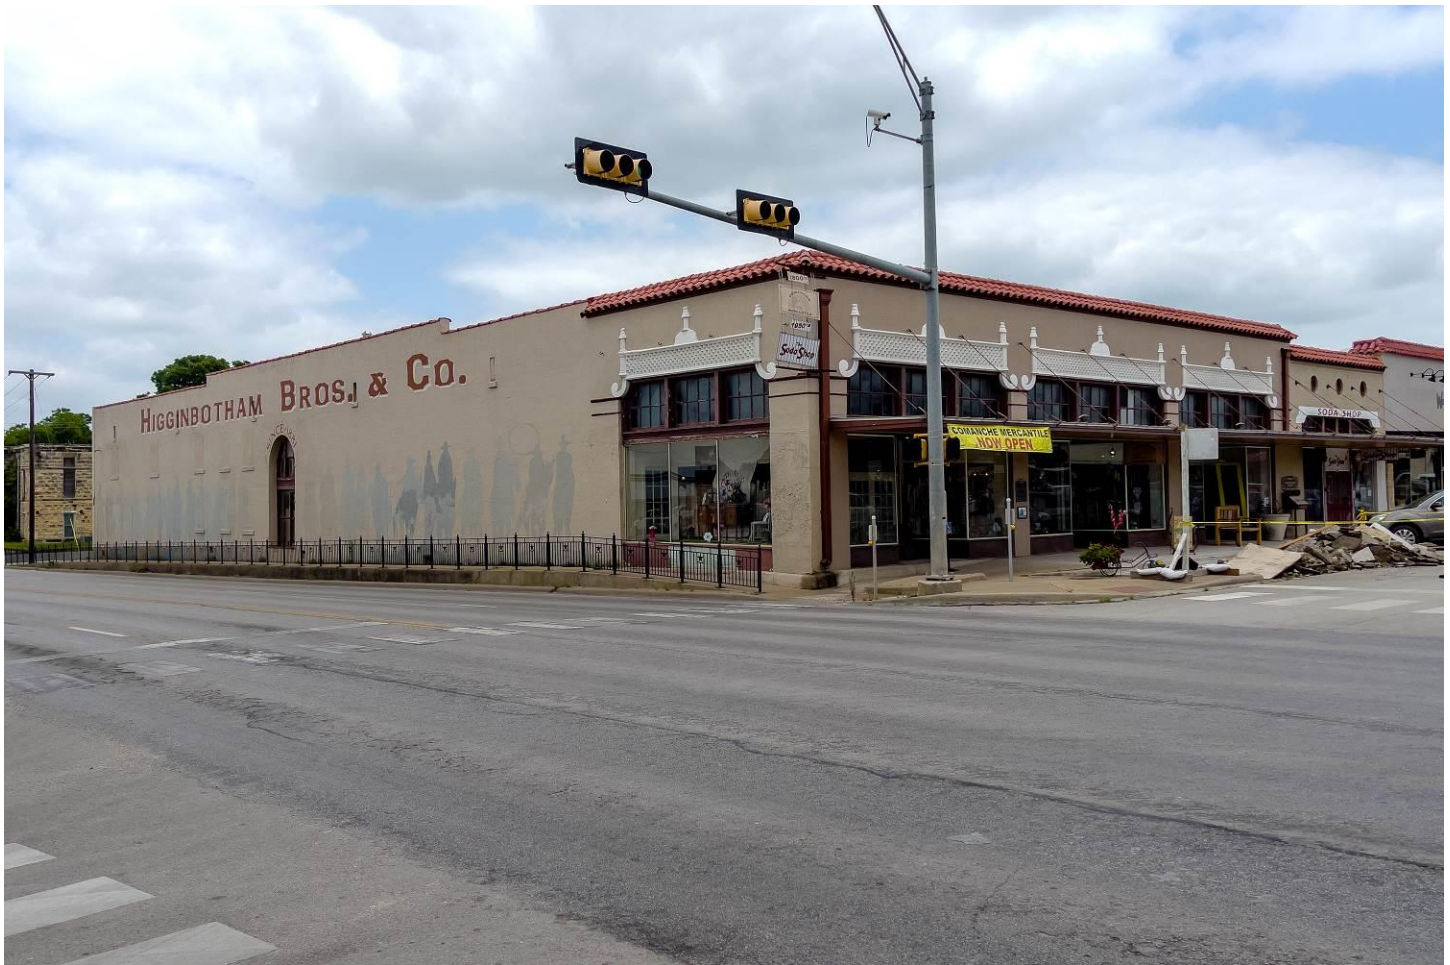
Photograph 27 - 107A N. Houston St. (Resource 24, Contributing). Camera facing northwest.

24	107A	N	Houston	C	Neely Building/Neely-Harris-Cunningham/Higginbotham Brothers Company	1-part, Spanish Colonial Revival influences	1931	<p>The original 2-story stone buildings on this site were replaced by a large 1-story general merchandise store in about 1900. Originally the home of Neely-Harris-Cunningham, it was later rented to Higginbotham Brothers for use as a department store that included dry goods, groceries, hardware, and undertaking. It also housed the company offices. Fire damaged the building in 1912 and in 1930 another fire destroyed the entire building and its contents. Higginbotham's immediately rebuilt and the existing building opened in January 1931. The handsome 1-part building exhibits Spanish Colonial Revival influences and includes three storefront bays on the east elevation, each with a double door recessed entry and expansive plate glass display windows. A rod-supported canopy and multi-light transoms top the storefronts. Each bay is ornamented with an elaborate Venetian-style hood that appears to be cast stone. The main wall material is painted stucco. The parapets are topped with pent roofs or red barrel tile. It appears the two buildings to the north were later remodeled to unify them with the Higginbotham facade. Each has a pent roof at the parapet.</p>

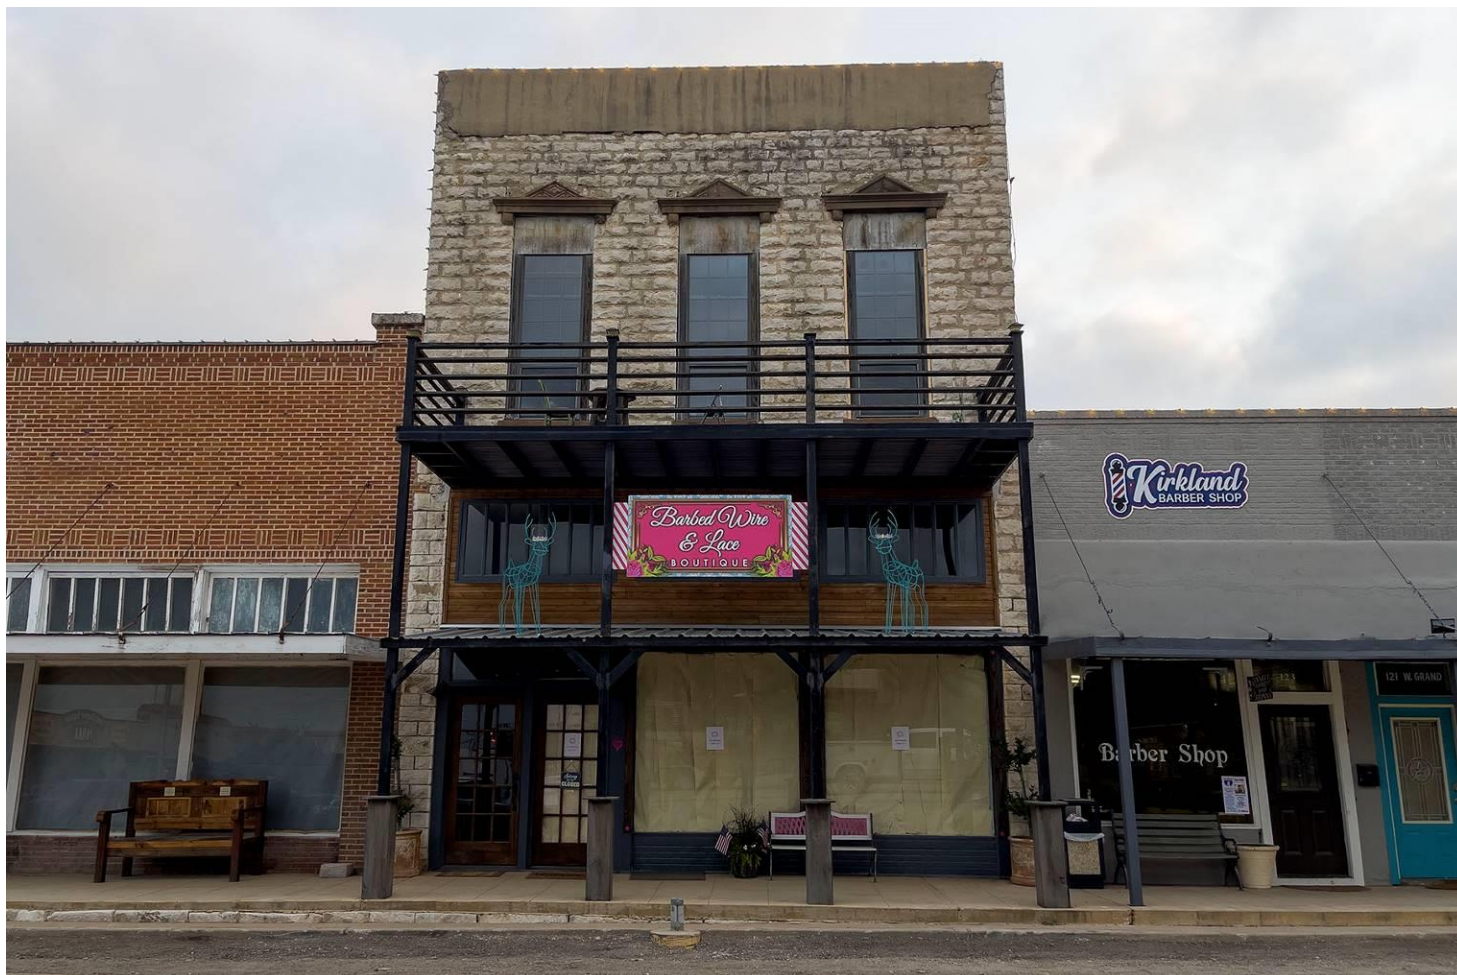
Photograph 30 – 125 W. Grand Ave. (Resource 41, Non-Contributing). Camera facing north.

41	125	W	Grand	N	Jim Cox Building	2-part	c.1895	This 2-part commercial building has a rusticated limestone façade with cast iron storefronts and cast-iron hoods over the second floor windows. The original pressed metal cornice is missing. It originally housed a meat market on the first floor and a lodge hall on the second. A 1942 fire in the building to the east heavily damaged the second floor and destroyed part of the stock of the Coleman Grocery on the first. Now a retail space on the first floor with a bed and breakfast on the second. A large porch addition and some non-historic siding on the front undermines the integrity making it currently non-contributing
