United States Department of the Interior
National Park Service
National Register of Historic Places Registration Form

Historic Name: Comanche Downtown Historic District

Street & number: Roughly bounded by West College Avenue, North Pearl Street, Oak Avenue, and the rear property line along North Mary Street

City or town: Comanche

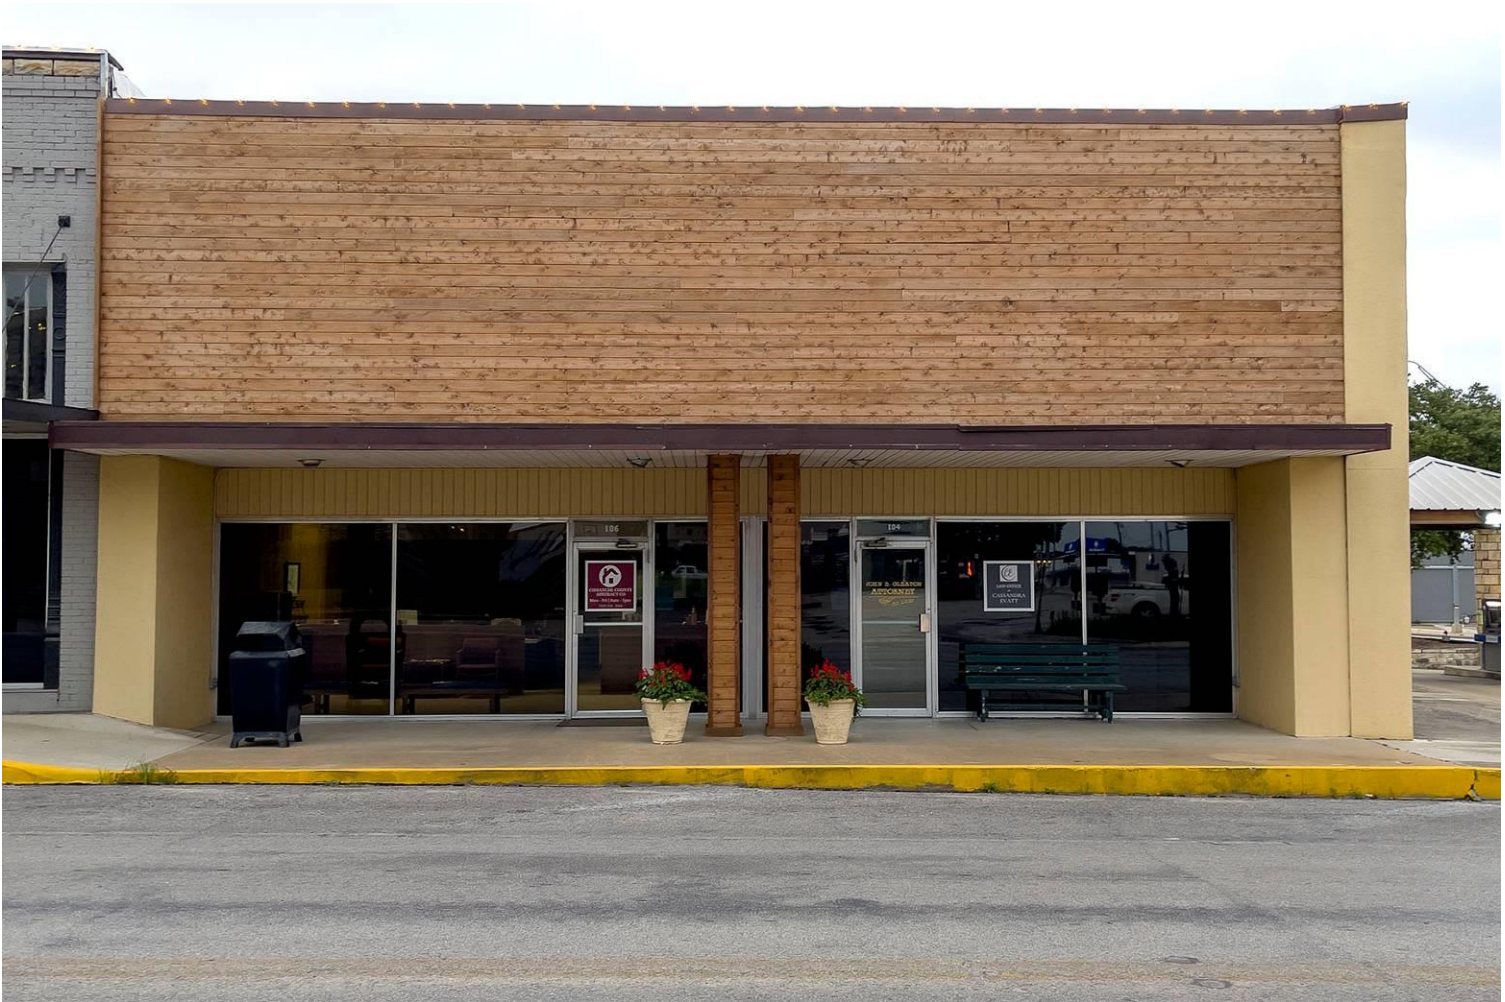
Photograph 31 – 106 N. Austin St. Resource 63, (Non-Contributing). Camera facing west.

63	106	N	Austin	N		1-part	1908	Historically two 1-part commercial stone buildings that housed a grocery and clothing store among other tenants. The previous buildings on the site were destroyed by fire in 1907. The original primary elevation is covered with non-historic stucco and wood and replacement storefronts. It appears the party wall between the two has been removed. The condition of the underlying historic materials is unknown. Non-contributing due to significant alterations.
64	100	N	Austin	N	State National Bank ATM	No style	2004	Empty lot with ATM drive-through structure. Non-contributing due to age.

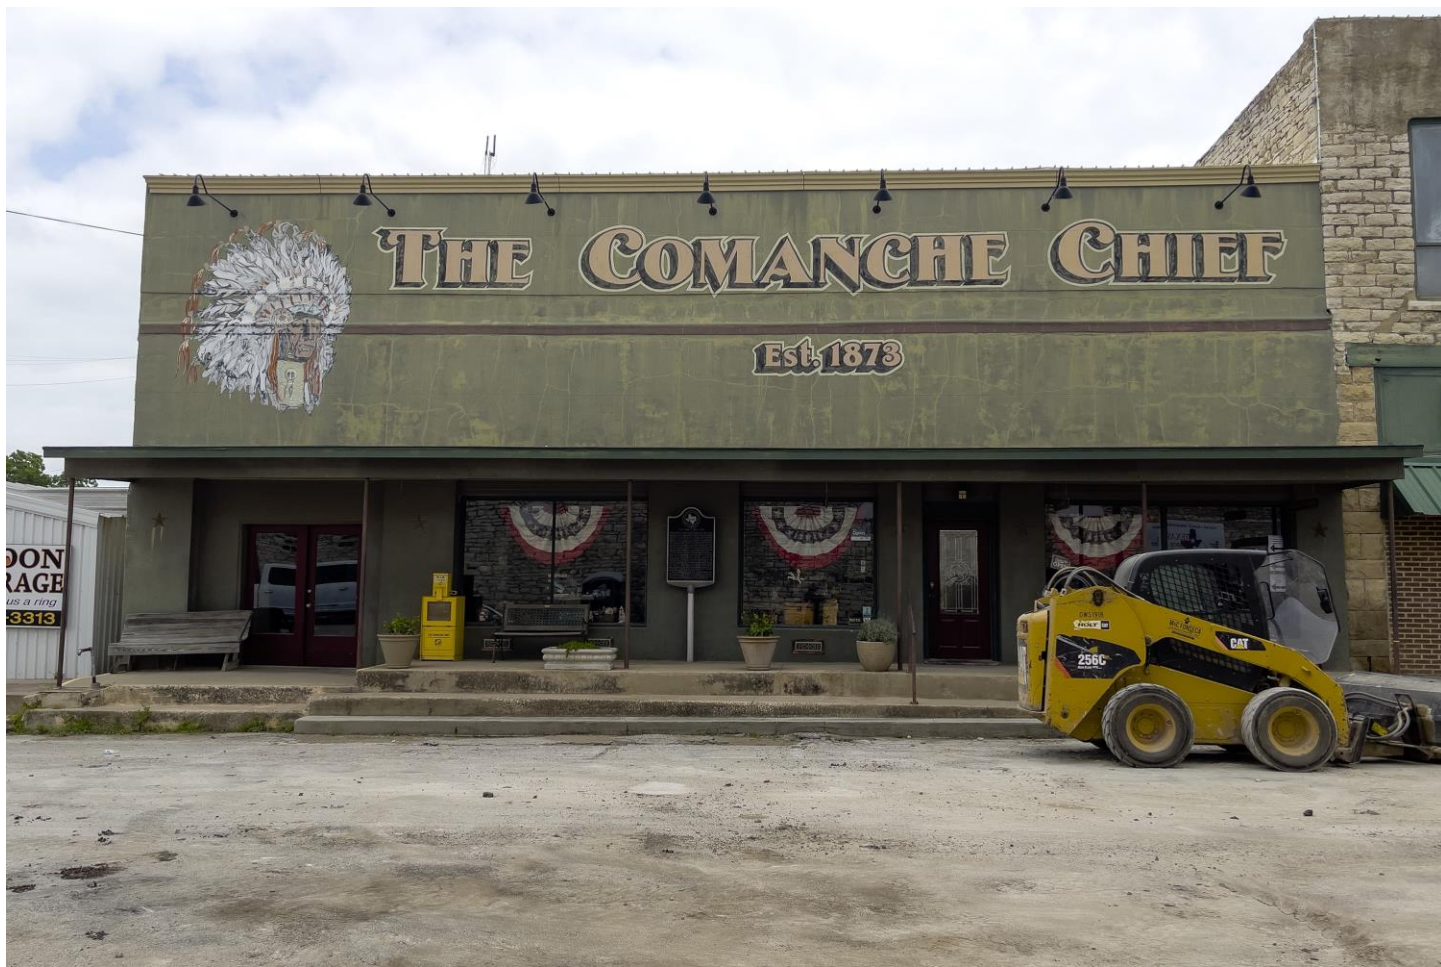
Photograph 35 – 205 W. Grand Ave. (Resource 31, Contributing). Camera facing north.

31	205	W	Grand	C	The Comanche Chief Building	1-part	c.1900/ 1960	This 1-part building is of rubble stone construction and originally had iron and pressed metal detailing on the primary elevation. It served a variety of retail purposes before being remodeled with a stucco elevation and occupied by <i>The Comanche Chief</i> in 1960.
32	201	N	Houston	C	Brightman Building	2-part	1891	This 2-part building of rusticated limestone was completed in 1891. It housed a furniture store on the first floor and the Woodman of the World Hall on the second. O. O. Brightman purchased the building in 1911 and it was eventually run by his son as White's Auto Store. The building originally had an elaborate pressed metal cornice, the loss of which detracts from this otherwise handsome building. The storefronts were modified to their non-historic appearance, and two round windows on Houston Street elevation enclosed.
