National Register of Historic Places Registration Form

Historic Name: Sills Building

Other name/site number: Sociedad Mutualista Obrera Mexicana Hall; SMOM Hall

Street & number: 5804 Canal Street

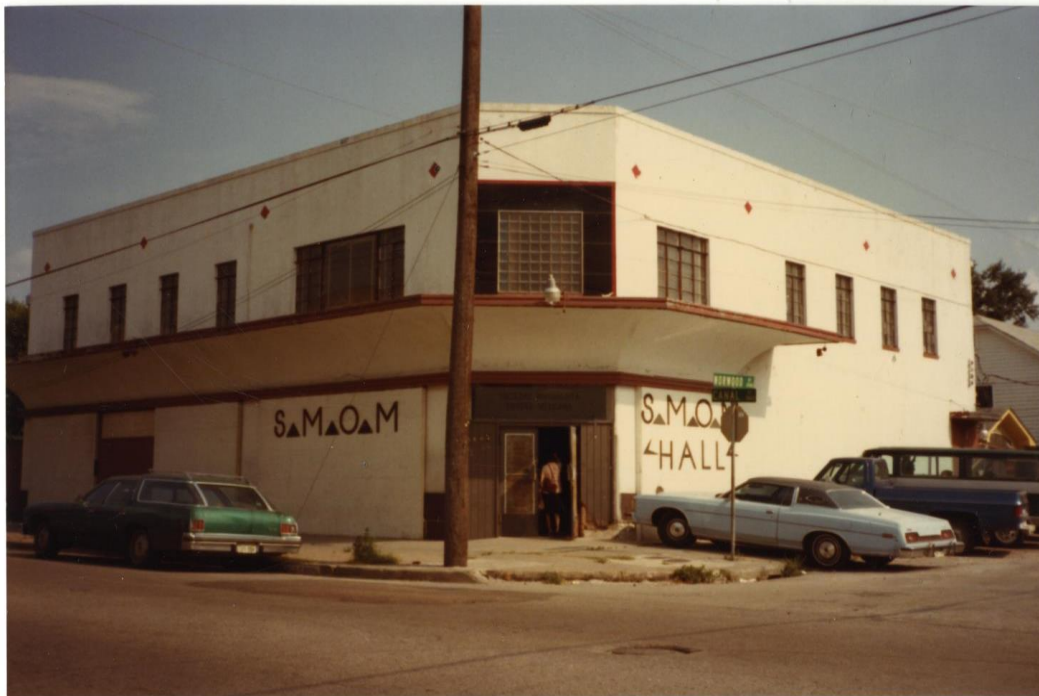
Figure 5: SMOM Hall in the 1980s, showing the enclosed windows and entrances, view facing southeast. Smomhouson.org.

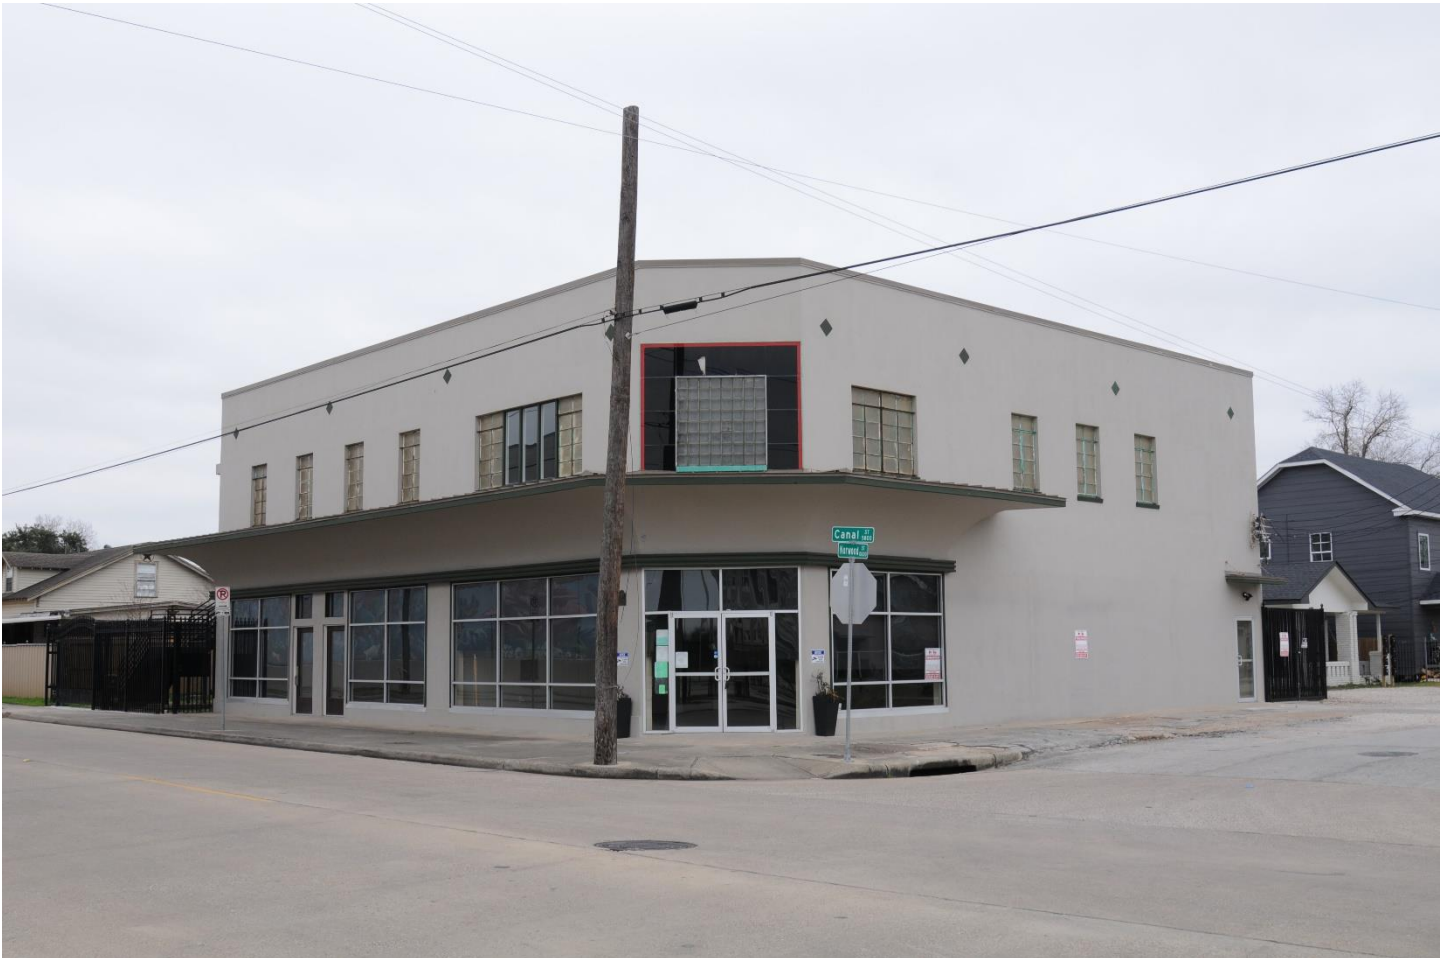
Photo 1: Northeast façade and main entrance, oblique angle, camera facing southeast.

The street-facing façades have the most detail. The chamfered corner has an aluminum-frame double glass door with transom and sidelights at street level under the canopy (**Photo 1**). Above is a glass-block window in Vitrolite frame—structural glass with a black pigment (**Photo 2**). The street level of the northeast façade, facing Canal Street, has three wide bays of asymmetrically placed aluminum storefront windows (**Photo 3**). Two single door entrances with transoms are on this façade. Above the canopy, four slender, metal casement windows with painted brick sills punctuate the upper level. Casement windows on this and other façades have 10 lights, the top 2 fixed in place. Near the chamfered corner, a fifth broad window has two outer metal casement windows on either side of three single-pane replacement lights. Between this row of windows and the parapet are four equidistantly placed, diamond-shaped tiles. The street level of the northwest façade, facing Norwood Street, has one aluminum-frame storefront window that the canopy wraps around to cover and a paired metal casement window above (**Photo 4**). At the street level's southern end, a single aluminum door has a flat-roof awning that metal rods support. The upper level has three metal casement windows. Like the northeast façade, the northwest façade has four equidistantly placed, diamond-shaped tiles between the upper-level windows and the parapet.

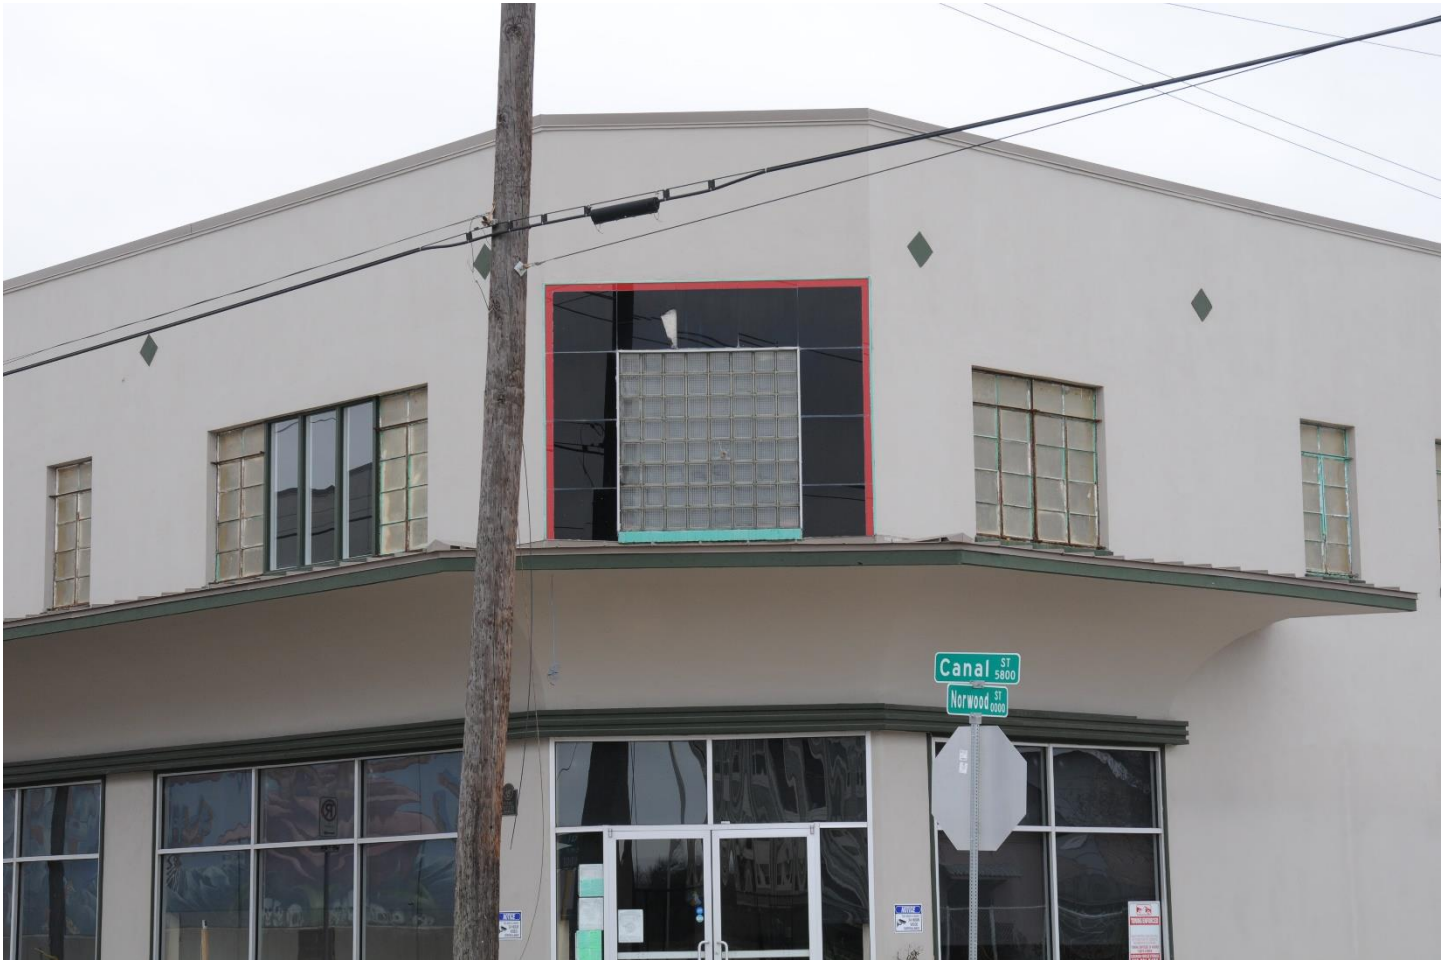
Photo 2: Detail view of canopy and glass block on northeast façade, camera facing southeast.

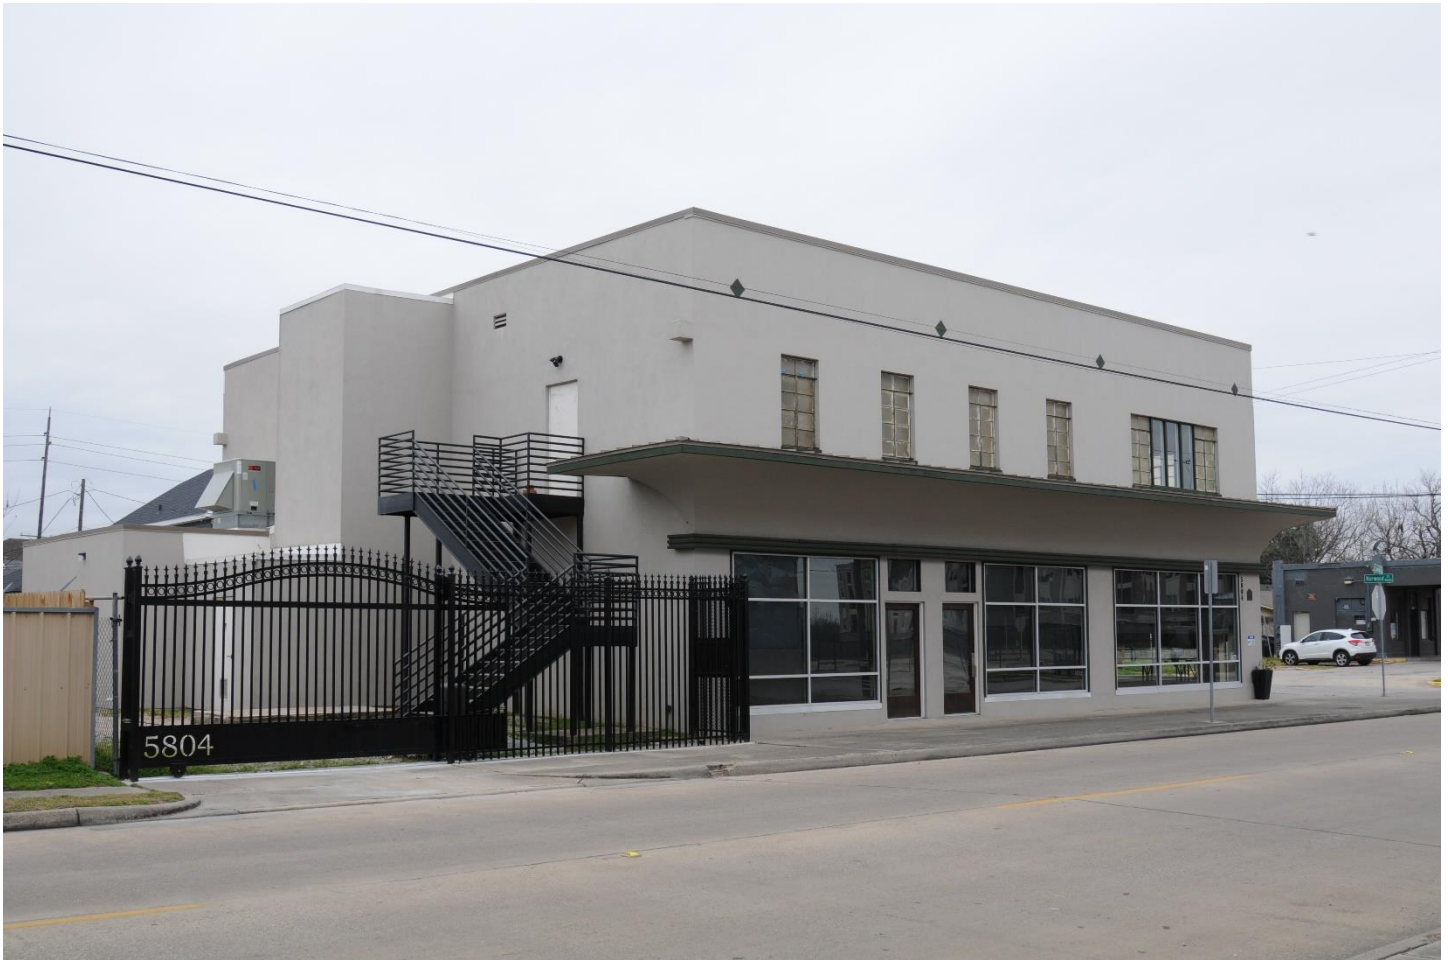
Photo 6: Northeast façade, oblique angle, camera facing southwest.

The southeast and southwest façades are utilitarian. At street level, the southwest (rear) façade has a single-door entrance near the east end and two small awning windows with painted brick sills (**Photo 5**). The upper level has five metal casement windows with painted brick sills. Above are six small, equidistantly placed vents with painted brick sills. The east façade is plain and has three appendages: an exterior metal staircase to an upper-level single steel door near Canal Street, a one-story unit with a double door that faces southwest, and an elevator shaft (**Photos 6 and 7**).

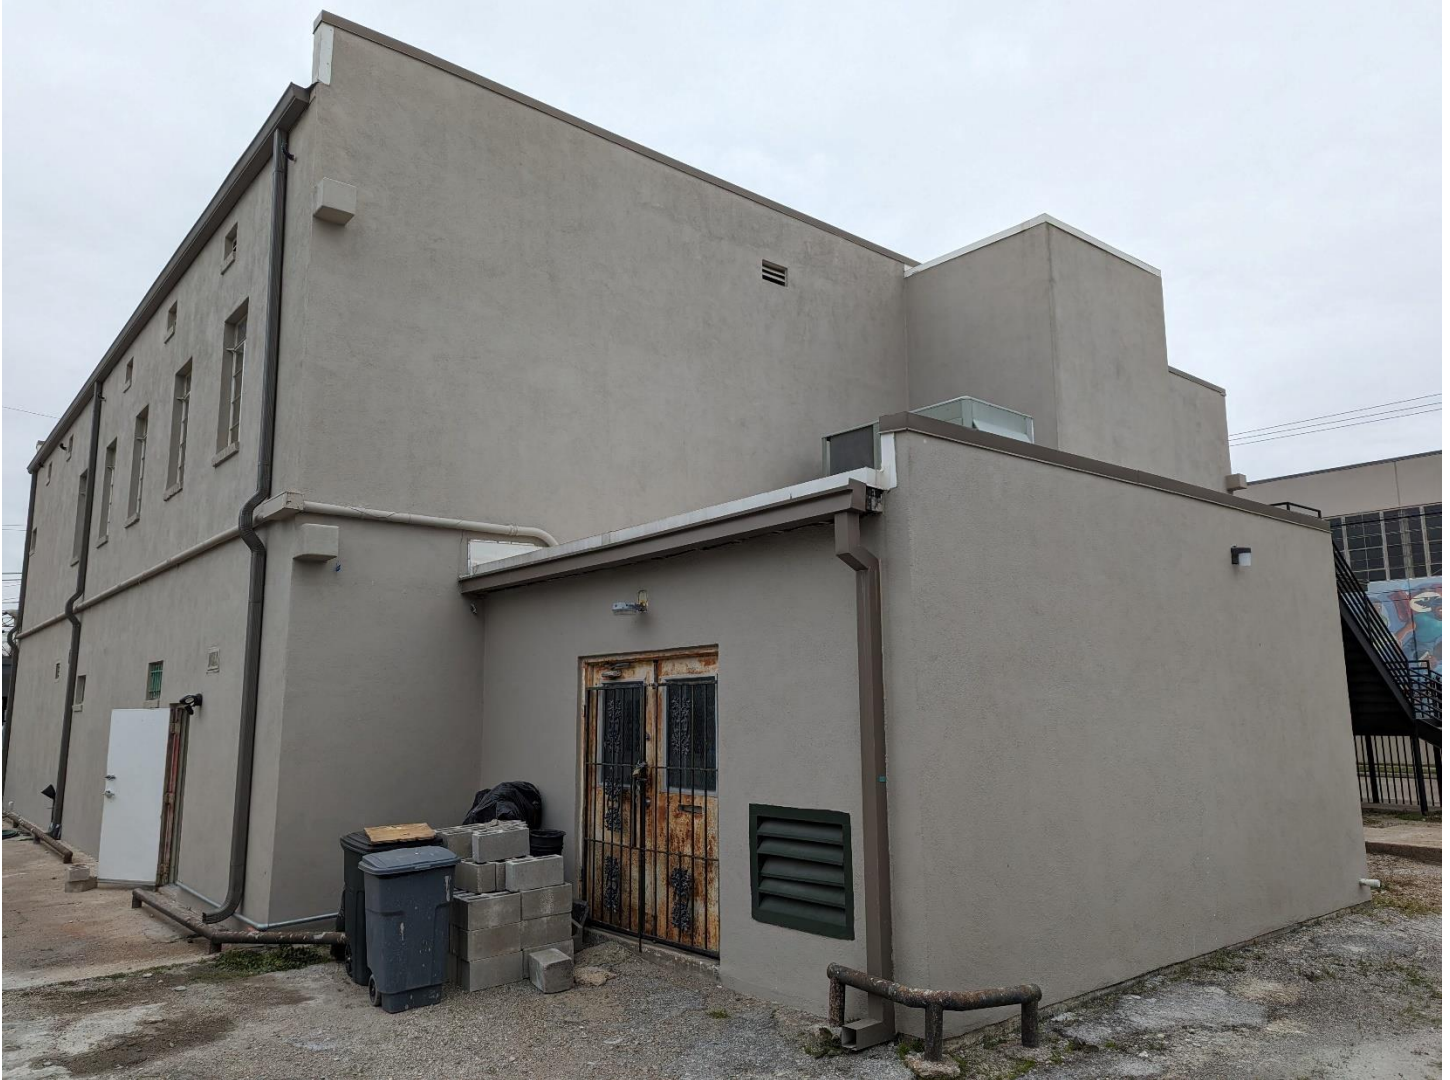
Photo 7: Southwest façade with utility room and elevator shaft additions, camera facing northwest.
(A fence on property prevented ground-level photographic documentation of the building's full height from this direction.)

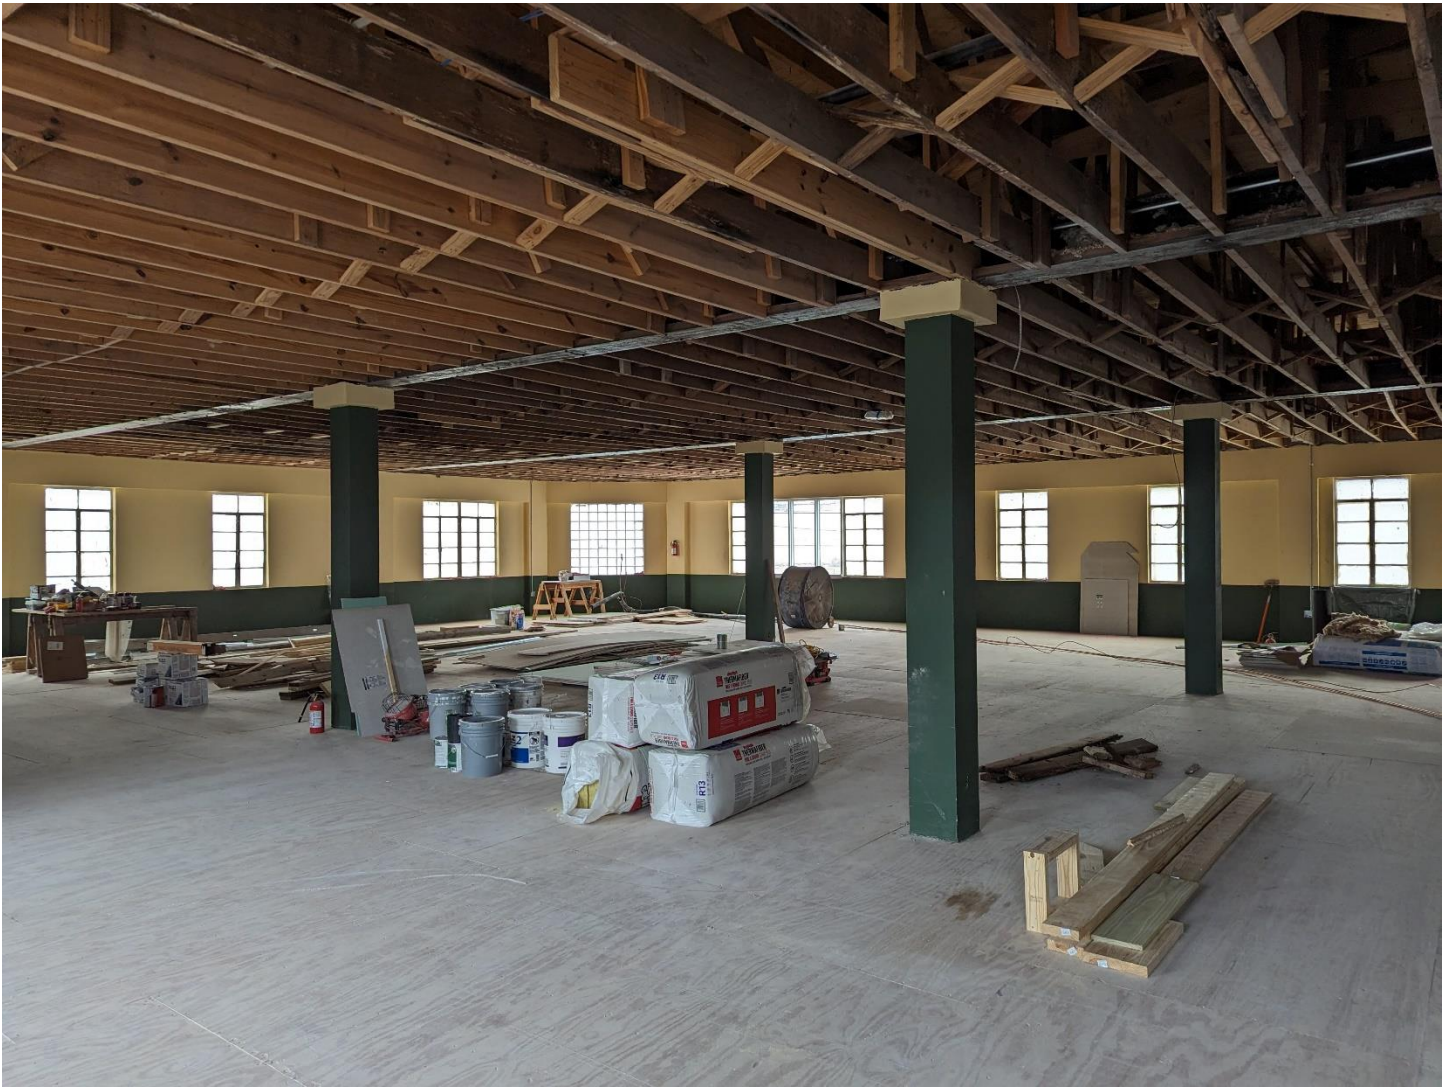
Photo 10: Second floor from southeast corner of the room, camera facing northwest.

The second-floor union hall has an open plan (**Figure 3**). Because the ceiling has been stripped, its wood beams and joists are visible (**Photo 10**). Square, concrete columns and pilasters support the ceiling beams. The floor has been removed, and a plywood subfloor has been installed.
