National Register of Historic Places Registration Form

1. Name of Property	
Historic Name: Armour Laboratory Building Other name/site number: NA Name of related multiple property listing: NA	
2. Location	
Street & number: 601 E. Exchange Avenue City or town: Fort Worth State: Texas County: Tarr Not for publication: Vicinity:	ant

Architectural Classification: Modern Movement: International Style

Architect/Builder: Hedrick, Wyatt C., architect; Thomas S. Byrne Company, builder

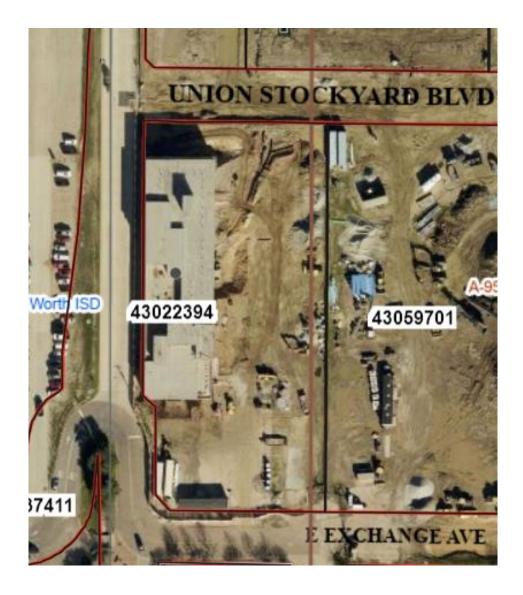
Map 5: Kairoi Stockyards Multifamily, Lot 1, Block 11 (Account: 43022394), Fort Worth, Tarrant County Texas, as recorded in the Tarrant Appraisal District. Data accessed June 11, 2024. The boundary includes the legal parcel and encompasses the property historically associated with the nominated resource. Boundary line shown in black.

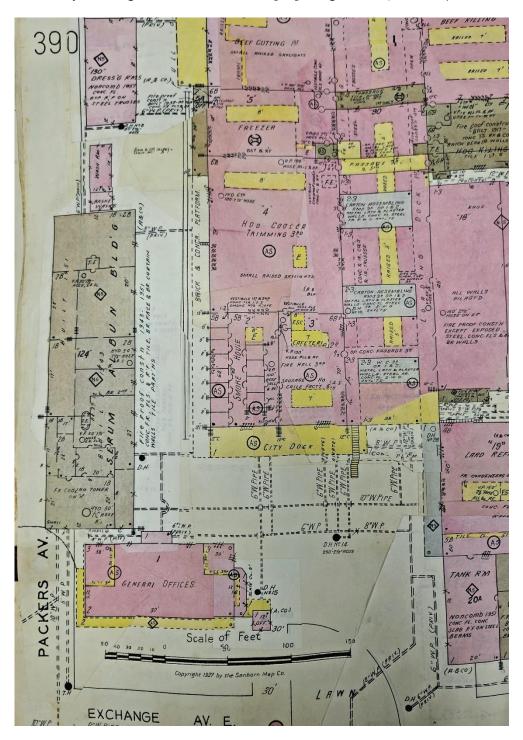
Map 10: Sanborn Fire Insurance Map, Fort Worth, Texas, Volume 3, Sheet 391, 1951, with later updates (Armour Laboratory Building labeled "Serum Albun [sic] Bld'g," on left). *Courtesy Tarrant County Archives*.

The 1951 addition was added within the period of significance and is considered a historic addition. Over time the building was altered with the removal of the glass block in the window openings which were then infilled with wood. Original doors also were replaced. The original concrete stairs with wing walls in front of the east elevation's south entrance (Figure 1) were removed and replaced with a concrete loading dock. The cooling tower on the roof was removed as were interior partition walls. The dates of these alterations are unknown. A pre-existing brick, one-story gabled-roof building abutting the north elevation was removed between 2009 and 2010. According to an updated 1951 Sanborn Fire Insurance Map, the south end of that building was used for basket washing and the north portion was used as a washroom (Map 10 and Figure 12).

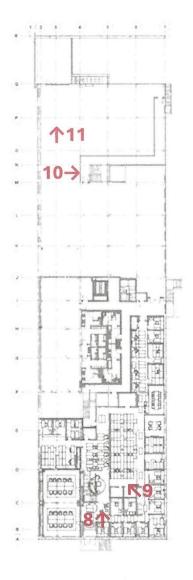
Map 14: Basement photo key (photos 8-11). Left depicts floor plan with photo key before rehabilitation, right depicts final floor plan photo key during rehabilitation. *Courtesy Bennett Partners*.

Rehabilitation of the building began in 2023 to convert it to office use in accordance with plans developed by Bennett Partners of Fort Worth, Texas (Maps 14-16). These plans have been reviewed and approved by the Texas Historical Commission and the National Park Service. The project follows the Secretary of the Interior's Standards for Rehabilitation. Exterior work includes the installation of new aluminum windows in existing window openings as well as in a limited number of new window openings that will facilitate the building's conversion to office space and add more light (for an example, see Photo 6). New exterior doors will also be added. Minimally covered rooftop patios will be added. A low, pop-up clerestory will be added to the roof at the approximate location of the historic rooftop tower that is not extant. The clerestory will provide additional interior illumination conducive to the building's new use. The nonoriginal concrete loading dock in front of the east elevation's south entrance failed structurally and is being replaced with a new concrete dock with stairs. An ADA-compliant ramp is being added on the south side of the main entrance's stairs on this elevation (Photo 1). A detached extended canopy is being added over the main entrance (Photos 1 and 2). Wall materials will be cleaned and repaired as needed. Failed brick will be replaced with brick salvaged from the new window openings.

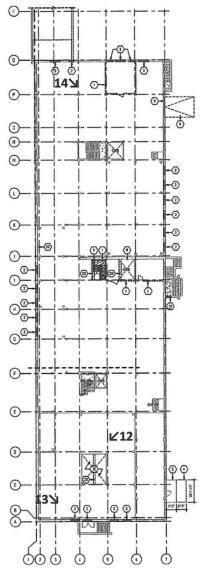
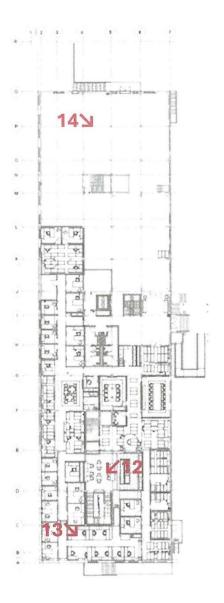
Map 15: First floor photo key (photos 12-14). Left depicts floor plan with photo key before rehabilitation, right depicts final floor plan photo key during rehabilitation. *Courtesy Bennett Partners*.

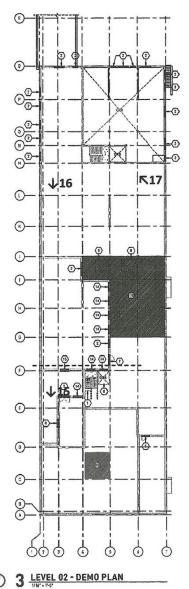
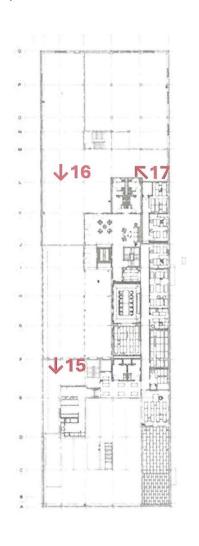
Map 16: Second floor photo key (photos 15-17). Left depicts floor plan with photo key before rehabilitation, right depicts final floor plan photo key during rehabilitation. *Courtesy Bennett Partners*.

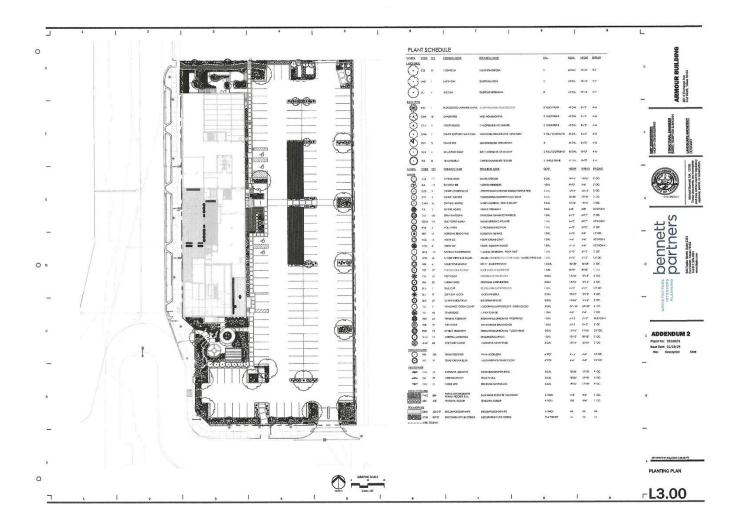
Map 17: Site and planting plan, January 19, 2024. Courtesy Bennett Partners.

Site work includes the construction of courtyards on the north and south ends of the building and compatible landscaping installed along the east and west elevations. New parking and loading surfaces of concrete and brick are being installed using salvaged brick from the existing paved areas. Other amenities will include shade structures, new fencing, trash enclosure, and sliding gates (Map 16). When completed, these latter features will be considered non-contributing resources.

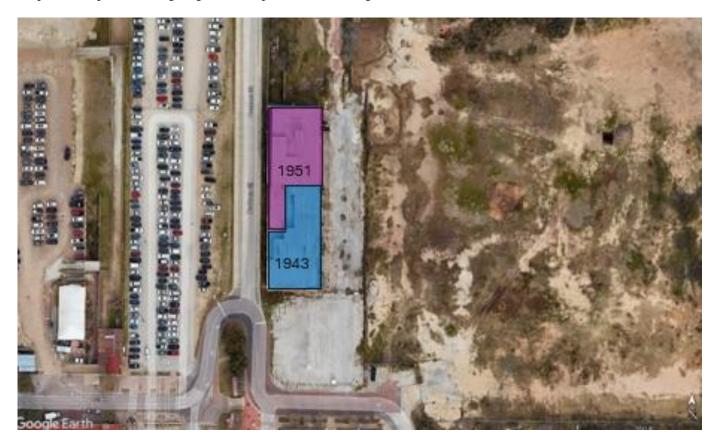
Map 18: Site plan showing original 1943 portion of building and 1951 addition.

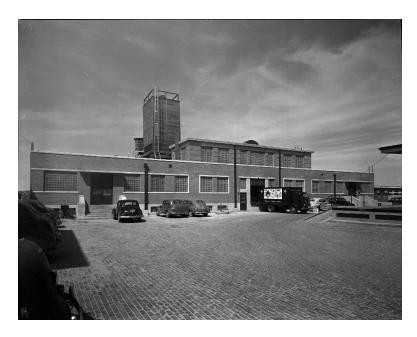
Figure 1: Armour Laboratory Building. Looking west/northwest at east elevation, c. 1944. *Courtesy, W. D. Smith Commercial Photography, Inc. Collection, Special Collections, The University of Texas at Arlington Libraries. Digital Gallery, #20090243.*

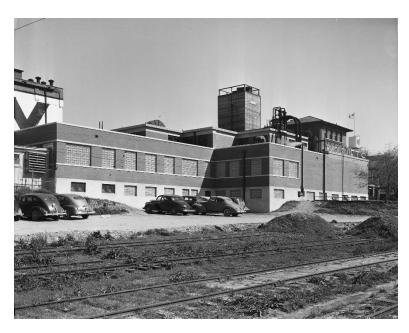
Figure 2: Armour Laboratory Building, west elevation looking southeast, c. 1944. *Courtesy, W. D. Smith Commercial Photography, Inc. Collection, Special Collections, The University of Texas at Arlington Libraries, Special Collections, Digital Gallery, #20090240.*

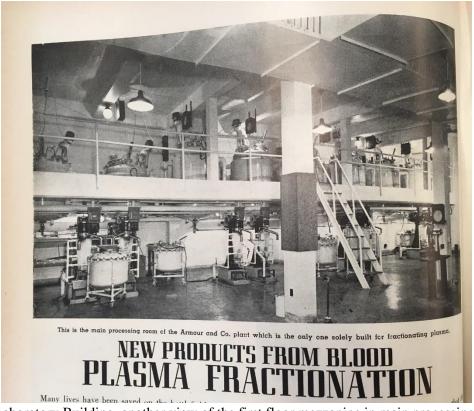
Figure 5: Armour Laboratory Building, main processing room with mezzanine and blood plasma equipment. From *This Month in Fort Worth* 22 (March 1945): 8.

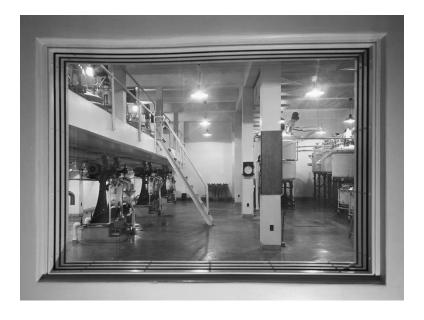
Figure 6: Armour Laboratory Building, another view of the first floor mezzanine in main processing room from an interior window, looking west, c. 1944. *Courtesy, W. D. Smith Commercial Photography, Inc. Collection, Special Collections, The University of Texas at Arlington Libraries, Digital Gallery, #20090442.*

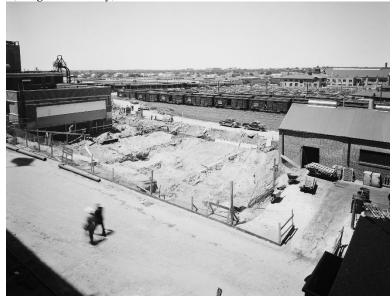
Figure 7: Armour Laboratory Building, site preparation for addition to original building. At right is the pre-existing building that was demolished c. 2009. Armour & Company Serum Albumin Plant-Progress #4, 1951. Looking southwest. *Courtesy, W. D. Smith Commercial Photography, Inc. Collection, Special Collections, The University of Texas at Arlington Libraries, Digital Gallery, #20096620.*

The north elevation is two stories tall. At its center is the ghost of a one-story gable-roofed brick building that predated the north end's 1951 addition (Figures 7, 12, Photos 4 & 5). Aerial photographs and Google Earth Pro images suggest it was removed between 2009 and 2010. Within the ghost lines are window openings infilled with masonry and brick. Below the right window opening is a boarded-over pedestrian opening that accesses the basement (Photo 4). At the west end of this elevation is a below-grade garage/freight opening and a pedestrian entrance that provide access to the basement (Photos 4, 5 & 11). A below grade driveway with concrete retaining walls provides access to this area (Photo 5). A cast belt course separates the first floor from the second. Openings with multi-light aluminum windows have been added on the first and second floors as part of the NPS approved rehabilitation. Three projecting courses of brick span the wall of the second floor (Photo 4, see also Figure 12 for photo dated June 12, 2023, before exterior rehabilitation work began).

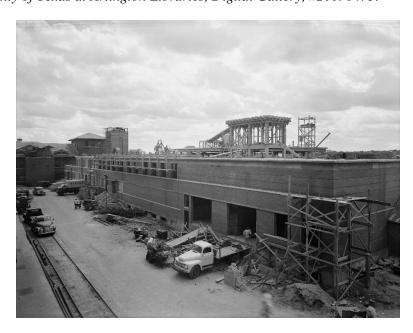
Figure 8: Armour Laboratory Building, addition during construction. Armour & Company Serum Albumin Plant-Progress #16, 1951. Looking southwest. *Courtesy, W. D. Smith Commercial Photography, Inc. Collection, Special Collections, The University of Texas at Arlington Libraries, Digital Gallery, #20096473.*

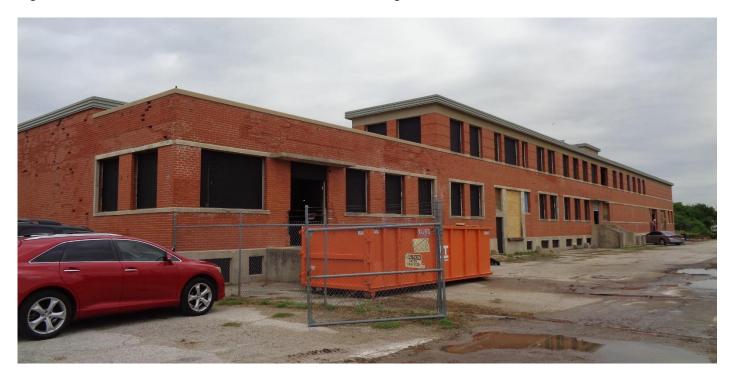
Figure 11: East elevations before exterior rehabilitation work began, June 12, 2023.

The historic façade (east) elevation features ribbons of rectangular window openings on the first and second floor. The first-floor windows have continuous cast sills and lintels that frame the windows, creating elongated rectangles (Photos 1-3). The original glass block was removed from the basement and first- and second-story windows and the openings infilled with wood prior to the present rehabilitation. They now contain multi-light aluminum windows as part of the NPS approved rehabilitation. Near the south end of the first floor is a double door entrance (original doors replaced) protected by a narrow cast concrete awning that aligns with the continuous cast lintels. A concrete loading dock fronts this entrance. Further north is a pedestrian entrance next to a freight opening. To the right of this grouping is the primary entrance consisting of a double door opening (original doors replaced) with a canopy like the one over the southern entrance. During the rehabilitation, a detached canopy is also being added. Fronting it are concrete stairs flanked by concrete wing walls. On the right side of the stairs are L-shaped concrete stairs that access a basement entrance. The basement stairs marked the end of the original building (Figure 1, Photo 2). Near the north end of this elevation were two freight openings that are now infilled with full-height multi-light aluminum windows as part of the NPS approved rehabilitation. Openings with multi-light windows have also been added on the second floor above the former freight openings. (Photo 3, see also Figure 11 for photo dated June 12, 2023, before exterior rehabilitation work began).

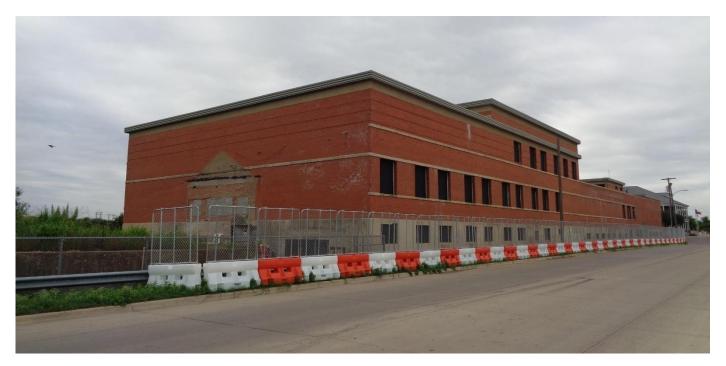
Figure 12: North and west elevations before exterior rehabilitation work began, June 12, 2023.

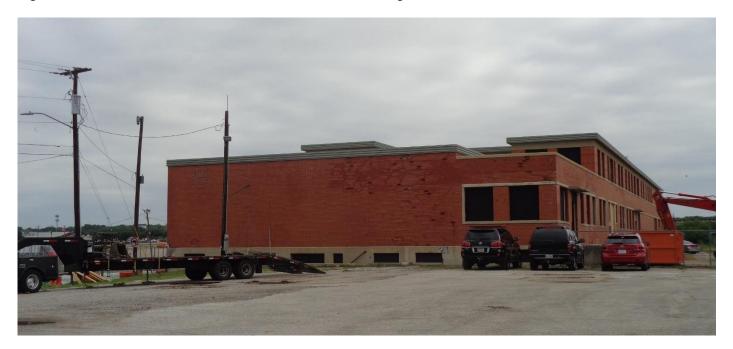
Figure 13: South elevation before exterior rehabilitation work began, June 12, 2023.

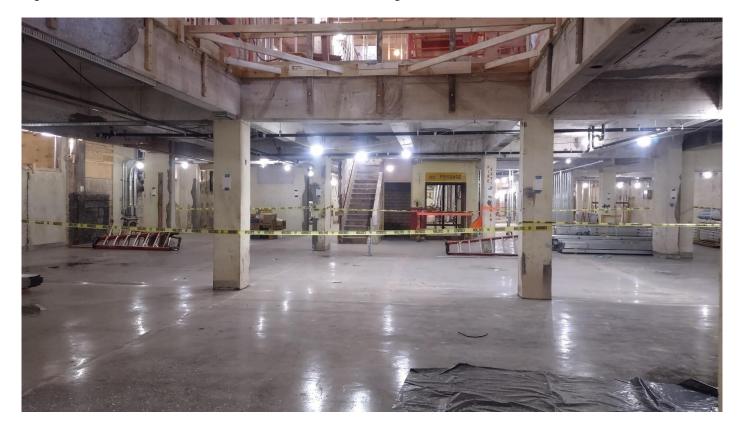
Figure 14: South end of basement before rehabilitation work began, June 12, 2023.

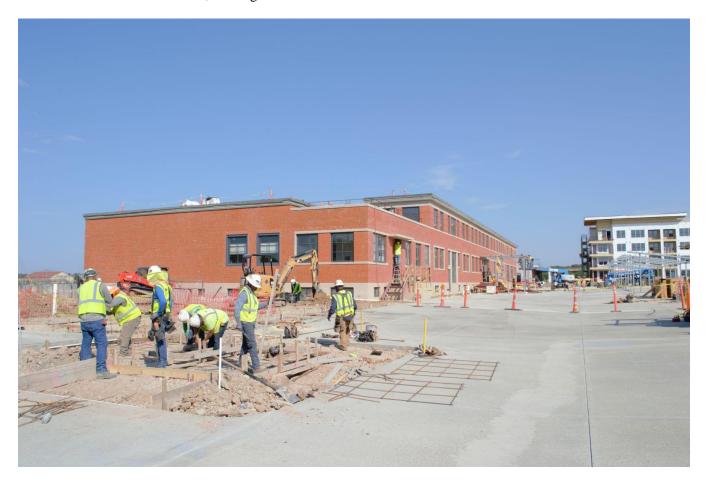
Photo 1: South and east elevations, looking northwest.

The Armour Laboratory Building sits north of East Exchange Avenue and east of Packers Street/Stockyards Boulevard (Maps 1-12). The building was constructed in 1943 as a one-story structure and received an addition on its north end in 1951 that nearly doubled its size. The southern portion is one-story (1943) and the northern three-quarters of the building is two-stories (1951) (Map 18). The flat-roofed building has poured-in-place reinforced concrete structural framing. It sits on a raised basement and has red brick and tile curtain walls. The second story's roof has a slight overhang that also emphasizes the horizontal massing. There is a raised section of the second story and a penthouse on the north half of the building. The property is surrounded by a chain link fence (Photos 5-7). It has gravel and asphalt (over brick) parking lots along its south and east elevations. Acres of mostly undeveloped land that was formerly filled with buildings associated with the Armour & Company packing plant borders it to the north and east. Currently, a multi-story apartment building is being constructed northeast of the nominated resource (Photo 1).

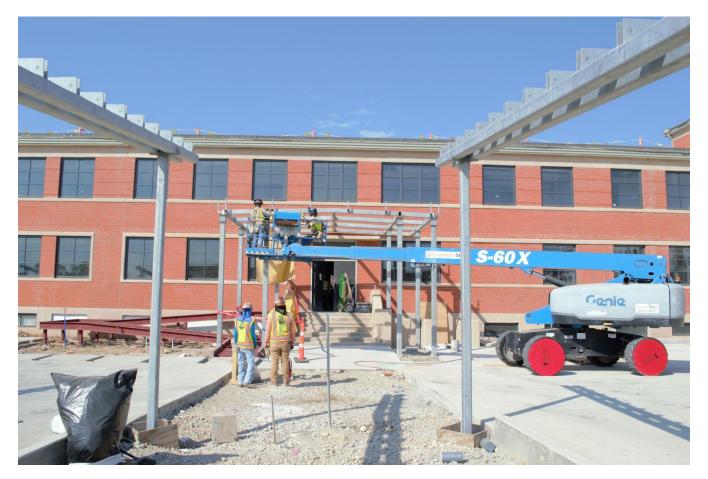
Photo 2: Main entrance, east elevation, looking west.

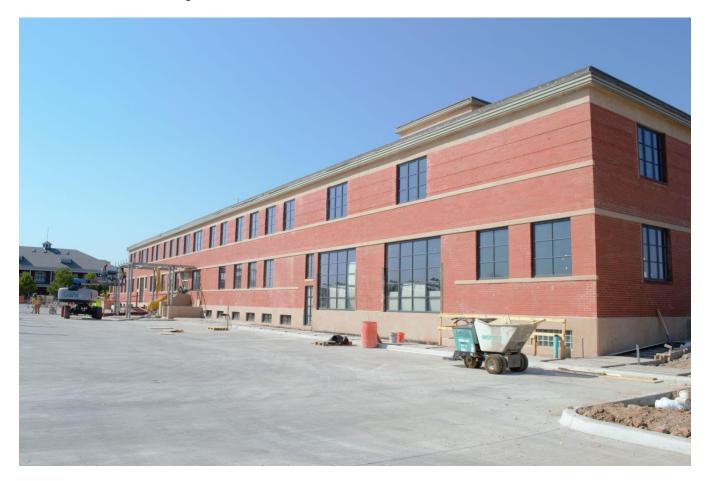
Photo 3: East elevation, looking southwest.

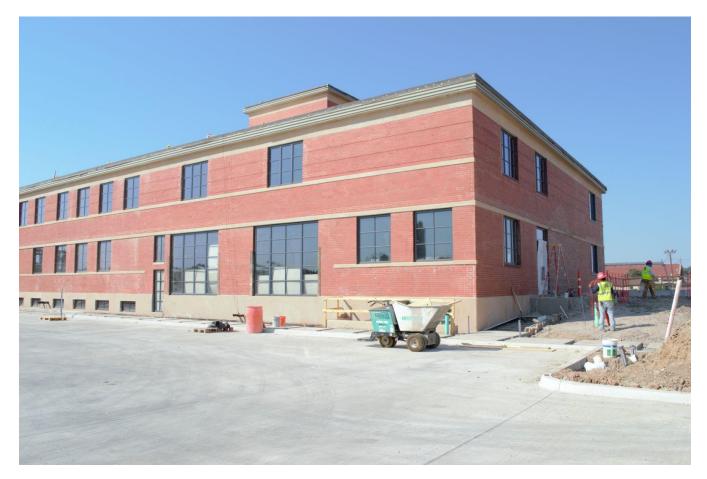
Photo 4: East and north elevations, looking southwest.

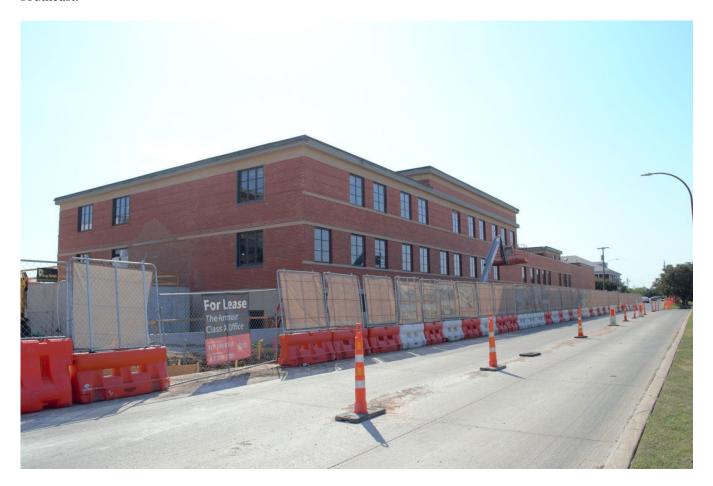
Photo 5: North and west elevations. New window openings on north end of second story, west elevation, looking southeast.

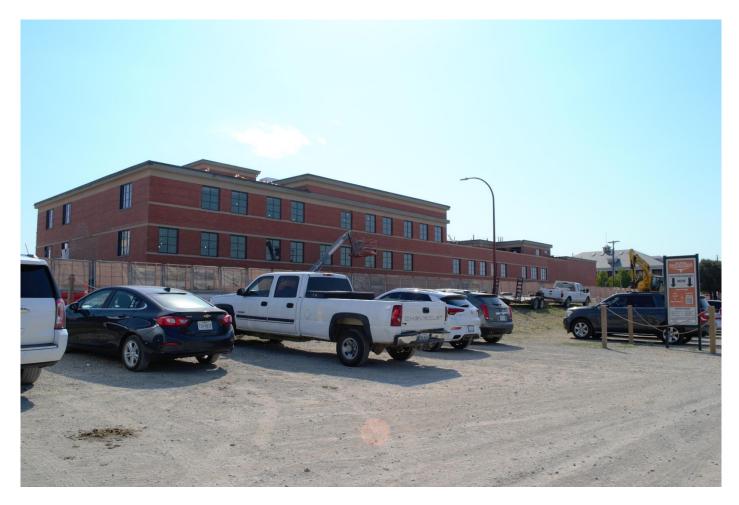
Photo 6: West elevation, new window openings on north end of second story and center south on first floor, looking southeast.

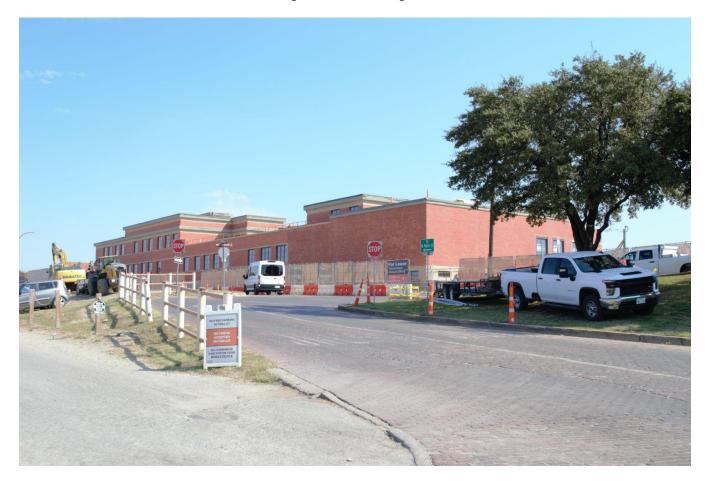
Photo 7: West and south elevations from Exchange Avenue, looking northeast.

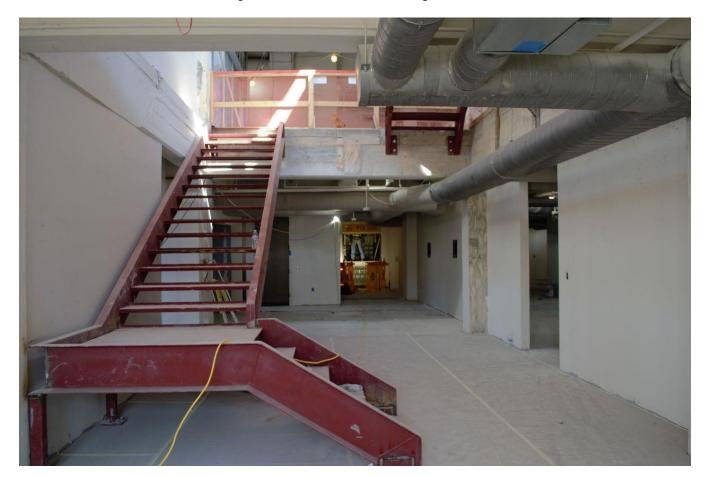
Photo 8: South end of basement showing slab cut for new stairs, looking north.

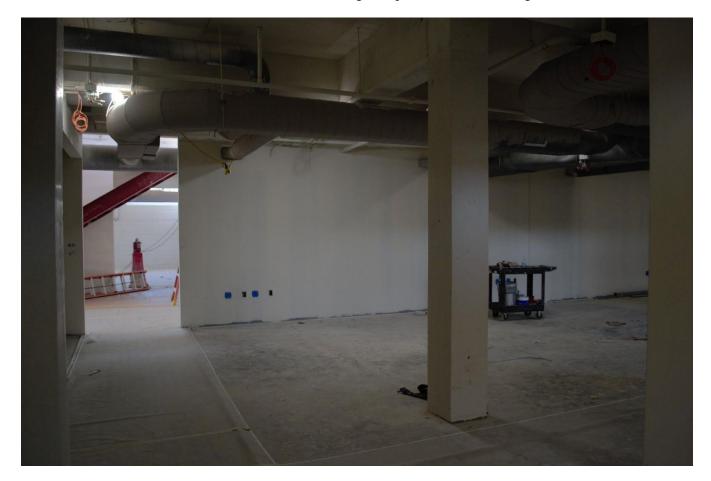
Photo 9: South end of basement near east elevation, showing new partition walls, looking west.

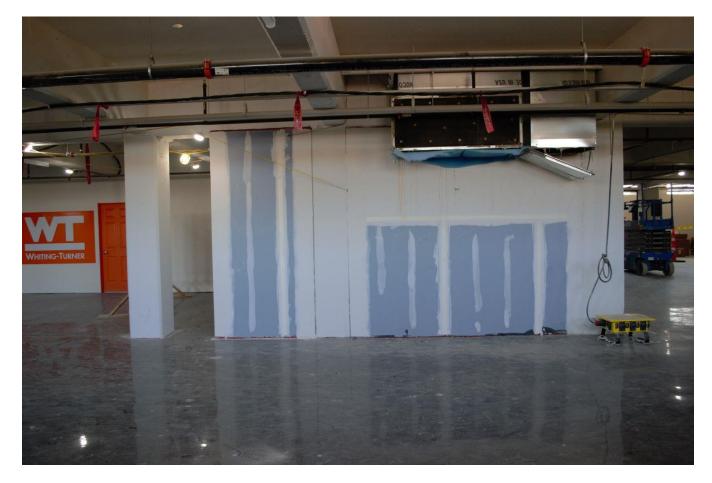
Photo 10: New partition wall around north stairs in basement, looking east.

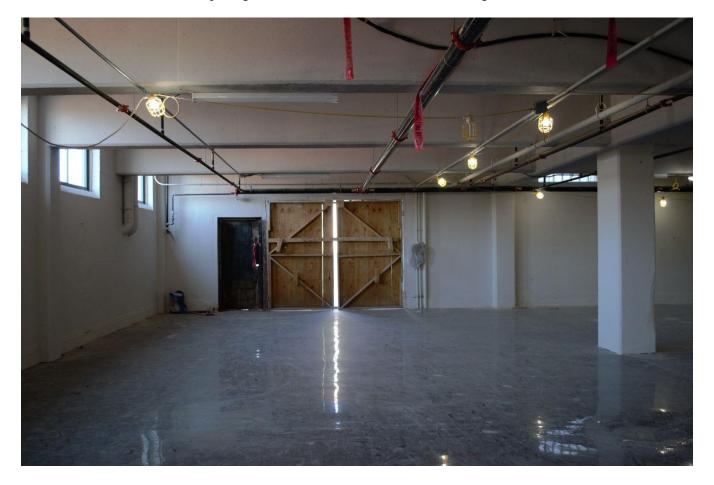
Photo 11: Pedestrian and vehicle openings, northwest corner of basement, looking north.

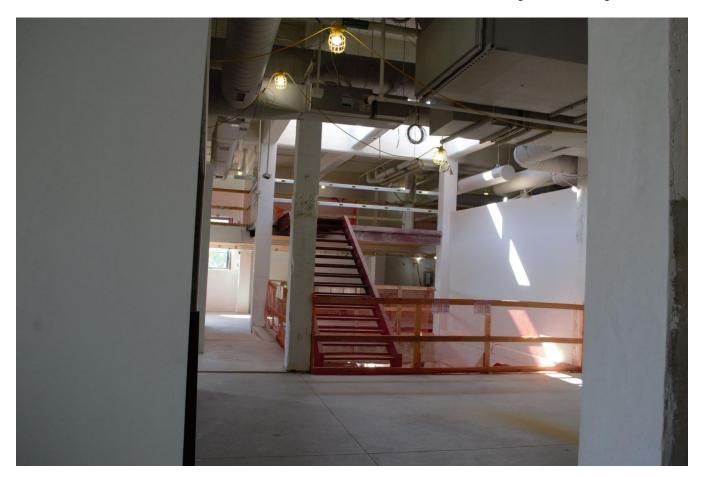
Photo 12: South end of first floor with slab cut for new stairs and mezzanine in the background, looking southwest.

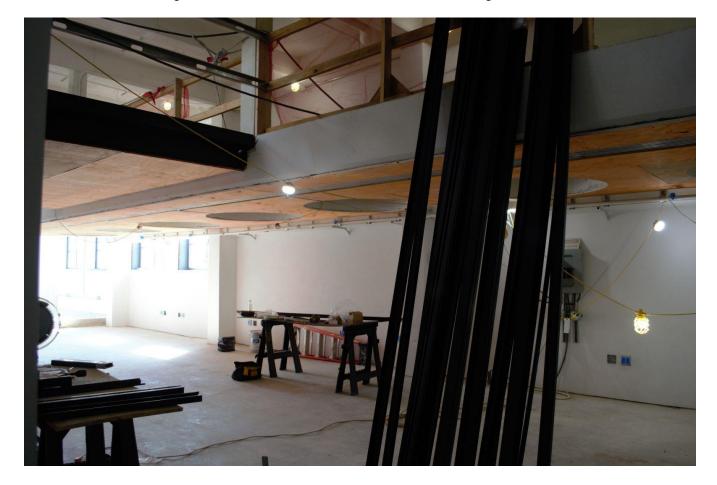
Photo 13: First floor, looking at circular cutouts beneath south mezzanine, looking southeast.

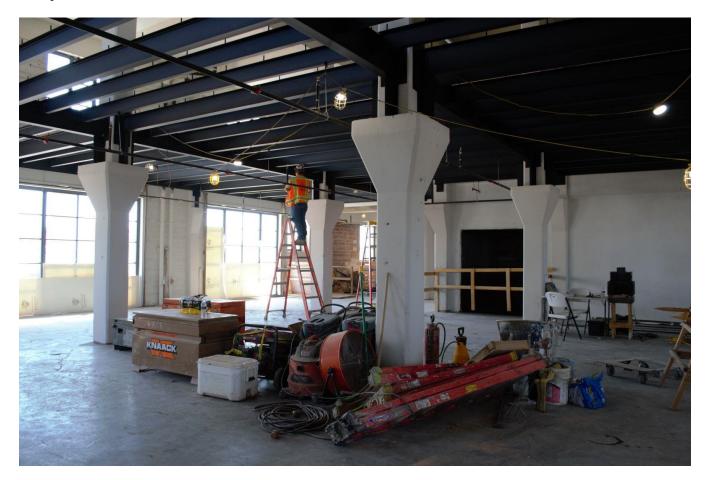
Photo 14: First floor in 1951 addition, looking southeast toward historic freight opening. A second floor is being added in this space.

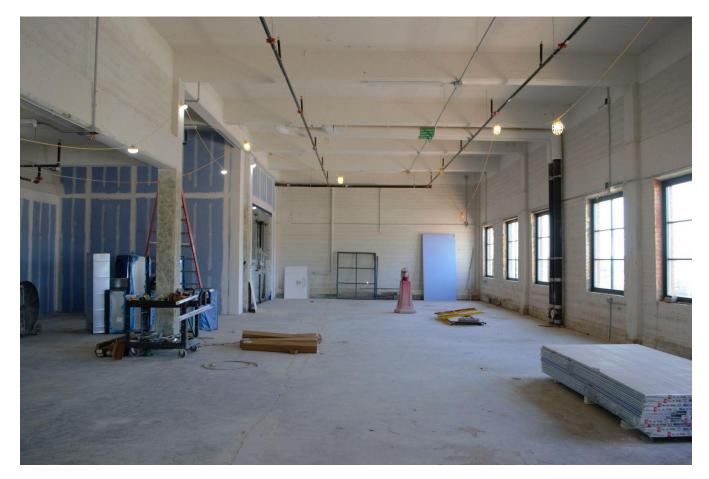
Photo 16: Second floor, looking south along west elevation.

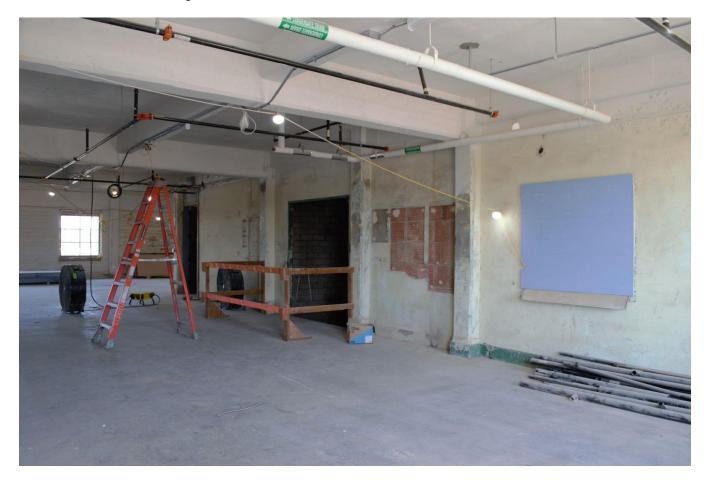
Photo 17: Second floor, looking northwest.

The interior's concrete floors, ceilings, columns, and beams and partially open floor plan reflect the building's historic industrial function. The perimeter walls of the basement are mostly concrete (Photo 11). There are two sets of enclosed concrete stairs extending from the basement to the upper floors. They are in the middle of the south and north portions of the building. Freight elevator shafts are located next to the south (Photo 8; see also Figure 14 for photo dated June 12, 2023, before rehabilitation work began) and north stairs. Interior concrete block walls are painted (Photo 15). Perimeter walls on the first and second floors are mostly clay tile; some have been covered with drywall (Photo 13) and others have been painted (Photo 16). At the south end of the first floor is a concrete mezzanine with large round openings on the floor. This was originally part of the laboratory's main processing room (Photos 12 & 13 and Figures 5 & 6). The second floor has an irregular-rectangular shape as parts of the west wall are set back from the plain of the first floor of the west elevation. Window openings in this area overlook the first floor's roof. A window opening at the east end of the north wall overlooks the first floor's freight area (currently boarded over, Photo 17).
