United States Department of the Interior  
National Park Service**National Register of Historic Places Registration Form**

**1. Name of Property**Historic name: Sour Lake Downtown Historic DistrictOther names/site number: N/AName of related multiple property listing: N/A**2. Location**Street & number: Three blocks in downtown Sour Lake centered around Sixth Street and S. Merchant StreetCity or town: Sour LakeState: TXCounty: HardinNot For Publication: ☐ Vicinity: ☐**3. State/Federal Agency Certification**

Sour Lake Downtown Historic District  
Name of Property

Hardin County, Texas  
County and State

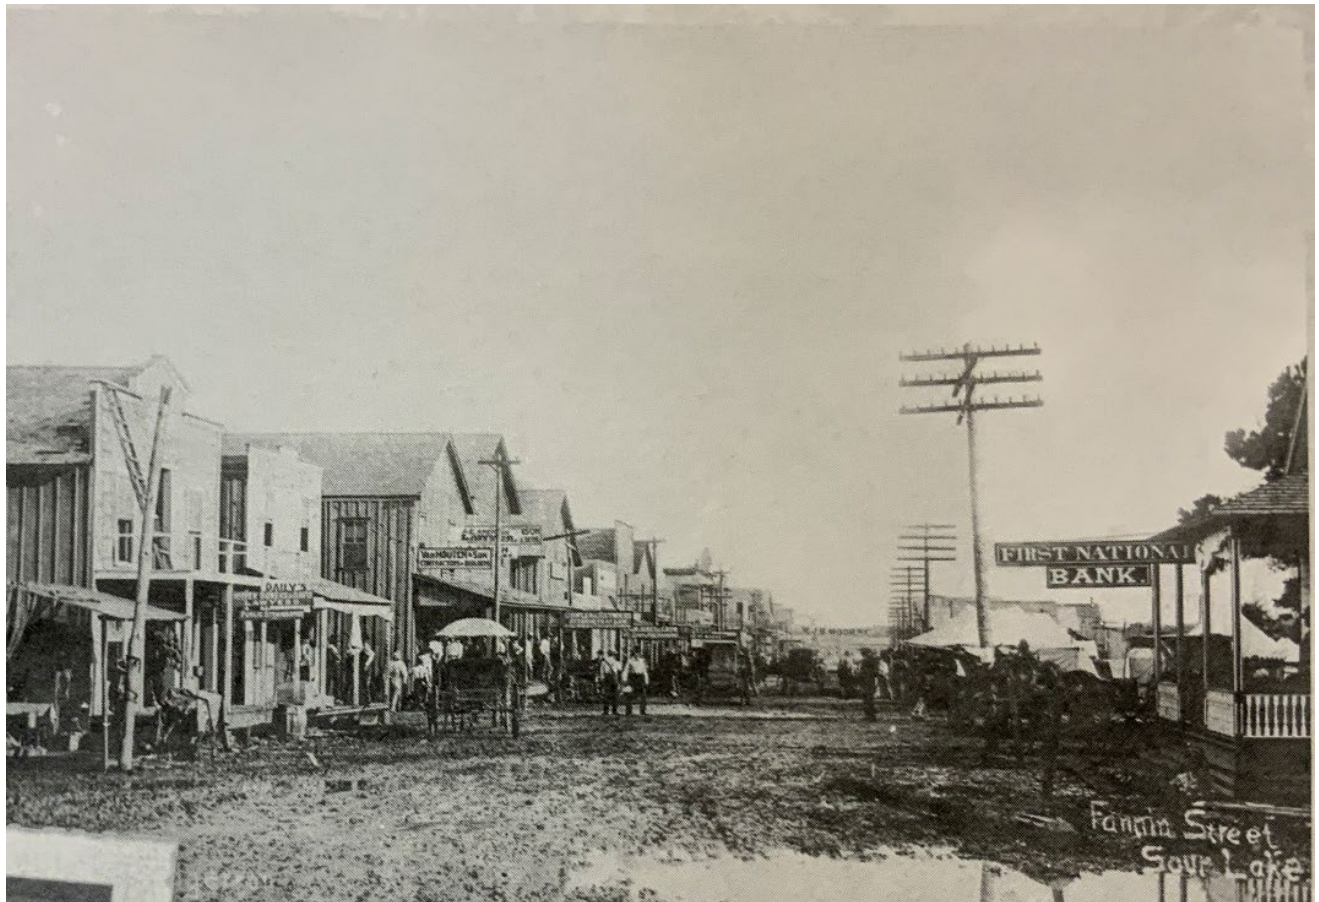
Sour Lake's earliest buildings were wood-frame construction (Figure 1), including the 1883 Sour Lake Springs Hotel, a beacon of Sour Lake's time as a health resort.<sup>2</sup> In the mid-to-late nineteenth century, the earliest buildings constructed in town included stores and saloons. However, it was the 1903 discovery of an oil gusher at nearby Sour Lake Field that spurred the development of the area. In the first decade of the twentieth century, Sour Lake saw the construction of post offices, schools, and churches in response to the oil

Figure 1. 1903 photo of Fannin Street showing wood frame construction prior to 1904 fire.  
Source: Block, W.T. Mud, Gushers, and Sour Lake 'Molasses:' A Tale of Texas' [sic] Second Oil Boom Town.

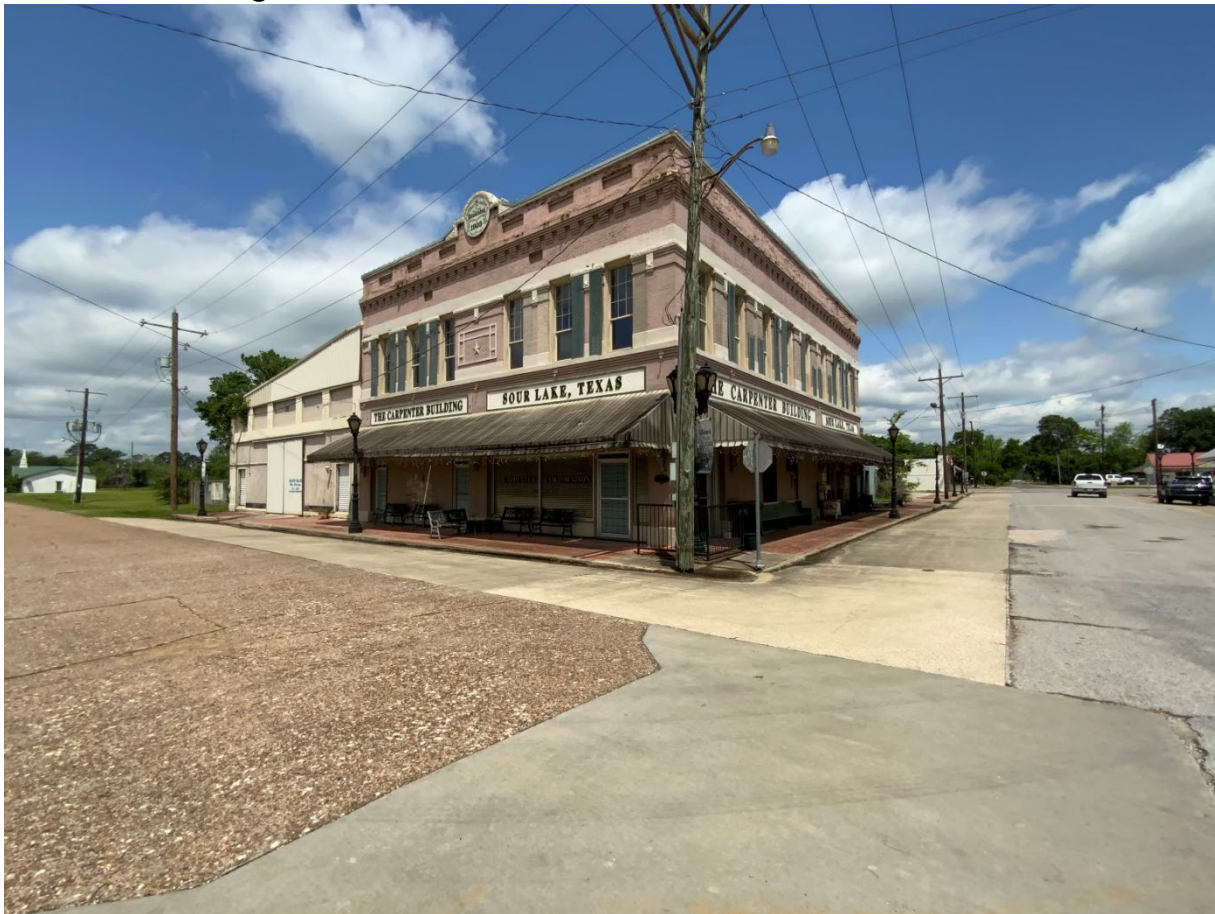
Photo 1. 730 Sixth Street. Carpenter Building (constructed 1903). Shows Sixth Street looking west and Merchant Street looking north. Noncontributing 758 Sixth Street shown at left. Camera facing northwest.

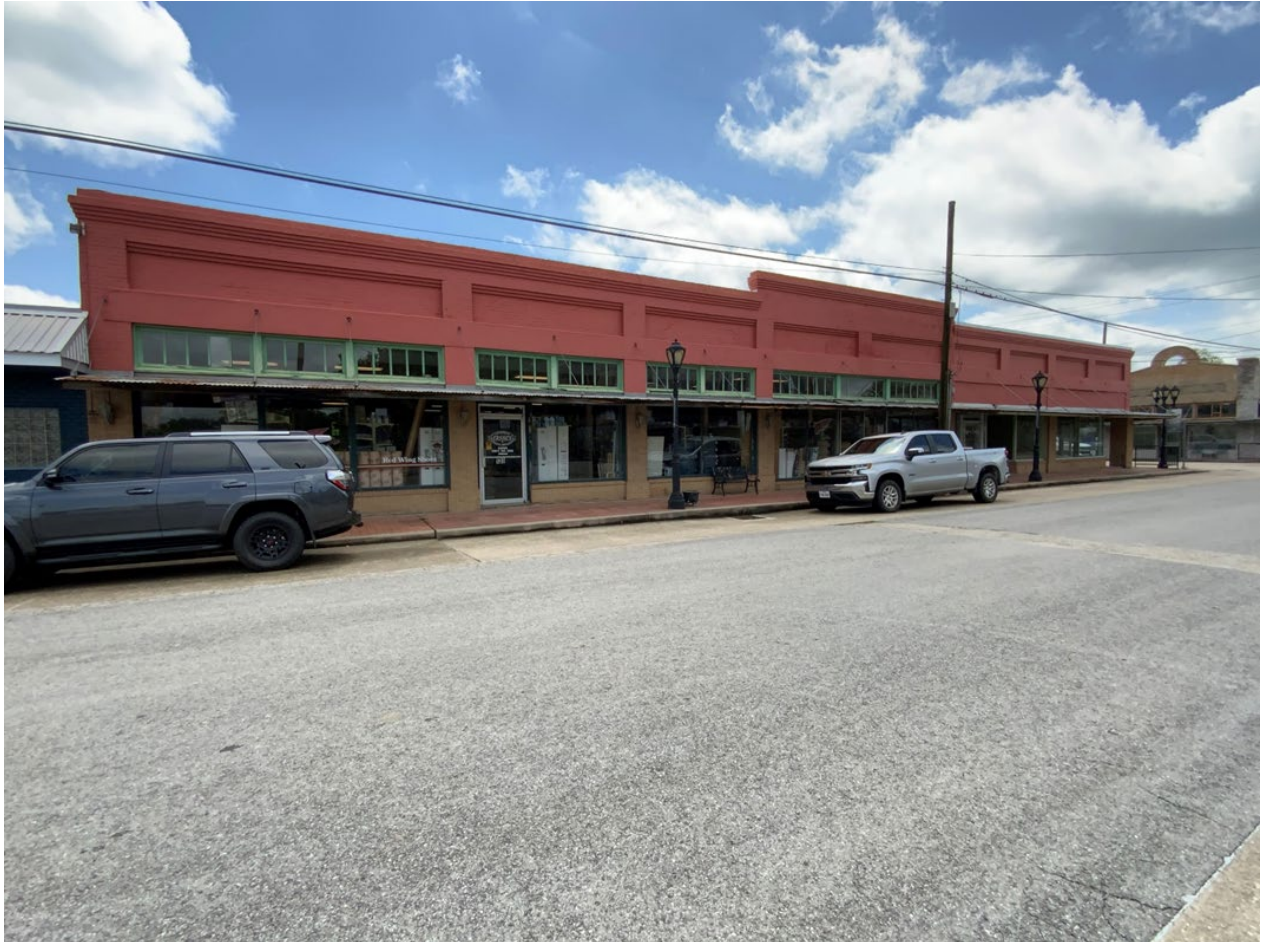
Photo 4. 100 Block of Merchant Street (constructed 1916). Left to right: 135 Merchant Street and 125 Merchant Street. Camera facing southeast.

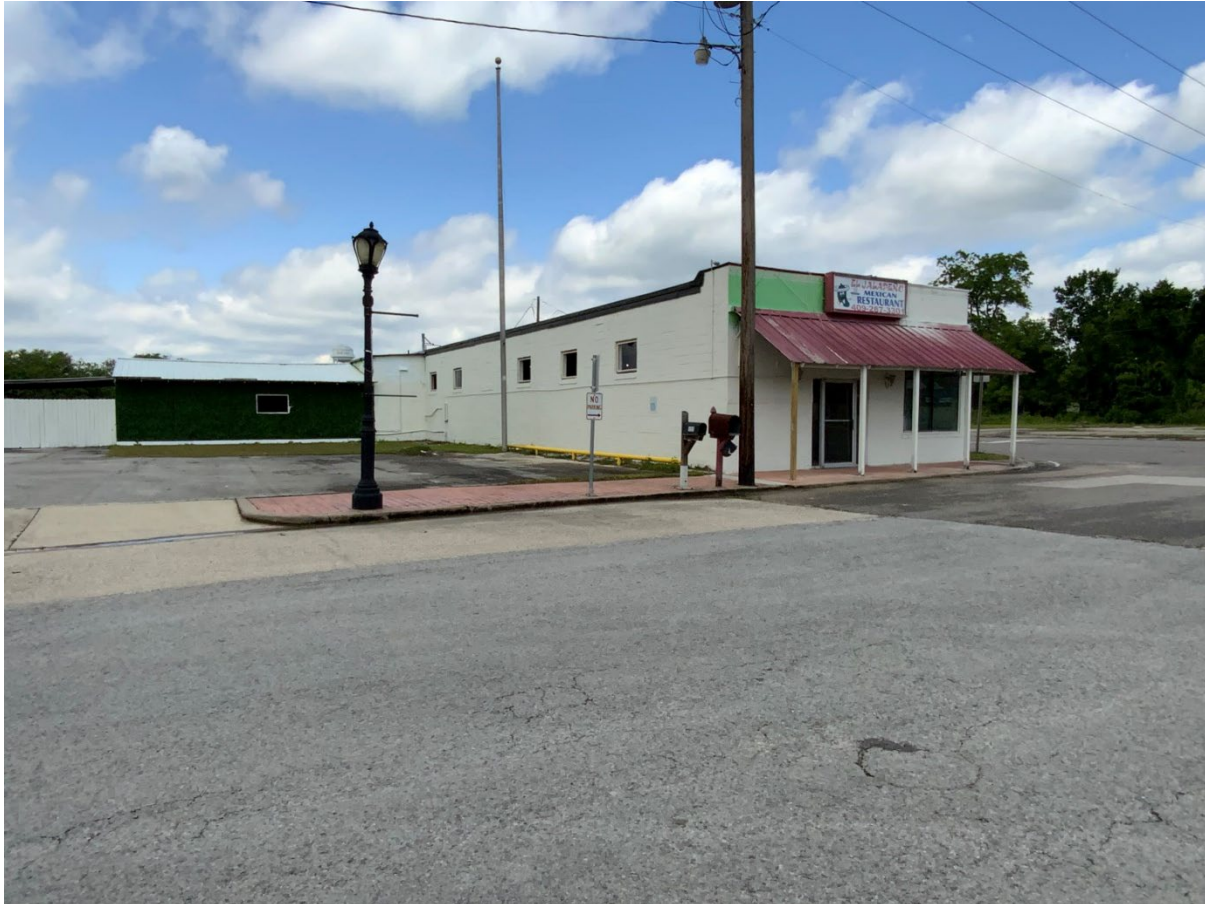
Constructed in 1950, the building at 104 Merchant Street is a free-standing one-part commercial block building with painted cinderblock walls and a flat parapet (Photo 7). The building is at the southwest corner of Merchant Street's intersection with State Highway 105, and its primary elevation faces east toward Merchant Street. Historically, the building most likely shared a party wall with a neighboring building to its south that is no longer extant—a parking lot now occupies this space. The north elevation, which faces State Highway 105, would have always been exposed. The primary entrance to the building is situated at the east end (left side if looking at the building) of the elevation and contains a fully glazed aluminum door flanked by skylights. There is a single-pane aluminum display window at the west (right) side of the elevation. Four square wood posts support a sloped, red-painted corrugated metal awning that spans the elevation over the entrance and window. The north elevation facing State Highway 105 features a painted mural containing four images including the 1883 Sour Lake Hotel (non-extant). The now exposed south elevation has a line of punched window openings. Historically, the building functioned as Q.P. Grocery.<sup>6</sup>

Photo 6. Northwest Merchant Street, showing 104 Merchant Street, a contributing resource.

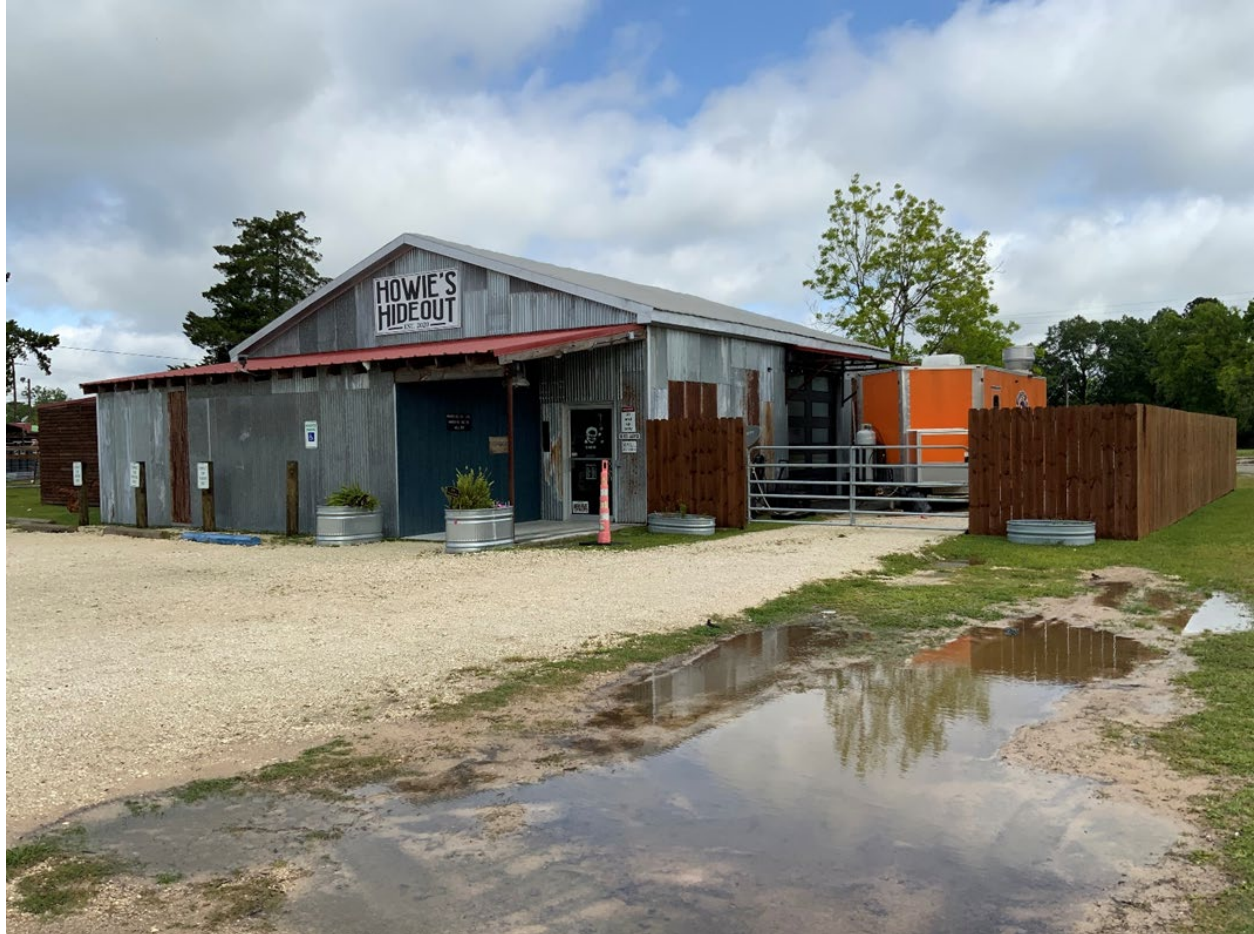
| Image | Address<br>Resource # | Year<br>Built | Original Use<br>Type - Form | Stylistic<br>Influence(s)<br>) | Alterations<br>Additions | Contributing<br>Status |
|---|---|---|---|---|---|---|
| | 650 6TH ST<br>9 | 1950 | Warehouse<br>Metal workshop | No stylistic influences visible | Doors replaced, Original porch enclosed<br>Rear/side porches, Detached auxiliary building | Contributing |

Photo 7. 650 Sixth Street. Workshop Building (constructed 1950). Camera facing northeast.

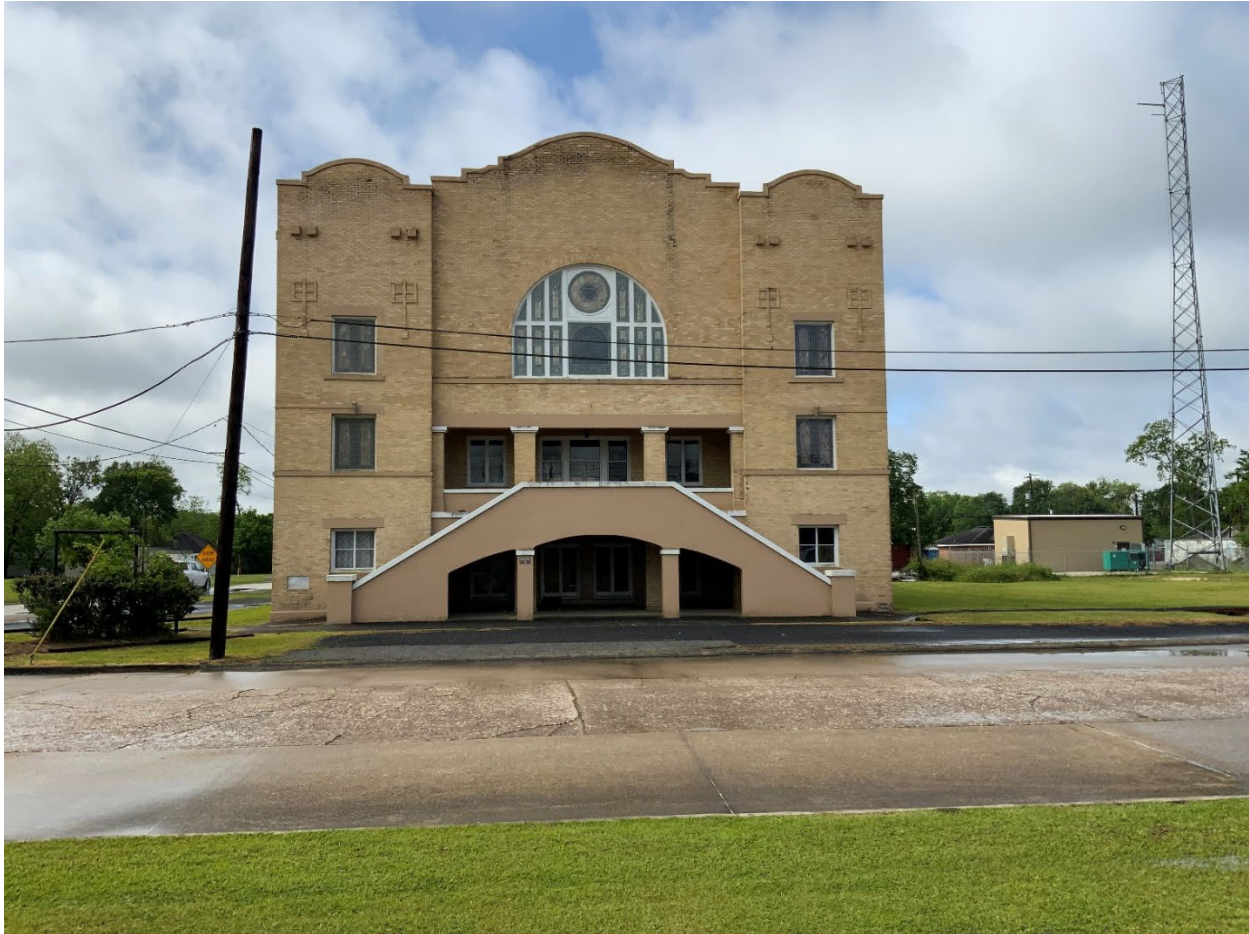
The **First M.E. Church South** (615 Sixth Street) was constructed in 1921 and sits at the east end of the district on the south side of Sixth Street (Photo 2).<sup>22</sup> It is a three-story buff brick Mission Revival building characterized by curved parapets and a large stained glass arched window on the primary elevation. The building has a central front gable mass flanked by two circulation towers. A raised double staircase accesses the primary entrance which is inset into a porch with square brick piers. The entrance contains paired, fully glazed wood doors with transoms and flanking sidelights. The First M.E. Church South retains its historic windows including the large semicircular stained-glass window on the central mass, the smaller rectangular stained-glass windows on the circulation towers, and tripled one-over-one wood windows on the side elevations (Photo 24). Brick pilasters punctuate the side (west and east) elevations of the building. A large open field occupies the space to the west of the church.

Photo 9. 615 Sixth Street (ID: 139896). First M.E. Church South (constructed 1921). Camera facing south.

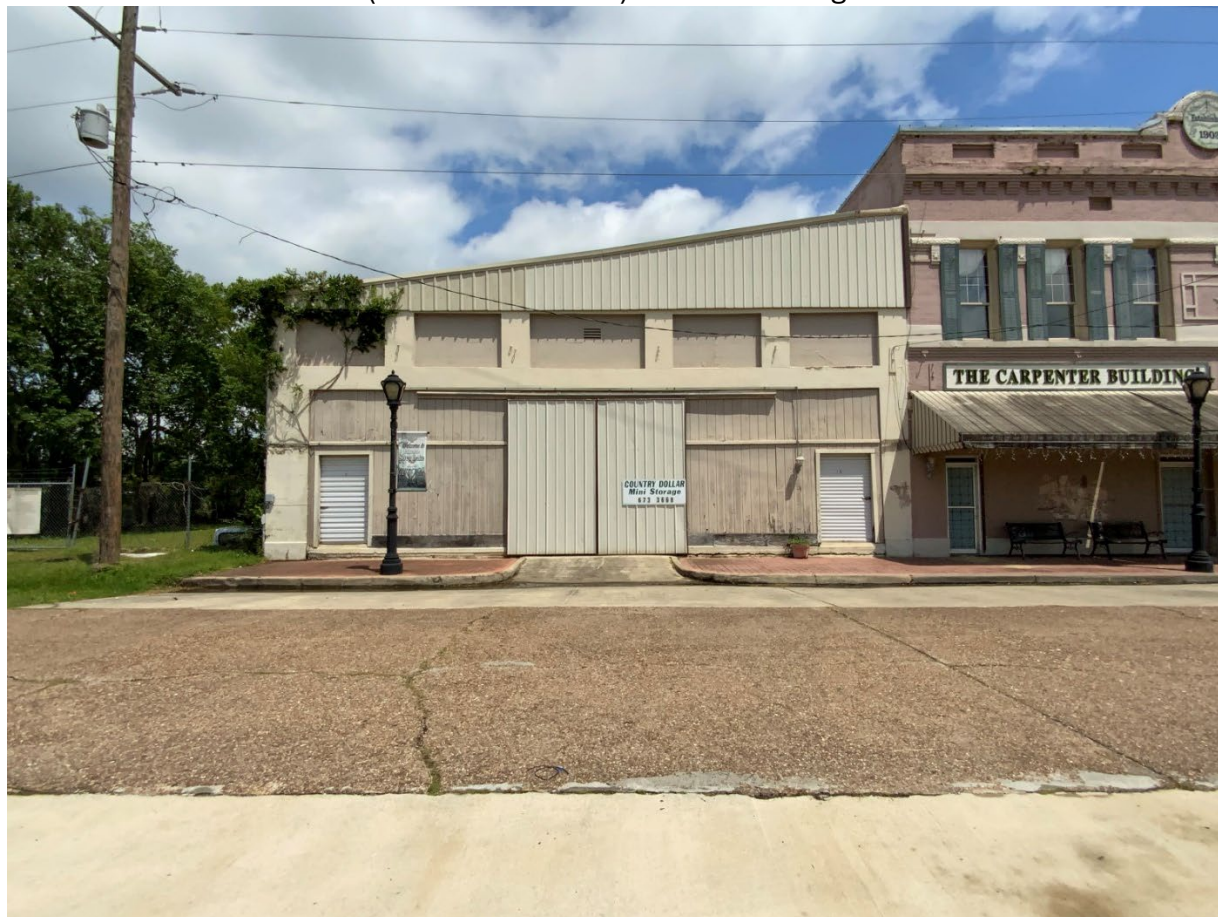
The building at 758 Sixth Street is one story with a slanted shed roof (Photo 13). It is located on the north side of Sixth Street and shares a party wall with the Carpenter Building (730 Sixth Street) to the east. Originally constructed in 1930 as a one-part brick commercial block, the building has undergone alterations including the infill of storefronts with vinyl siding and installation of stucco. Four recessed panels mark the primary (south) elevation between the infilled storefront and the shed roof. Historically, the building at 758 Sixth Street was known as the Earl Hankamer Building and housed Hankamer Clothing for Men

| Image | Address | Year | Original Use | Stylistic | Alterations | Contributing |
|---|---|---|---|---|---|---|
| | 758 6TH ST | c. 1930 | Commercial | No stylistic influences visible | Roof shape altered, Storefront boarded, Doors replaced, Transoms enclosed | Noncontributing |

Photo 10. 758 Sixth Street (constructed 1930). Camera facing north.

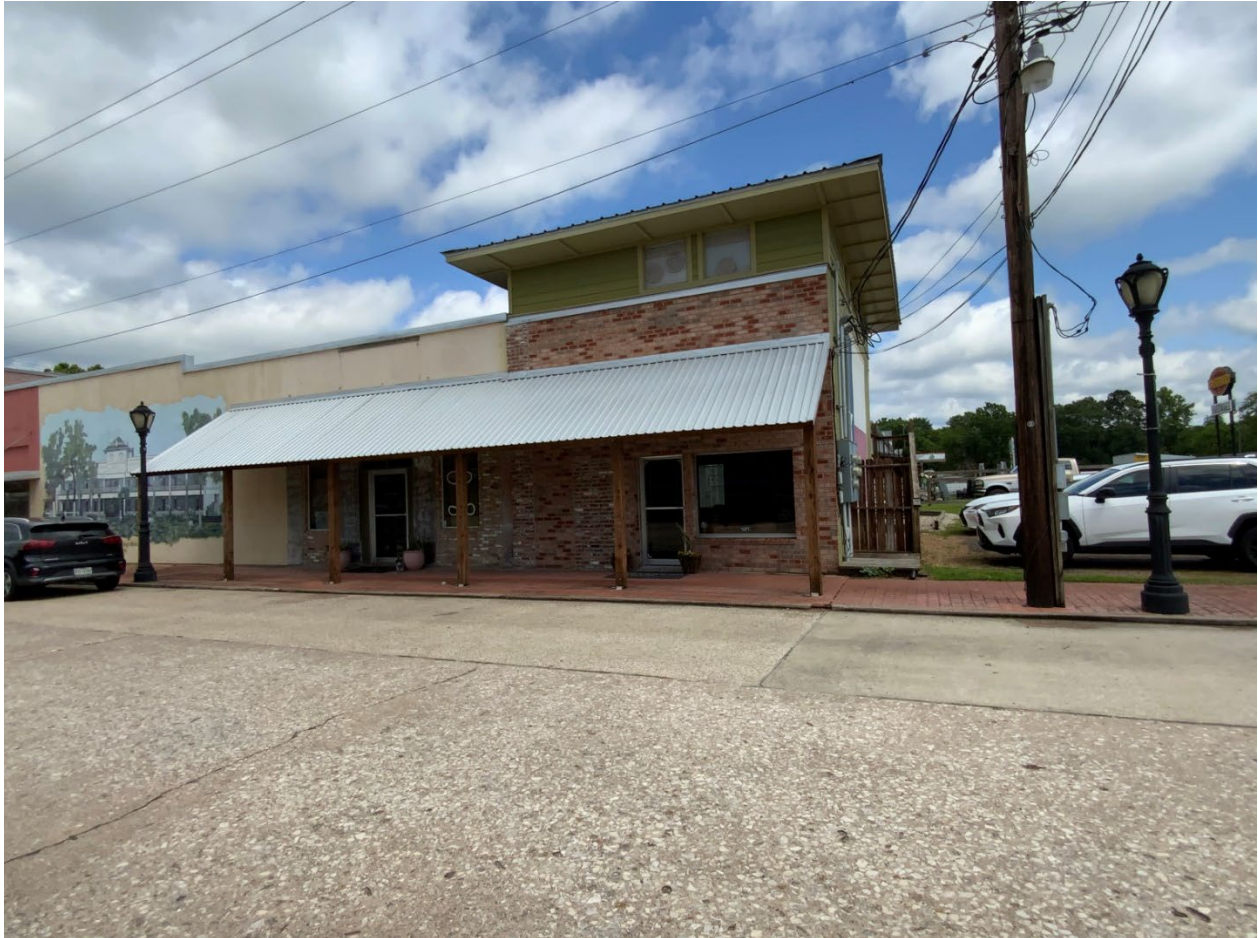
| Image | Address<br>Resource # | Year<br>Built | Original Use<br>Type - Form | Stylistic<br>Influence(s)<br>) | Alterations<br>Additions | Contributing<br>Status |
|---|---|---|---|---|---|---|
| | 690 6TH ST<br>7 | 1935 | Commercial<br>Office - One-part commercial block | No stylistic influences visible | All windows replaced, Fenestration pattern altered, Doors replaced, Canopy replaced, Partially stuccoed ca. 1970 | Noncontributing |
| | 680 6TH ST<br>8 | c. 1960 | Commercial<br>Store - One-part commercial block | No stylistic influences visible | All windows replaced, One window enclosed, Canopy altered/replaced, Doors replaced<br>Additional story added | Noncontributing |

Photo 11. Left to right: 690 Sixth Street (constructed 1935) and 680 Sixth Street (constructed 1960). Noncontributing due to extensive alterations. Camera facing northwest.

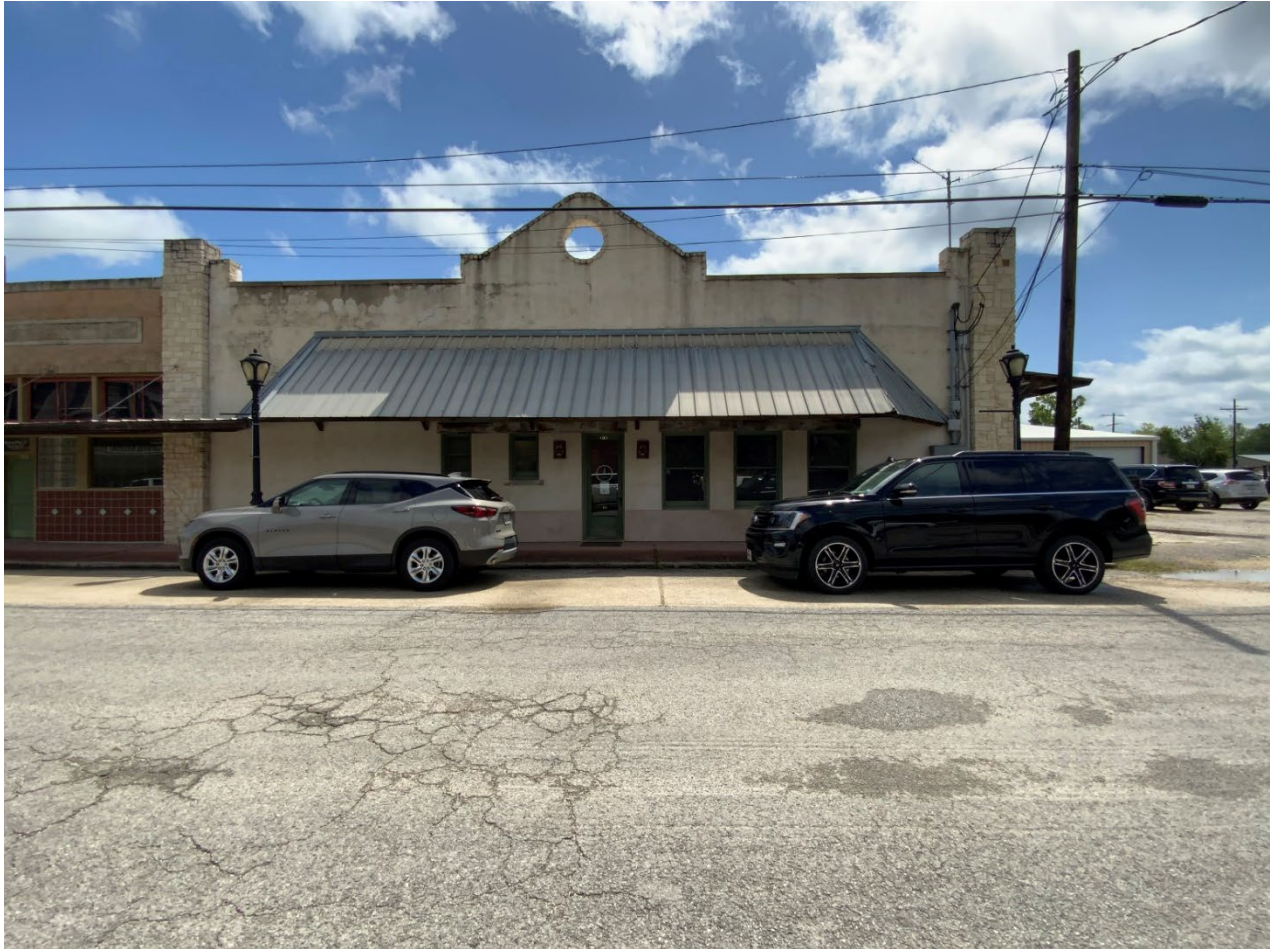
The rear portion of this building is addressed as 165 Merchant Street and accessed by a separate entrance via the west side façade. Today this portion of the building is differentiated from the front of the building by a non-historic stepped parapet with a centered pediment (Photo 16). A sloped corrugated metal awning covers the 165 Merchant Street entrance, with a centered partially glazed wood door. Two wood windows flank the entrance on either side. Multiple alterations detract from the integrity of this portion of the building, including an altered parapet, replaced canopy, and stone veneering of piers flanking the elevation. Most egregiously, the elevation was covered with stucco in 2005. The visible side (south) elevation retains its historic wood entrance configuration, plat canopy, and brick walls, evidencing what the primary elevation looked like before these irreversible changes. Despite these changes, the building overall retains integrity to contribute to the district's significance (justification is further explained on page 14). The circa 1950s Occupancy Map shows that this portion of the building housed doctor's offices: Dr. Hart's and earlier, Dr. Lancaster's office.<sup>18</sup>

Photo 12. 165 Merchant Street – also showing the rear portion of 695 Sixth Street at the right. Camera facing east.

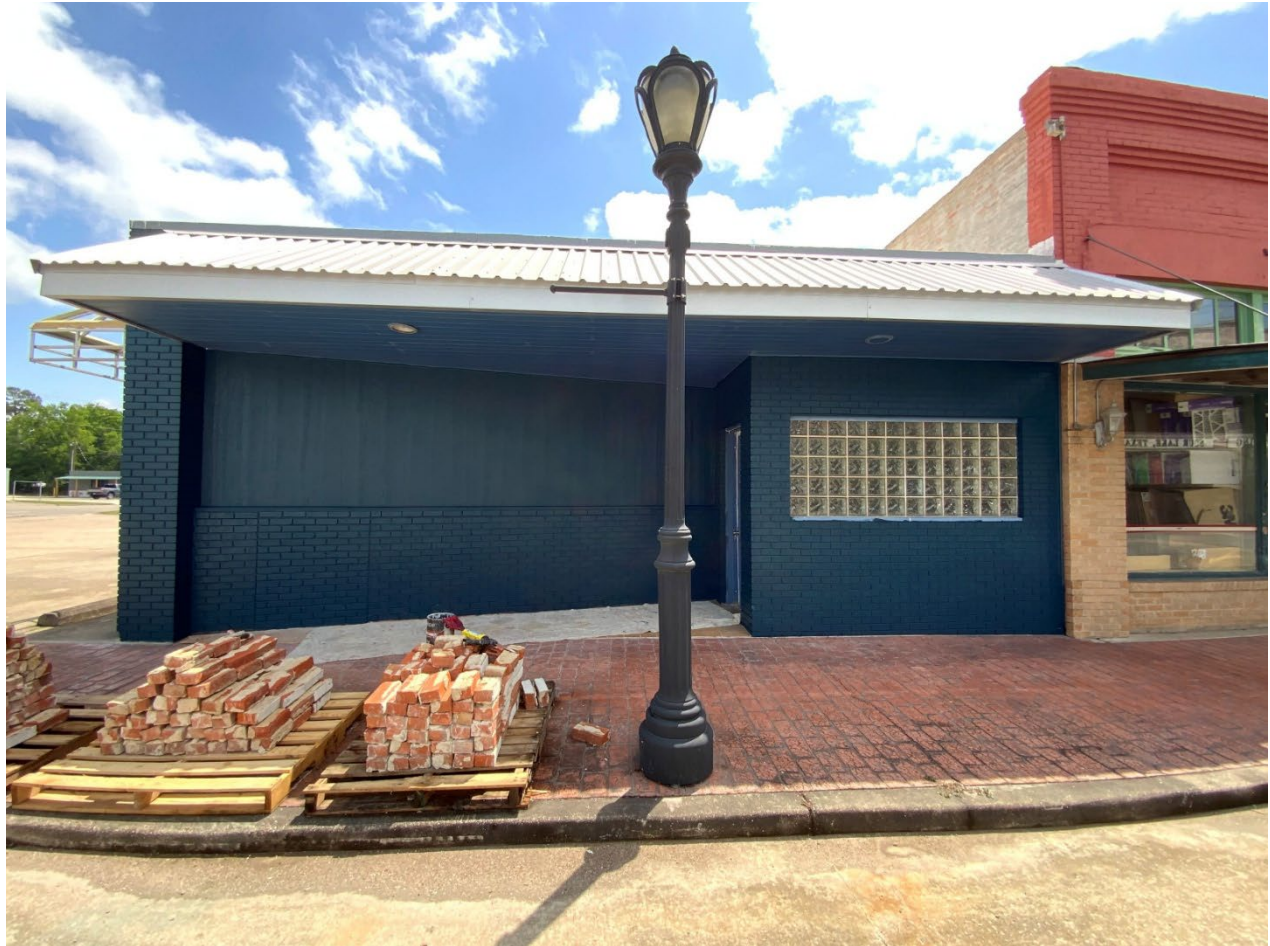
The building at 111 Merchant Street was constructed around 1965 as a restaurant. The building faces west toward Merchant Street, and its north side elevation faces Highway 105. Today, a surface parking lot is located between the building and Highway 105 (Photo 25); it is likely that the buildings historically in this location were demolished around the

time of the restaurant's construction to create the adjacent parking lot. The building's form is a one-part commercial block with brick exterior walls and a flat roof. Extensive alterations ongoing in 2023 significantly altered the building's appearance. On the front façade, the original front storefront and window have been enclosed with fiber-cement siding and glass block, the doors have been replaced, and the canopy has been replaced. On the north elevation, new window and door openings have been installed. The historic brick masonry has been painted on all visible exterior wall surfaces. Because no materials or architectural features from the historic period remain visible today, the building lacks integrity to contribute to the district's historical significance.

| Image | Address | Year | Original Use | Stylistic | Alterations | Contributing |
|---|---|---|---|---|---|---|
| | 111<br>MERCHANT ST | 1965 | Commercial | No stylistic influences visible | Front windows enclosed with glass block, Front storefront enclosed, New window and door openings punched on side facades, All doors replaced, Canopies replaced, Brick painted | Noncontributing |

Photo 13. Restaurant at 111 Merchant Street, constructed around 1965. Camera facing east.

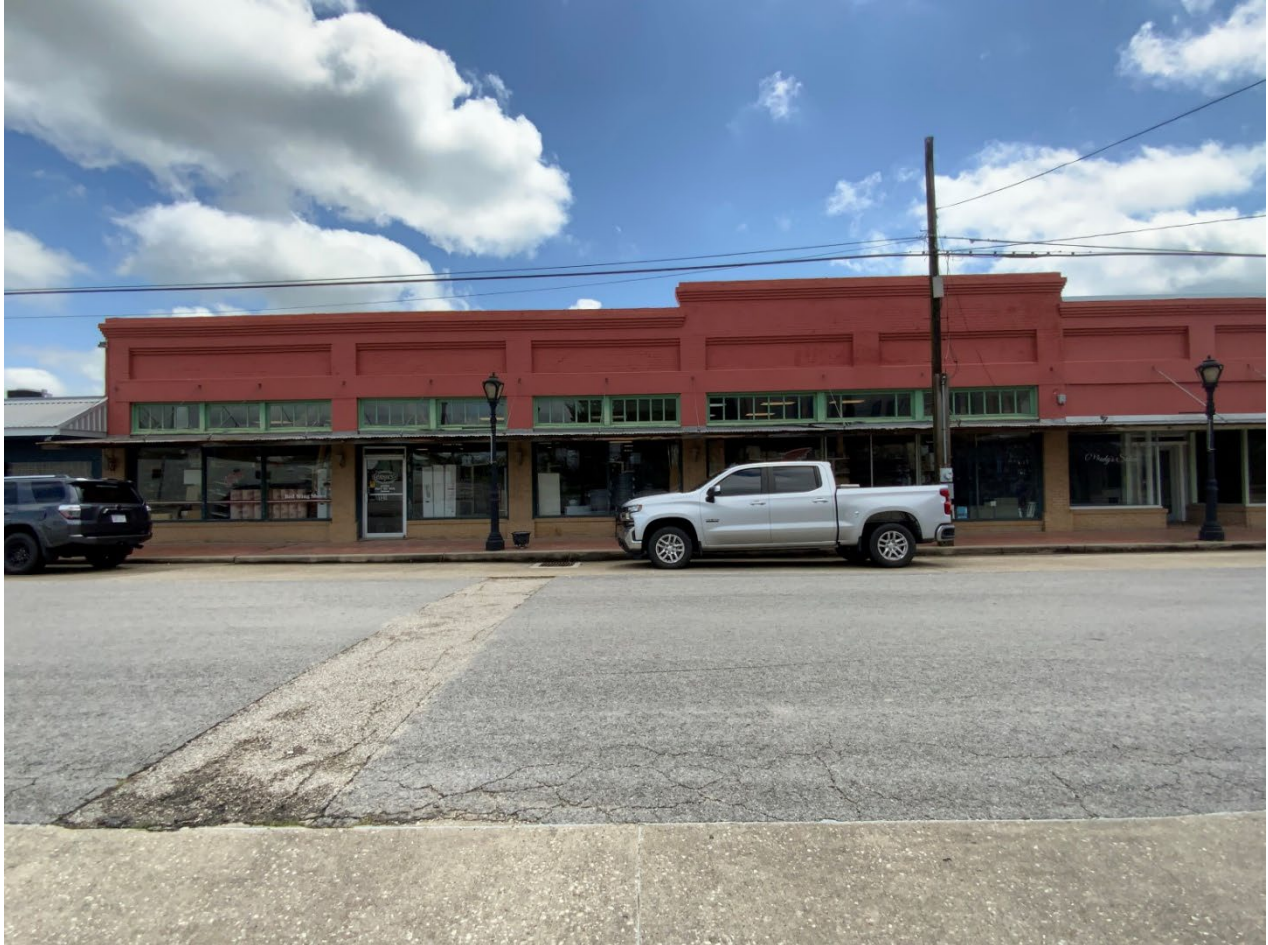
The building at 135 Merchant Street is a part of a long contiguous one-part brick commercial block building with five storefronts that occupies the east side of the 100 block of Merchant Street (Photos 10, 12). 125 Merchant Street comprises the rest of the commercial block (discussed above). 135 Merchant Street contains the first bay (north, left if looking at the building) and second bay (center); the second bay has a parapet, making it taller than the flanking bays (Photo 23). The first bay contains three recessed panels above the intact row of transoms; the northernmost panel is wider than the rest of the panels comprising 135 and 125 Merchant Street, and the storefront below is the same width. The center bay has two recessed panels over intact transoms. The entrances on 135 Merchant Street are flush with the elevation rather than recessed as on 125 Merchant Street. The circa 1950 Occupancy Map Shows that the first bay (north) contained the Royal Café, P.A. Childress Cleaning and Tailor Shop, and F.D. Smith Quality Cleaners.<sup>7</sup> The center bay contained Gorden's Furniture Store, J.W. Parr Furniture Store, Frank Swain Hardware, White-Luce Hardware, Western Auto, and Ernie's Ace Hardware.<sup>8</sup>

| Image | Address | Year | Original Use | Stylistic | Alterations | Contributing |
|---|---|---|---|---|---|---|
| | 135<br>MERCHANT ST | c. 1916 | Commercial | Commercial | Doors replaced, Transoms replaced compatibly | Contributing |

Photo 14. 135 Merchant Street (constructed 1916). Camera facing east.

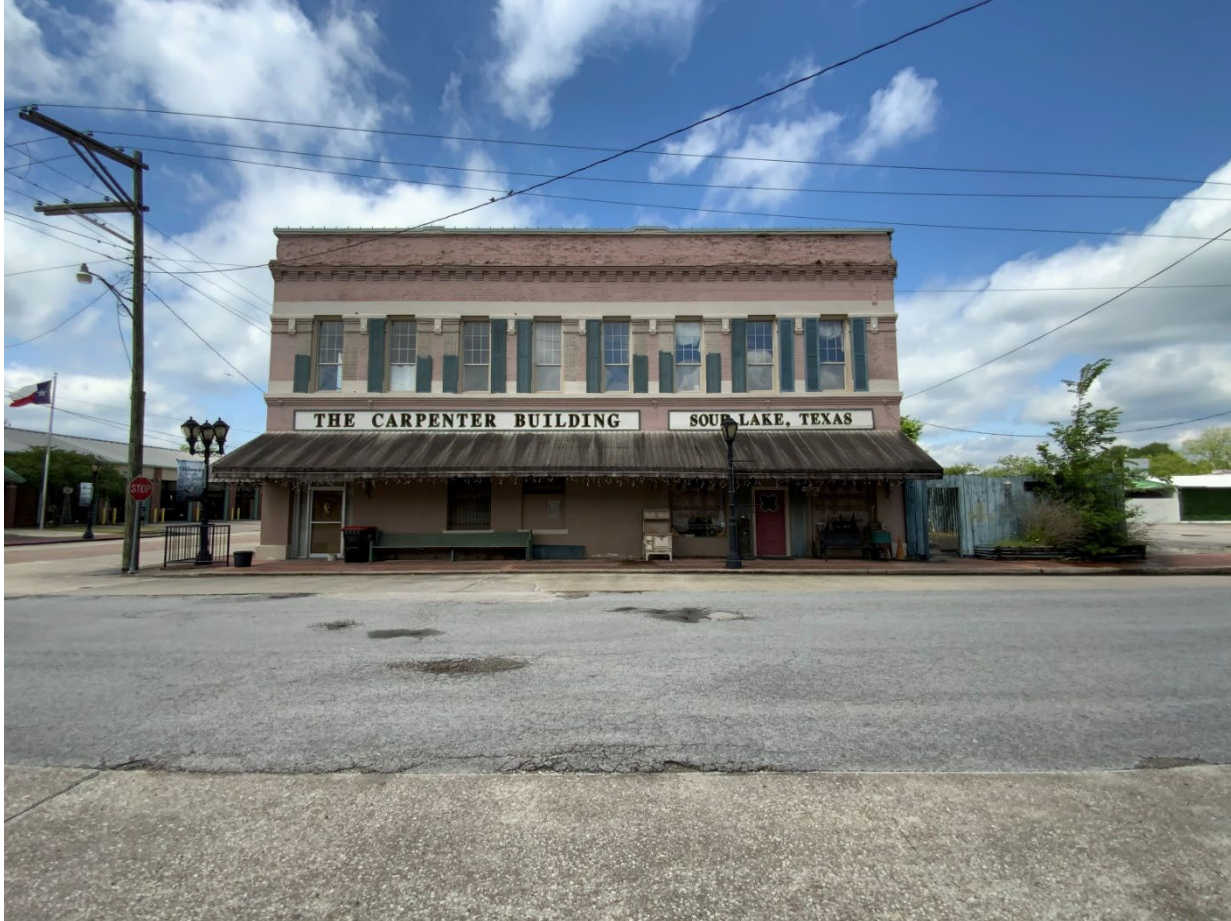
Most resources in the Downtown Sour Lake Historic District embody the American Commercial movement of the late nineteenth and early twentieth centuries. The Carpenter Building at 730 Sixth Street exemplifies this movement and also embraces Italianate influences of the late Victorian era (Photos 1, 17), with character-defining features including narrow second-story windows, a parapet with corbelled brackets, and rusticated stone detailing. The First M.E. Church South at 615 Sixth Street displays the Mission Revival style, characterized by a molded parapet and round-arched central window (Photo 2). The Post Office at 665 Sixth Street provides the district's only example of Mid-century Modern architecture, with a character-defining flat roof, cantilevered canopy, and wall of large metal-framed fixed windows (Photo 15).

| Image | Address | Year | Original Use | Stylistic | Alterations | Contributing |
|---|---|---|---|---|---|---|
| | 730 6TH ST | 1903 | Commercial | Italianate | Some windows replaced, Canopy removed, Doors replaced | Contributing |

Photo 15. 730 Sixth Street. Carpenter Building (constructed 1903). Camera facing west.

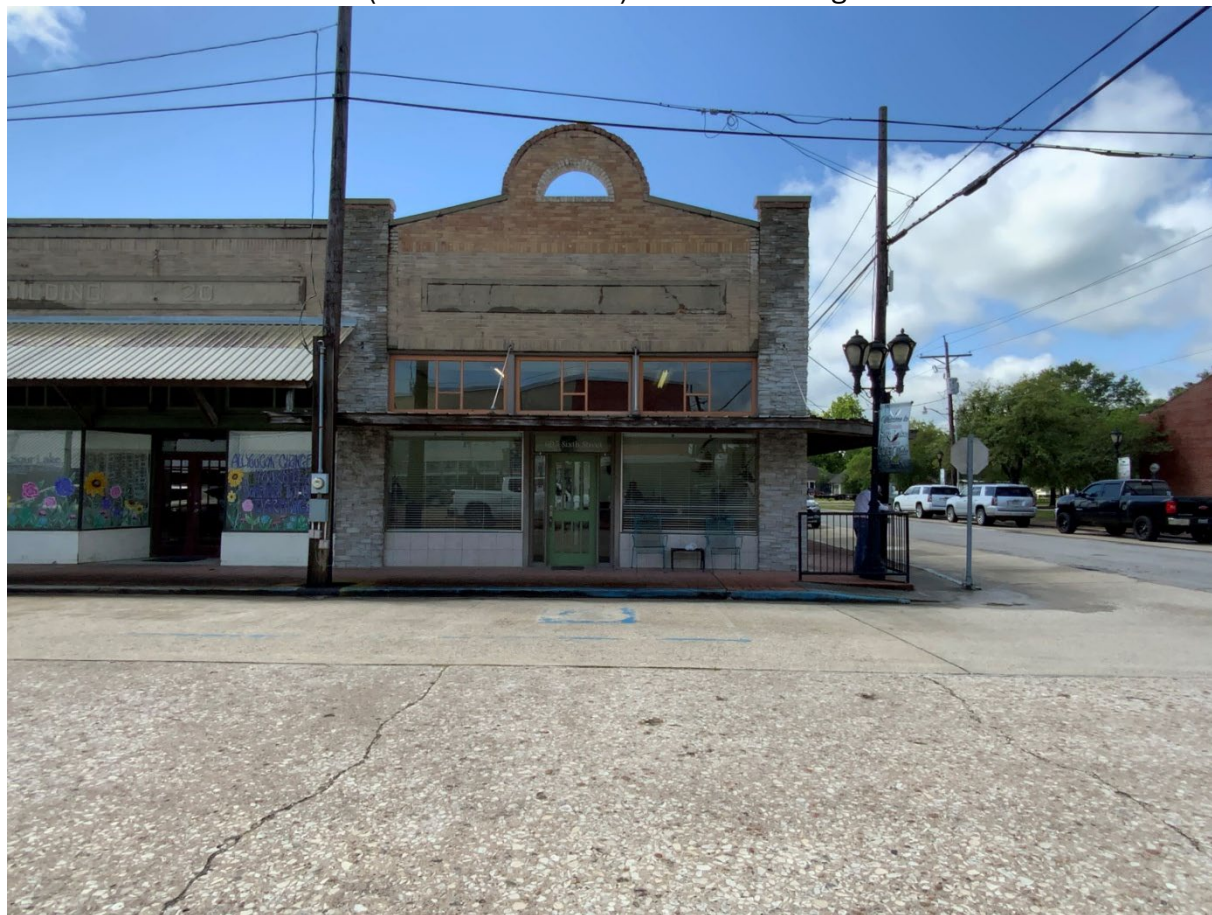
| Image | Address<br>Resource # | Year<br>Built | Original Use<br>Type - Form | Stylistic<br>Influence(s)<br>) | Alterations<br>Additions | Contributing<br>Status |
|---|---|---|---|---|---|---|
| | 695 6TH ST<br>10 | 1921 | Commercial<br>Bank - One-part commercial block | Commercial | Parapet altered, Transoms & canopy compatibly replaced ca. 2005, Some windows enclosed with glass block, West side facade stuccoed, Piers veneered with stone | Contributing |

Photo 16. 695 Sixth Street (constructed 1920). Camera facing south.

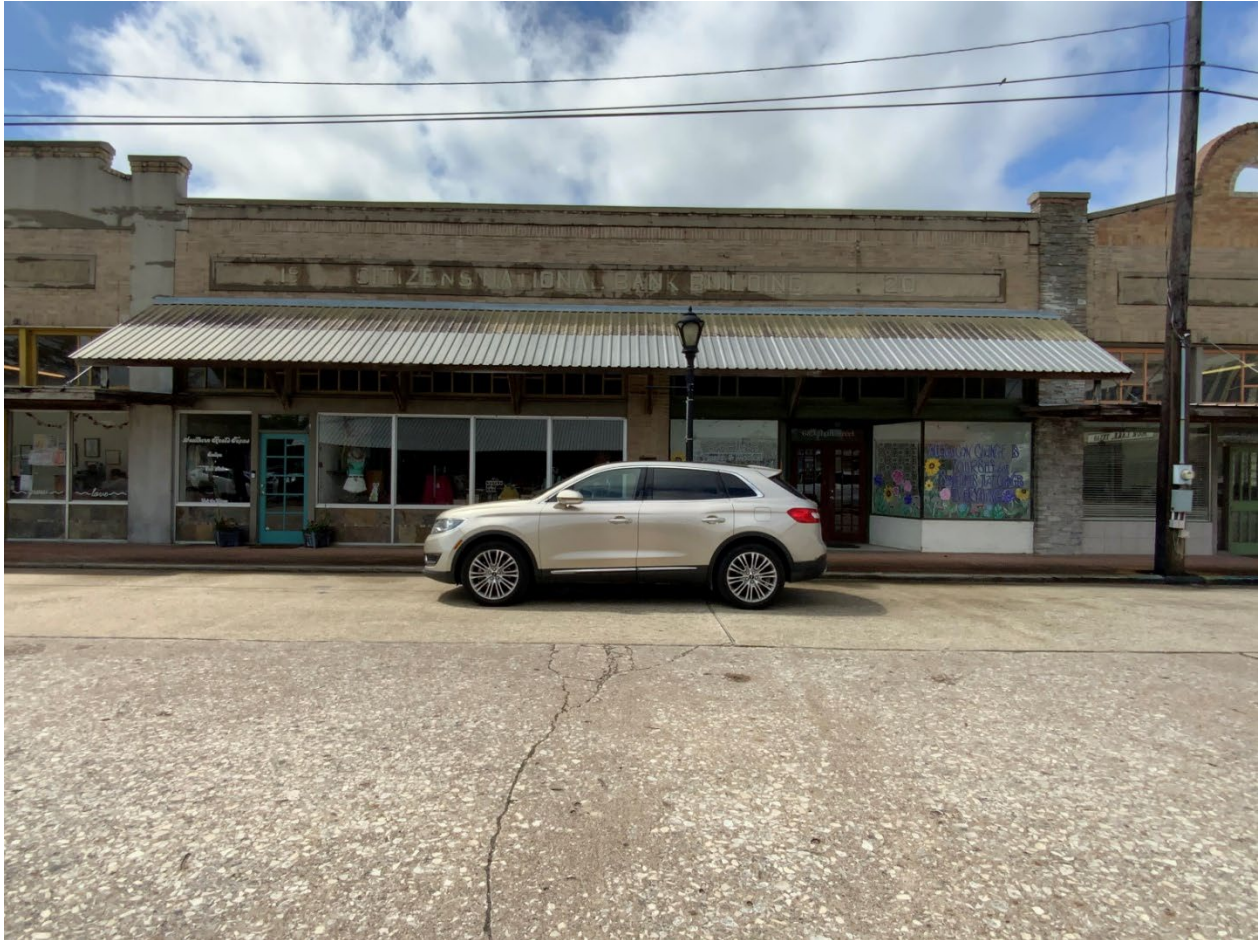
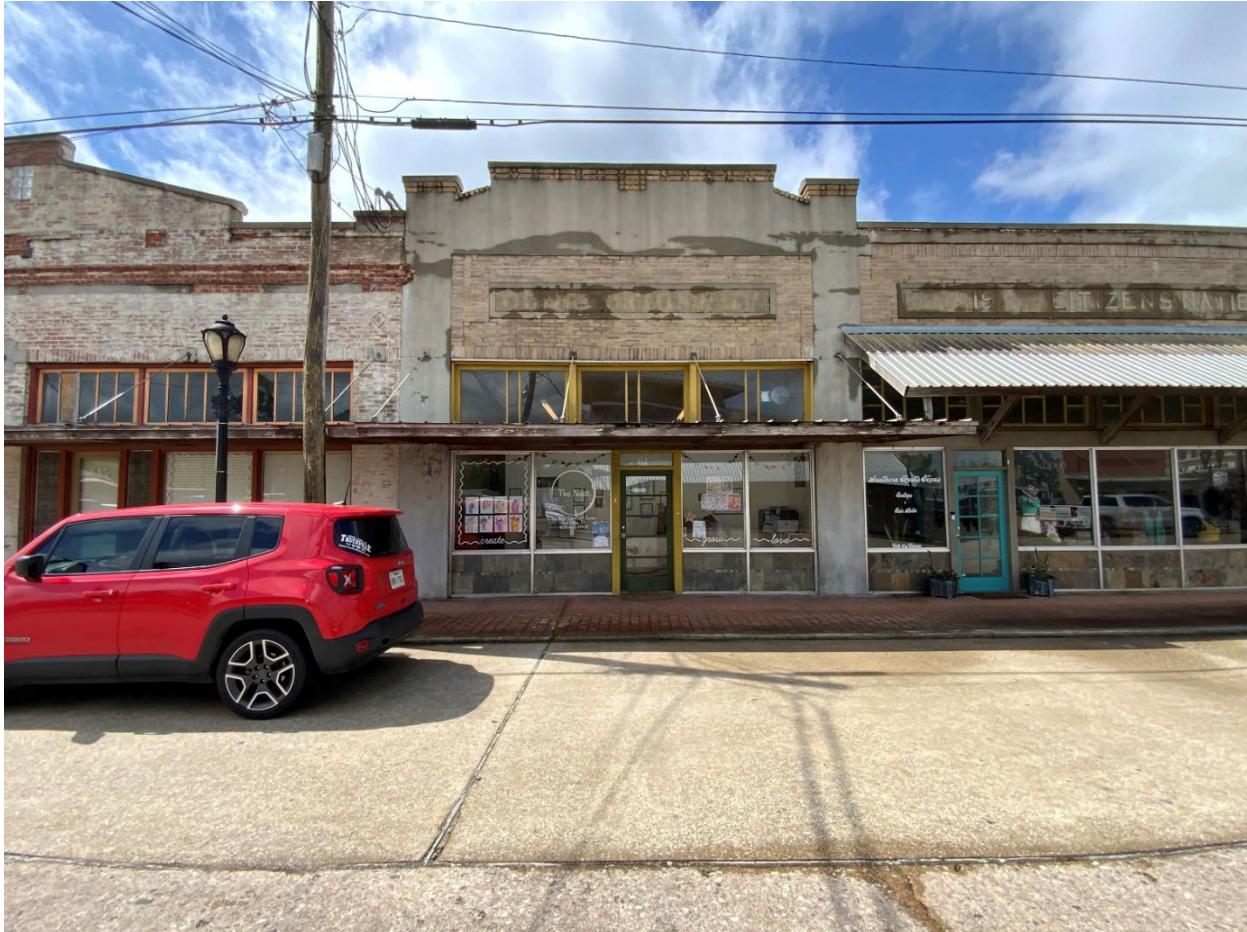
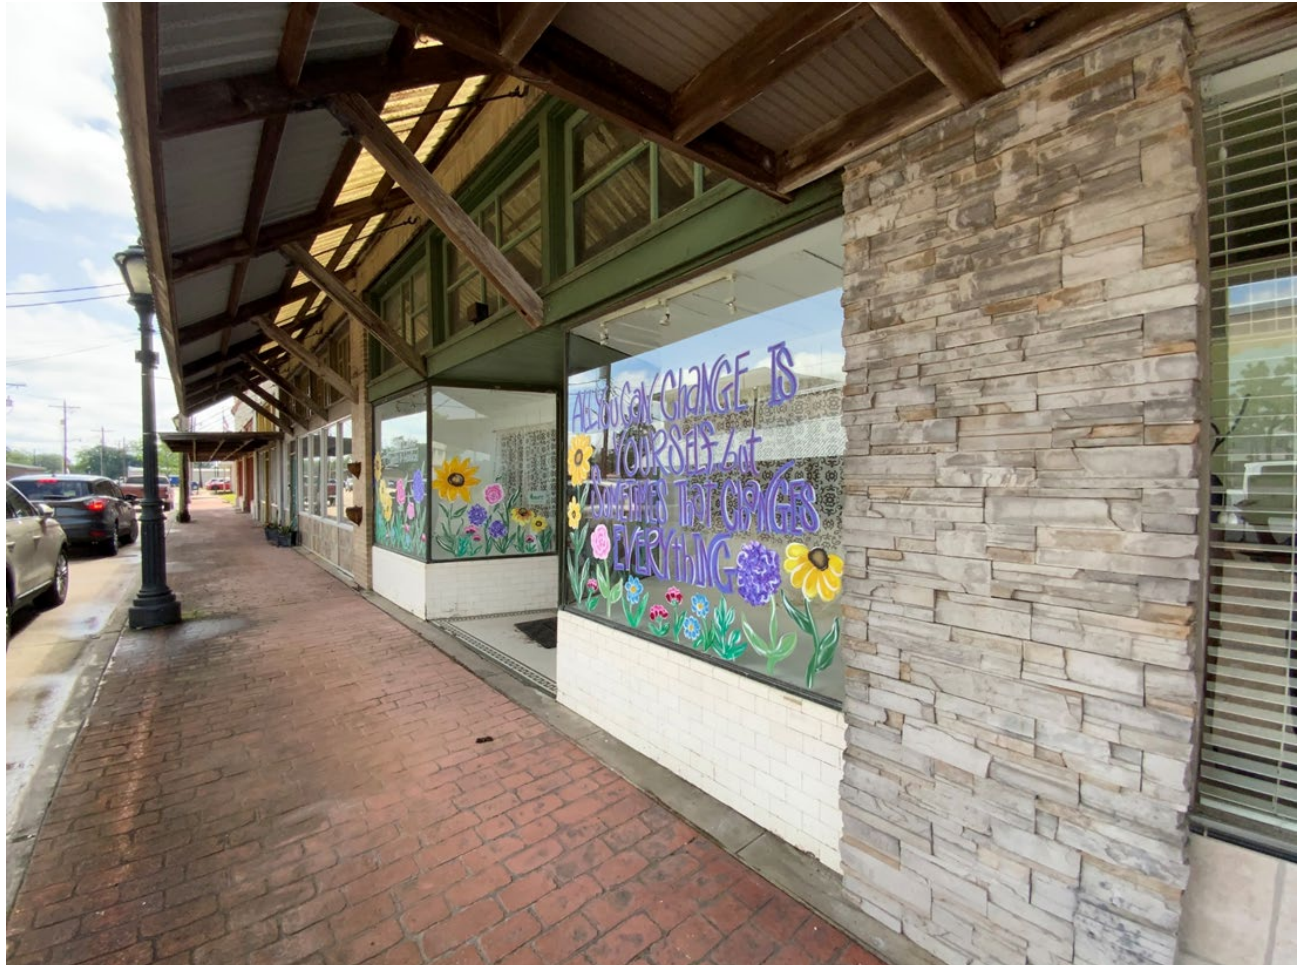
| Image | Address<br>Resource # | Year<br>Built | Original Use<br>Type - Form | Stylistic<br>Influence(s)<br>) | Alterations<br>Additions | Contributing<br>Status |
|---|---|---|---|---|---|---|
| | 685-689 6TH ST<br>11 | 1920 | Commercial<br>Store - One-part commercial block | Commercial | Storefront partially replaced, Transoms replaced compatibly ca. 2005, Canopy replaced; Tile veneer under some windows; Parapet possibly altered on westernmost bay<br>Rear addition | Contributing |

Photo 17. Middle and westernmost bays of 685-689 Sixth Street (constructed 1920).  
Camera facing south.

Photo 18. Easternmost bay of 685-689 Sixth Street (constructed 1920). Camera facing south.

Photo 19. Detail of the storefronts at the middle and westernmost bays of 685-689 Sixth Street (constructed 1920). Camera facing southeast.
