United States Department of the Interior  
National Park Service**National Register of Historic Places Registration Form**

**1. Name of Property**Historic name: Sour Lake Downtown Historic DistrictOther names/site number: N/AName of related multiple property listing: N/A**2. Location**Street & number: Three blocks in downtown Sour Lake centered around Sixth Street and S. Merchant StreetCity or town: Sour LakeState: TXCounty: HardinNot For Publication: ☐ Vicinity: ☐**3. State/Federal Agency Certification**

Sour Lake Downtown Historic District  
Name of Property

Hardin County, Texas  
County and State

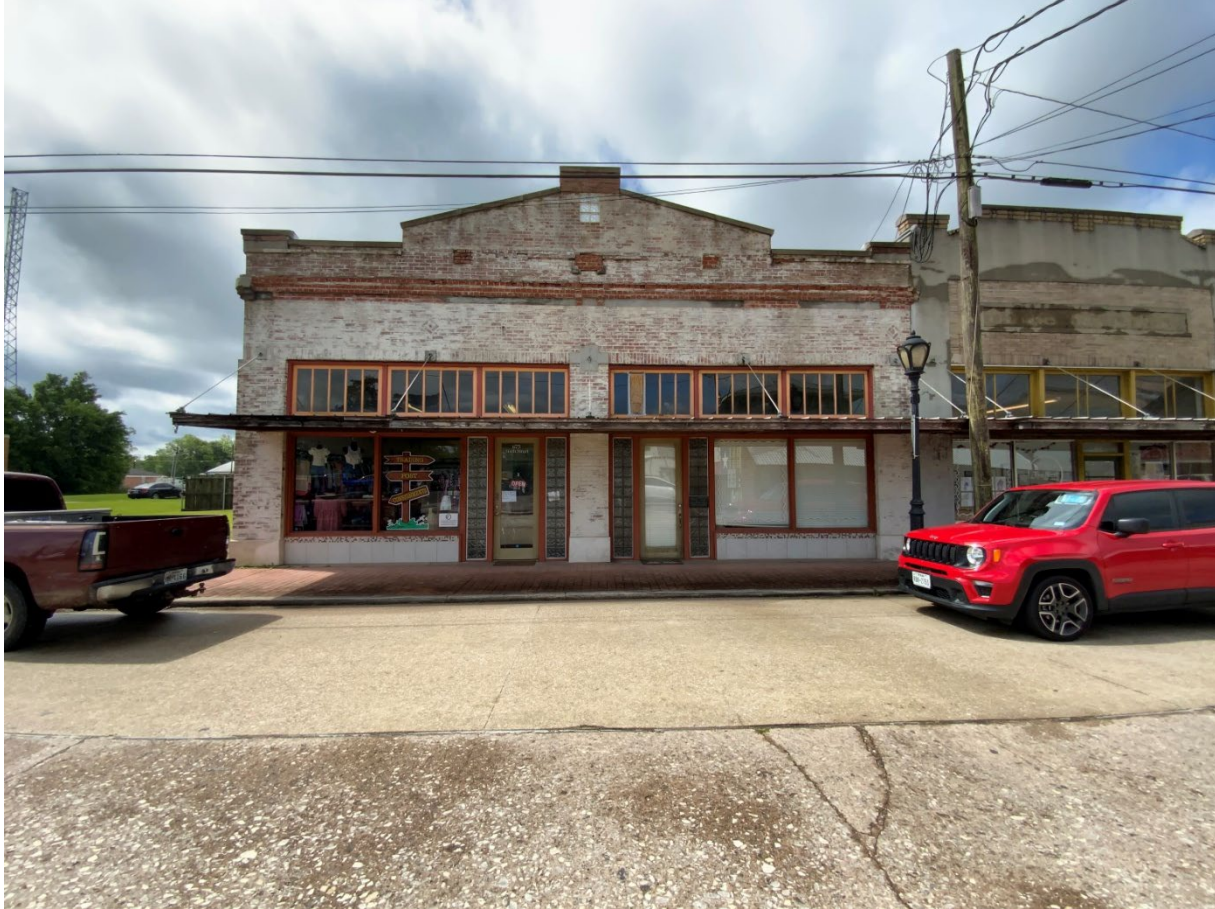
| Image | Address<br>Resource # | Year<br>Built | Original Use<br>Type - Form | Stylistic<br>Influence(s)<br>) | Alterations<br>Additions | Contributing<br>Status |
|---|---|---|---|---|---|---|
| | 675 6TH ST<br>12 | 1920 | Commercial<br>Store - One-part commercial block | Commercial | Transoms & canopy replaced compatibly ca. 2005, cornice lost ca. 1970, sidelights enclosed with glass block, tile veneer under windows<br>Rear porch | Contributing |

Photo 20. 675 Sixth Street (constructed 1920). Camera facing southwest.
