**United States Department of the Interior
National Park Service****National Register of Historic Places Registration Form****1. Name of Property**

Historic Name: Colwick Homestead
Other name/site number: 41BQ332; CP Farm; Cleng Peerson Farm
Name of related multiple property listing: The Norwegian Settlement of Bosque County (1983)

Street & number: 736 County Road 4230
City or town: Clifton State: Texas County: Bosque
Not for publication: ☒ Vicinity: ☒

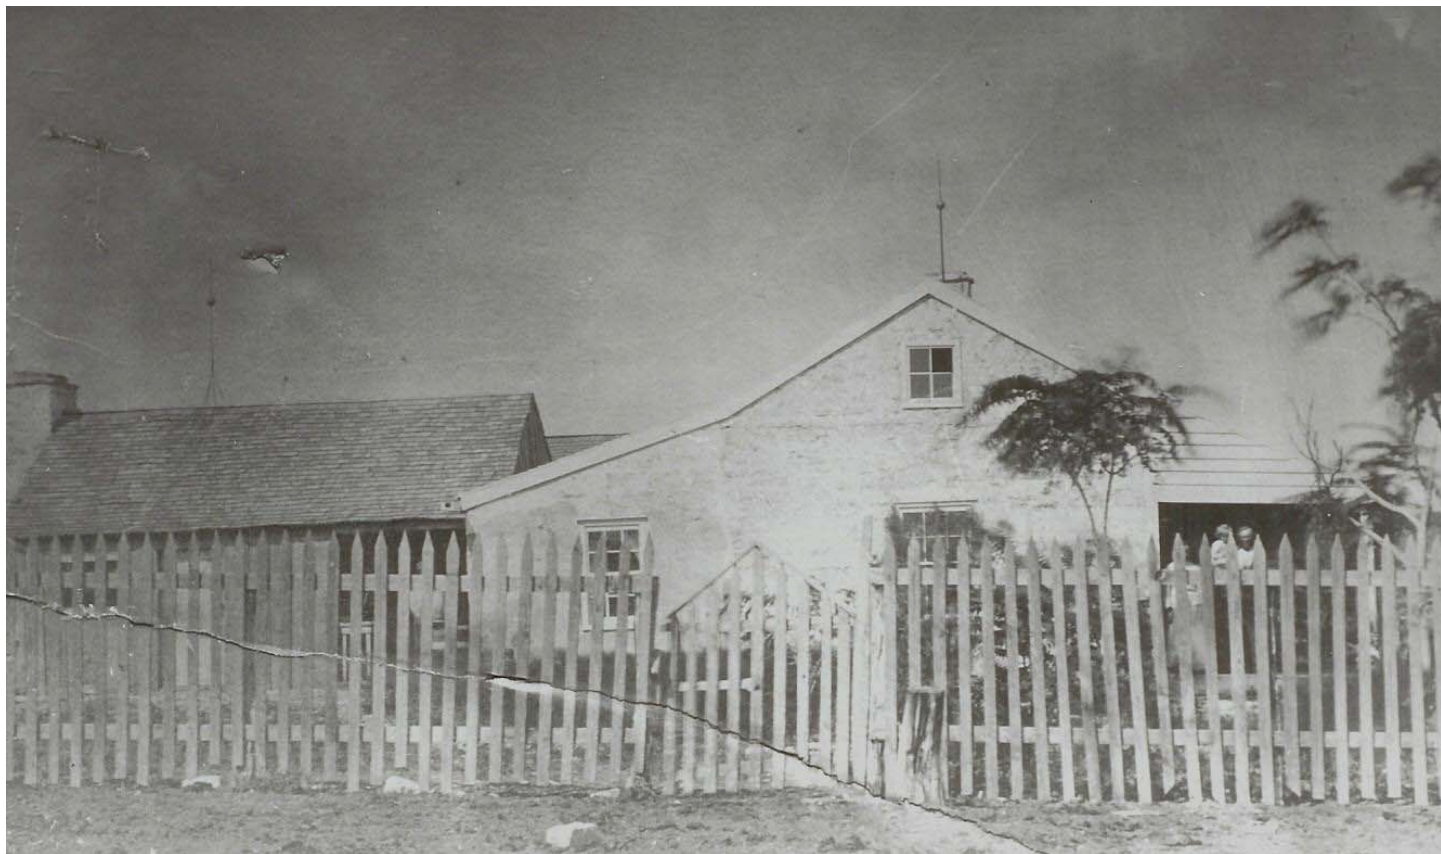
Figure 3: The earliest known photograph of the Colwick rock house.

The earliest known photograph of the rock house (Figure 3) depicts the rooflines of other buildings in very close proximity to the house prior to the frame additions. As a working farm on an isolated frontier, the homestead undoubtedly once had a number of support buildings. The exact appearance and locations of these additional resources are not yet known.

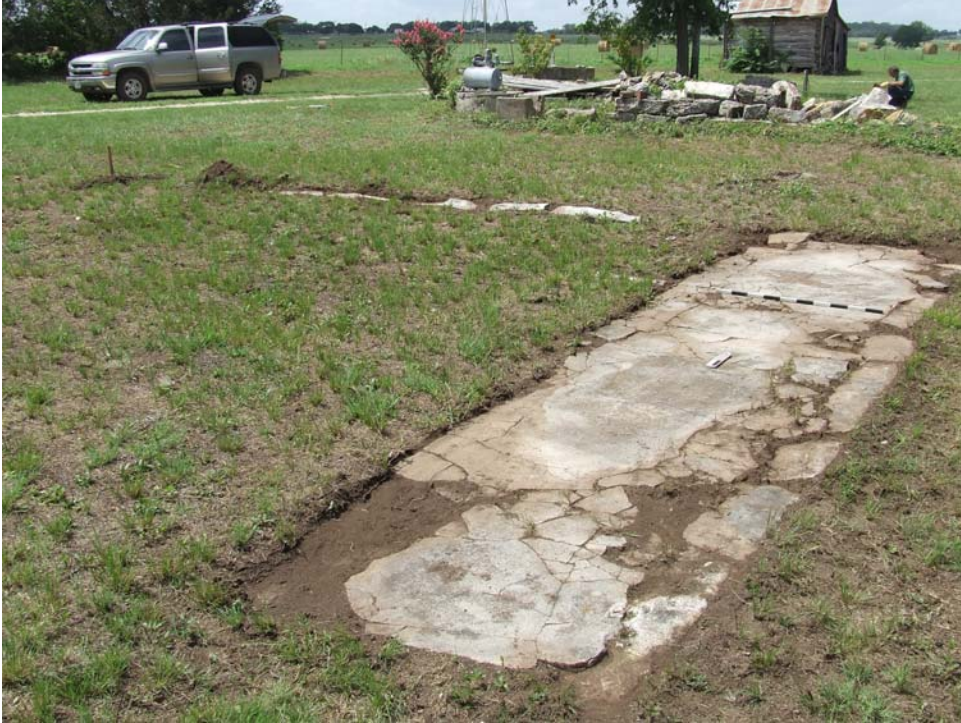
TX_Bosque County_Colwick Homestead_0002.tiff

Feature 1 in the foreground; view to the north-northeast. June 26, 2014.

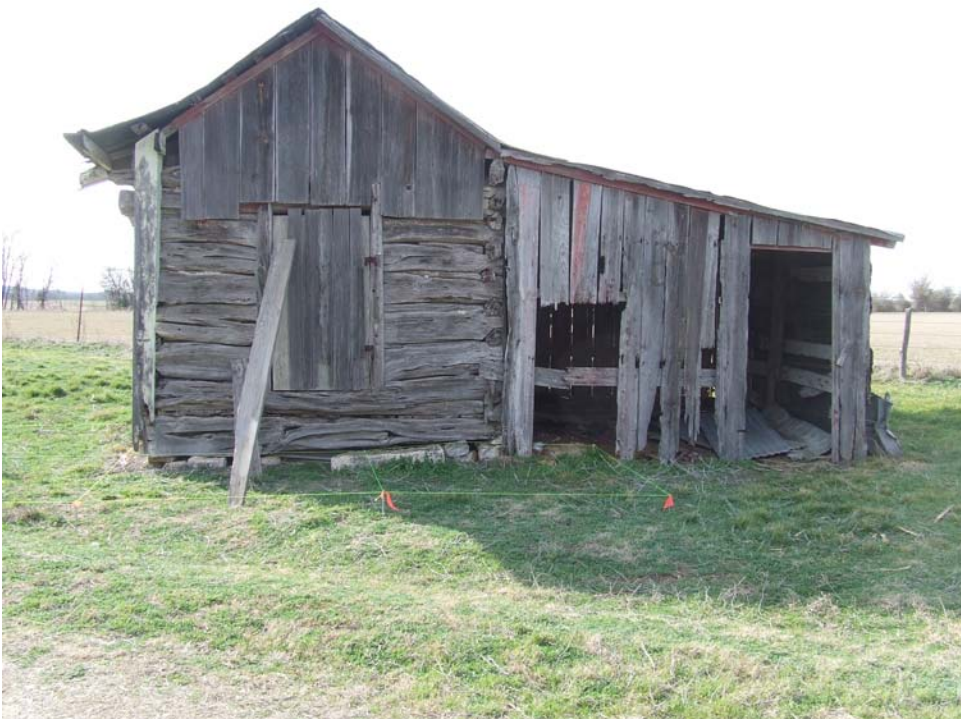
TX_Bosque County_Colwick Homestead_0003.tiff

East façade of the log building (contributing). Camera facing west. February 20, 2015.

The log building measures approximately 14 feet by 10 feet and stands about 100 feet north of the rock house site. Its only opening is a small door on the gable end and faces east. It is constructed of a combination of whole, rough, and half hewn oak and cypress logs—which results in wide gaps between logs—and utilizes both V-notching and saddle notching at the corners. Chinking consists of small timbers and slats of wood to fill the wide gaps, as well as small stones and mortar. What remains of the mortar appears to be lime and sand. The gable ends are covered with vertical wood planks and the building is sheltered by a tin roof. The roof is supported by whole cedar log joists and milled lumber rafters that are not original to the building. The central-most joist is externally supported on either end (east and west) by a vertical cedar log brace. Used as storage for many years, the flooring is plank, and the interior walls are sheathed in vertical boards of varying sizes. No evidence of a hearth can be found. A small, frame shed addition with no internal connection to the log building was constructed off of the north wall at some point. In poor condition, the addition is slated for removal.

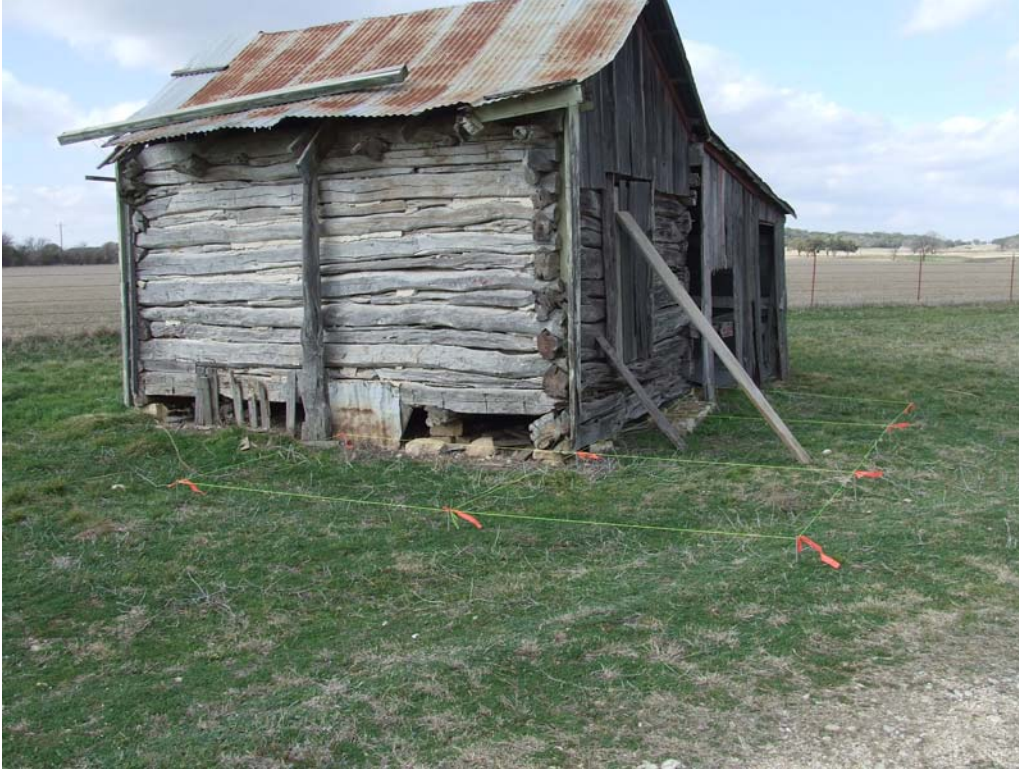
TX_Bosque County_Colwick Homestead_0004.tiff

Southeast oblique. Camera facing approximately northwest. February 20, 2015.

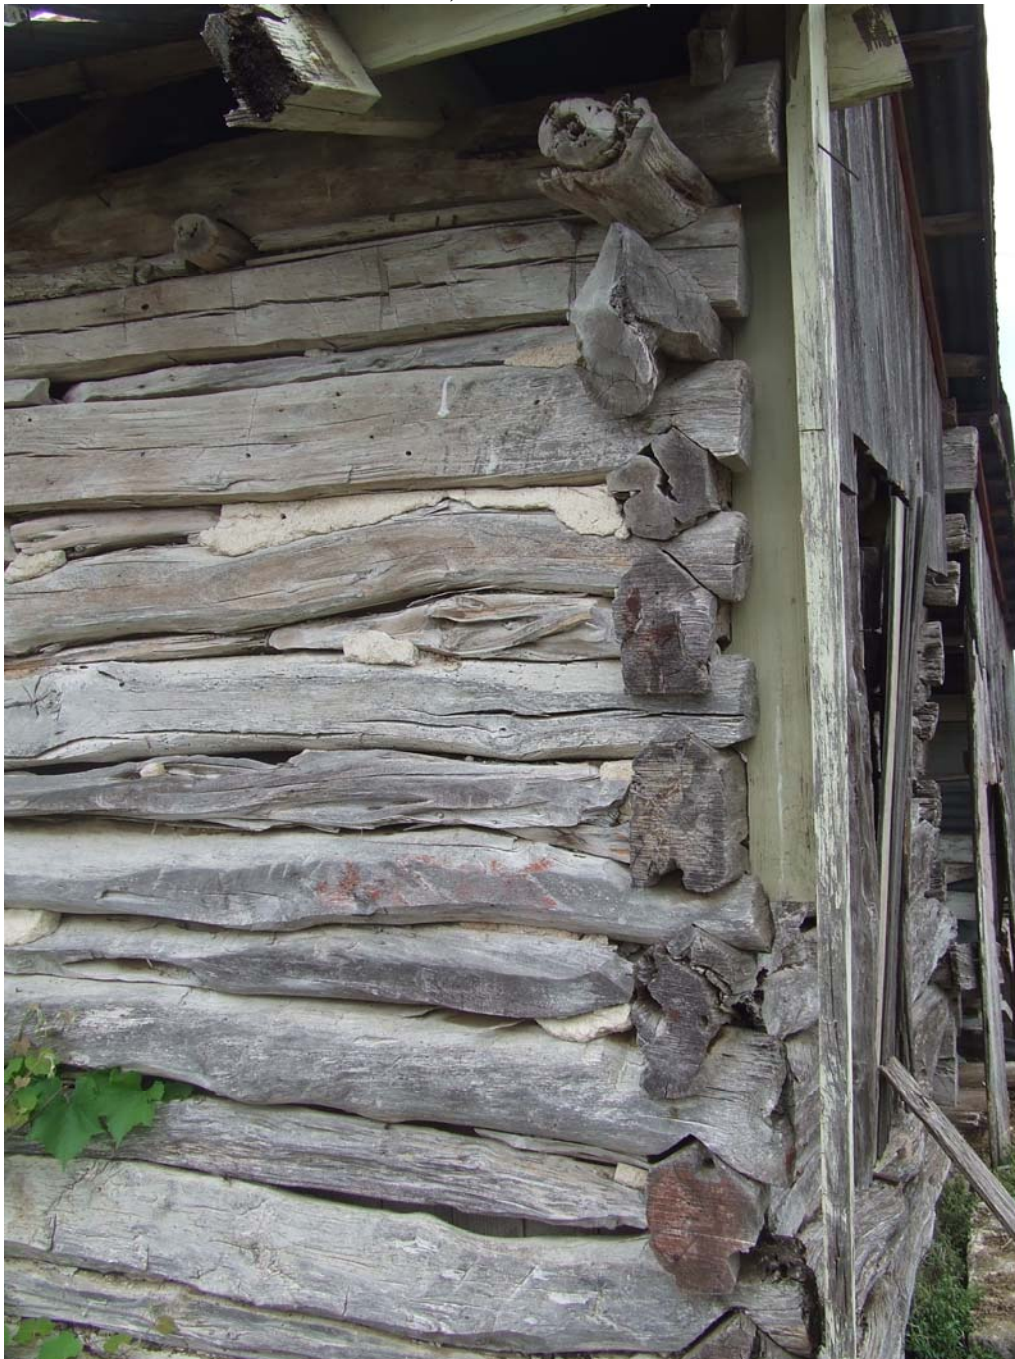
TX_Bosque County_Colwick Homestead_0005.tiff
Detail of southeast corner. June 26, 2014.

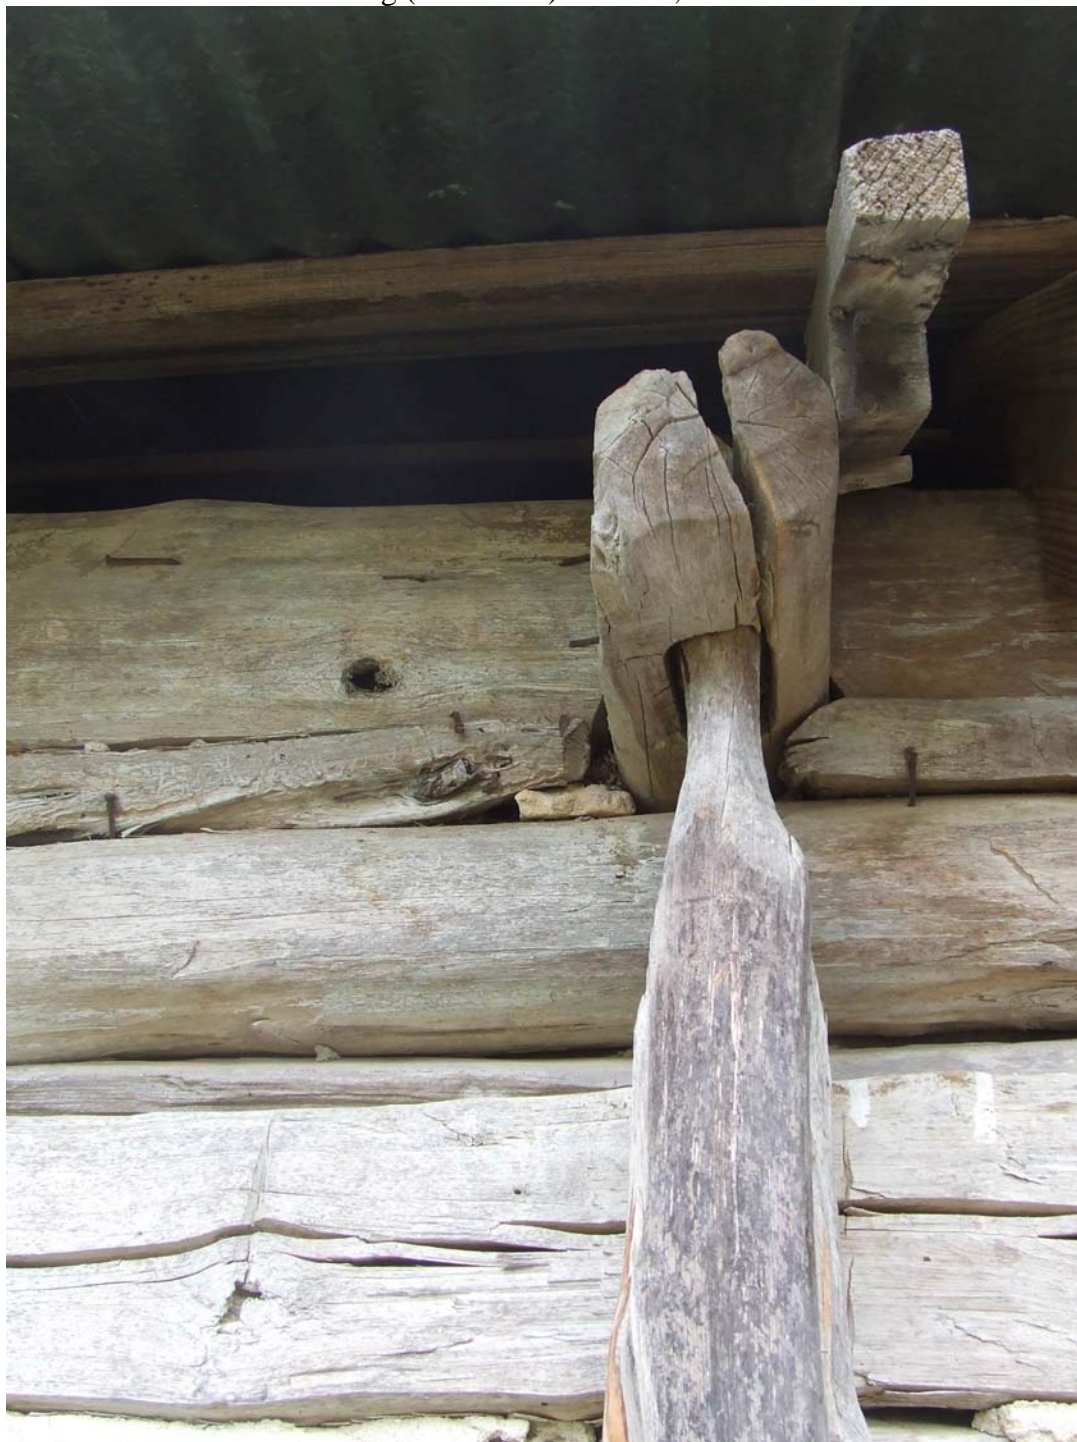
TX_Bosque County_Colwick Homestead_0006.tiff
Detail of external wall bracing (south wall). June 26, 2014.

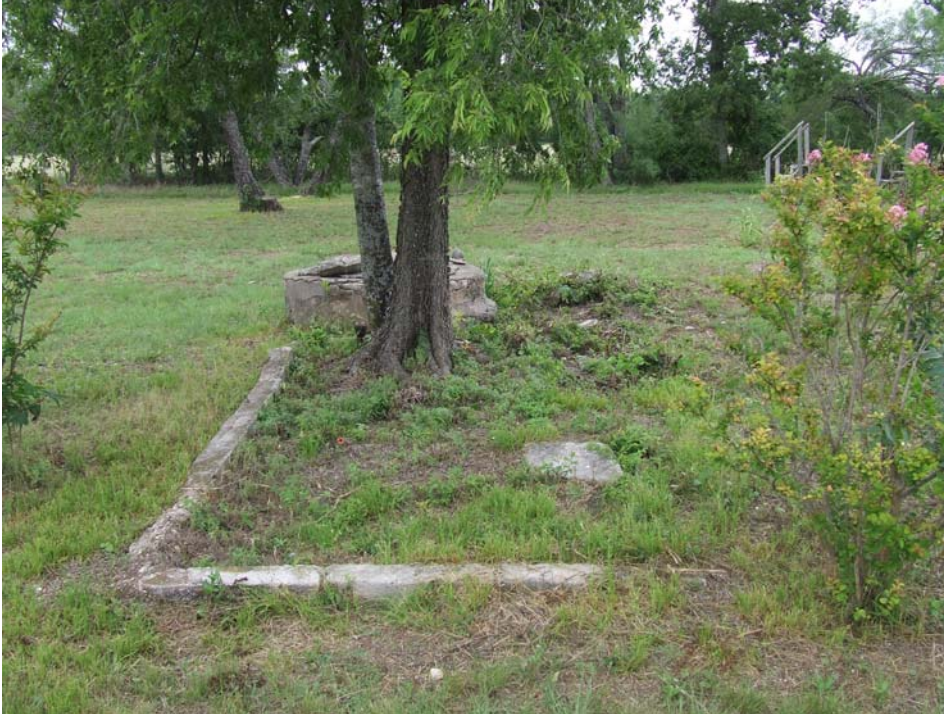
TX_Bosque County_Colwick Homestead_0007.tiff
Features 6(foreground) and 5 (background). View to the east. June 26, 2014.

- Earthen wall cellar 8 ½ ft x 14 ft (2.6meters x 4.27meters) (Feature 9)
- Cement and stones associated with the rock house foundation 26 ft long (7.93meters) (Feature 6)
- Wooden post for a gate (associated with cement walkway) 6 ft long (1.83 meters) (Feature 1)
- Foundation stones associated with a wooden fence 33 ½ ft x 35 ft (10.2 x 10.67 meters) (Feature 2)
- Cement capped cistern 5 ½ ft width x 2 ft height (1.68 meters width x 92 cm height) (Feature 5)
- Cement well 4 ft width x 3 ft height (1.22 meters width x 92 cm height) (Feature 7)
- Cement water trough 47” length x 19”width x 5”height (1.2 m x 50 cm x 10.3 cm) (Feature 8)

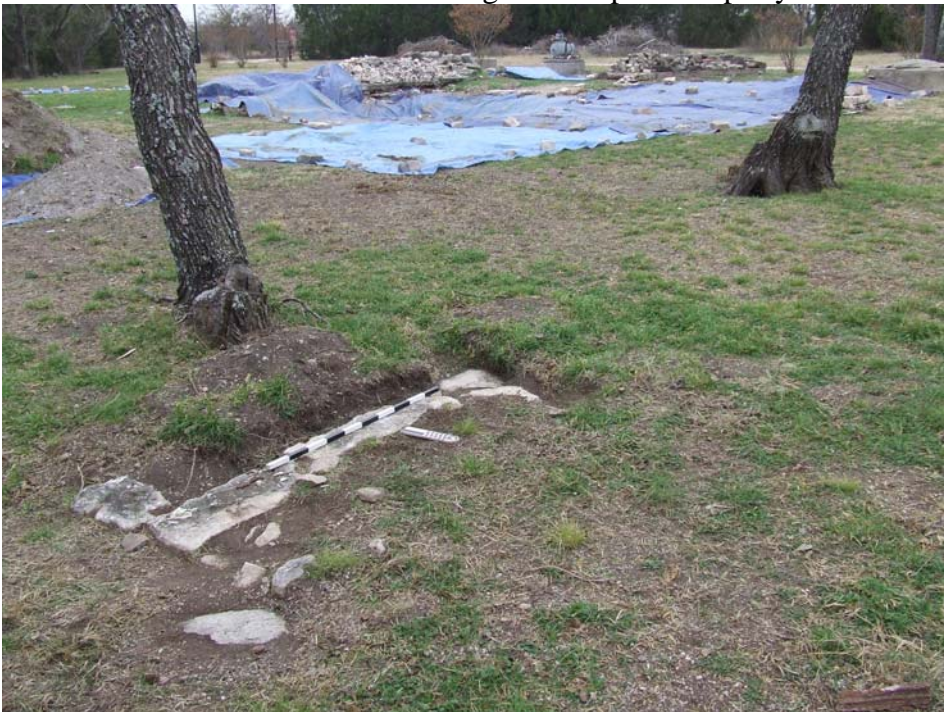
TX_Bosque County_Colwick Homestead_0008.tiff
View to the southeast. Feature in foreground is possible privy location. December 3, 2014.

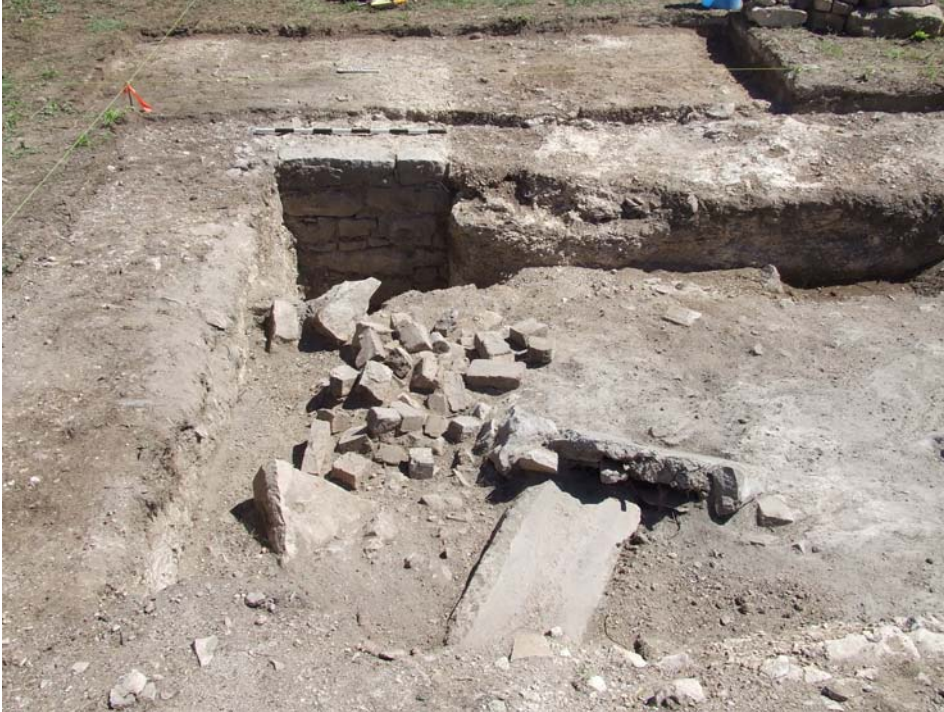
TX_Bosque County_Colwick Homestead_0009.tiff

Feature 9 (earthen wall cellar). View to the east. October 3, 2014.

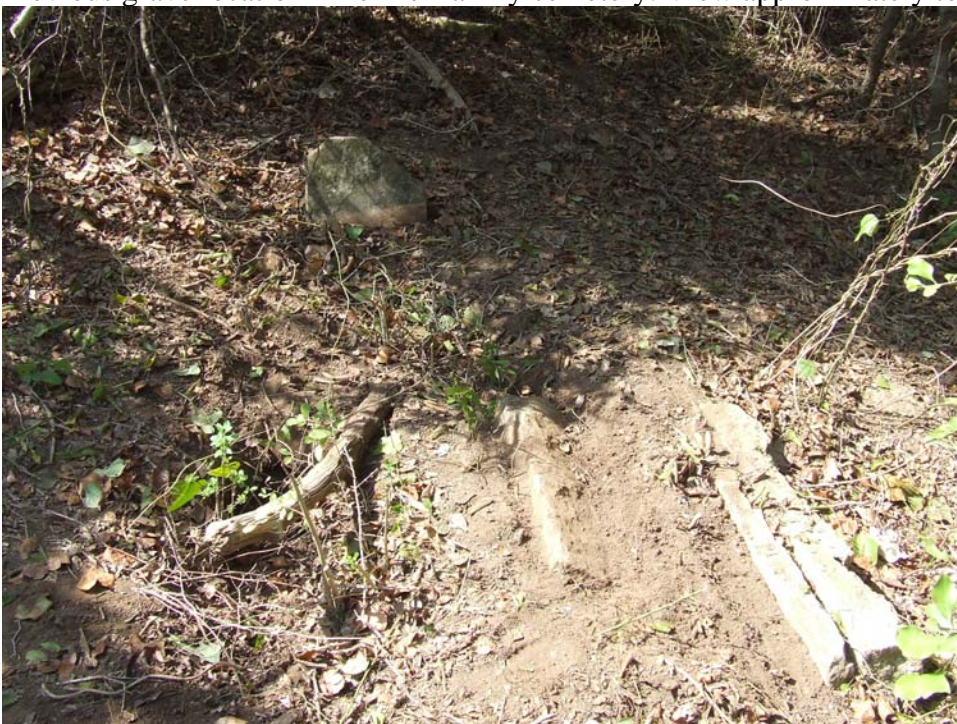
TX_Bosque County_Colwick Homestead_0010.tiff

Previous grave location in former family cemetery. View approximately to the southeast. October 20, 2014.
