United States Department of the Interior
National Park ServiceNational Register of Historic Places
Inventory—Nomination Form

John Pederson farm

FM 219, 9 miles southwest of Clifton, Bosque
County, Texas, on J. Houston survey

Site No. 24, John Pederson Farm, FM 219, 9 miles
southwest of Clifton, Bosque County, Texas

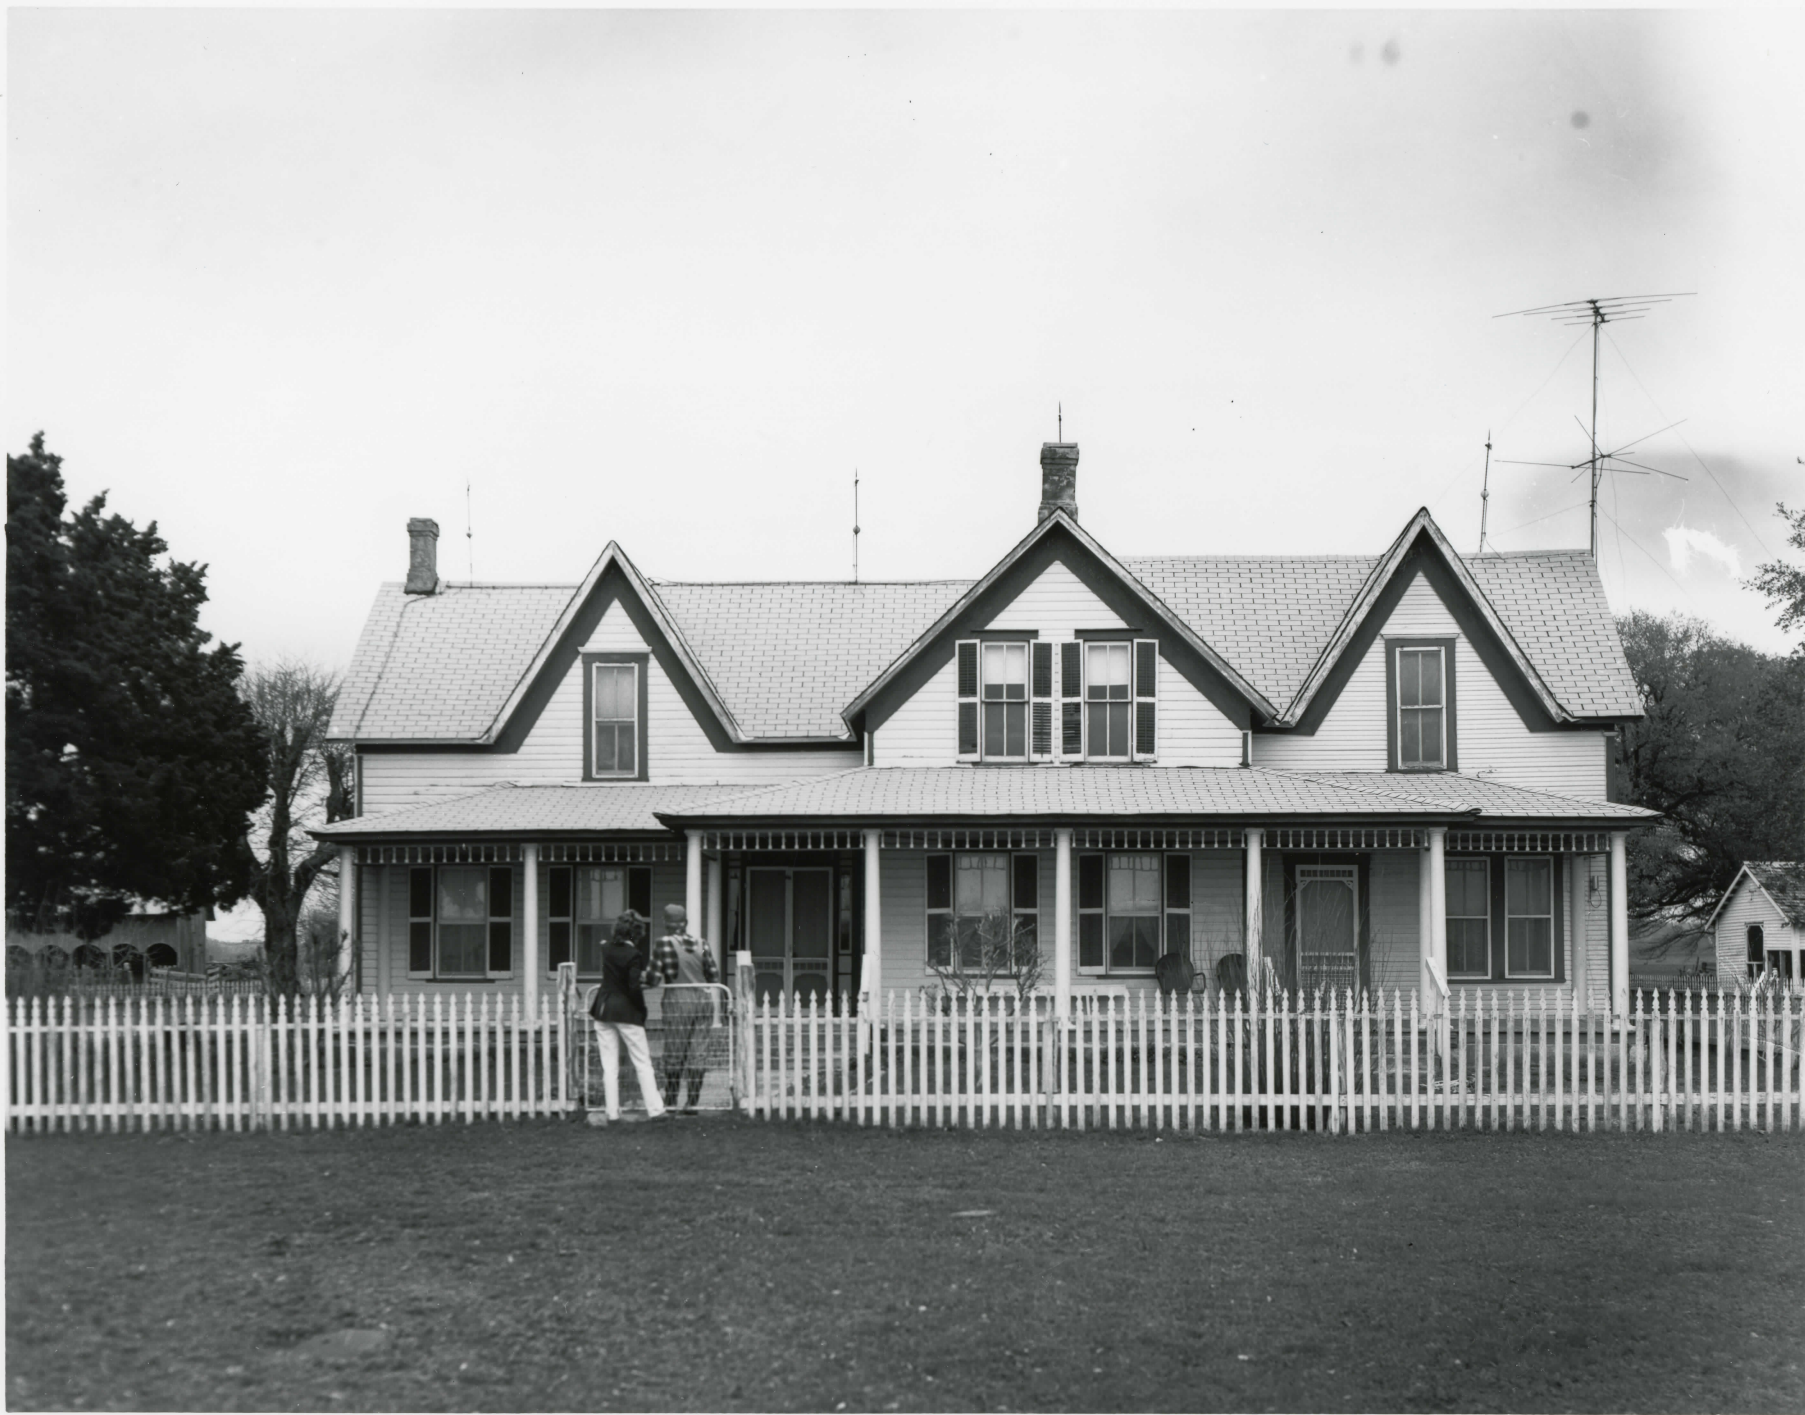
Photo 36 of 72

The John Pederson farm is located on the gently rolling land of the Neils Creek valley, about nine miles west of Clifton. It is in good condition, and retains much of its historic integrity. The original plan of the house was T-shaped but, with the addition in 1913 of a one-and-a-half-story wing onto the east side of the house, the plan was changed to its present cross-shaped configuration. Originally, it was very similar in plan and appearance to the Colwick (no. 22) and Rogstad (no. 23) houses. The front, which faces south toward FM 219, features a one-story porch with Doric columns linked at the top by a frieze of turned spindles. Two front entrances flank each side of the projecting central section. The windows are double hung with two-

over-two lights. The gabled roof, covered by composition shingles, shows three prominent gables on the front elevation, and is pierced by two chimneys of corbeled brick. Lightning rods occur on the ridges. Several small additions have been built on the rear, or west, side of the house. The complex includes several outbuildings, but the most significant is a frame barn which stands northwest of the house. This structure is of board-and-batten construction, and has an arcade of round-arch openings on the east end of the south elevation. The other outbuildings also contribute to the historic character of the farm.

Tilden Pederson, who is the present owner of this farm, states that the house was erected in 1891 and 1892 for his father, John Pederson. It was constructed by Johan Nordahl, who built several other frame houses in the area. The Pederson house is noteworthy for its dormer-like gables, whose ends are flush with the underlying walls, and for its one-story porch and simple plan.

View of front facade, looking north

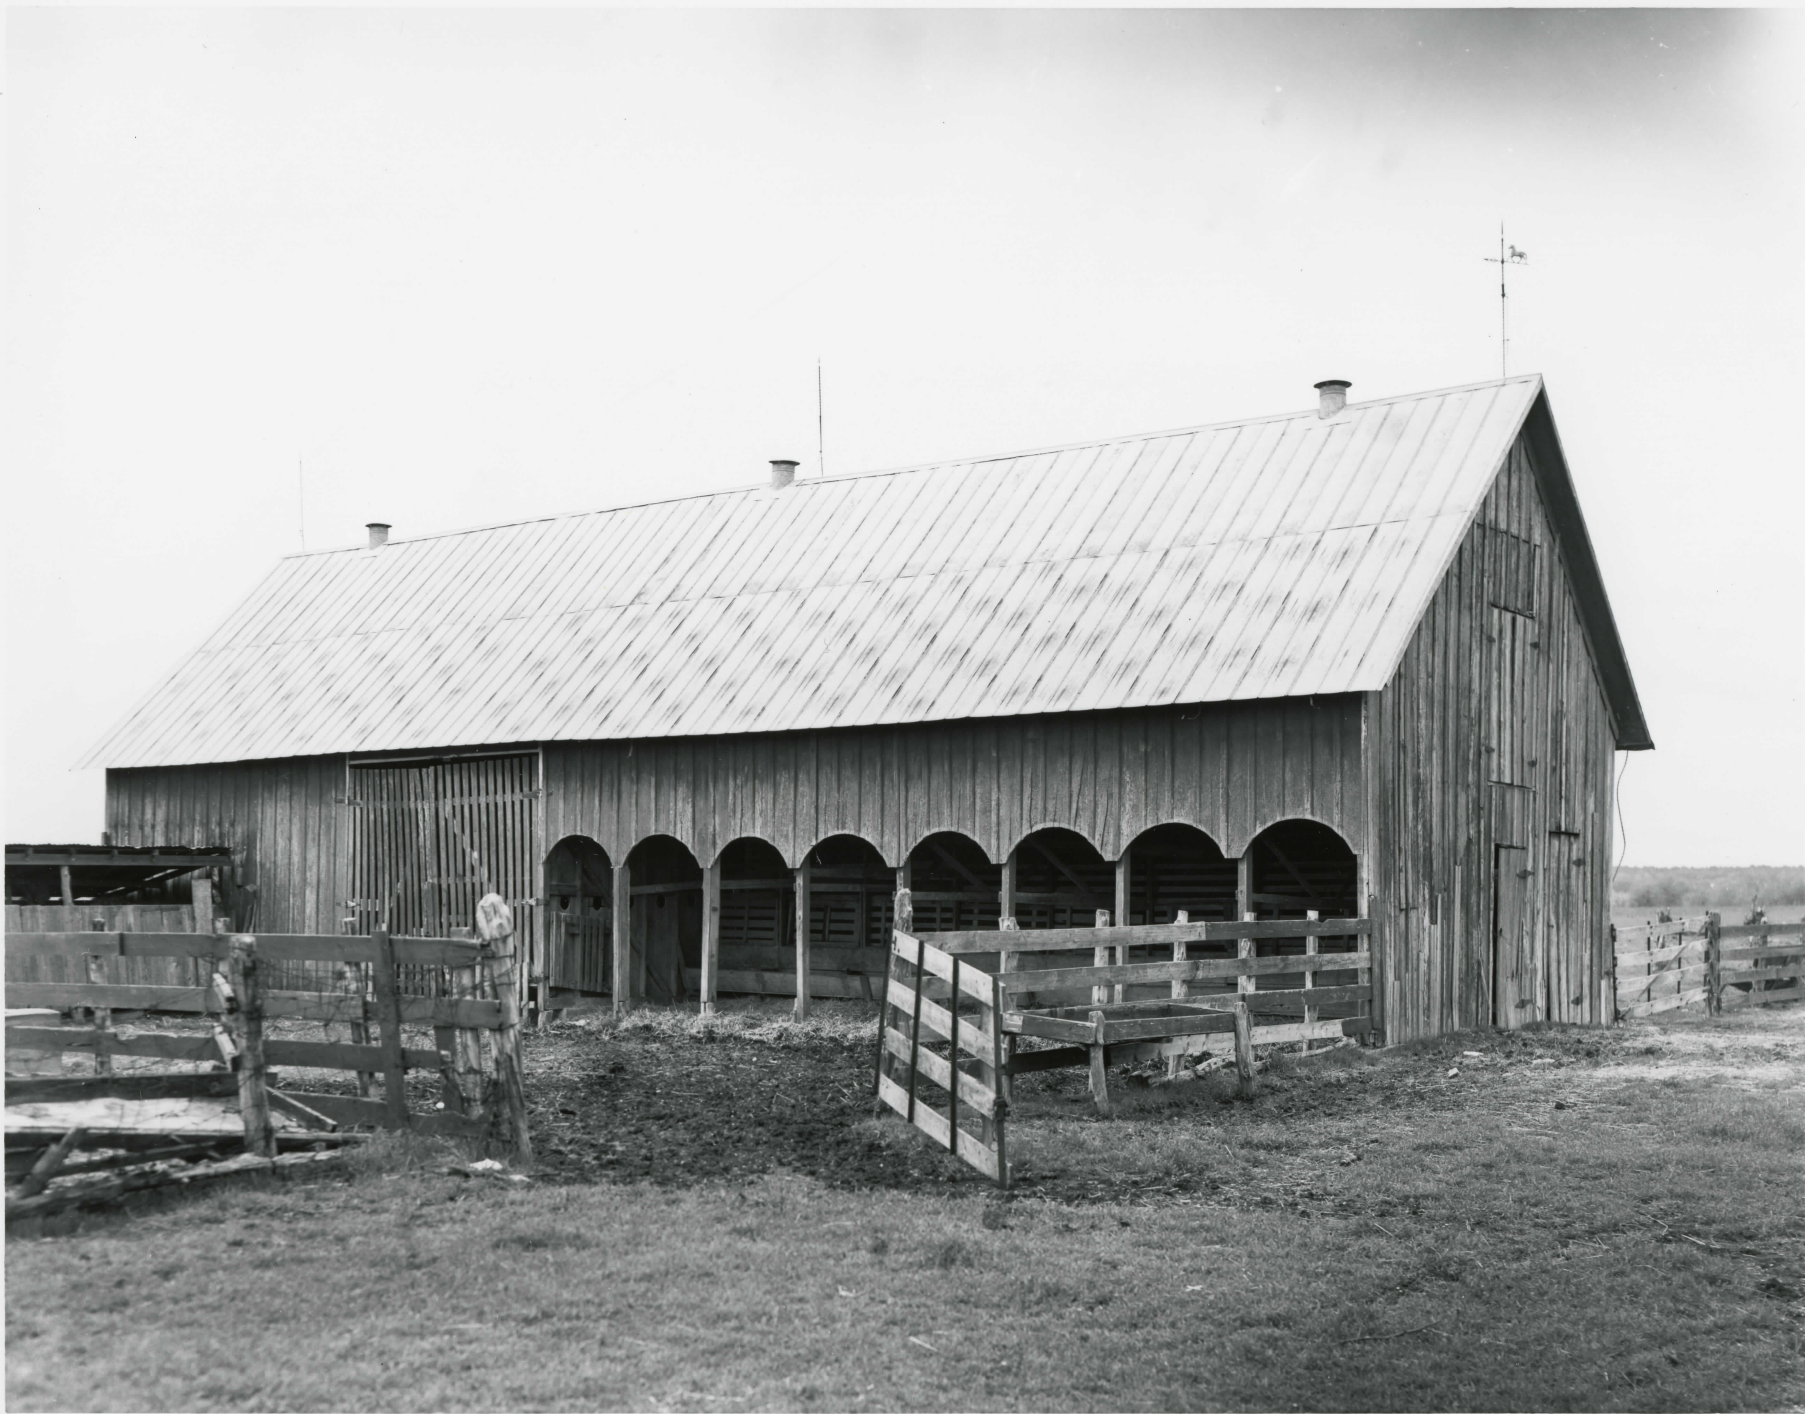
Photo 37 of 72

View of barn, looking north
