National Register of Historic Places
Inventory—Nomination Form

Carl and Sedsel Questad farm

The Norwegian Settlement of Bosque County

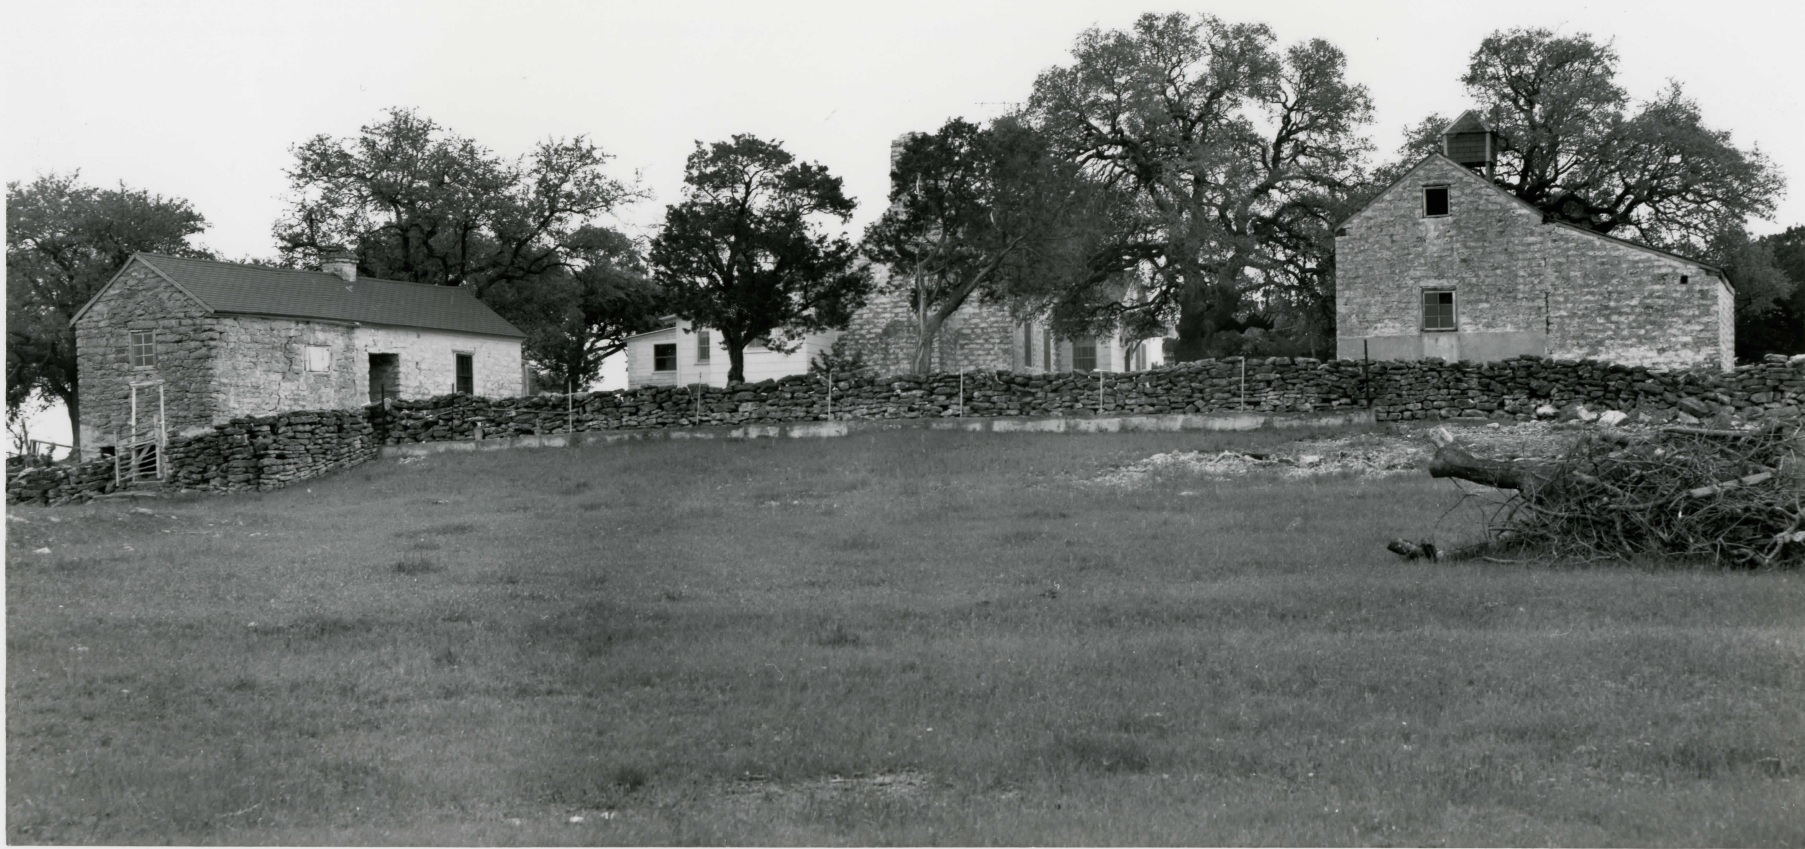
Site No. 1, Carl and Sedsel Questad Farm,
6 miles west of Clifton, Bosque County, Texas
Photograph: June 1979, by David Moore
On file, Texas Historical Commission
View of farm, looking south
Photo 1 of 72.

The Carl and Sedsel Questad farm retains, to a remarkable degree, much of its original character and ambiance. Prominently sited atop a hill that overlooks the Meridian Creek valley, the Questad Place, as it is known locally, is located about one and a half miles north of the old townsite of Norse. All of the farm's stone buildings and fences are well maintained and are equally important to the integrity of the property. The house has been substantially altered, but the changes were generally sensitive to the historic character of the structure. It consists of two stone sections joined only at their very corners, and dating possibly to the 1850s. A photograph made about 1930 shows a porch with balcony in the outside angle of this juncture, although the present gabled addition replaced the porch in 1949. This frame addition now serves as the entrance front. The northwest stone section of the house is particularly noteworthy because of its massive stone chimney and watertable.

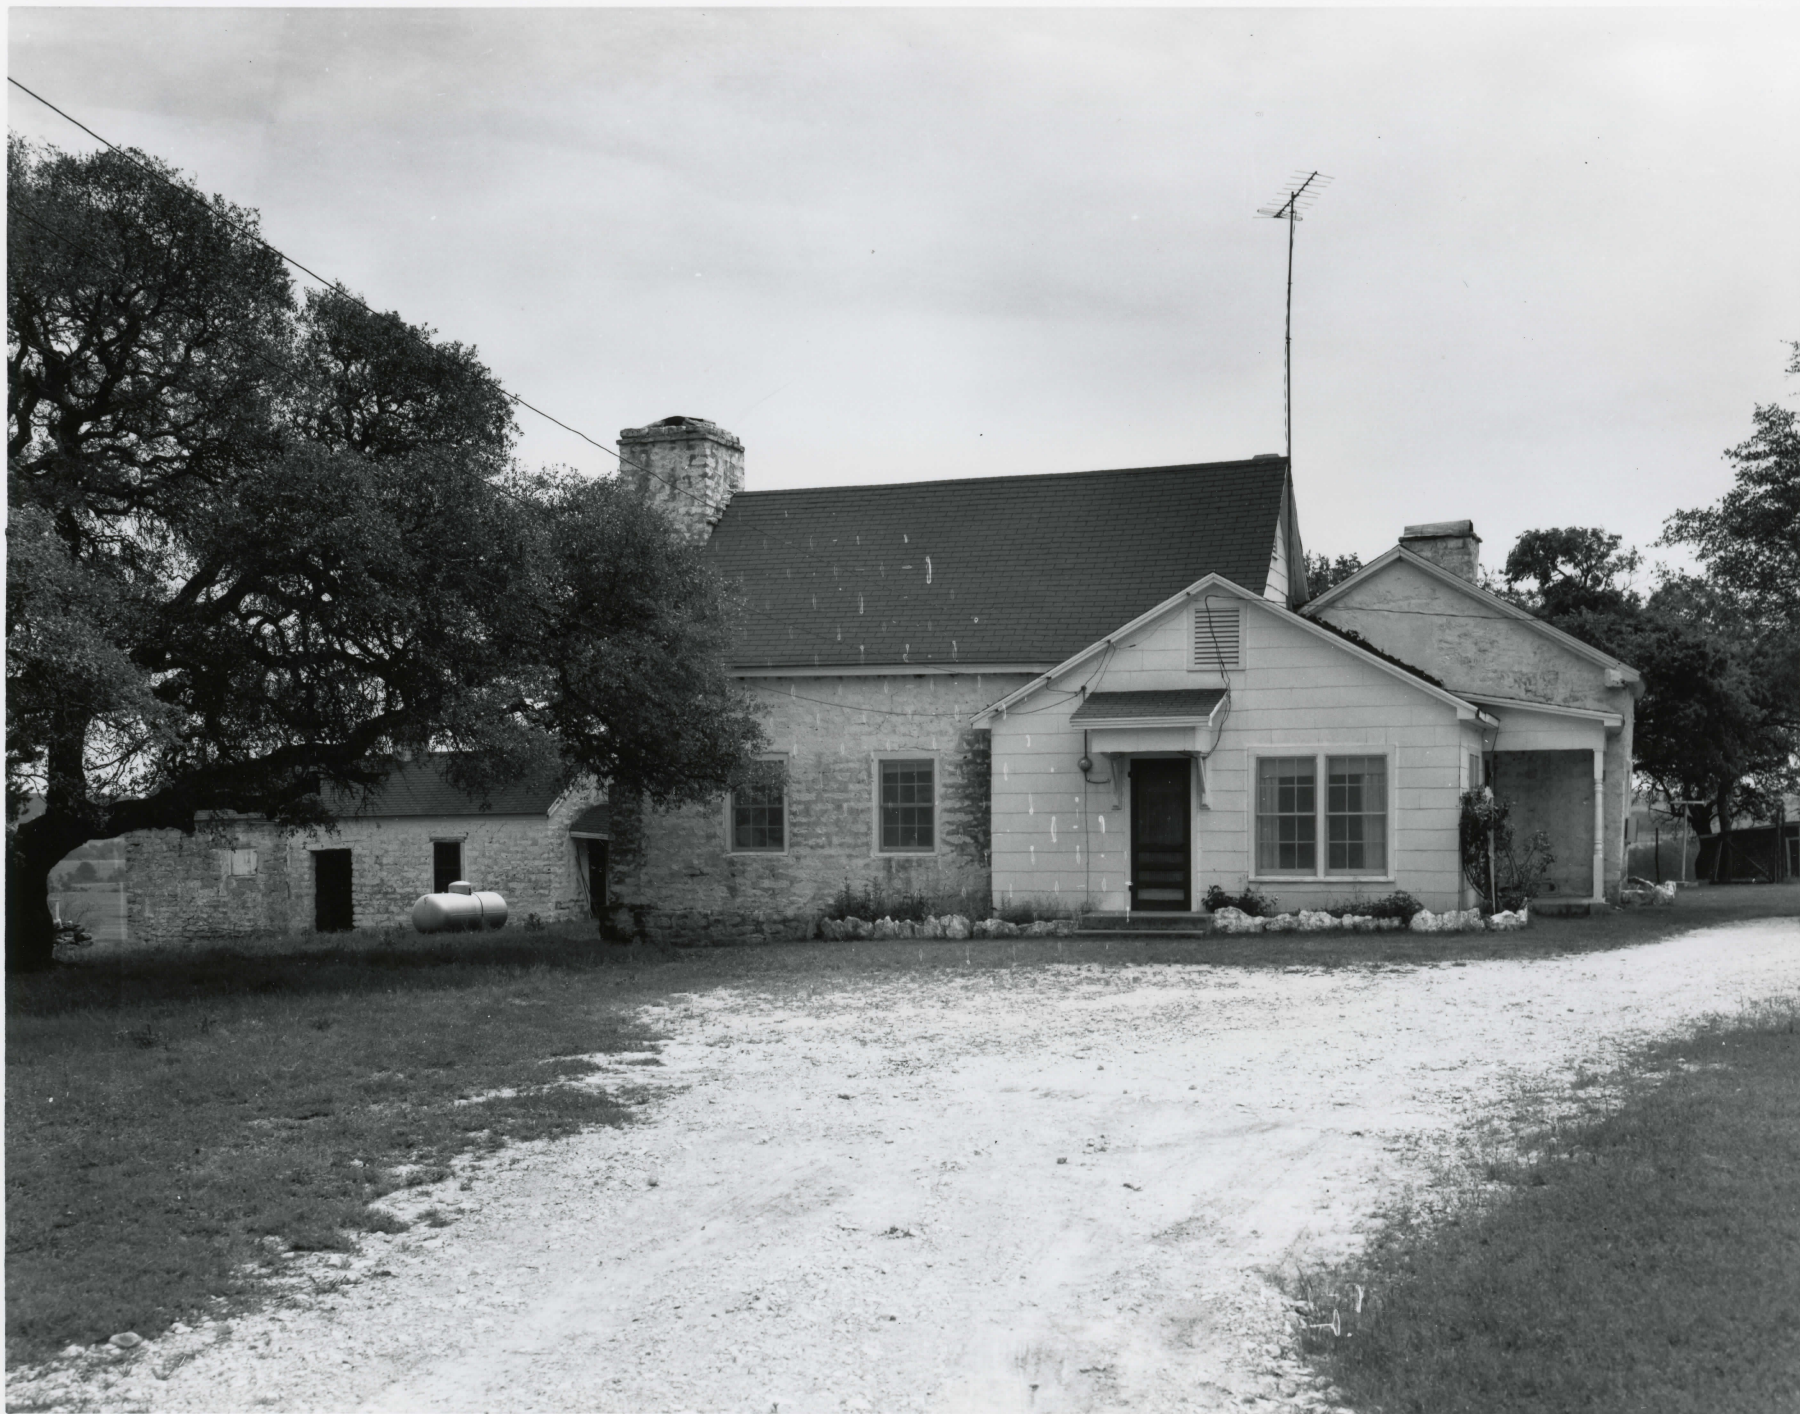
Photo 2 of 72

View of Questad house, looking east

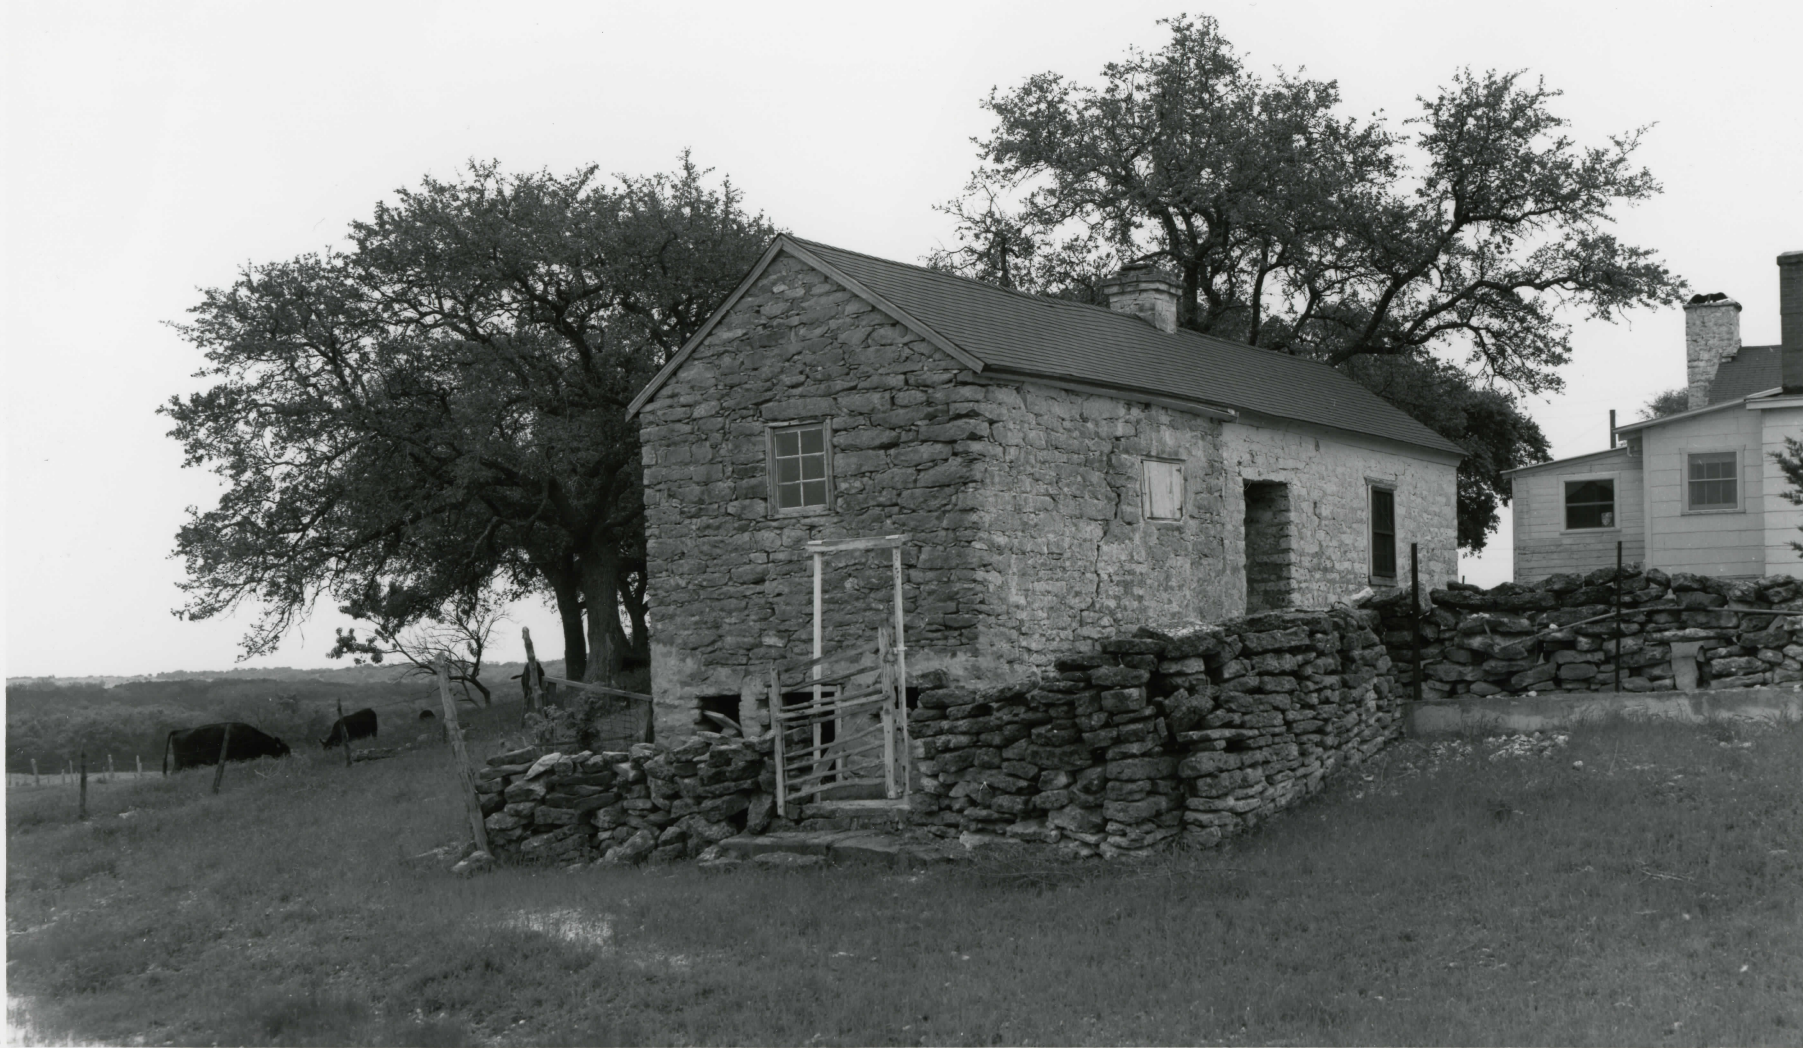
Photo 3 of 72

View of springhouse/kitchen, looking southeast

farmstead. The springhouse and kitchen building, located northeast of the main residence, is built into the hillside and reflects the European heritage of its original owner. An open breezeway divides the structure into halves, with the springhouse at the north end and the kitchen opposite. The spring that once flowed from the hill has long been dry. Like the other buildings on the farm, the blacksmith shop is of lime-stone construction. Standing northwest of the house, it retains its original dirt floor and has a small tower, with cast-iron bell, atop the gabled roof. The largest structure on the farm is the two-story barn about 200 feet south of the house. The massive stone north wall is pierced on each floor by door-like openings. One-story lean-tos extend from the east and west ends of the barn. The stables are located on the south side and are protected by a shed roof extension. A stone fence extends about a third of a mile from the old farmstead to the grounds of Our Savior's Church (no. 33).

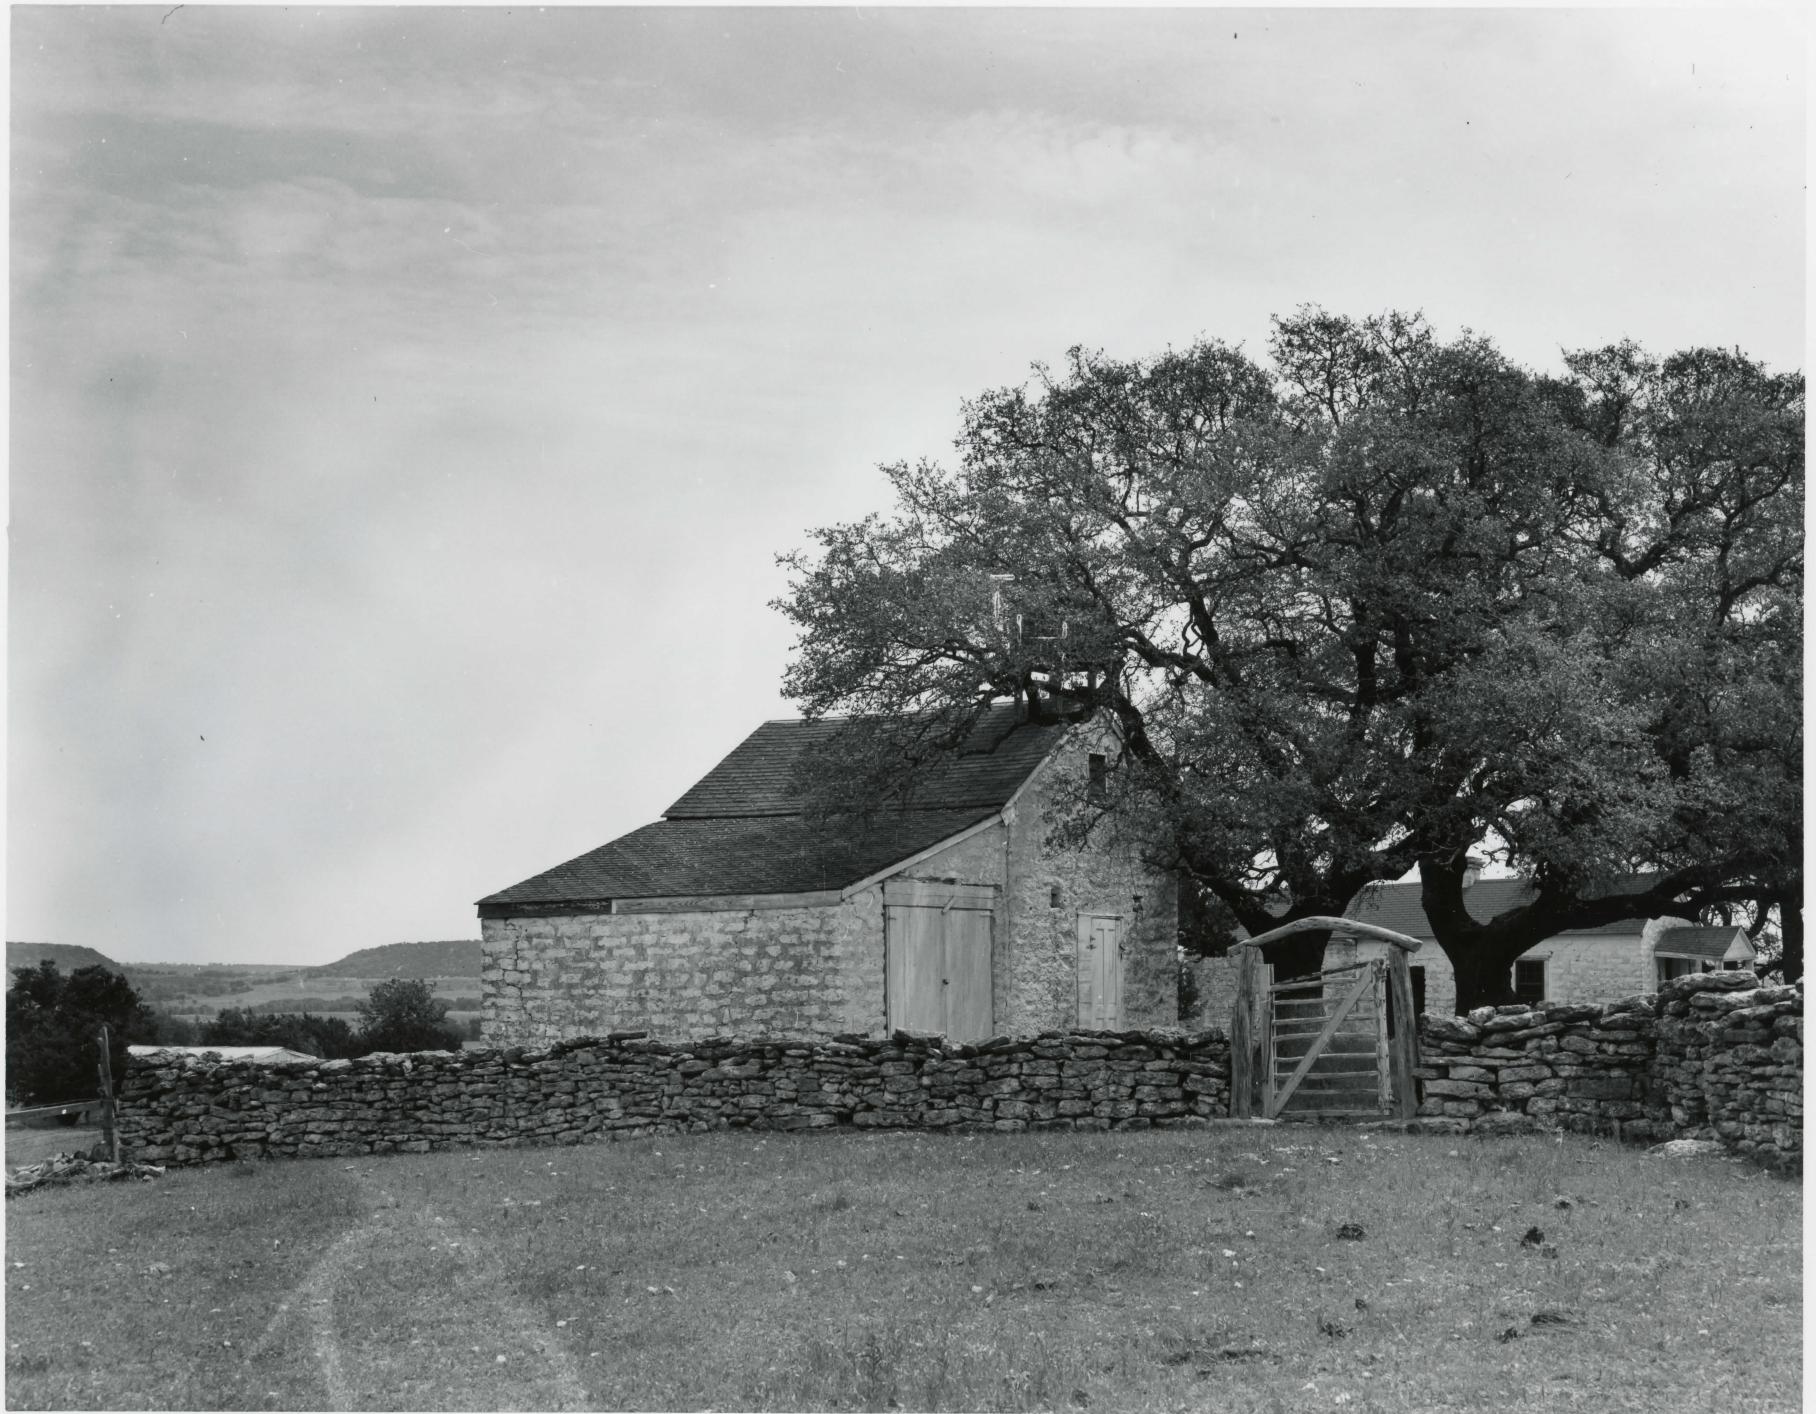
Site No. 1, Carl and Sedsel Questad Farm,
6 miles west of Clifton, Bosque County, Texas
Photograph: June 1979, by David Moore
On file, Texas Historical Commission
View of blacksmith shop, looking northeast
Photo 4 of 72

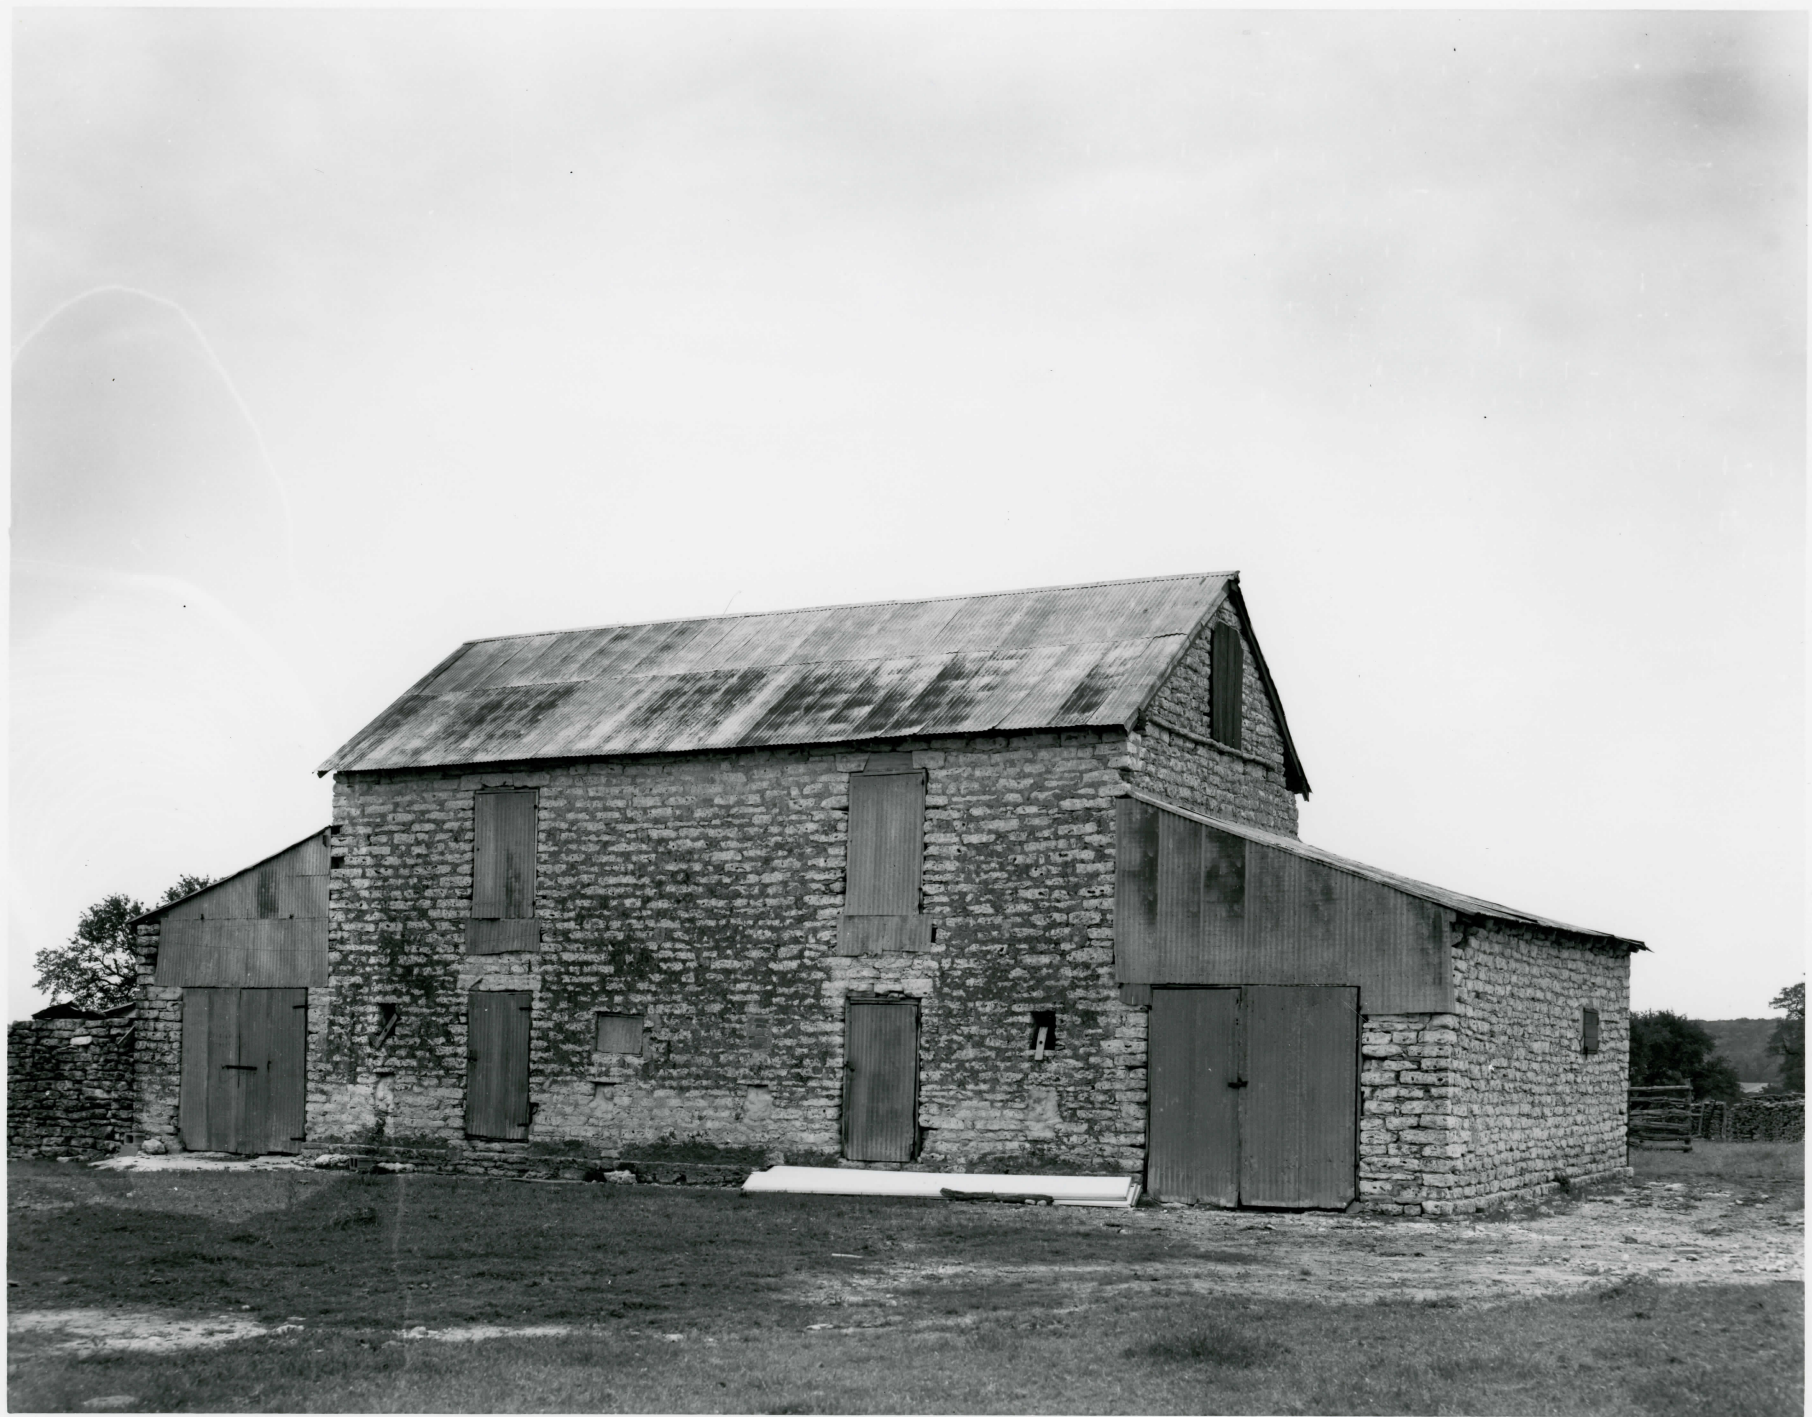
Site No. 1, Carl and Sedsel Questad Farm,
6 miles west of Clifton, Bosque County, Texas
Photograph: June 1979, by David Moore
On file, Texas Historical Commission
View of barn, looking southeast
Photo 5 of 72
