United States Department of the Interior  
National Park ServiceNational Register of Historic Places  
Inventory—Nomination Form

Jens and Kari Ringness farm

Site No. 4, Jens and Kari Ringness Farm,  
FM 219, 8 miles southwest of Clifton, Bosque  
County, Texas

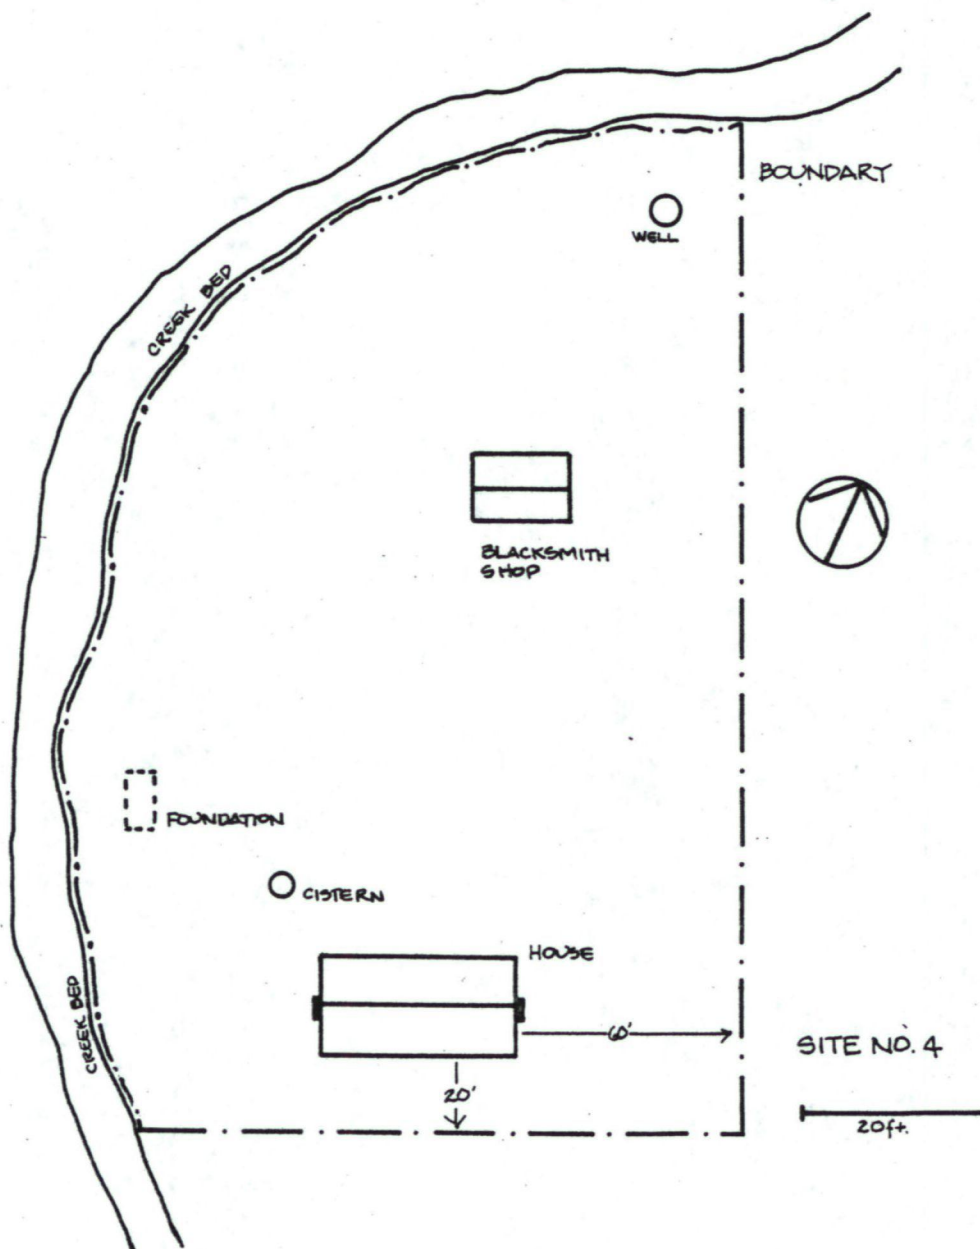
AREA TO BE NOMINATED

The old well and cistern located on the property contribute to the historic character of the farm. The modern buildings, which stand east of the old farm, are not included within the property to be nominated.

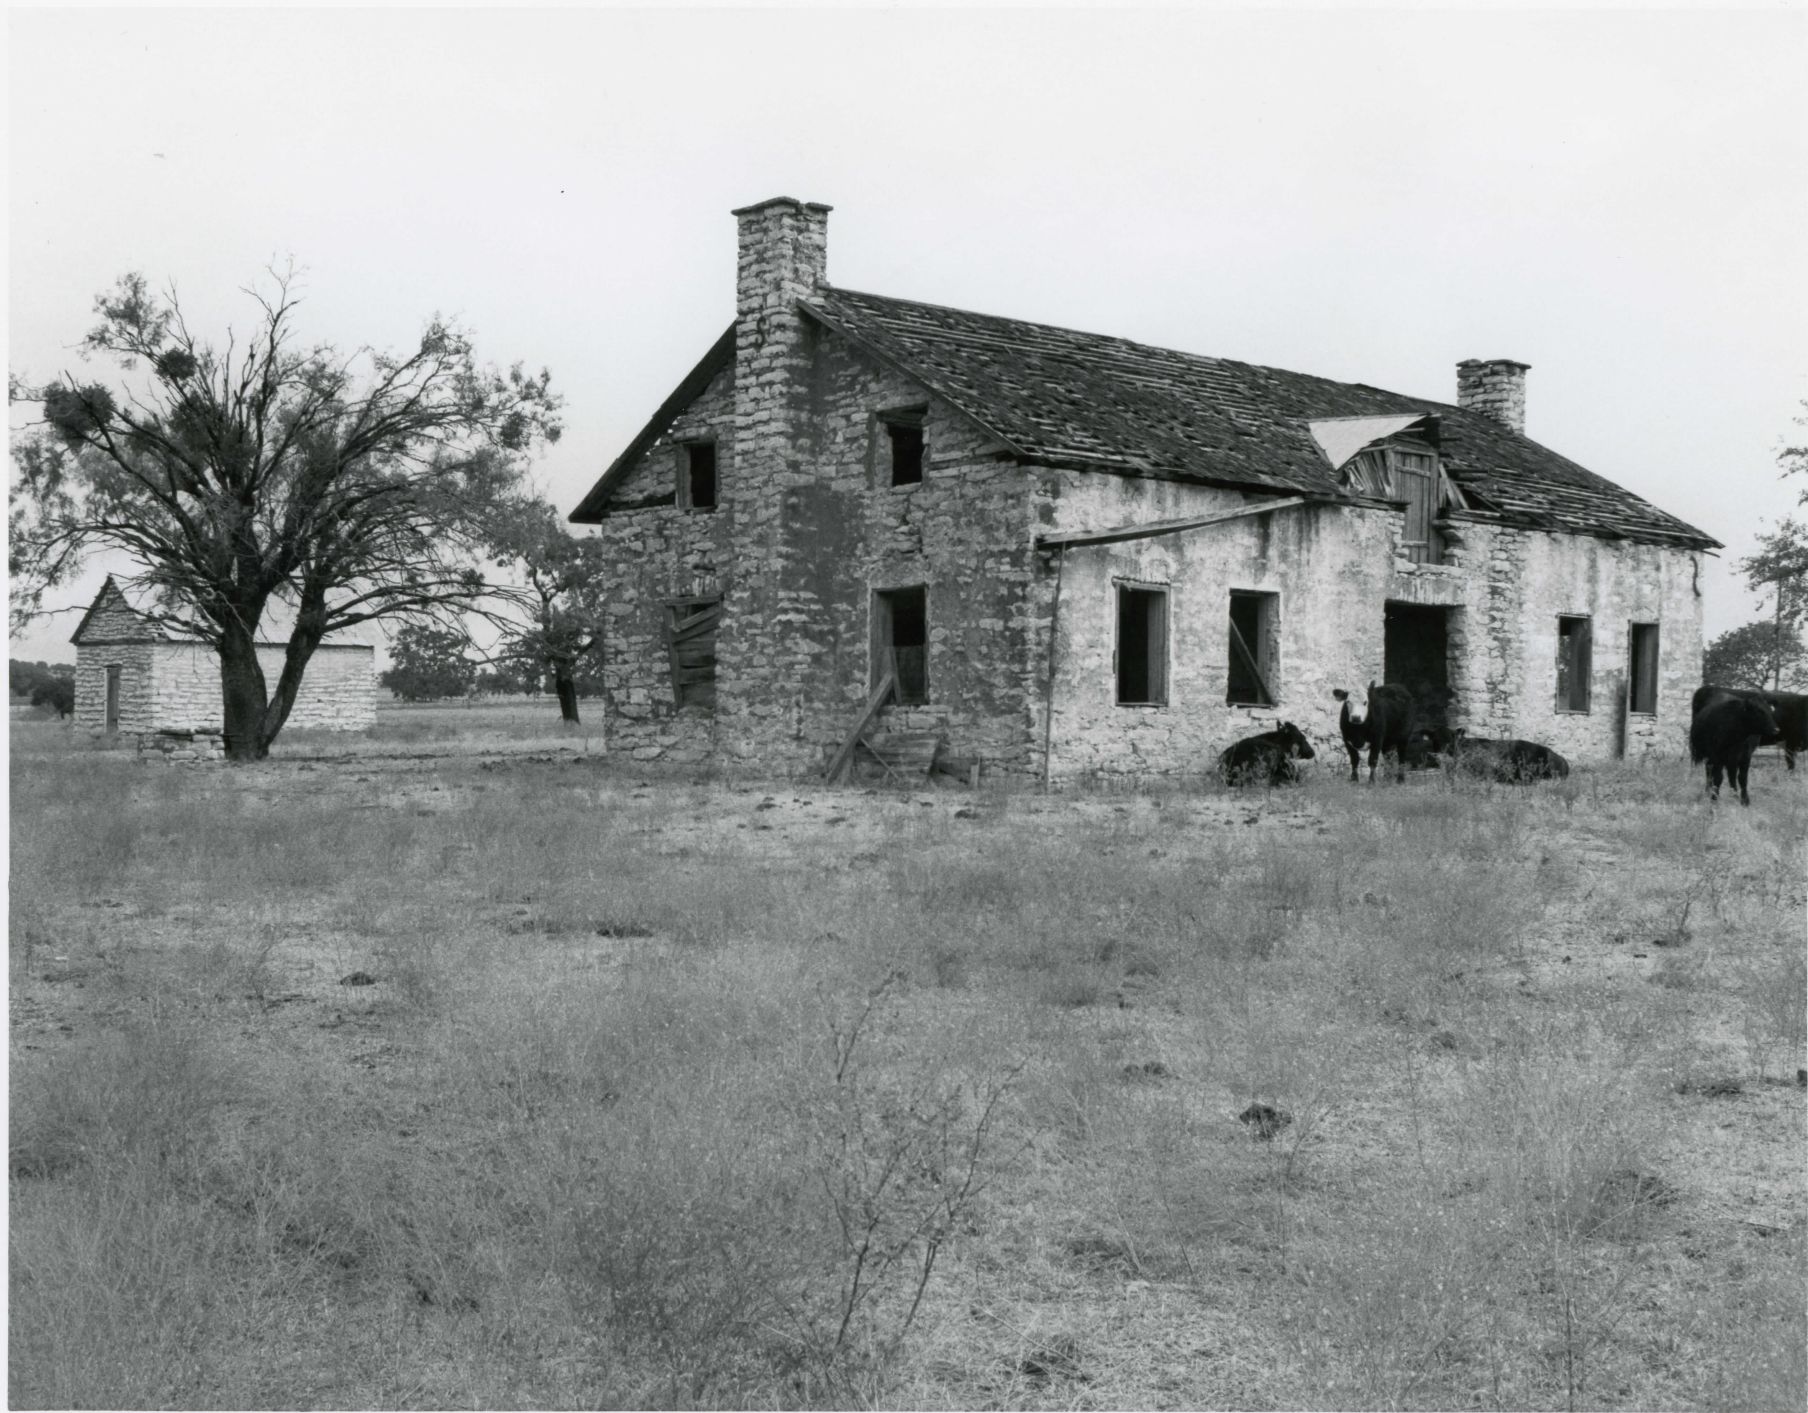
Photo 11 of 72

Located on a gently rising bluff overlooking the Neils Creek valley, the Jens and Kari Ringness farm stands near the east bank of a small creekbed. This rural complex is visible by car from its location south of FM 219, about two miles southwest of FM 182. The house, despite its poor condition, retains much of its integrity. It is a large, one-and-a-half-story building of limestone construction that was once covered

View of farm, looking northeast

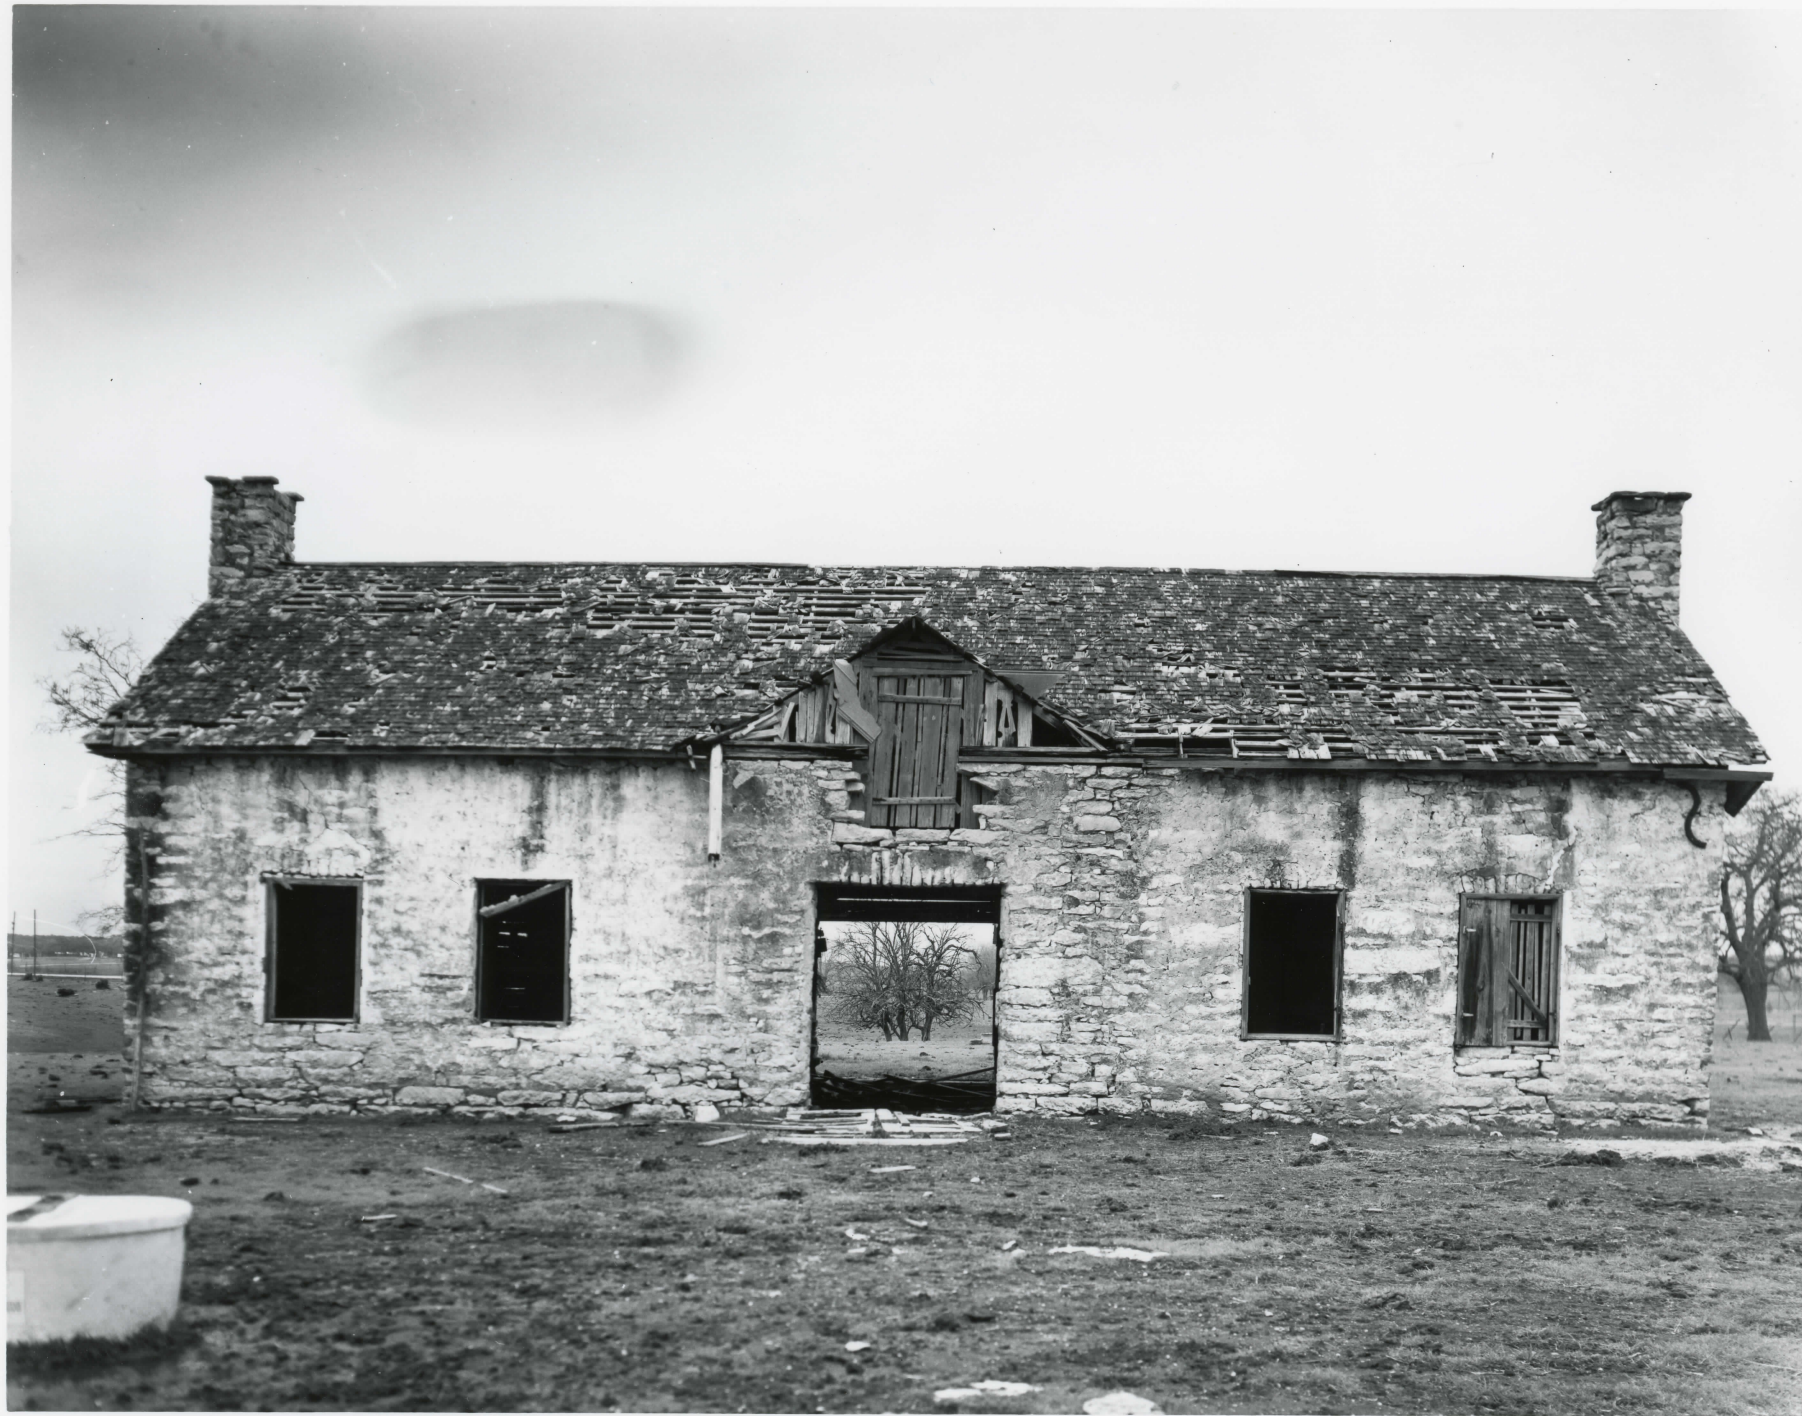
Photo 12 of 72

with plaster. The front faces south and exhibits a five-bay facade that is symmetrically composed. Flat arches with stone voussoirs span each of the openings. A small gable, which originally was part of a porch, extends above the broad central bay. The end elevations are virtually identical to one another, and feature stone chimneys in the center of the gables, with flanking attic windows supported by wooden plates. The rear elevation is similar in its composition to that of the front, but it did not have the central gable. A low-pitched gable roof, in poor condition, caps the structure. Because of its present use as a barn, the interior is virtually gutted. Its plan has a central hallway that is flanked on each side by a pair of rooms.

View of house, looking north

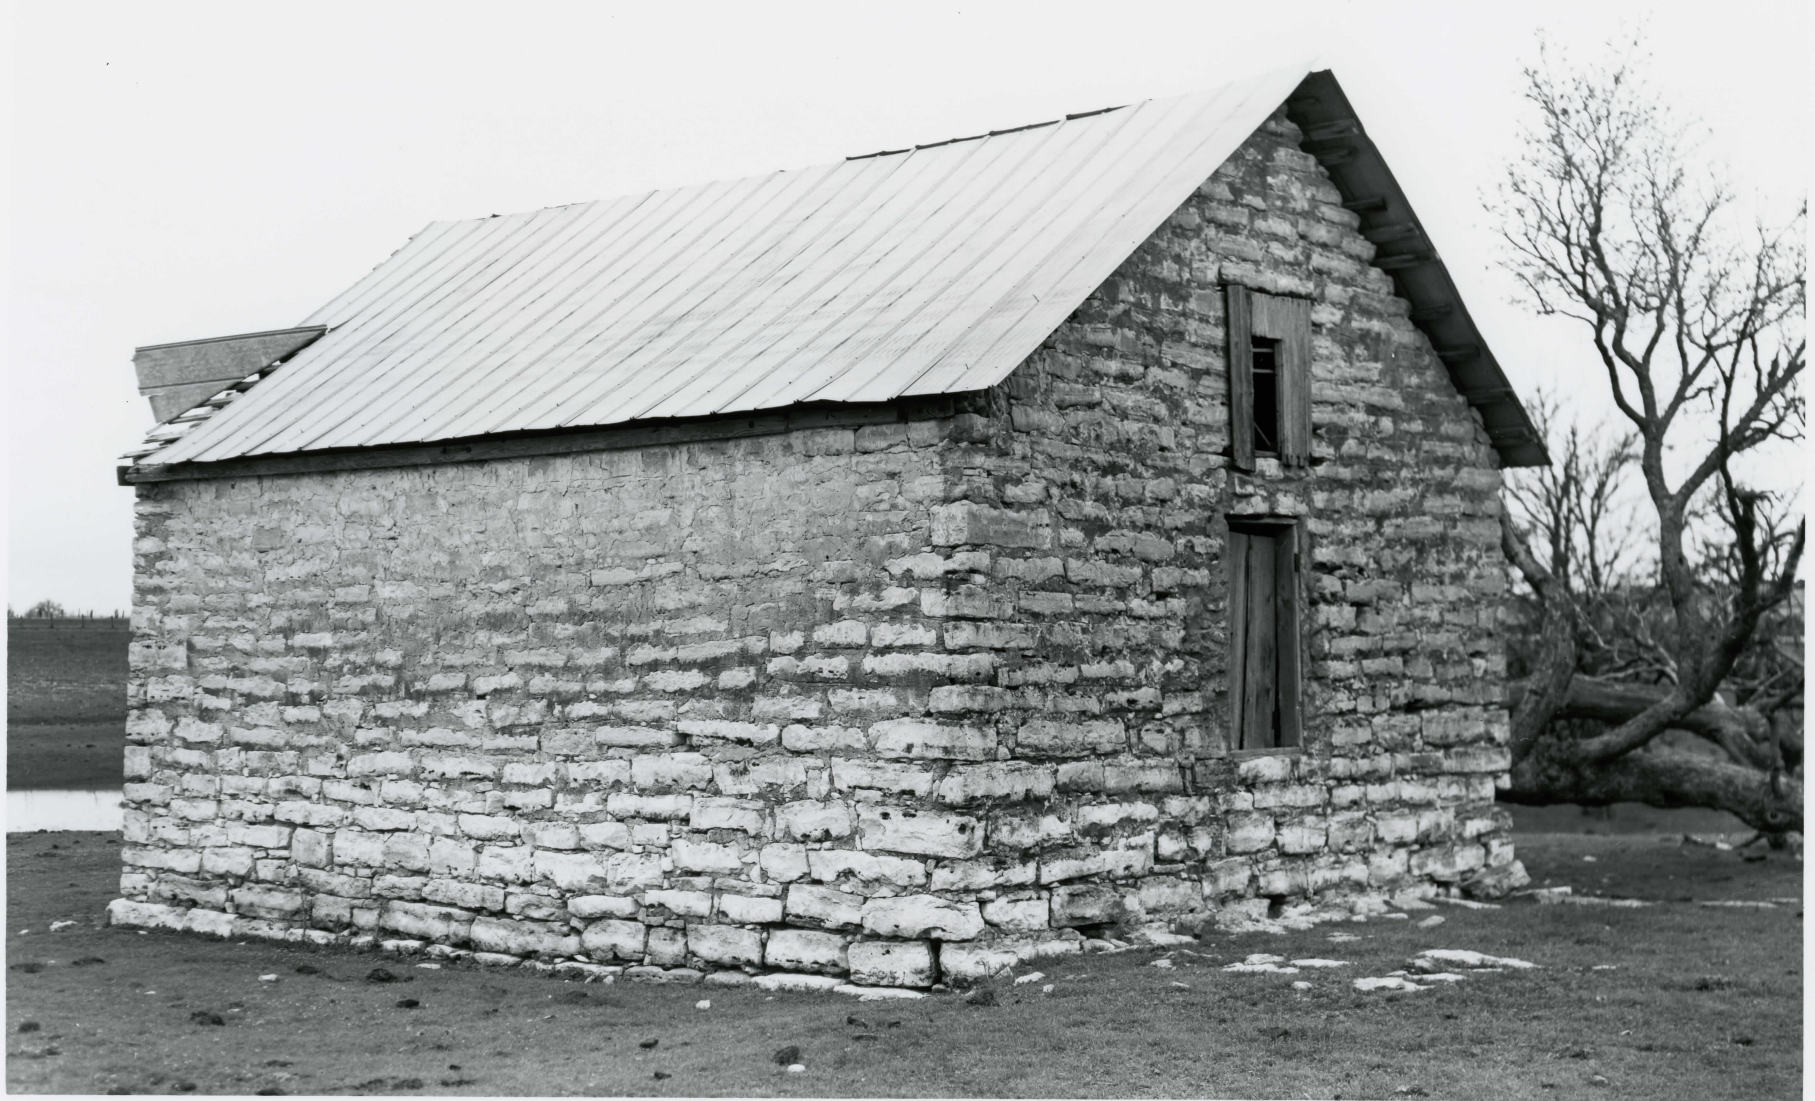
Photo 13 of 72

The old blacksmith shop, which stands about 100 feet north of the house, remains in good condition with few alterations. With a square-shaped plan, this one-and-a-half-story building features limestone walls that are canted inward toward the top. It is now used for storage.

View of blacksmith shop, looking northwest
