National Register of Historic Places  
Inventory—Nomination Form

Upper Settlement Rural Historic District

A  $4\frac{1}{2}$ -square-mile area within the upper Meridian  
Creek valley, just east of Cranfills Gap, Texas

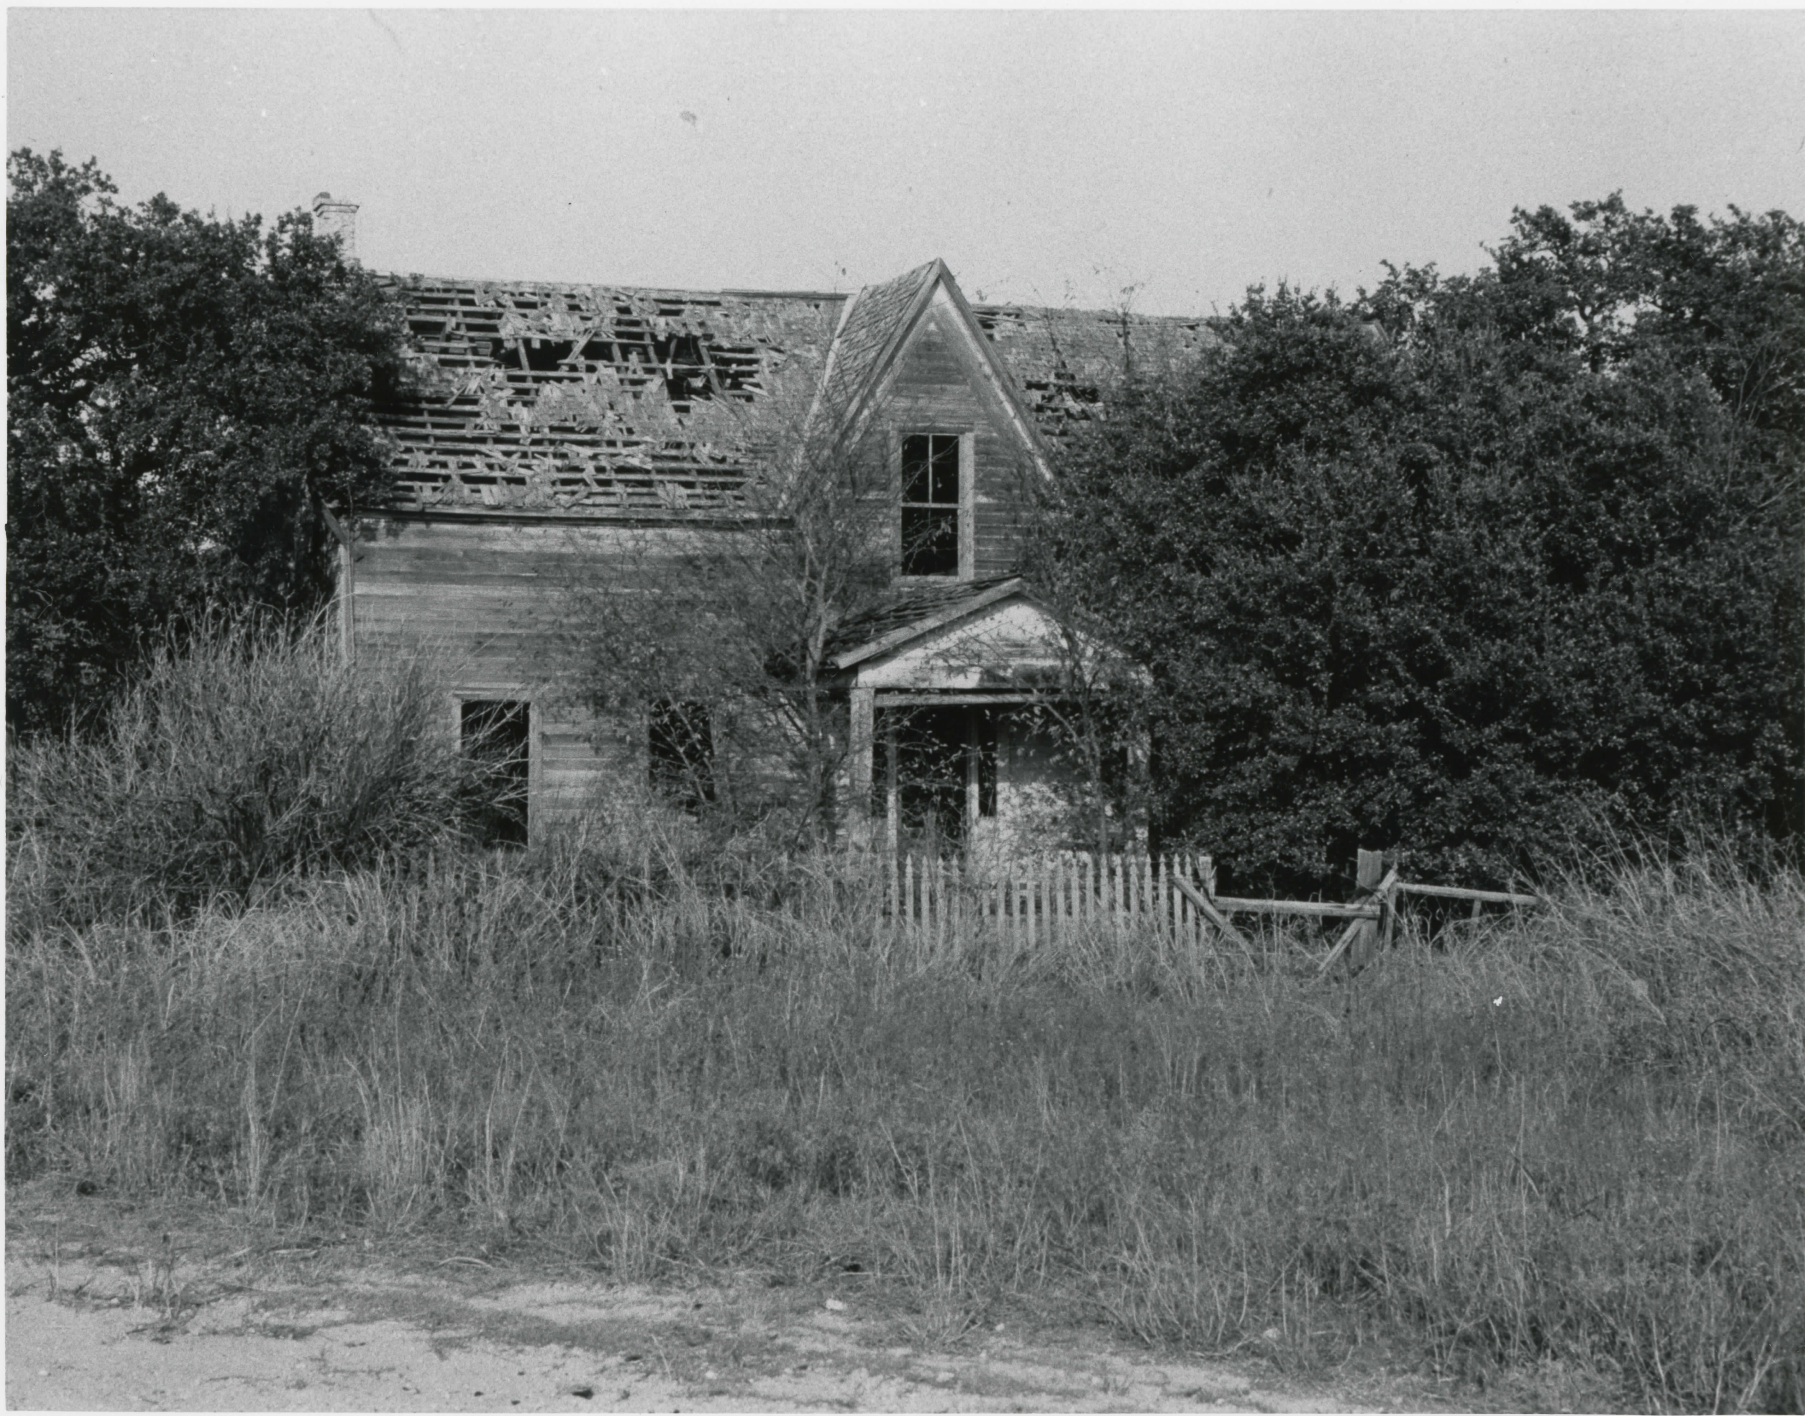
Photo 54 of 72

No. 36. Christen and Johanne Hansen farm (circa 1893), contributing, photo no. 54. This one-and-a-half-story, wood-frame residence is located at the far western edge of the district. The paved county road which serves as the north district boundary cuts through the farm, but the house and barns are within the district. The house is strategically sited on a bluff which overlooks the upper Meridian Creek valley, although the front facade turns away from the valley and looks southwest toward Cranfills Gap. The front is of a symmetrical five-bay composition with a centrally located, single-door entry. A steeply pitched gable extension rises above the entrance and is characteristic of other contemporary frame houses in the Norwegian settlement in Bosque County. Most of the original window sashes have been removed, but those that remain have two-over-two lights set in a sash with a vertical muntin. The original L-shaped plan of the house was changed with the addition of a rear wing about 1947, producing the present U-shaped plan. Because the house has been abandoned and converted into a barn, the interior is in very poor condition. The house is in deteriorated condition overall, and the wooden shingles on the gabled roof have all but disappeared. The outbuildings, which contribute to the historic character of the farm, include one barn of saddle-notched log construction, with board-and-batten siding, and another frame barn covered with clapboards.

View of front facade, looking east

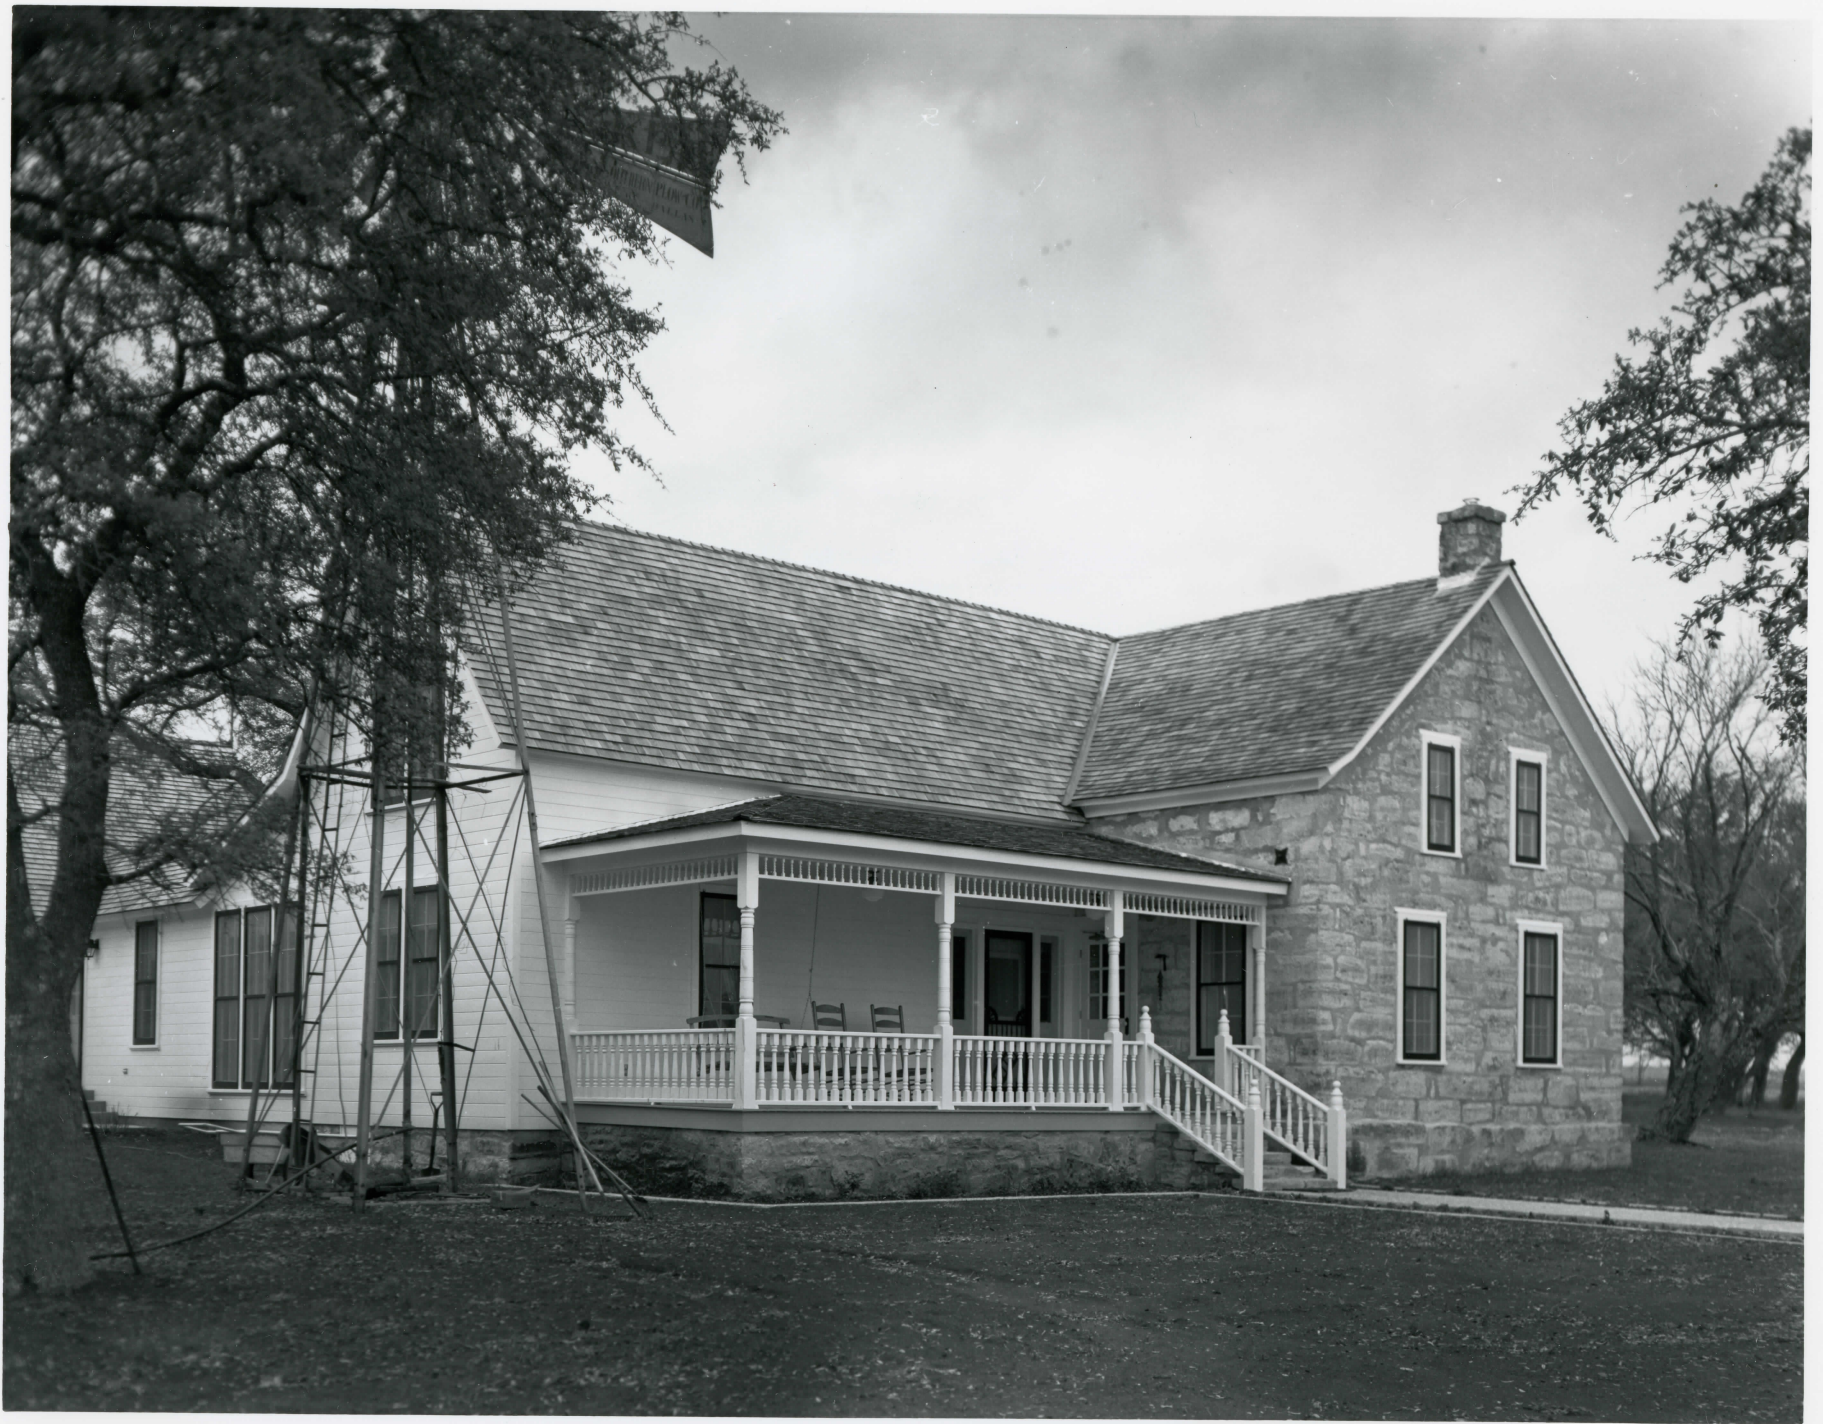
Photo 55 of 72

No. 37. Johnson-Bertelsen farm (1887/1908/1978), contributing, photo no. 55. The Johnson-Bertelsen house is a stone and wood-frame residence that was heavily remodeled in 1978. The original house was a one-and-a-half-story stone structure built in 1887 which resembled the Otto and Elene Swenson house (no. 42). A wood-frame wing was added in about 1908, and the resulting T-shaped plan was altered again in the most recent renovation. At that time (1978), a garage and connecting hallway were added

to the southwest corner of the house, and the 1903 entry-porch was enclosed. A new porch and entry-way were also added on the east side of the house, which since 1908 had been the rear elevation. Despite these changes the house still retains enough of its historical character to be classified as contributing. A small, clapboard outbuilding stands to the east of this house, and was covered with board-and-batten siding during the 1978 remodeling.

View of front facade, looking northwest

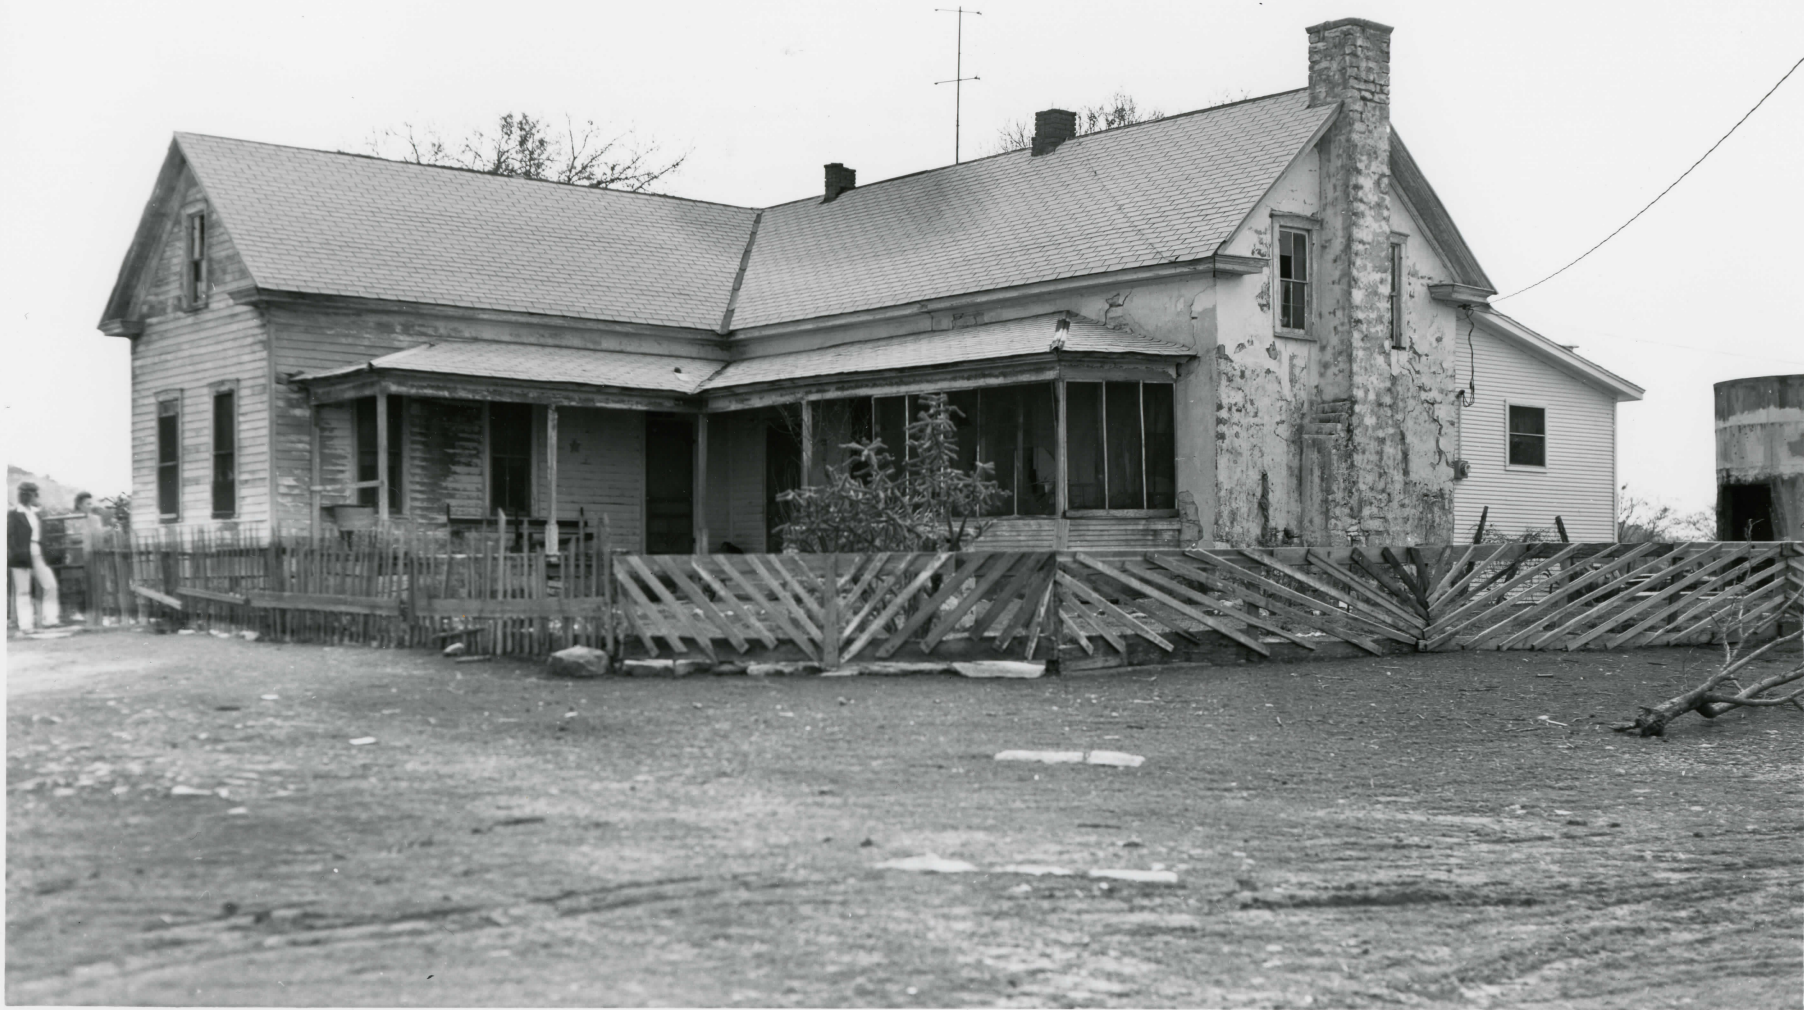
Photo 56 of 72

No. 38. Hans J. and Petra Hanson farm (c. 1870/c. 1900/ 1966), contributing, photo nos. 56, 57. Although in poor but stable condition, the Hanson farm is a good example of a late 19th-century Norwegian pioneer homestead. The original residence (c. 1870) was a one-and-a-half-story stone house with a rectangular plan of the asymmetrical type. Later additions to the stone core include a turn-of-the-century wood-frame "L" and a small shed-roof wing, built in 1966. A large barn of limestone and board-and-batten construction stands near the house, and is surrounded by a 19th-century cedar-post fence. A second, collapsed stone fence is also included on the property.

View of front facade, looking southwest

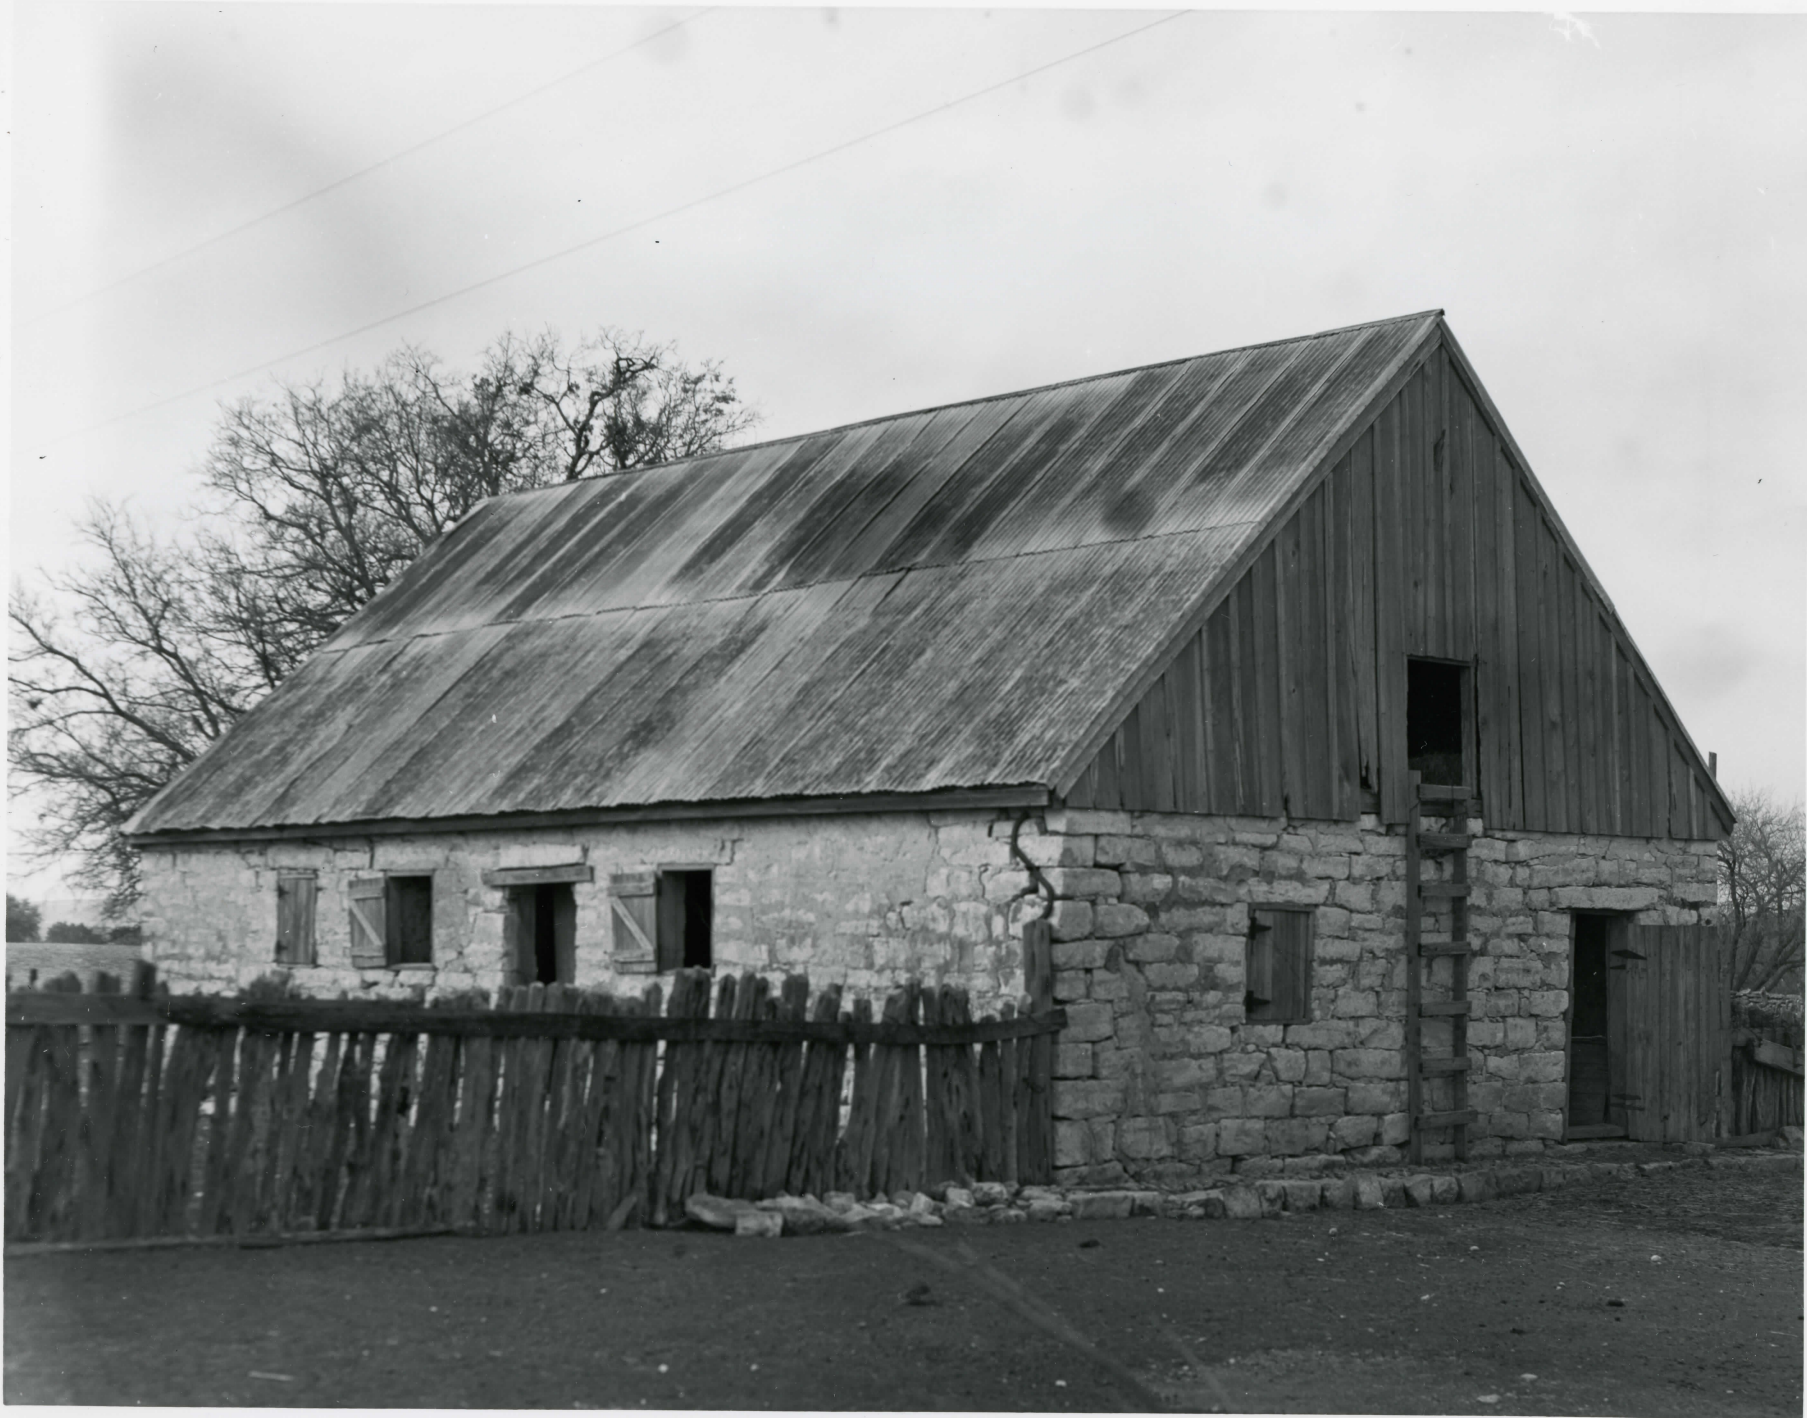
Photo 57 of 72

View of barn, looking northwest

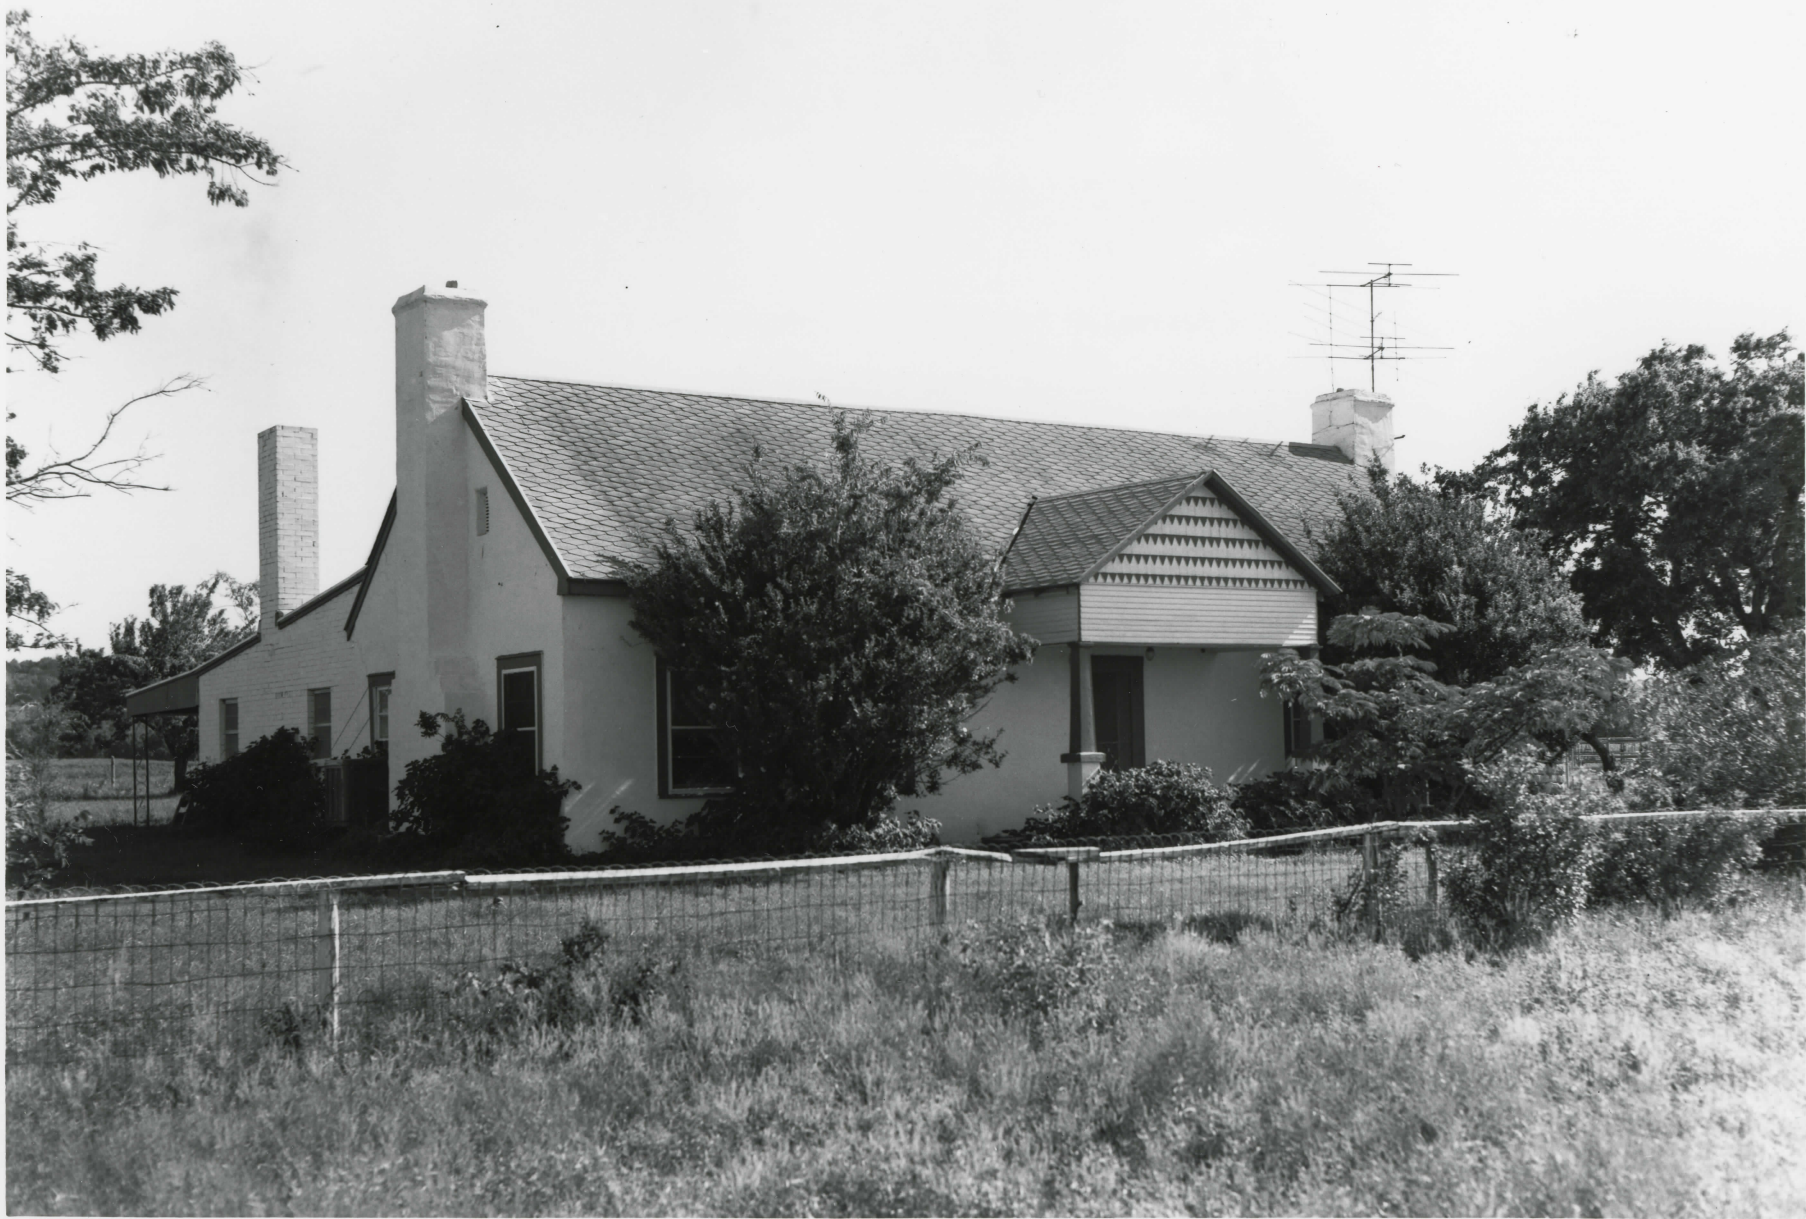
No. 39. Olson-Arneson farm (c. 1870), contributing, photo no. 58. The Olson-Arneson farm includes a one-and-a-half-story stone house, and commands a majestic view of Old St. Olaf's Church (no. 40). With a rectangular, three-part plan, and an exterior stone chimney at each side, this house bears a striking resemblance to other symmetrical stone houses such as the Ringness (no. 4) and the Keddel and Liv Grimland (no. 9) residences. A stucco finish in excellent repair covers the limestone construction. The five-bay facade features a small porch that extends over the main entryway. Supported by Bungalow-style columns, this porch has alternating rows of toothed wooden shingles in the gable end. Despite the addition of a multiroom brick wing at the rear, and the installation of modern sash windows, the house retains much of its historic integrity. A small, one-room outbuilding of limestone construction stands near the house.

Upper Settlement Rural Historic District  
Site No. 39, Olson-Arneson Farm, 3 miles  
east of Cranfills Gap, Bosque County, Texas  
Photograph: July 1979, by Daniel Hardy  
On file, Texas Historical Commission  
View of front facade, looking south  
Photo 58 of 72

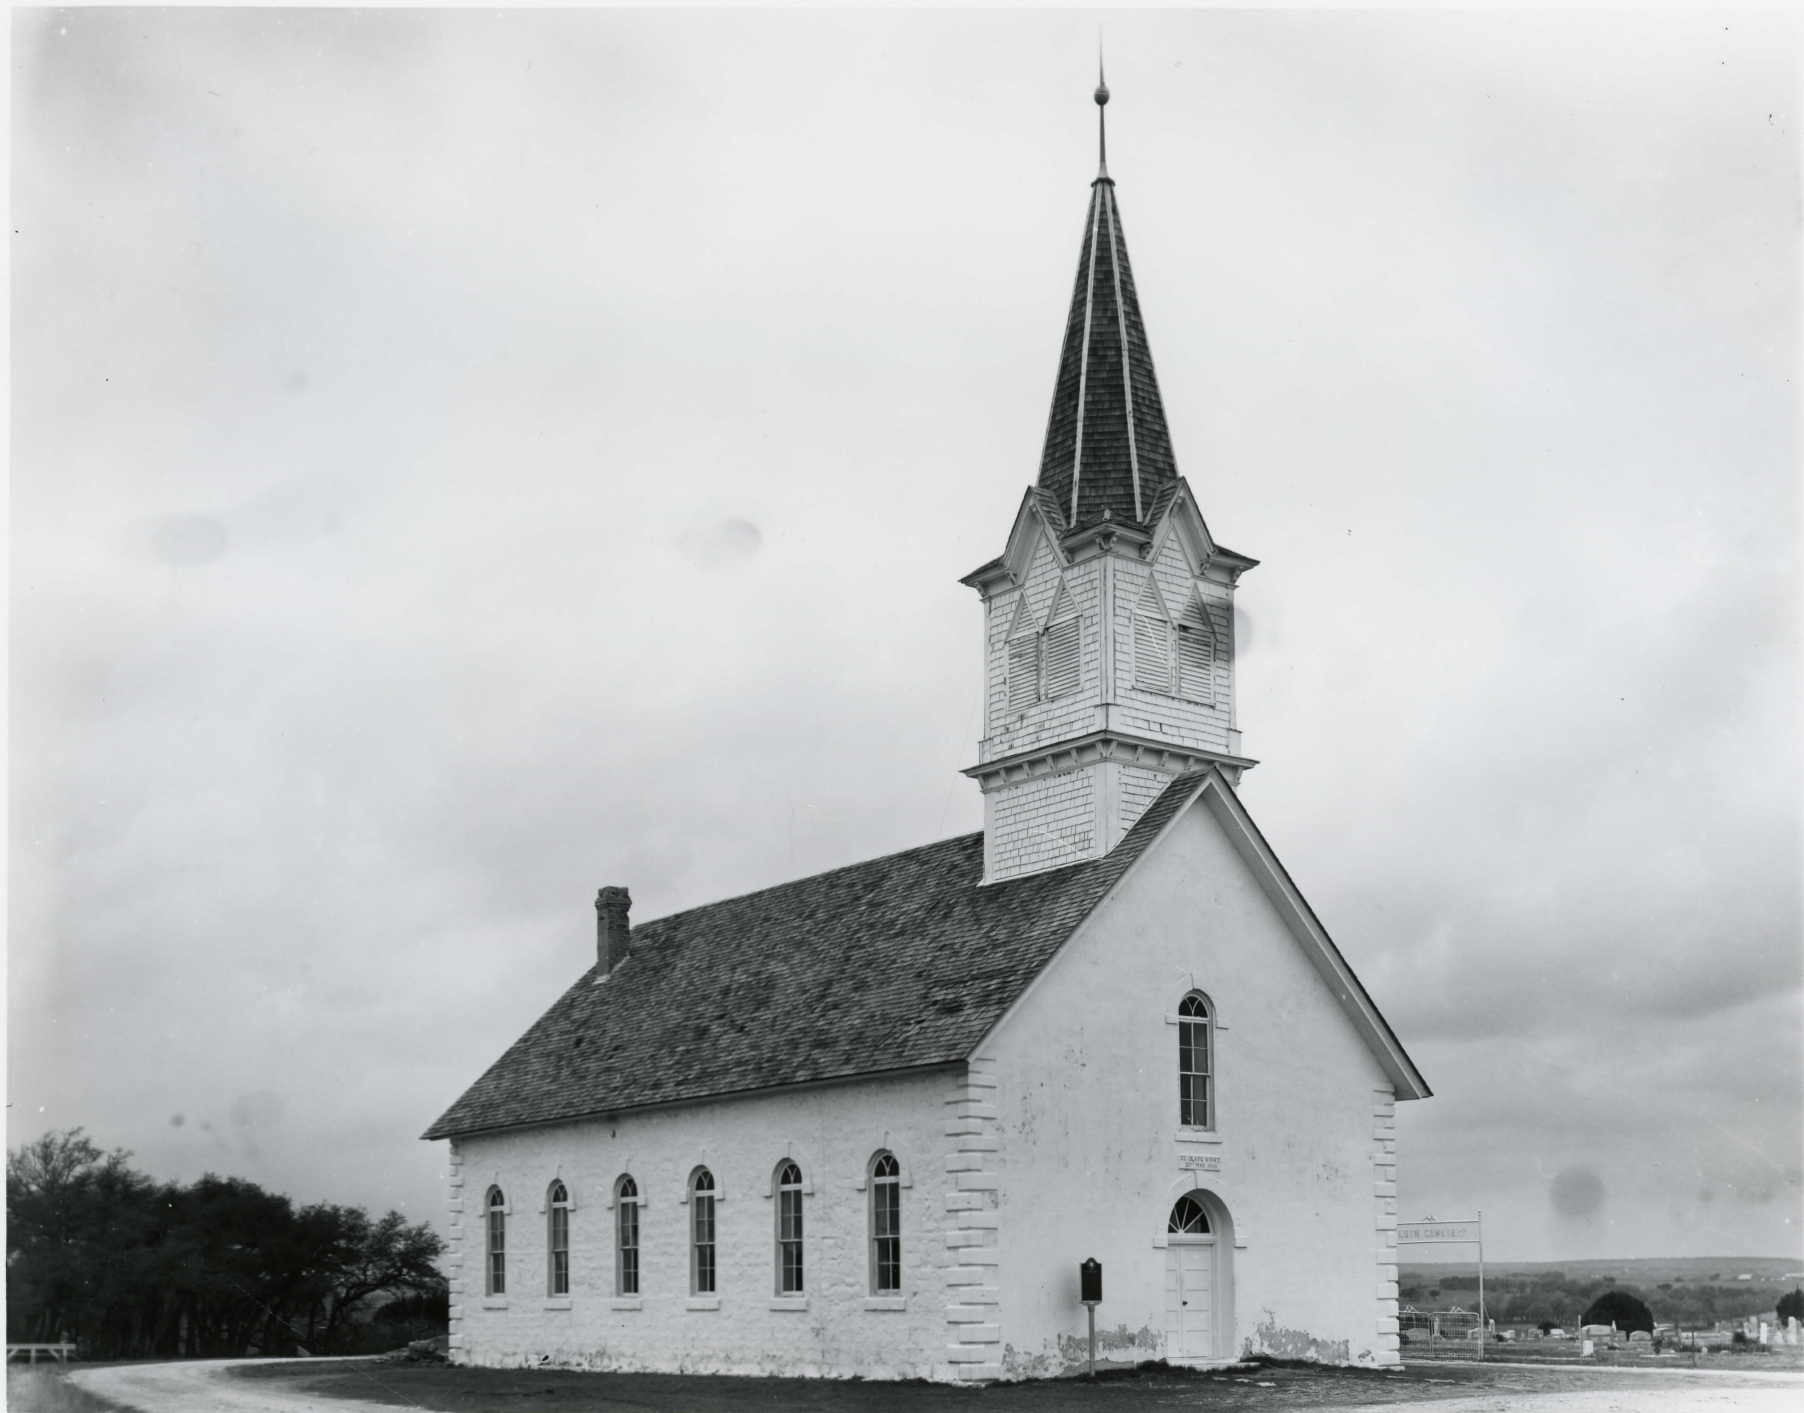
Photo 59 of 72

No. 40. Old St. Olaf's Church (1886-1890s), contributing, photo nos. 59, 60. Situated on a hill near the geographic center of the Upper Meridian Creek valley, Old St. Olaf's Church is a large, stuccoed stone building that remains in excellent condition and exhibits some of the most outstanding stone masonry in the entire Norwegian settlement. The plan of the church is rectangular. A wooden-frame bell tower with shingle siding and a steeply pitched, octagonal spire extends upward from the east end of the building. A round arch with hood molding spans the main entrance beneath this tower. Six windows with round arches pierce each of the side elevations, and are capped with stone hood moldings. They are composed of four-over-four lights, with fixed tracery above a transom bar. Stone quoins reinforce the four corners of the edifice, whose roof is covered with wooden shingles and pierced by a chimney toward the rear. Like the exterior, the interior remains virtually unaltered and still retains its original

View of front facade, looking northwest

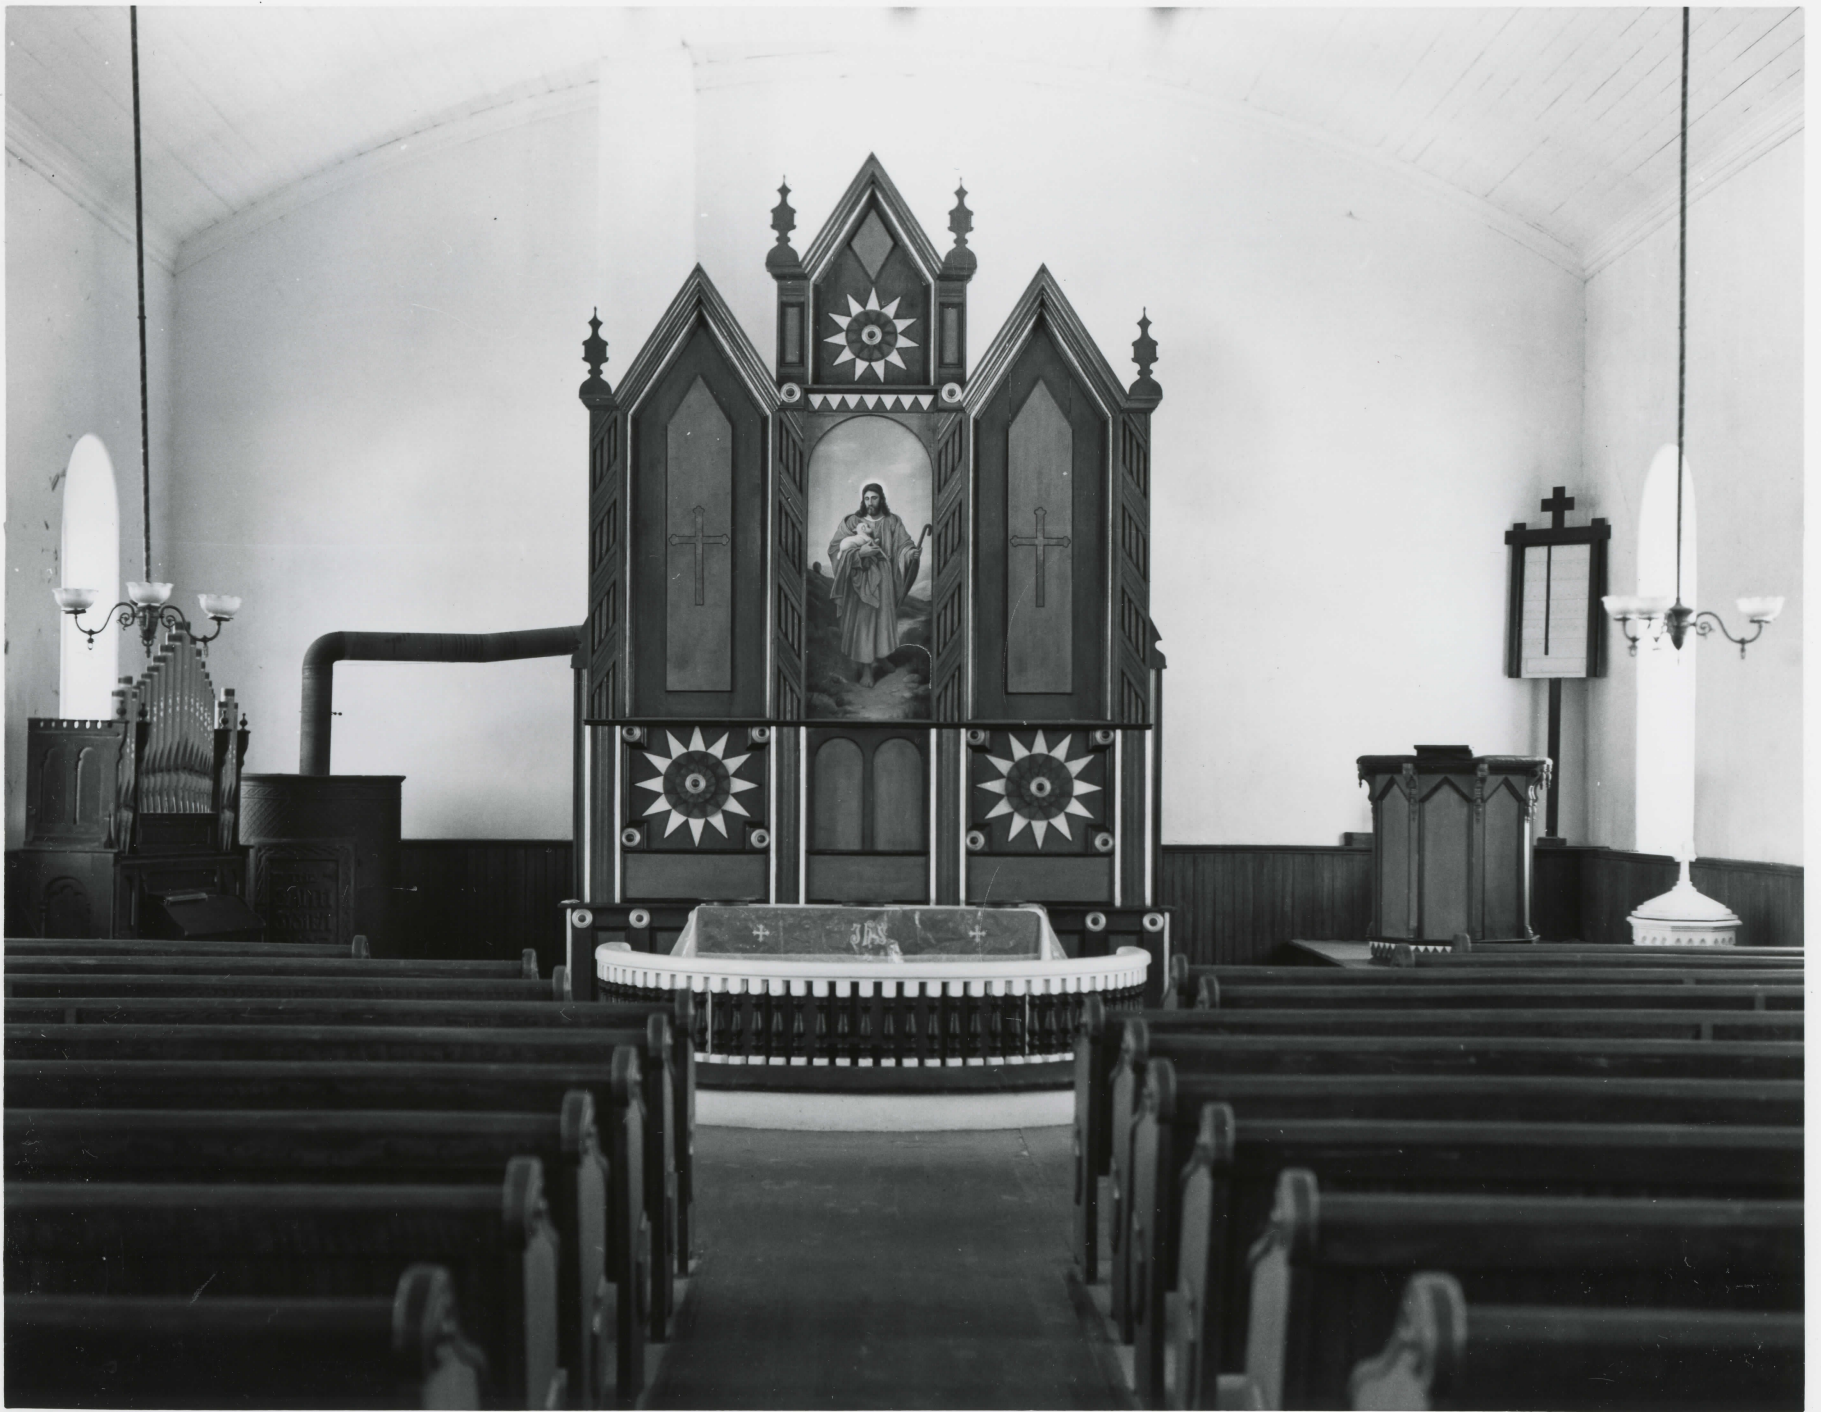
Photo 60 of 72

altar, gas-burning lamps, and oil-burning furnace. The pews feature handpainted wood graining, and the barrel-vault ceiling is faced by beaded boards. The cemetery, which is located immediately north of the structure, is an integral part of the church and is included within the district.

View of interior, looking west

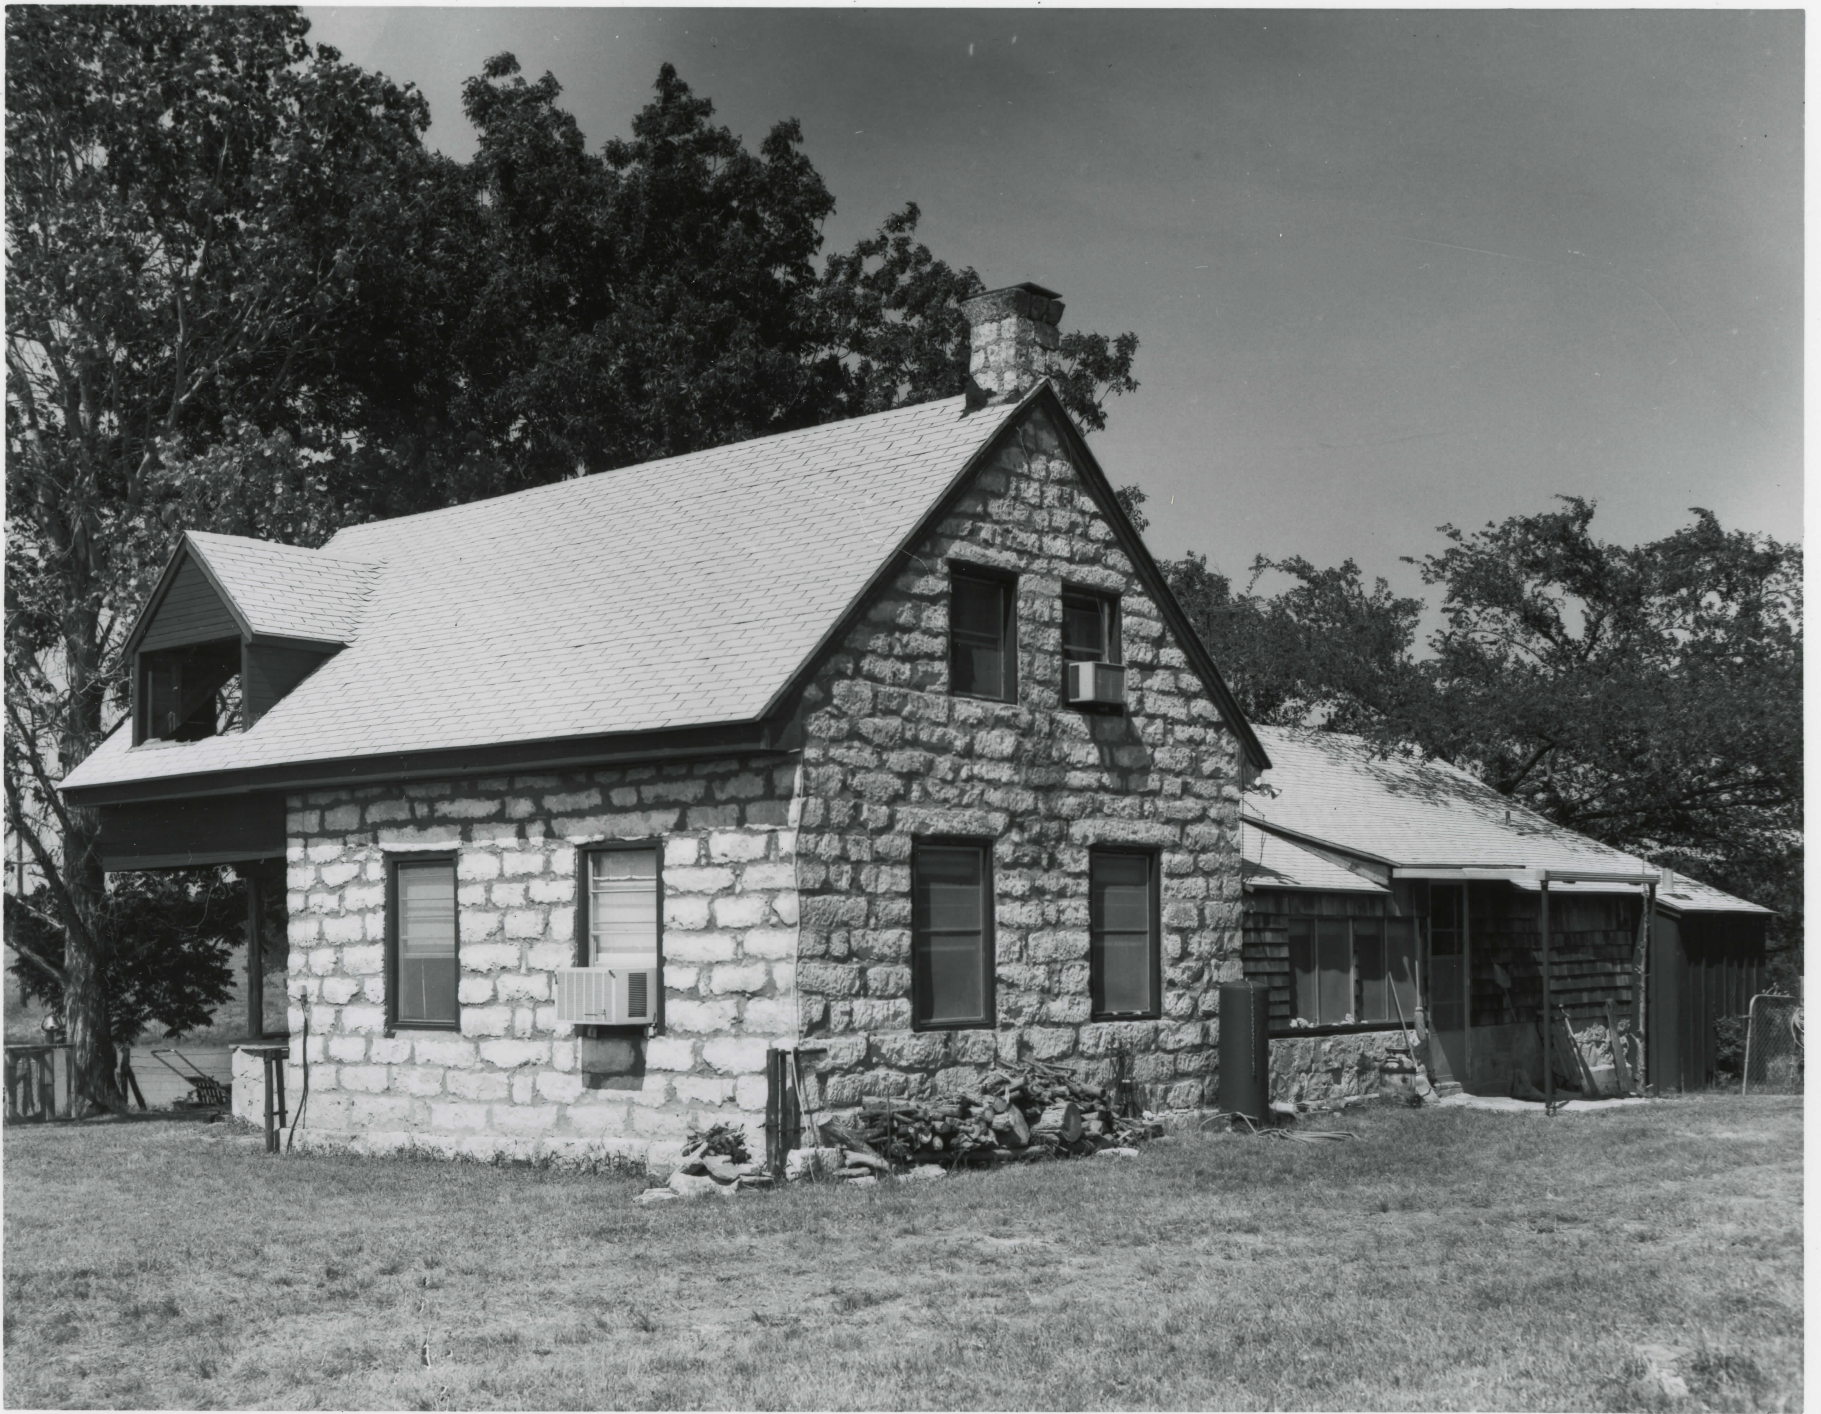
Photo 61 of 72

No. 41. Otto and Elene Swenson farm (c. 1870), contributing, photo no. 61. The one-and-a-half-story stone residence stands at the base of Rogstad Mountain, between the Olson-Arneson farm and the Pederson farm. A small, tree-lined creek runs immediately east of the house and flows north toward Meridian Creek. The plan of the house is rectangular. The western section of the house rises one-and-a-half stories in height, with a one-story "L" of a later construction date at the rear. The west end is similar in detailing and massing to the Johnson-Bertelson house (no. 37), and features an interior stone chimney that rises from the south gable end. A second-story loft extends from the opposite (north) gable end but remains open on the ground level. All original windows have been replaced with aluminum sash windows, and the limestone walls have been re-pointed with portland cement. Despite the alterations, the house maintains just enough of its historic character and integrity to be classified as contributing. Collapsed stone fences also can be found on the property.

View of side elevation, looking northeast
