National Register of Historic Places  
Inventory—Nomination Form

Upper Settlement Rural Historic District

A  $4\frac{1}{2}$ -square-mile area within the upper Meridian  
Creek valley, just east of Cranfills Gap, Texas

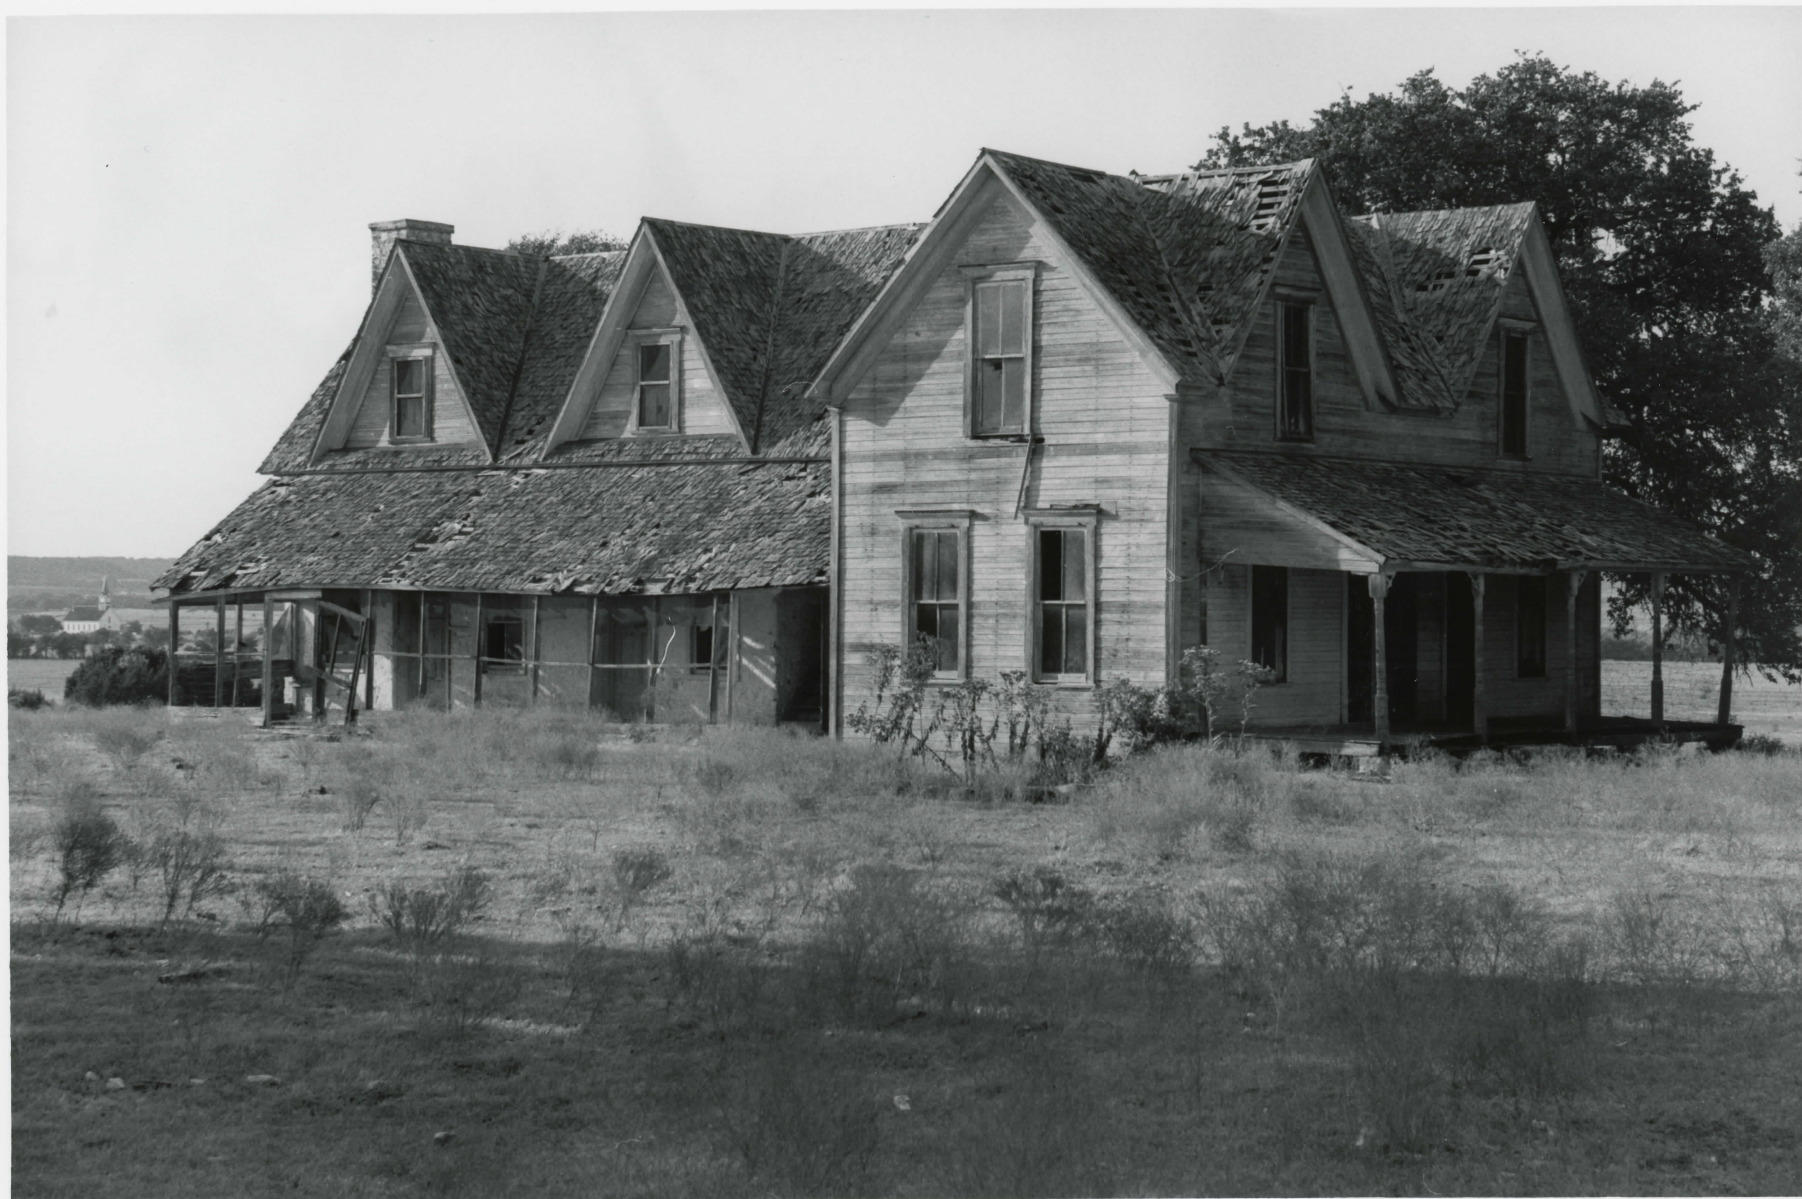
Photo 62 of 72

No. 42. The Bersvend and Kari Swenson farm (early 1860s/c. 1900), contributing, photo nos. 62, 63, 64. The Bersvend and Kari Swenson farm is one of the most outstanding examples of a pioneer Norwegian farm complex in Bosque County. Prominently sited on the northside of Rogstad Mountain, it includes a stone and wood-frame residence, a stone barn, a detached dug-out cellar, collapsed stone fences, and the ruins of another stone outbuilding. The house is in poor condition and has been unoccupied since the 1950s. The oldest section of the house is of stone and was probably built in the early 1860s. The plan is asymmetrical, and is very similar to that of the Pierson house (no. 2). The stuccoed exterior veneer has begun to peel from the stone walls, exposing the ashlar limestone below. A single tie-rod provides structural support at the west end. The three-bay main facade, with its asymmetrical fenestration, faces south toward the mountains. Around the turn-of-the-century, the house was substantially remodeled and expanded. On the stone part of the home, the gable end of the west facade, with its exterior stone chimney, clearly shows that the pitch of the gable was made steeper to accommodate a new roof and dormers. A partially enclosed breezeway connects the stone house with the later, two-story, wood-frame addition which gives a T-shaped plan to the whole. A one-and-a-half-story stone barn, with a broken-pitch gabled roof, stands to the east of the main house. Just to the north is a barrel-vaulted cellar that has been dug into the side of the hill. Its entrance is capped with a fine segmental arch. The nearby water well, stone troughs, and the ruins of a frame outbuilding are associated with a light surface scatter of glass, ceramics, and metal tools.

View of front facade, looking northwest

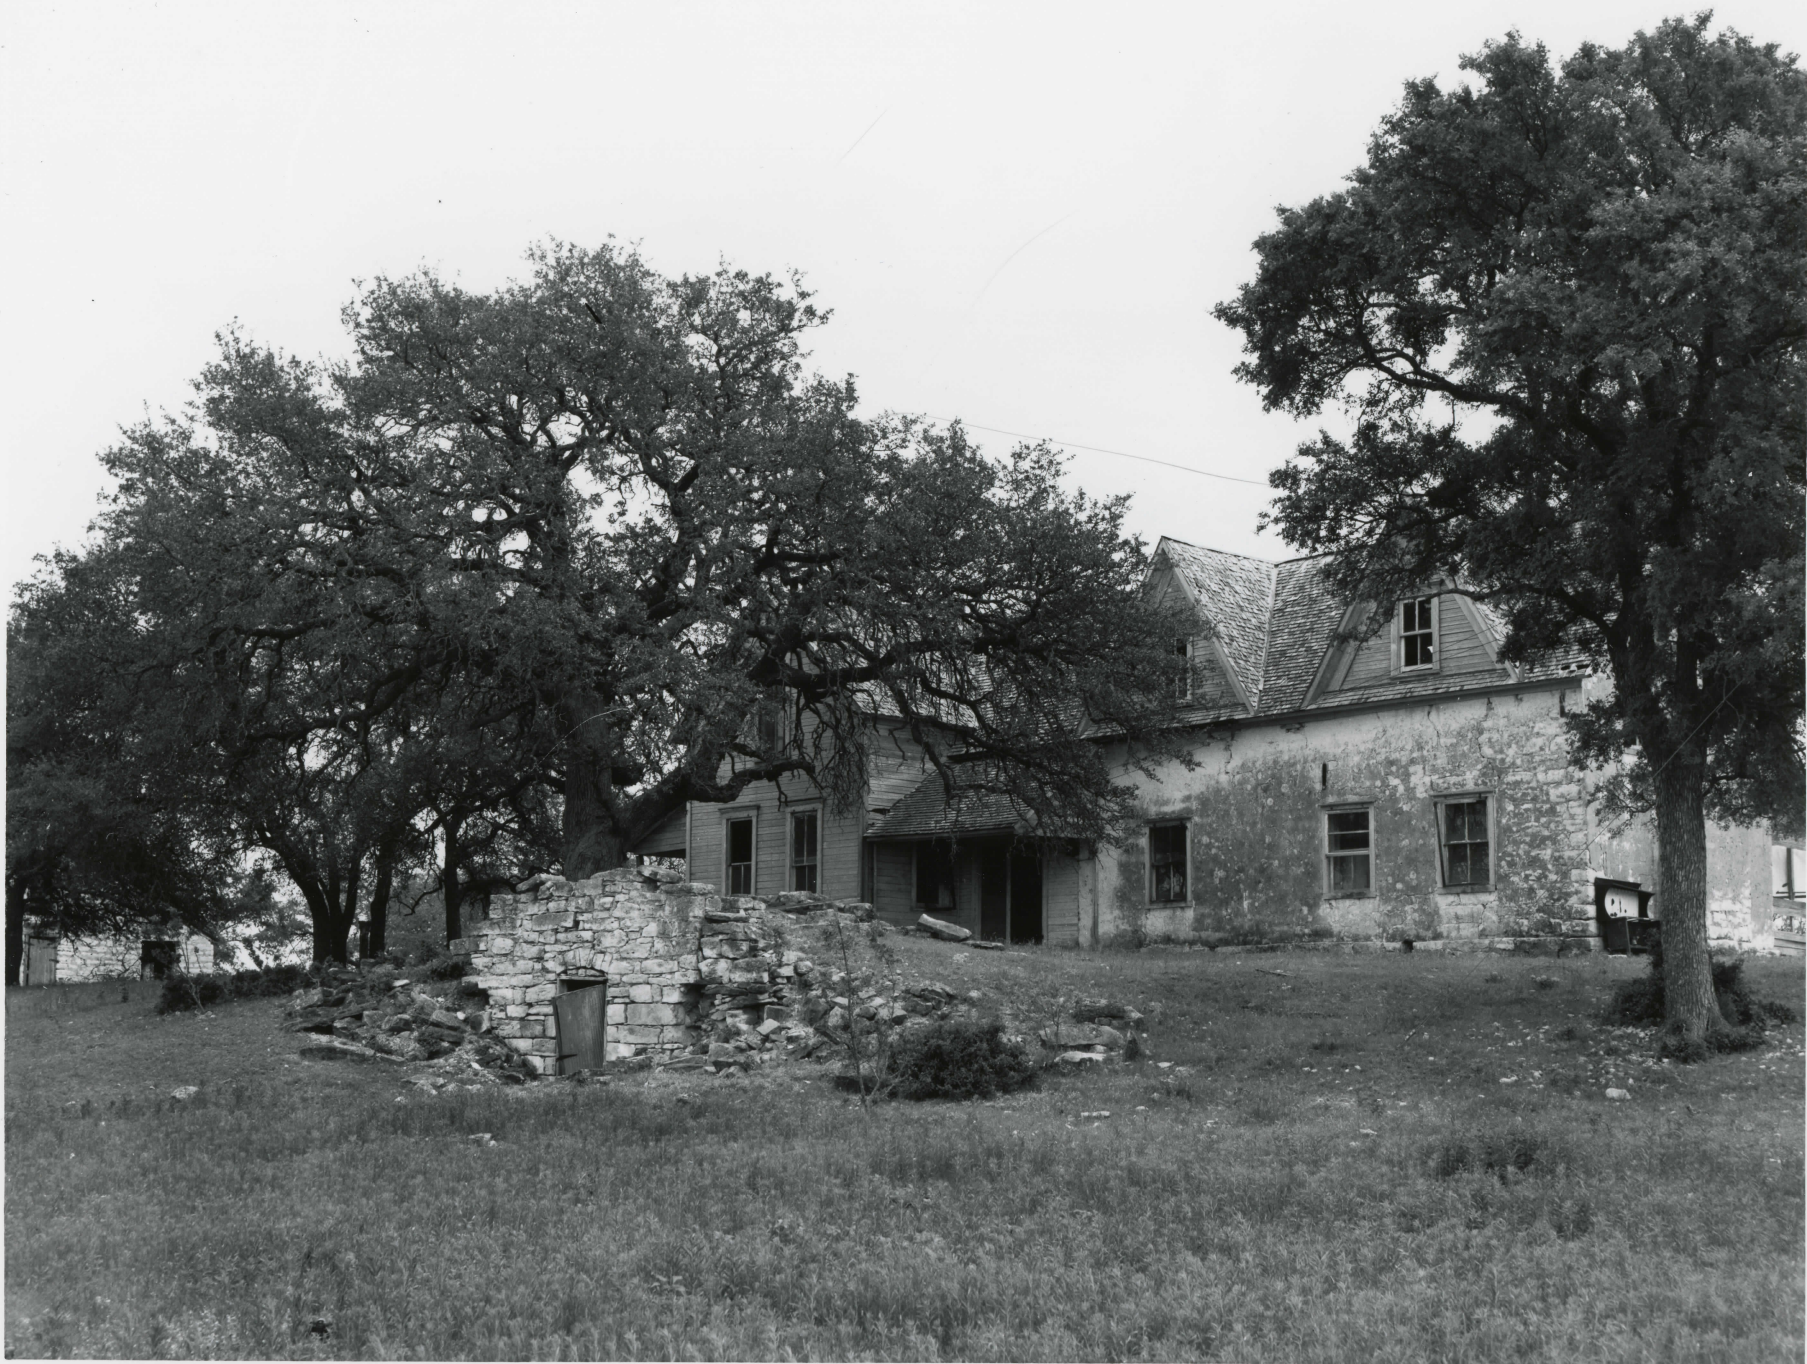
Photo 63 of 72

View of rear elevation, looking southeast

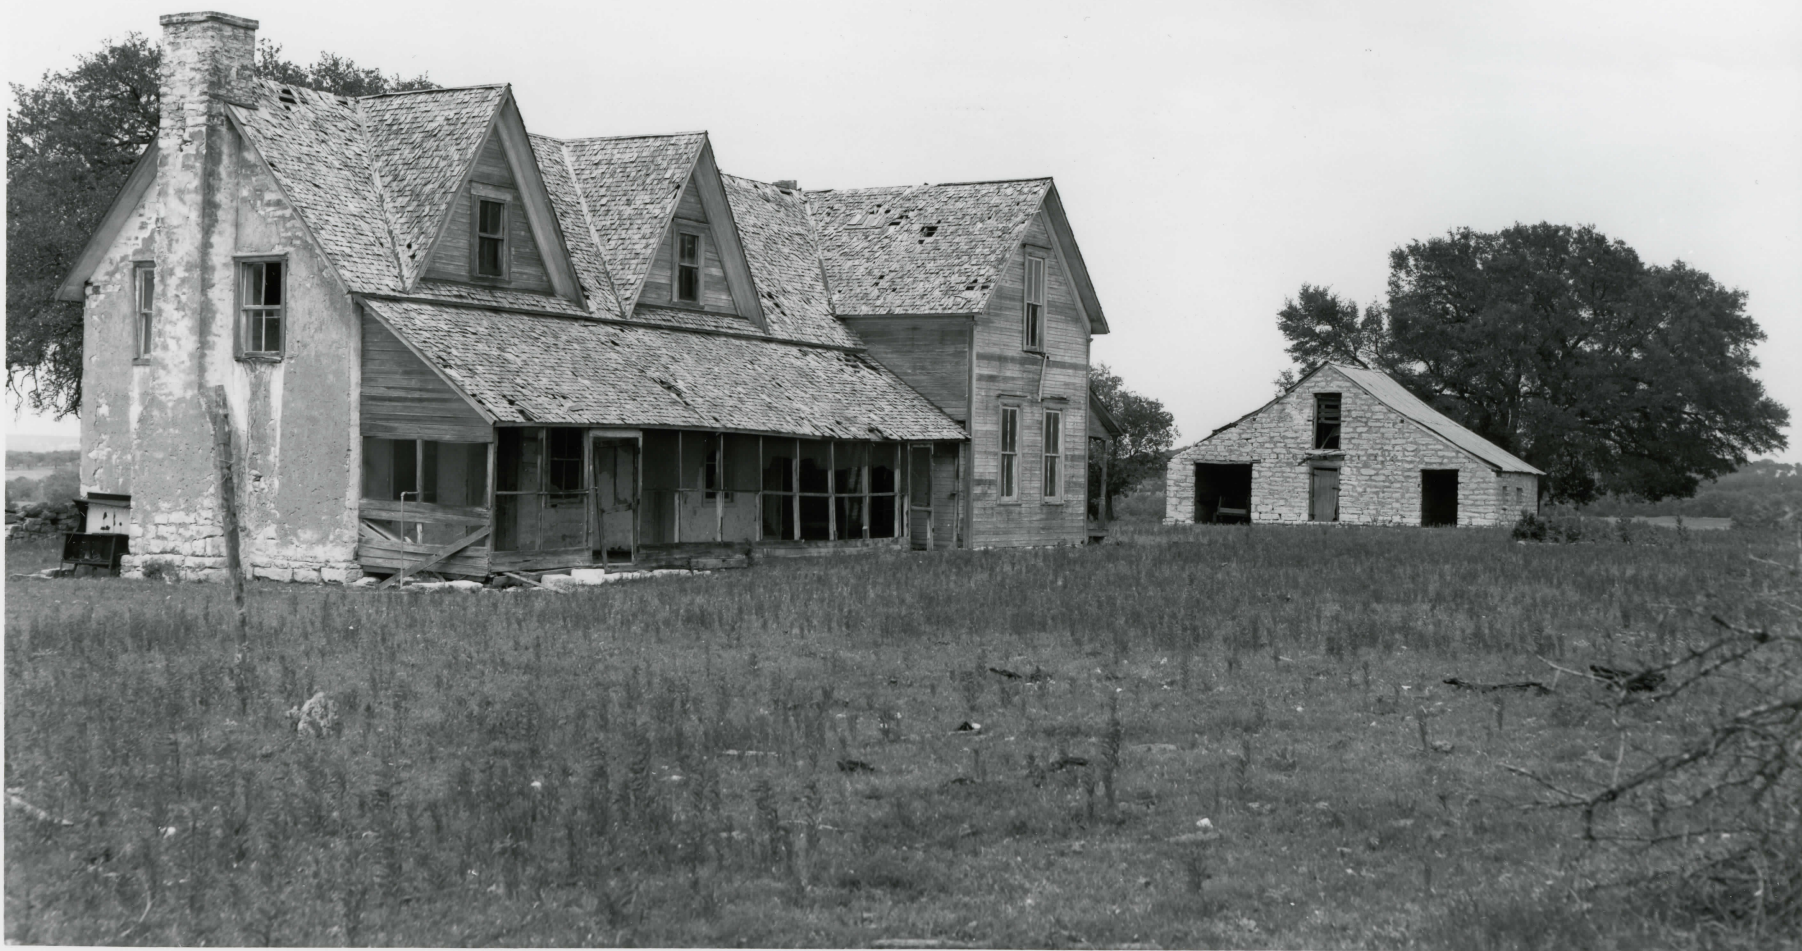
Photo 64 of 72

View of house and barn, looking northeast

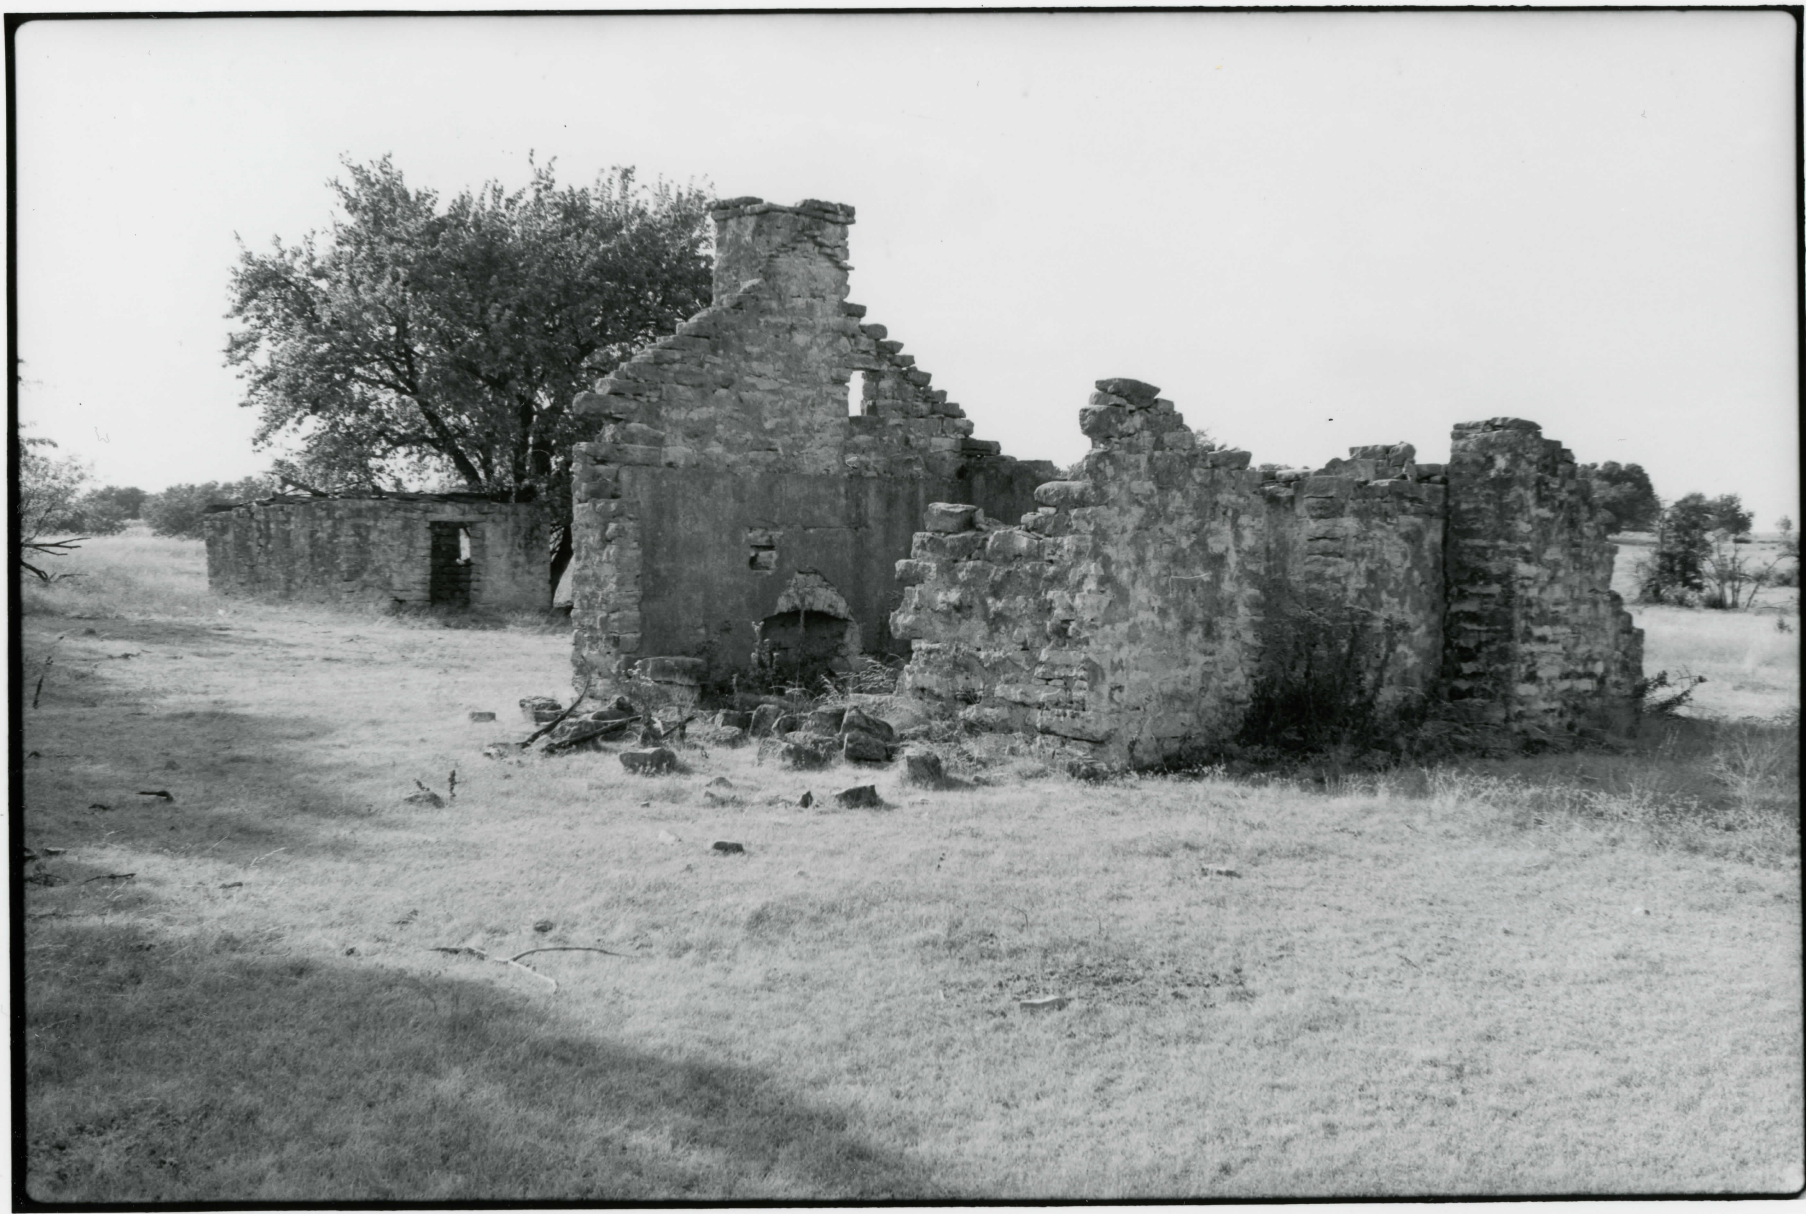
No. 43. A.O. and Olia Alfei farm (c. 1880), contributing, photo no. 65. The Old Alfei farm stands in a pasture just southeast of the Bersvend and Kari Swenson place. The Alfei house stands in ruins with no roof, and only a part of its stone walls remain intact. The original plan was rectangular, with a later one-room addition attached at the northeast corner. The house was built of rough-cut limestone, and retains much of its exterior stucco veneer as well as the plaster covering on the interior walls. The original fenestration is difficult to determine, but door openings are evident in the north and east walls. A hand-hewn wooden lintel still spans the north doorway. The west wall is the best preserved and reveals that the house once had a gable roof. Little of the interior remains intact, but some of the wooden ceiling beams and the hearth, with its segmentally arched fireplace, have survived. A one-room outbuilding of limestone construction is located to the west of the house, and a stone cistern has been found to the southeast. Despite the deteriorated condition of this site, it is important because its archeological potential appears to be strong. The entire area has remained undisturbed for decades and a rich surface scatter of potshards, fragments of wood, and other historical debris has been observed. For this reason, the Alfei Site has been deemed contributing.

Photograph: July 1982, by Ken Breisch  
On file, Texas Historical Commission  
View of ruins, looking northwest  
Photo 65 of 72

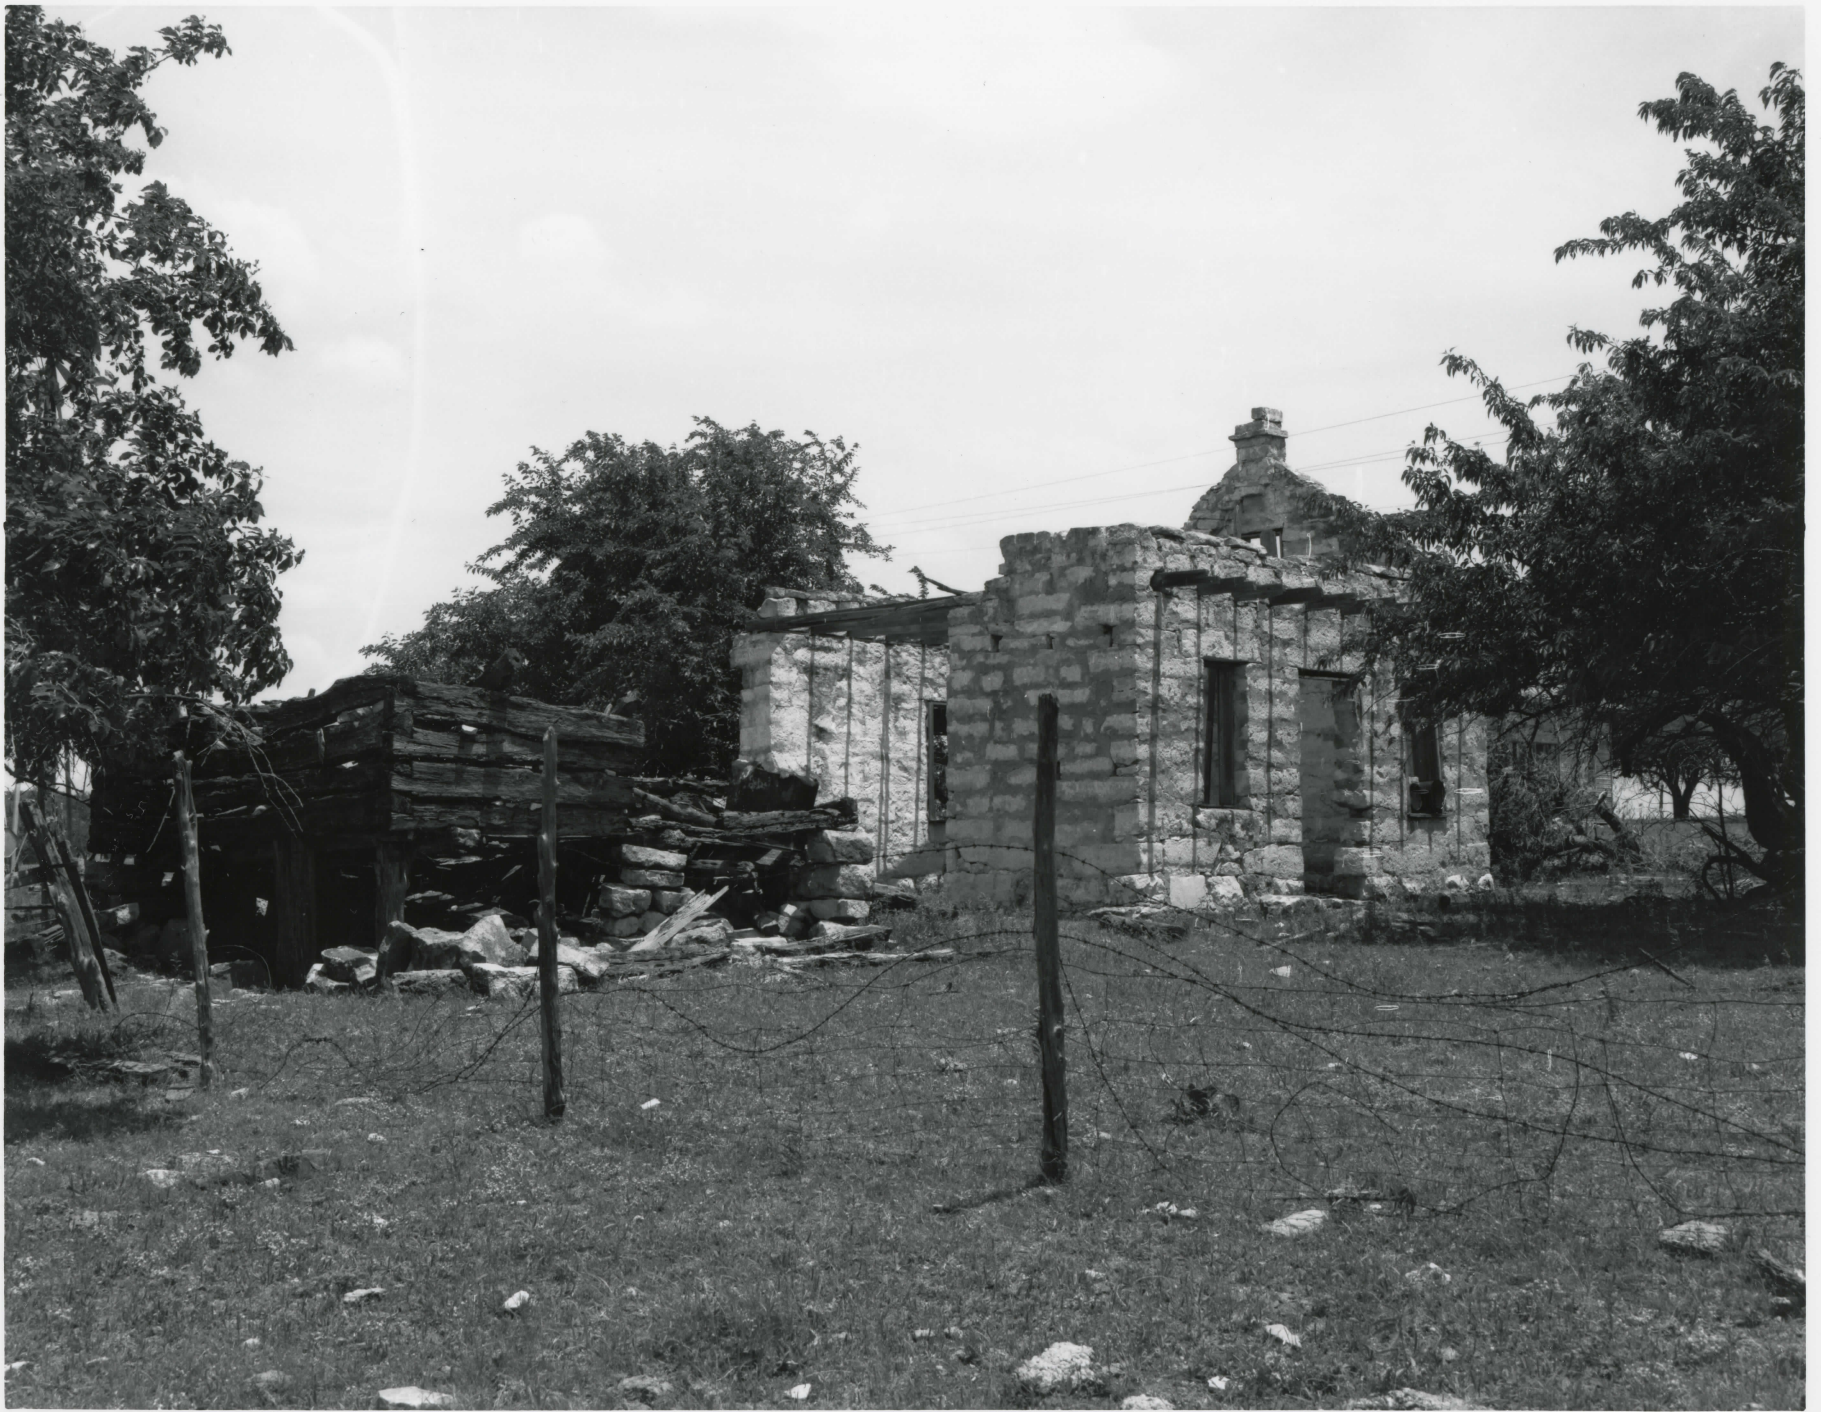
Photo 66 of 72

No. 44. Peder and Trine Pederson farm (circa 1877), contributing, photo no. 66. The Pederson farm features the ruins of a log cabin and an adjacent, but separate, stone house. This log cabin, one of the few extant examples of a log structure within the entire Norwegian Settlement, rests upon a raised stone foundation. The hewn logs are finely crafted and have full-dovetail corner notching. Fenestration of the house is difficult to determine because of its present state of repair, but single openings pierce the north, south, and west walls. A one-room stone house was built about ten feet northeast of the log cabin, and it, too, stands in ruins. Although the entire roof is missing, some of the wooden beams still survive. The fenestration of the front follows an ABA rhythm, with a single doorway in the center. Large stone lintels span each of the openings. A small stone chimney rises from the gable end of the northeast wall. It was used as an outlet for a stove. Both the log cabin and stone house appear to have been joined at one time by a breezeway and porch. An early 20th-century frame house, with a square-shaped plan and hip roof, stands nearby. The concrete foundations of two other outbuildings still remain visible to the northwest of the log cabin, and numerous potshards and historical objects, such as hand-forged hinges, have been observed at the site.

View of ruins, looking east

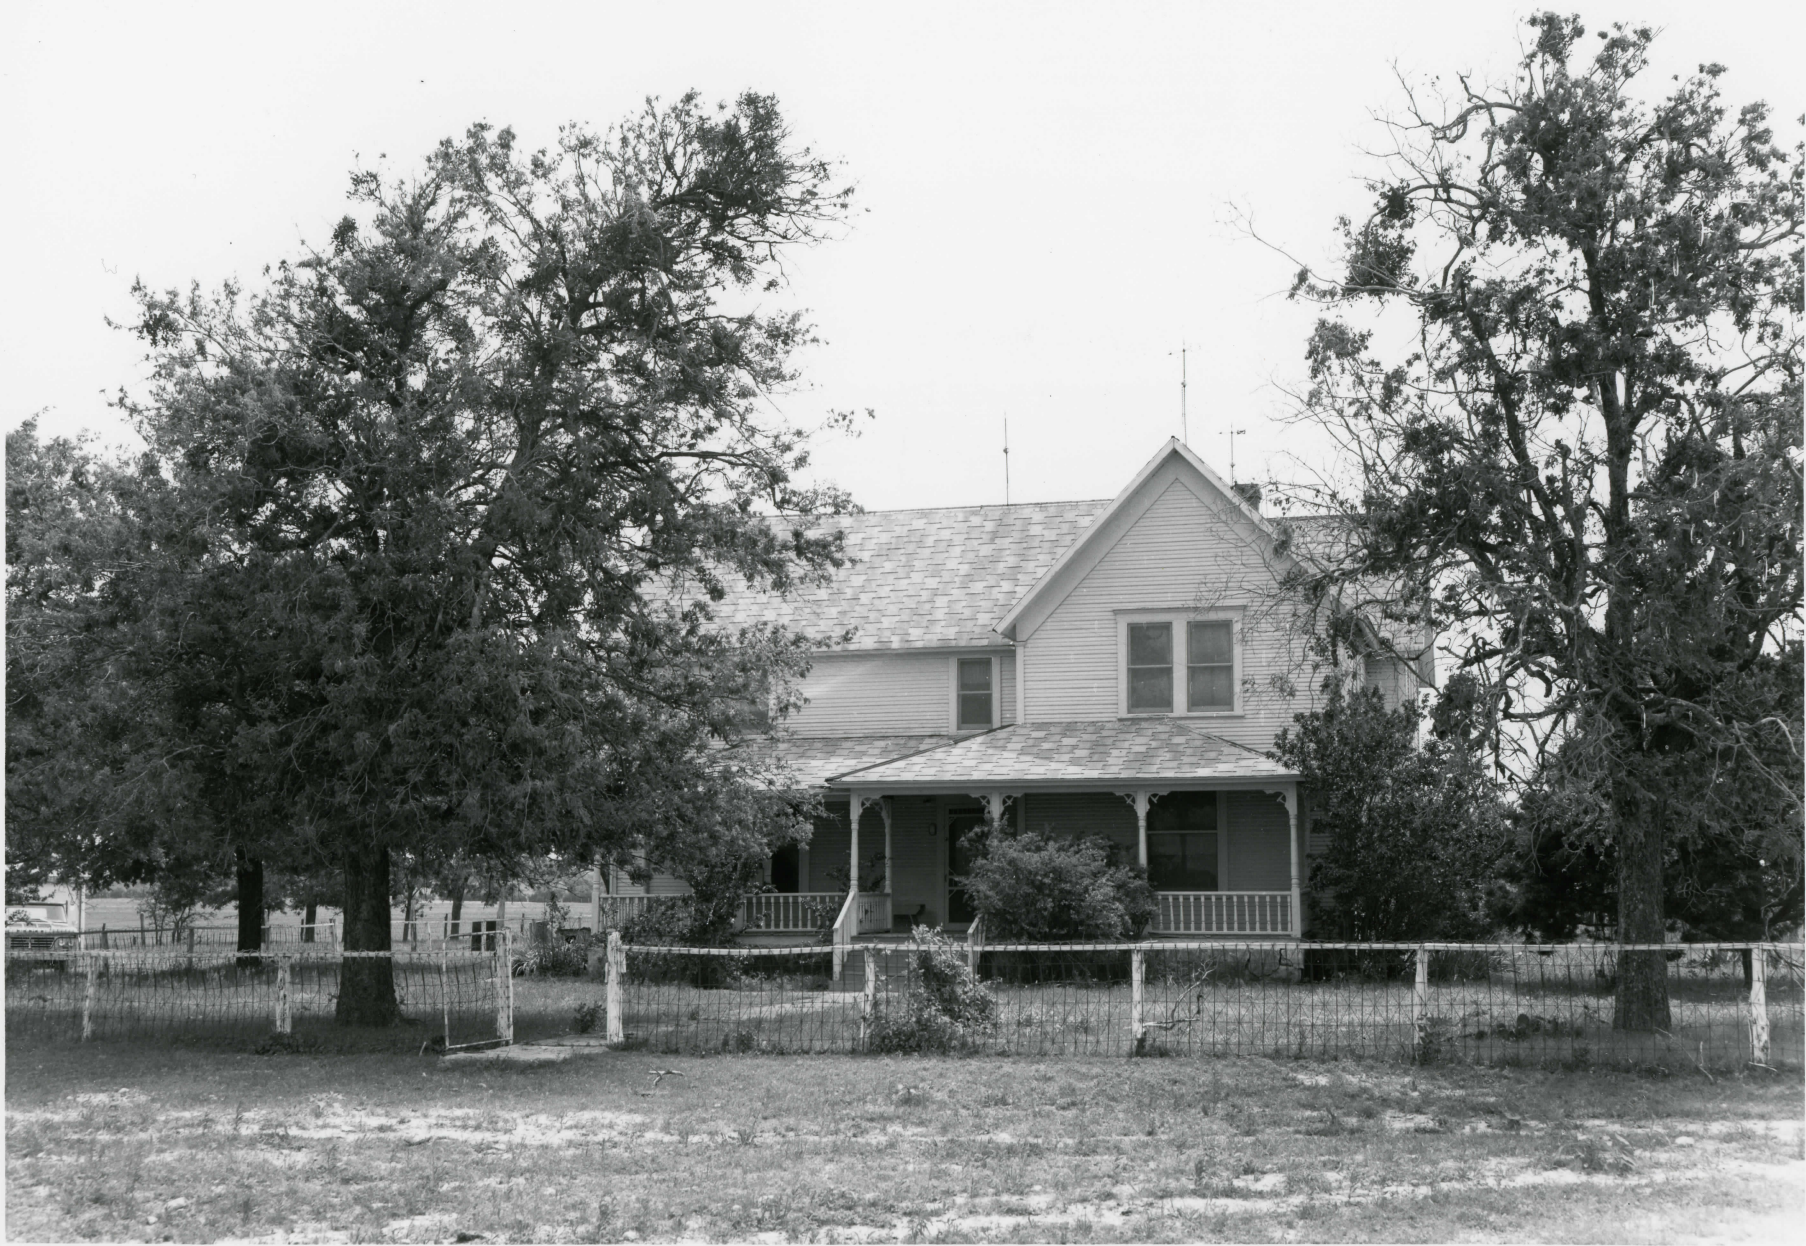
Photo 67 of 72

No. 45. Ole J. Reiersen farm (1912), contributing, photo no. 67. The Ole J. Reiersen farm has one of the few purely frame residences within the district. Built in 1912, this two-story house is one of the last structures erected in Bosque County that follows the tradition of the asymmetrical-type frame house, such as the Colwick house

(no. 22). It remains in good condition, with very few alterations. The plan of the house is T-shaped. A one-story porch, with turned wooden posts and decorative brackets, extends across the front facade. Double-hung windows with one-over-one lights pierce the clap-board-sided walls. The only major exterior alteration is a lean-to addition on the rear elevation. A board-and-batten barn also stands on this farm, as do several early 20th-century outbuildings.

View of front facade, looking west

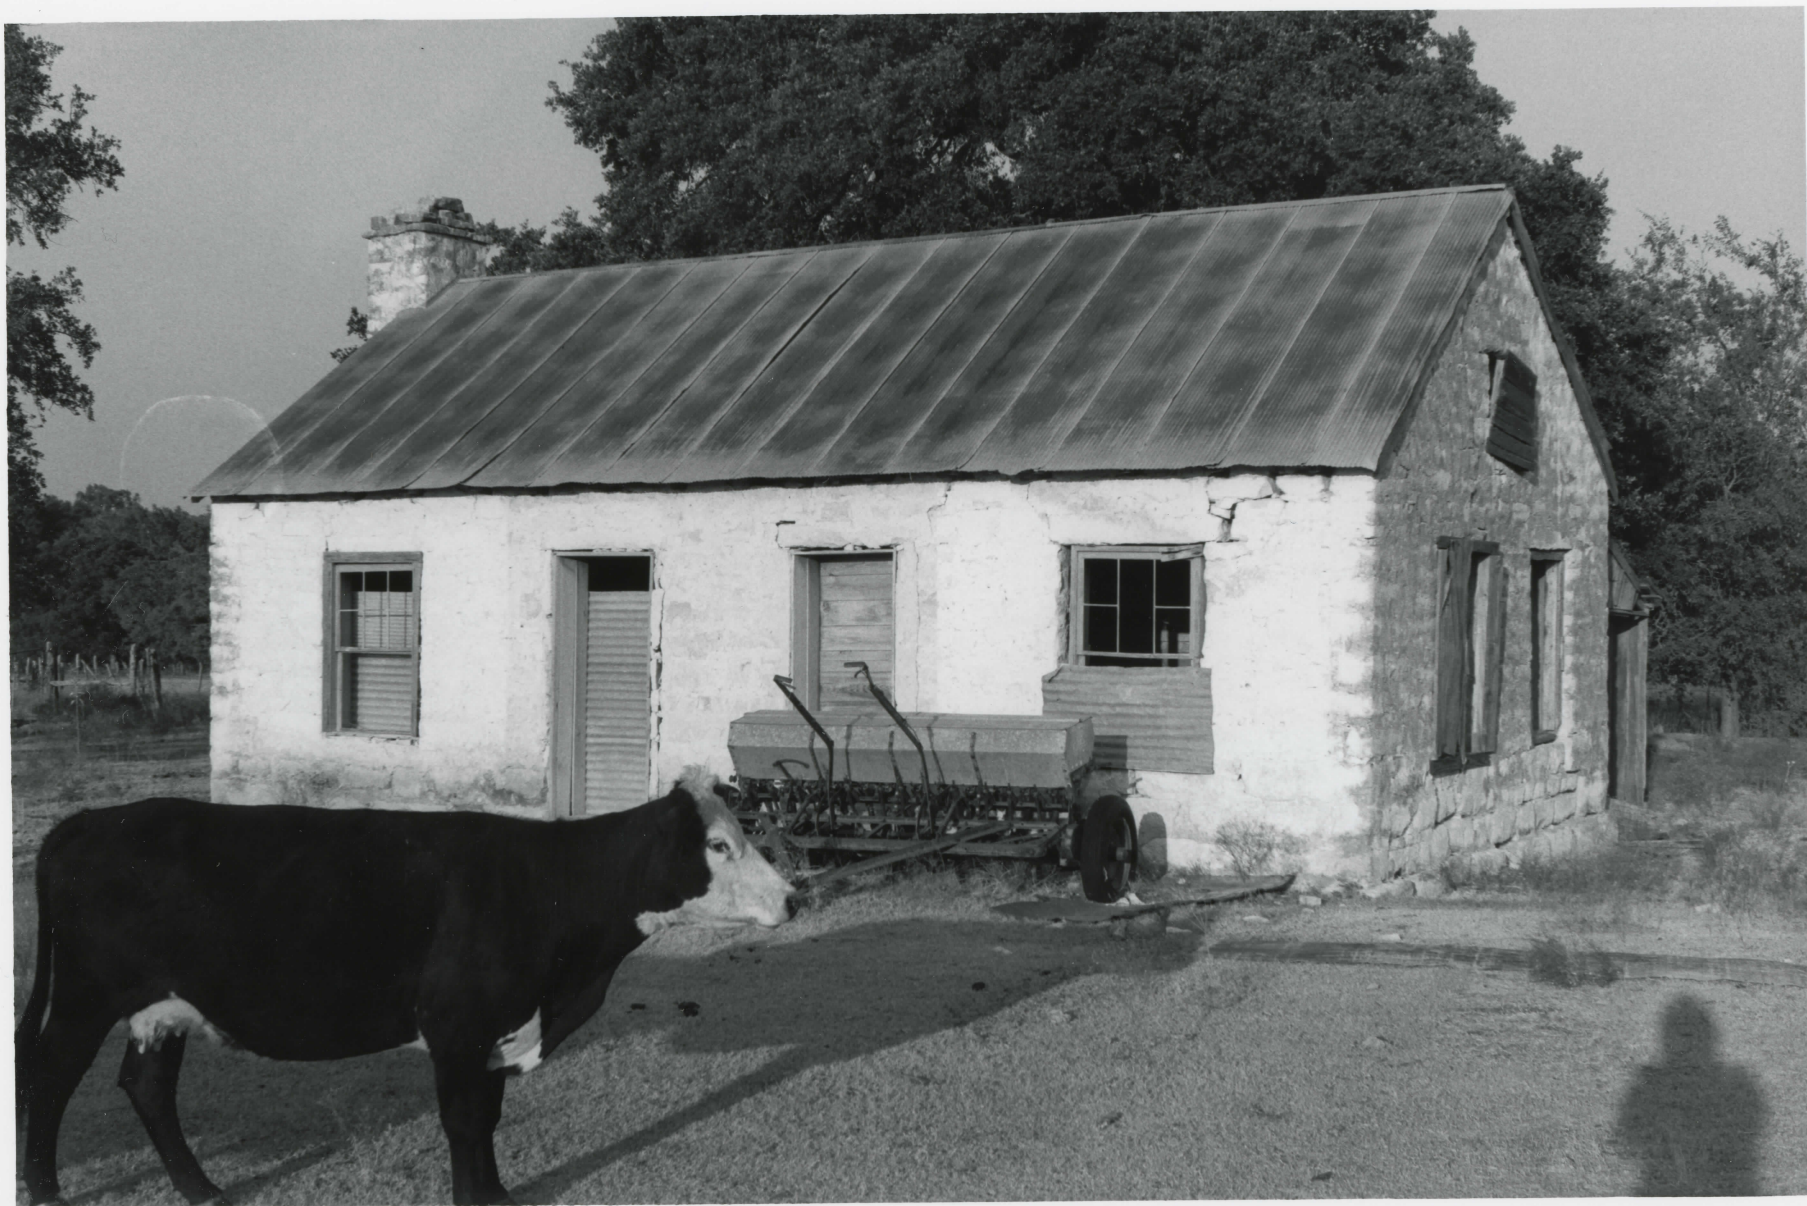
Photo 68 of 72

No. 46. J. Lasson and Oline Reiersen farm (circa 1865), contributing, photo nos. 68, 69. The Reiersen house is situated at the base of Rogstad Mountain, just west of a small stream that flows toward Meridian Creek. Of limestone construction, it is another intact example of an early, pioneer Norwegian farmhouse. Its plan is rectangular in shape. The west facade exhibits a four-bay composition with two central doorways that open into separate rooms. The outer bays have wood sashes with six-over-six lights. A stone chimney is built onto the north wall. The two-bay east elevation has a shed-roof porch that extends the entire length of this facade. Although presently used as a barn, the structure retains its basic interior plan. A stone wall with a central door divides the interior space into equal rooms. An underground cistern and the remains of a dug-out cellar are located nearby, with a light surface scatter of household remains visible on the ground.

View of front facade, looking northeast

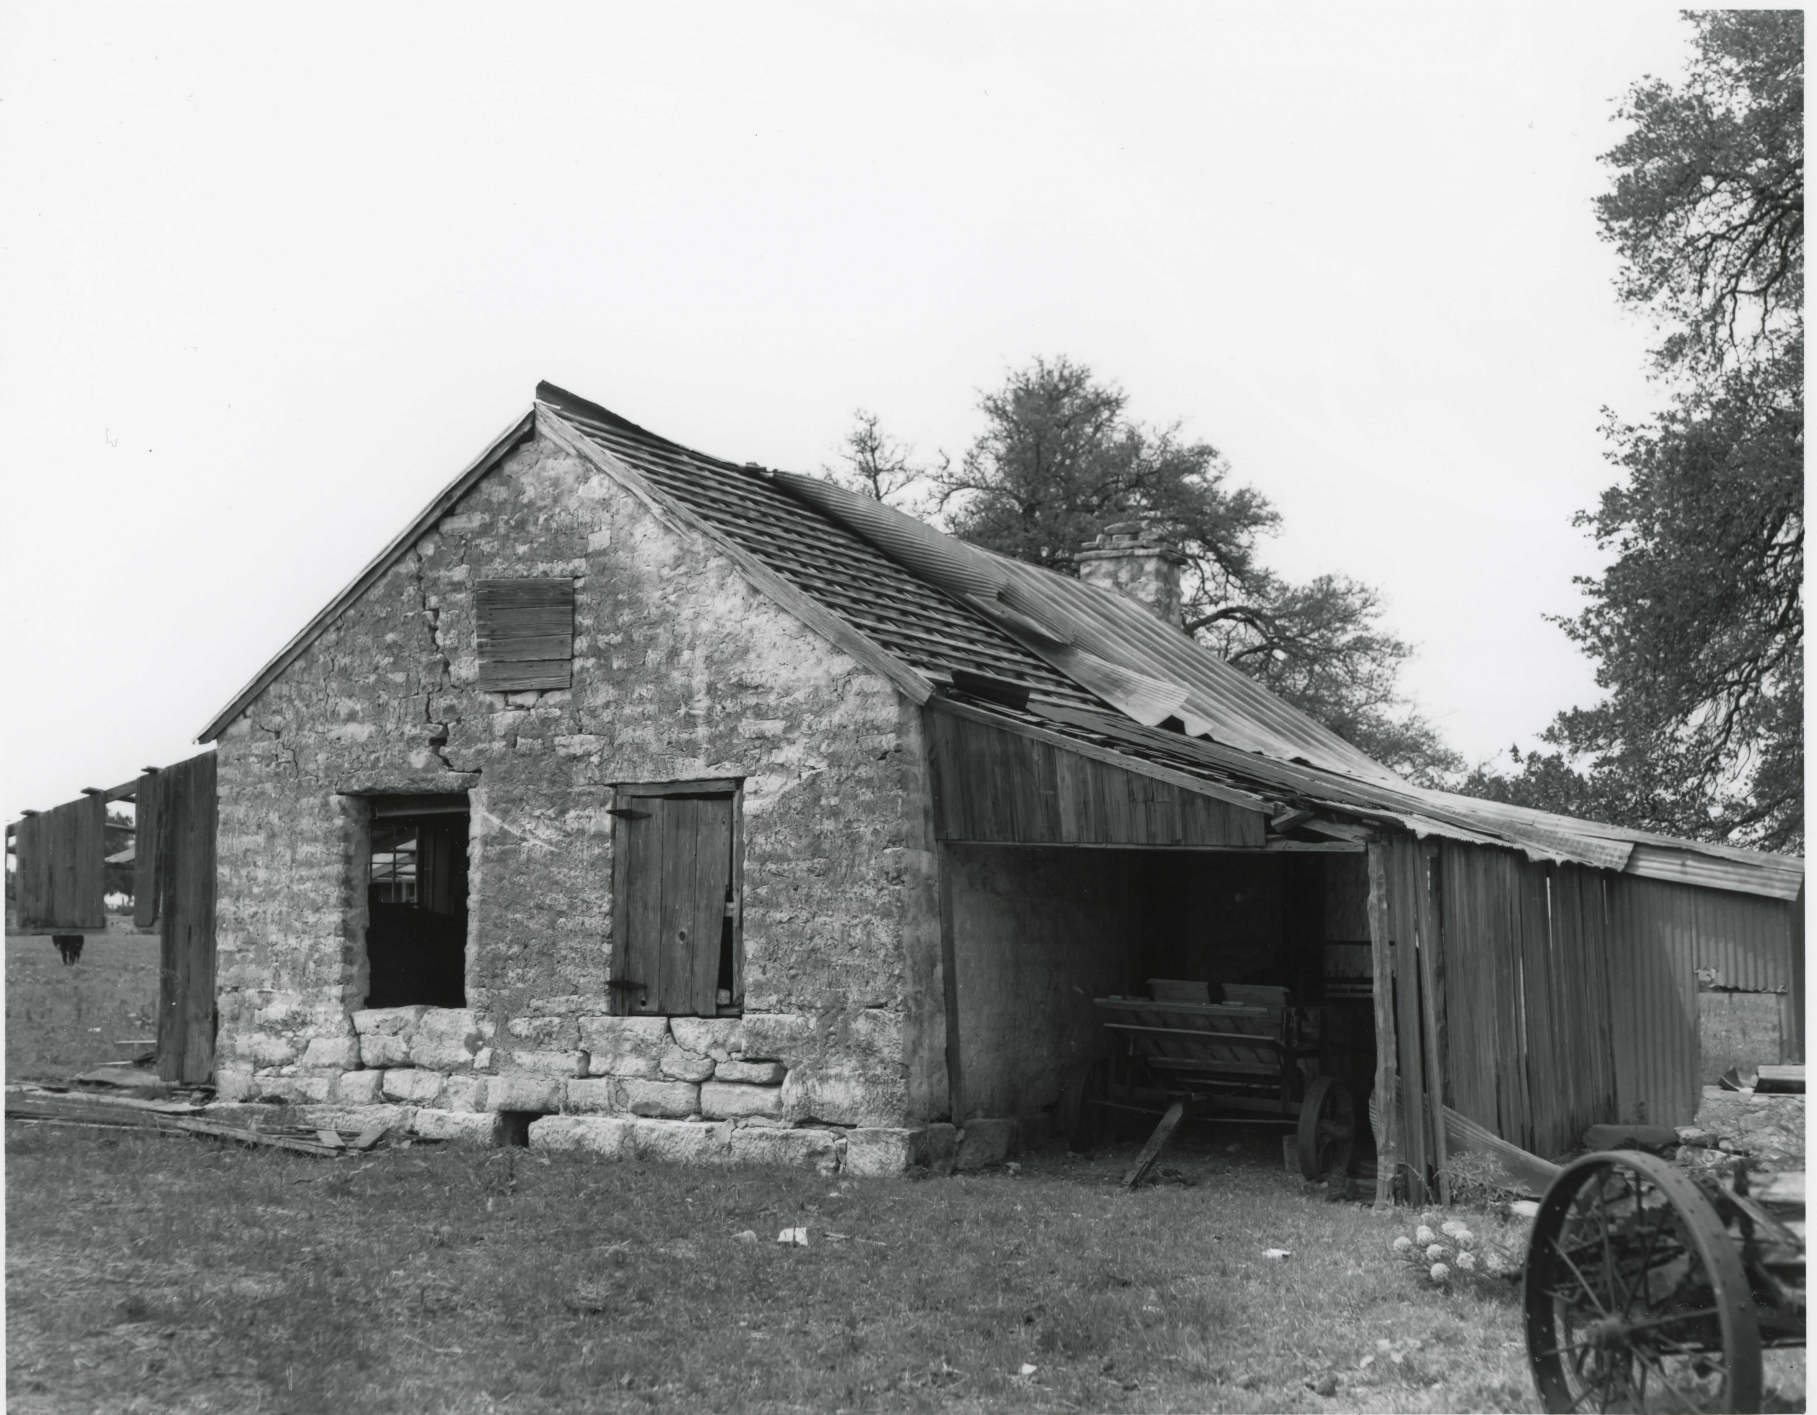
Photo 69 of 72

View of side elevation, looking northwest

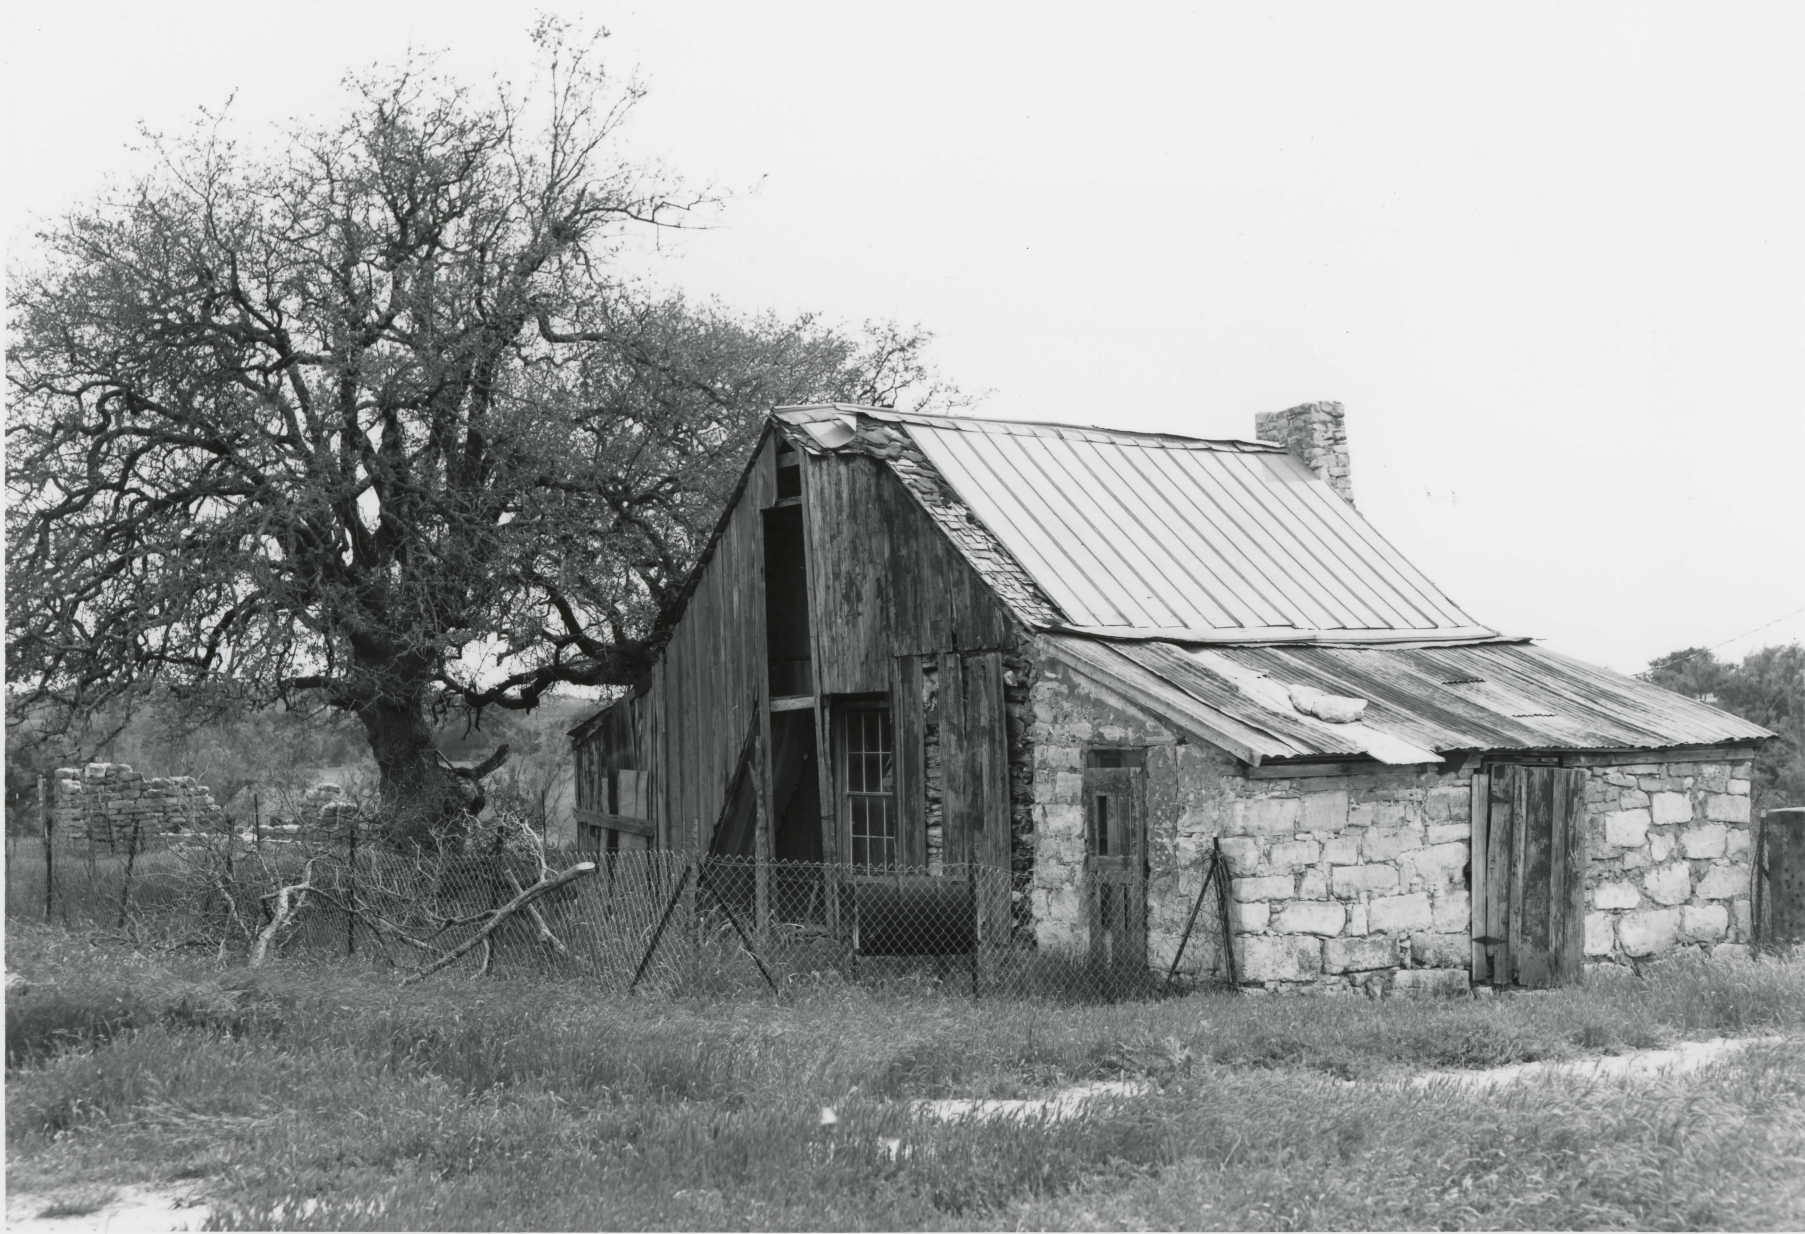
Photo 70 of 72

No. 47. Amund and Carlin Ilseng farm (circa 1877), contributing, photo no. 70. The Ilseng house, located near the east bank of a small stream that flows near the J. Lasson Reiersen house (no. 46), is one of only a handful of log-built residences that still stand within the area of the Norwegian settlement. Despite its present poor condition, the log house retains much of its integrity. This small house is crudely constructed. Unhewn logs with "V" corner notching can be seen on the east side of the house. The other walls, however, are covered with board-and-batten siding. A stone chimney rises from the west gable end, while a covered exterior stairway, which provides access to the loft, appears on the east side of the house. This stairway is important for it may be the only survivor of this kind of upstairs entranceway once common on early Norwegian homes. Of stone construction, the attached lean-to is an early addition. The ruins of a one-room stone structure are located about 25 feet south of the house.

View of rear elevation, looking southwest
