National Register of Historic Places  
Inventory—Nomination Form

Upper Settlement Rural Historic District

A  $4\frac{1}{2}$ -square-mile area within the upper Meridian  
Creek valley, just east of Cranfills Gap, Texas

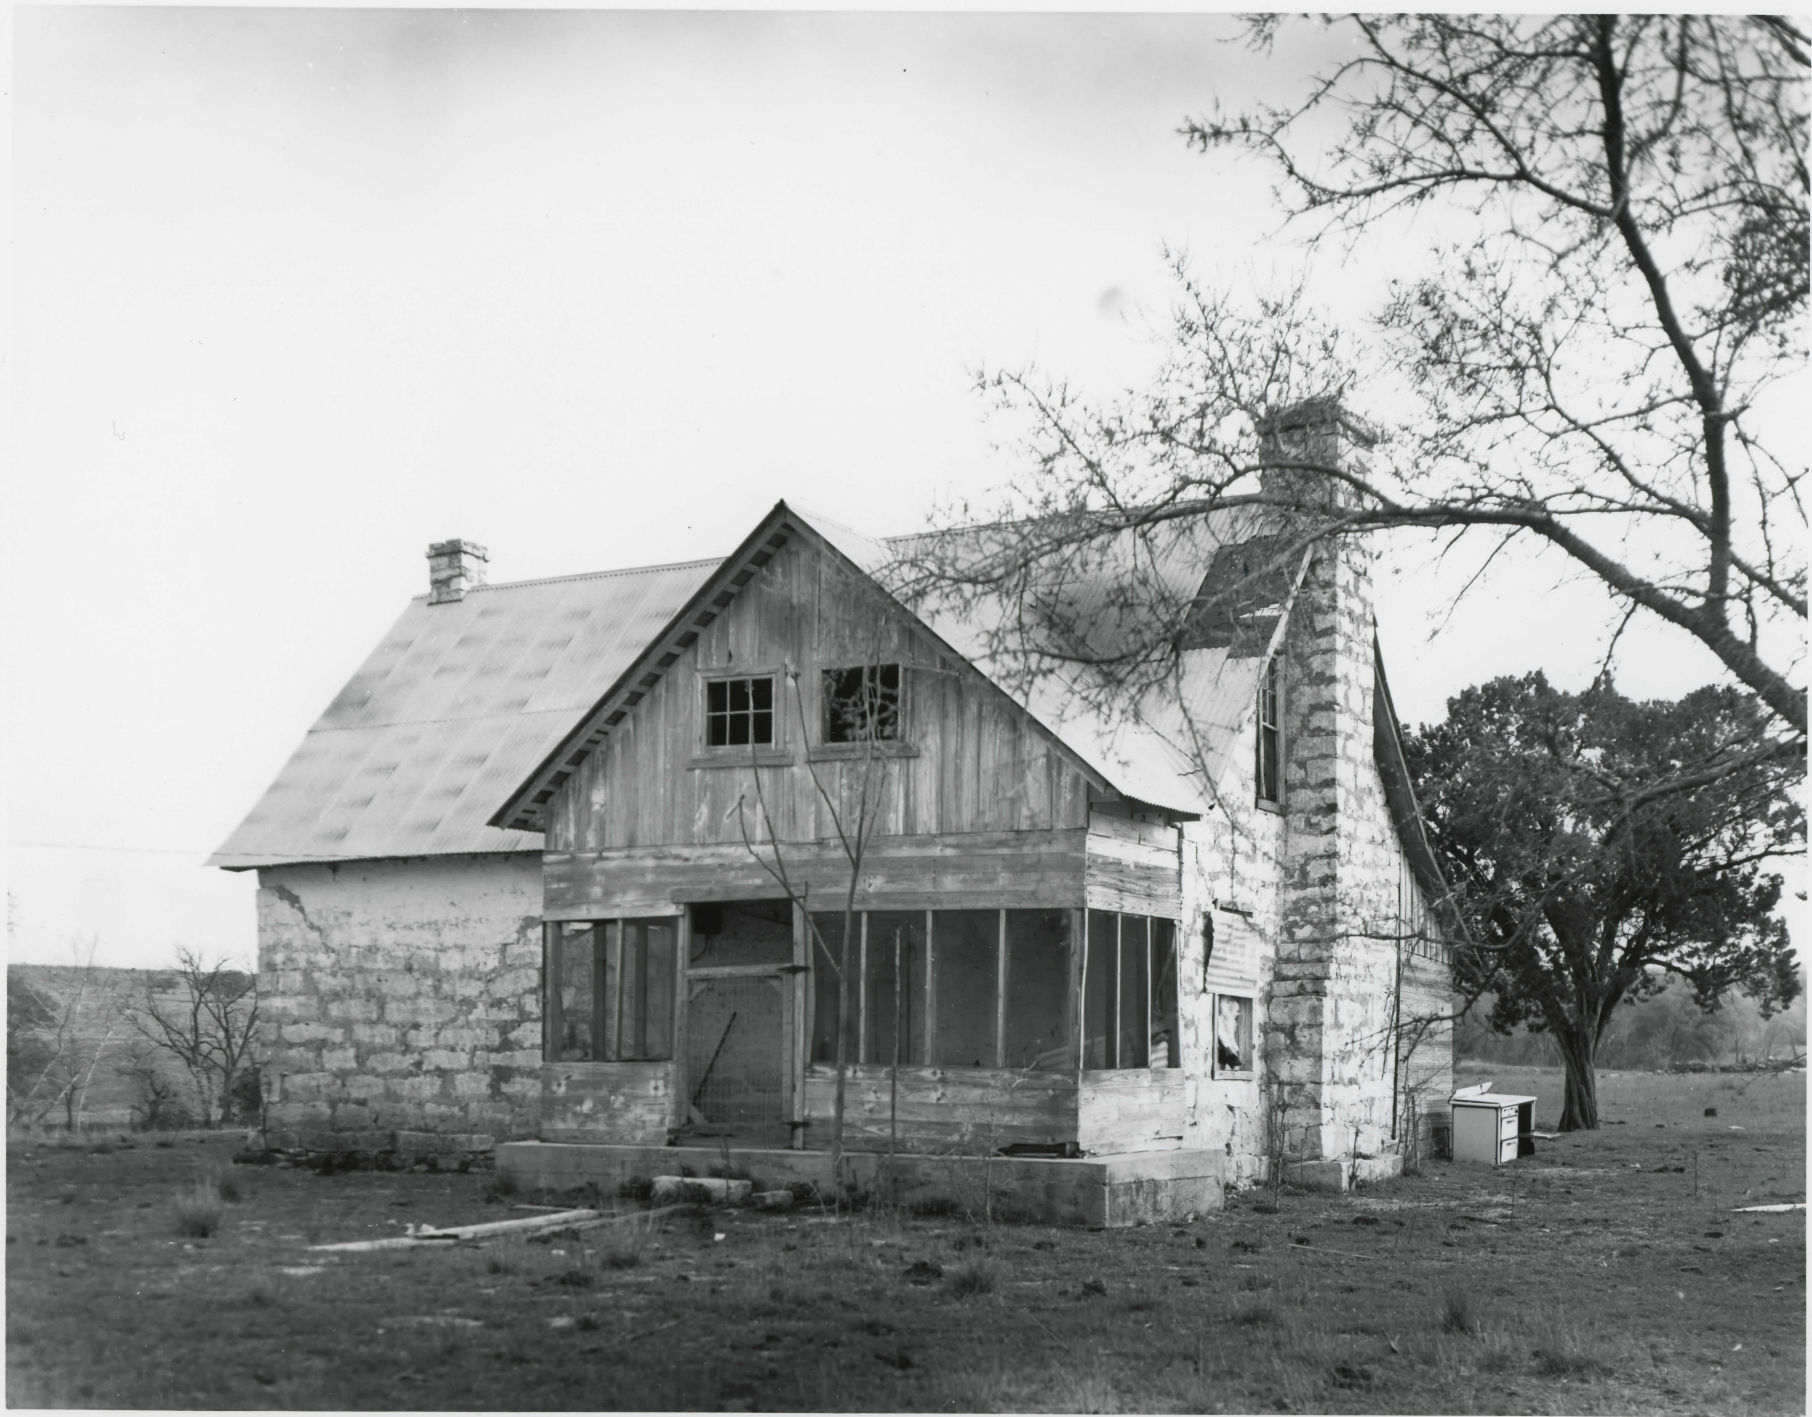
Photo 71 of 72

No. 48. Salve and Caroline Knudson farm (circa 1875), contributing, photo no. 71. The Salve and Caroline Knudson house stands in a plowed field just south of the paved county road. Presently unoccupied, it is in fair condition and retains much of its integrity. This one-and-a-half-story residence is of the asymmetrical type of stone house, although later additions have slightly modified its original configuration. The south elevation, which originally served as the front, now has a partially enclosed porch that obscures the original fenestration. This wall, however, is pierced by a door and

windows. The west elevation features an exterior chimney, while the opposite end has an interior chimney. One of the most distinctive elements of this structure appears on the north facade, where the long stone wall is interrupted by only one opening. A gabled porch, which was built before 1948, projects from the west end of this elevation, over the single door. Two mounds of quarried stone are located near a creekbed to the east of the house, and are assumed to represent razed outbuildings.

View of rear elevation, looking southeast

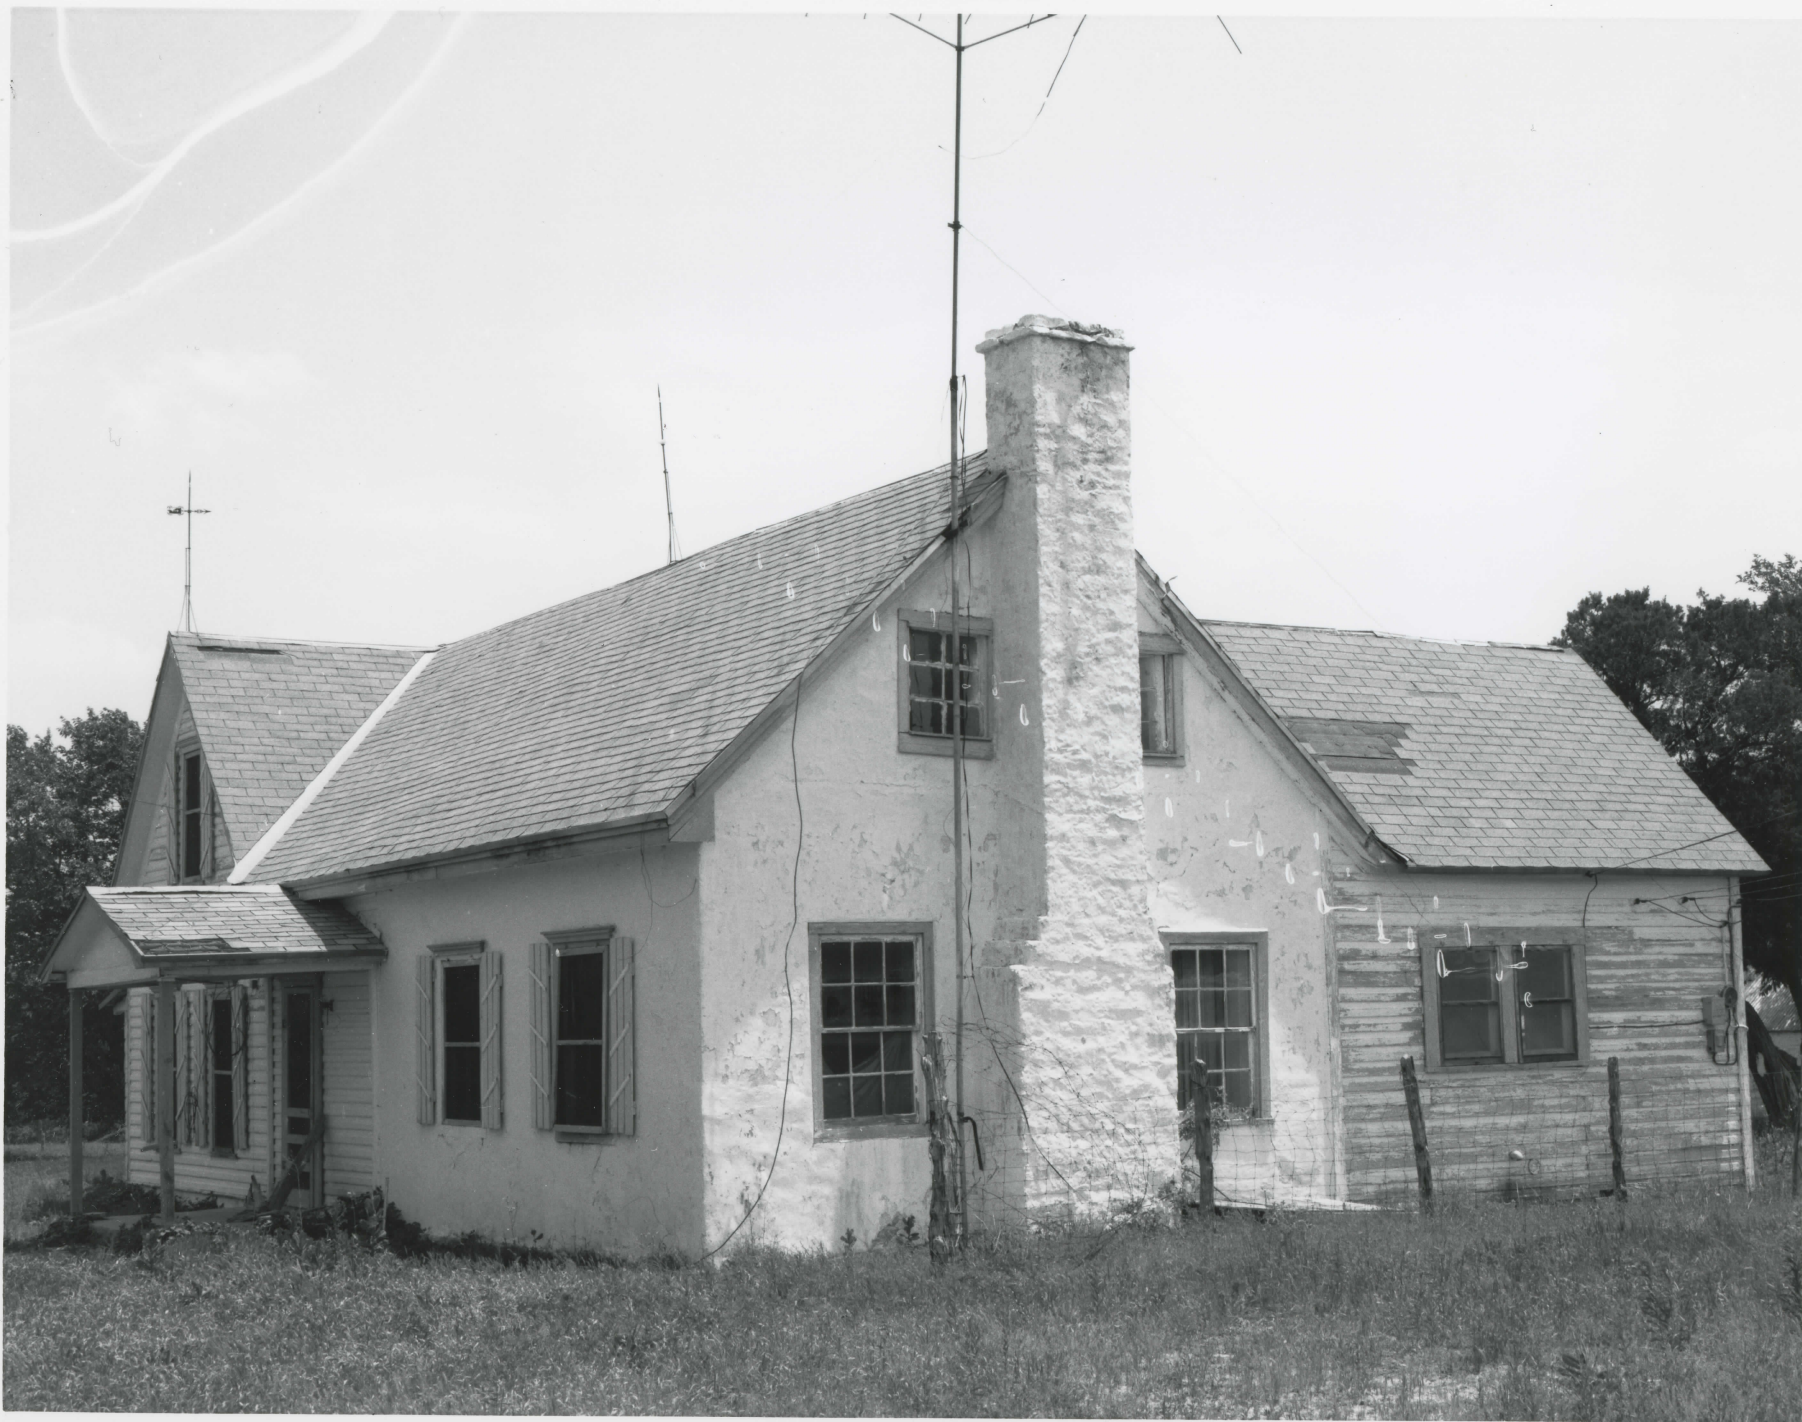
No. 49. Knud and Carmeal Knudson farm (c. 1875/c. 1900), contributing, photo no. 72. The Knud and Carmeal Knudson farm is easily visible by car from its location just south of the county road. It is presently unoccupied but remains in good condition. The one-and-a-half-story stone section is the oldest part of the residence, and its plan is of the asymmetrical type of stone house. A large stone chimney is built on the west wall, and double-hung windows with six-over-six lights flank either side of this chimney. High in the gable end, six-light casement windows appear on each side of the chimney. The north wall has two double-hung windows that are similar to those of the west end. Later frame additions to the east and south walls obscure the other openings of the original stone house. A single doorway opens onto a breezeway that connects the east wooden-frame addition to the stone block. This addition, which was probably built around the turn-of-the-century, exhibits a scale and fenestration similar to that of the original house and, therefore, is an important aspect of the structure's architectural evolution. A small stone building and two frame barn's also are located on the farm, and contribute to the historic character of the property.

Photograph: June 1979, by David Moore  
On file, Texas Historical Commission  
View of front facade, looking southeast  
Photo 72 of 72
