### National Register of Historic Places Inventory—Nomination Form

SITE NO. 14

Wilson homesite

314 miles west of Clifton, Bosque County, Texas,

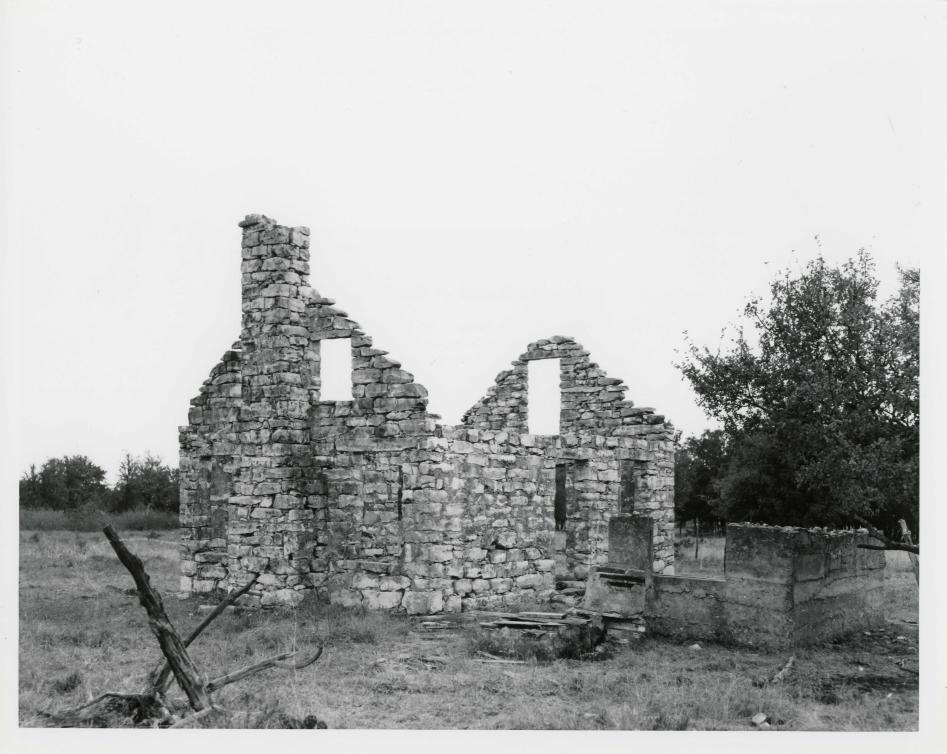
Site No. 14, Wilson Homesite, 3½ miles west of Clifton, Bosque County, Texas Photograph: July 1979, by Daniel Hardy On file, Texas Historical Commission View of house, looking southeast Photo 24 of 72
