**National Register of Historic Places  
Inventory—Nomination Form**

NAME: St. Mary's Catholic Church

LOCATION: 306 W. San Antonio  
Fredericksburg, Gillespie County, Texas

ARCHITECT: Leo M. J. Dielmann BUILDER: Jacob Wagner

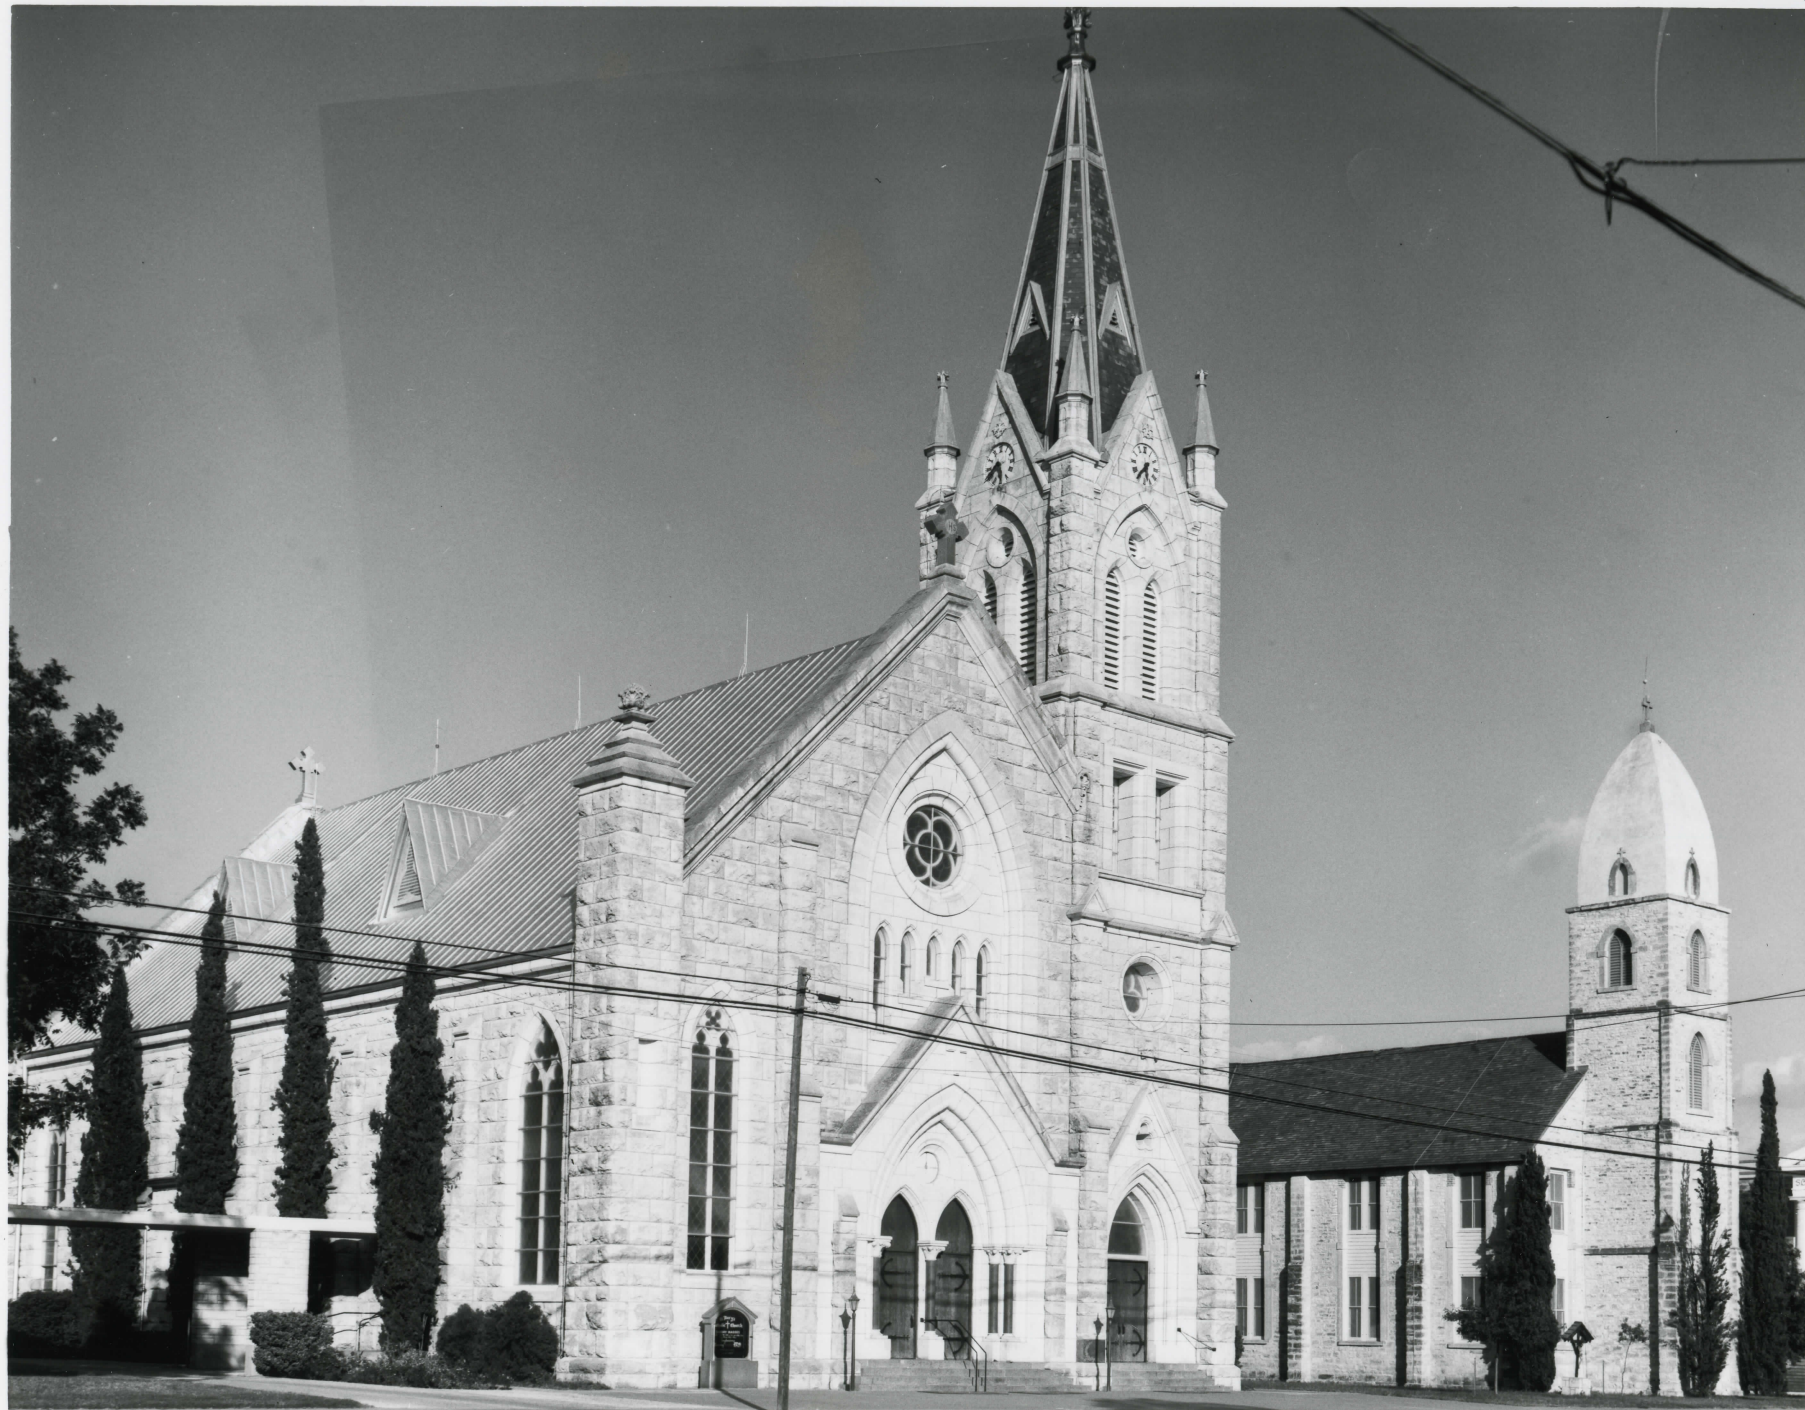
Photo #47 of 98

St. Mary's Catholic Church  
Churches in Texas with Decorative  
Interior Painting  
Fredericksburg, Gillespie County, Texas  
Linda C. Flory  
October, 1980  
Texas Historical Commission,  
Austin, Texas  
Exterior, Southwest oblique, camera  
facing Northeast

Saint Mary's Catholic Church stands beside its 1861 predecessor, and is a dominant structure amid a complex of related parish buildings. This handsome Gothic Revival church was executed in rusticated limestone ashlar offset with dressed limestone, quarried nearby. Its bold rectangular plan features a projecting polygonal apse and a corner tower rising well above the roofline of the entrance facade. Buttresses, lancet doors, and windows with trefoil and quatrefoil motifs reinforce the Gothic theme, as do the steeply pitched roof, pinnacles, and parapet details of the tower.

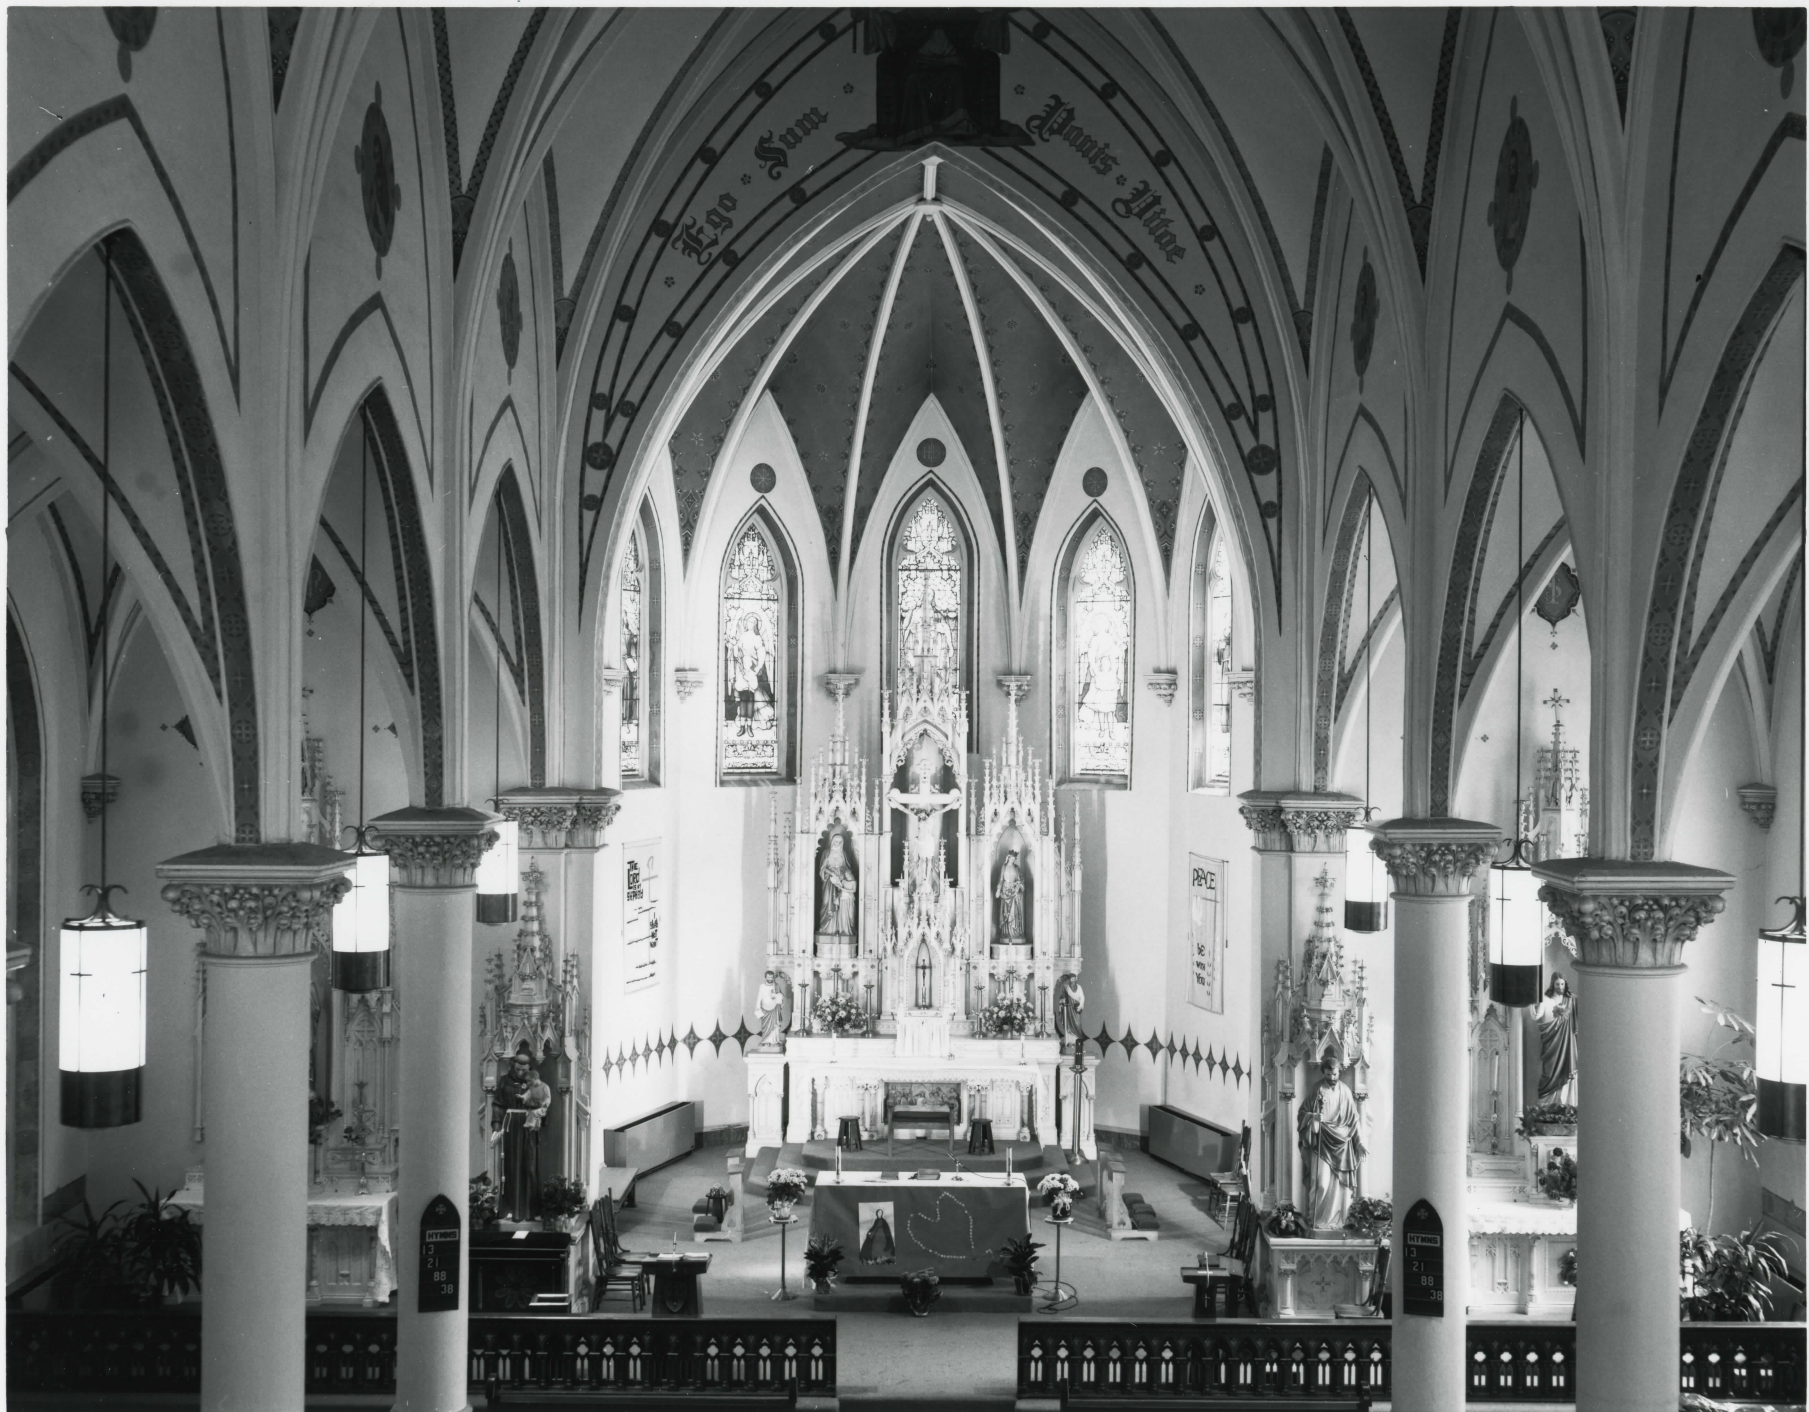
Photo #48 of 98

St. Mary's Catholic Church  
Churches in Texas with Decorative  
Interior Painting  
Fredericksburg, Gillespie County, Texas  
Linda C. Flory  
October, 1980  
Texas Historical Commission,  
Austin, Texas  
Interior, view facing apse

Refined and sophisticated interior painting combining symbolic religious motifs with geometric detailing enhances the spacious interior. The painting is applied to the plastered walls and ceiling. Columns with foliate capitals divide the nave into three sections, with the vaulting of the larger center section rising higher than that of the flanking side sections. Geometric banding in rich hues of red, blue-green, and yellow-gold against a white background accentuates the vaulting as well as the reveals of the stained-glass windows. A stenciled chair rail encircles the nave and entrance foyer. It is done in brown, red, and blue-green, and is accented with metallic gold. Characteristically, the apse decoration is treated more elaborately than that of the rest of the interior. Depicted above the apse spandrel is an enthroned "Christ in Majesty" holding a scepter and orb. This is superimposed on a geometric framework and flanked with the Latin words Ego Sum Panis Vitae, meaning "I am the bread of life." Two large murals which appear much like tapestries adorn the side walls of the apse. In contrast to the white walls and ceiling of the rest of the interior, the apse ceiling is painted blue-green. A geometric border design in blue-green, red, and metallic gold highlights the vault ribs.

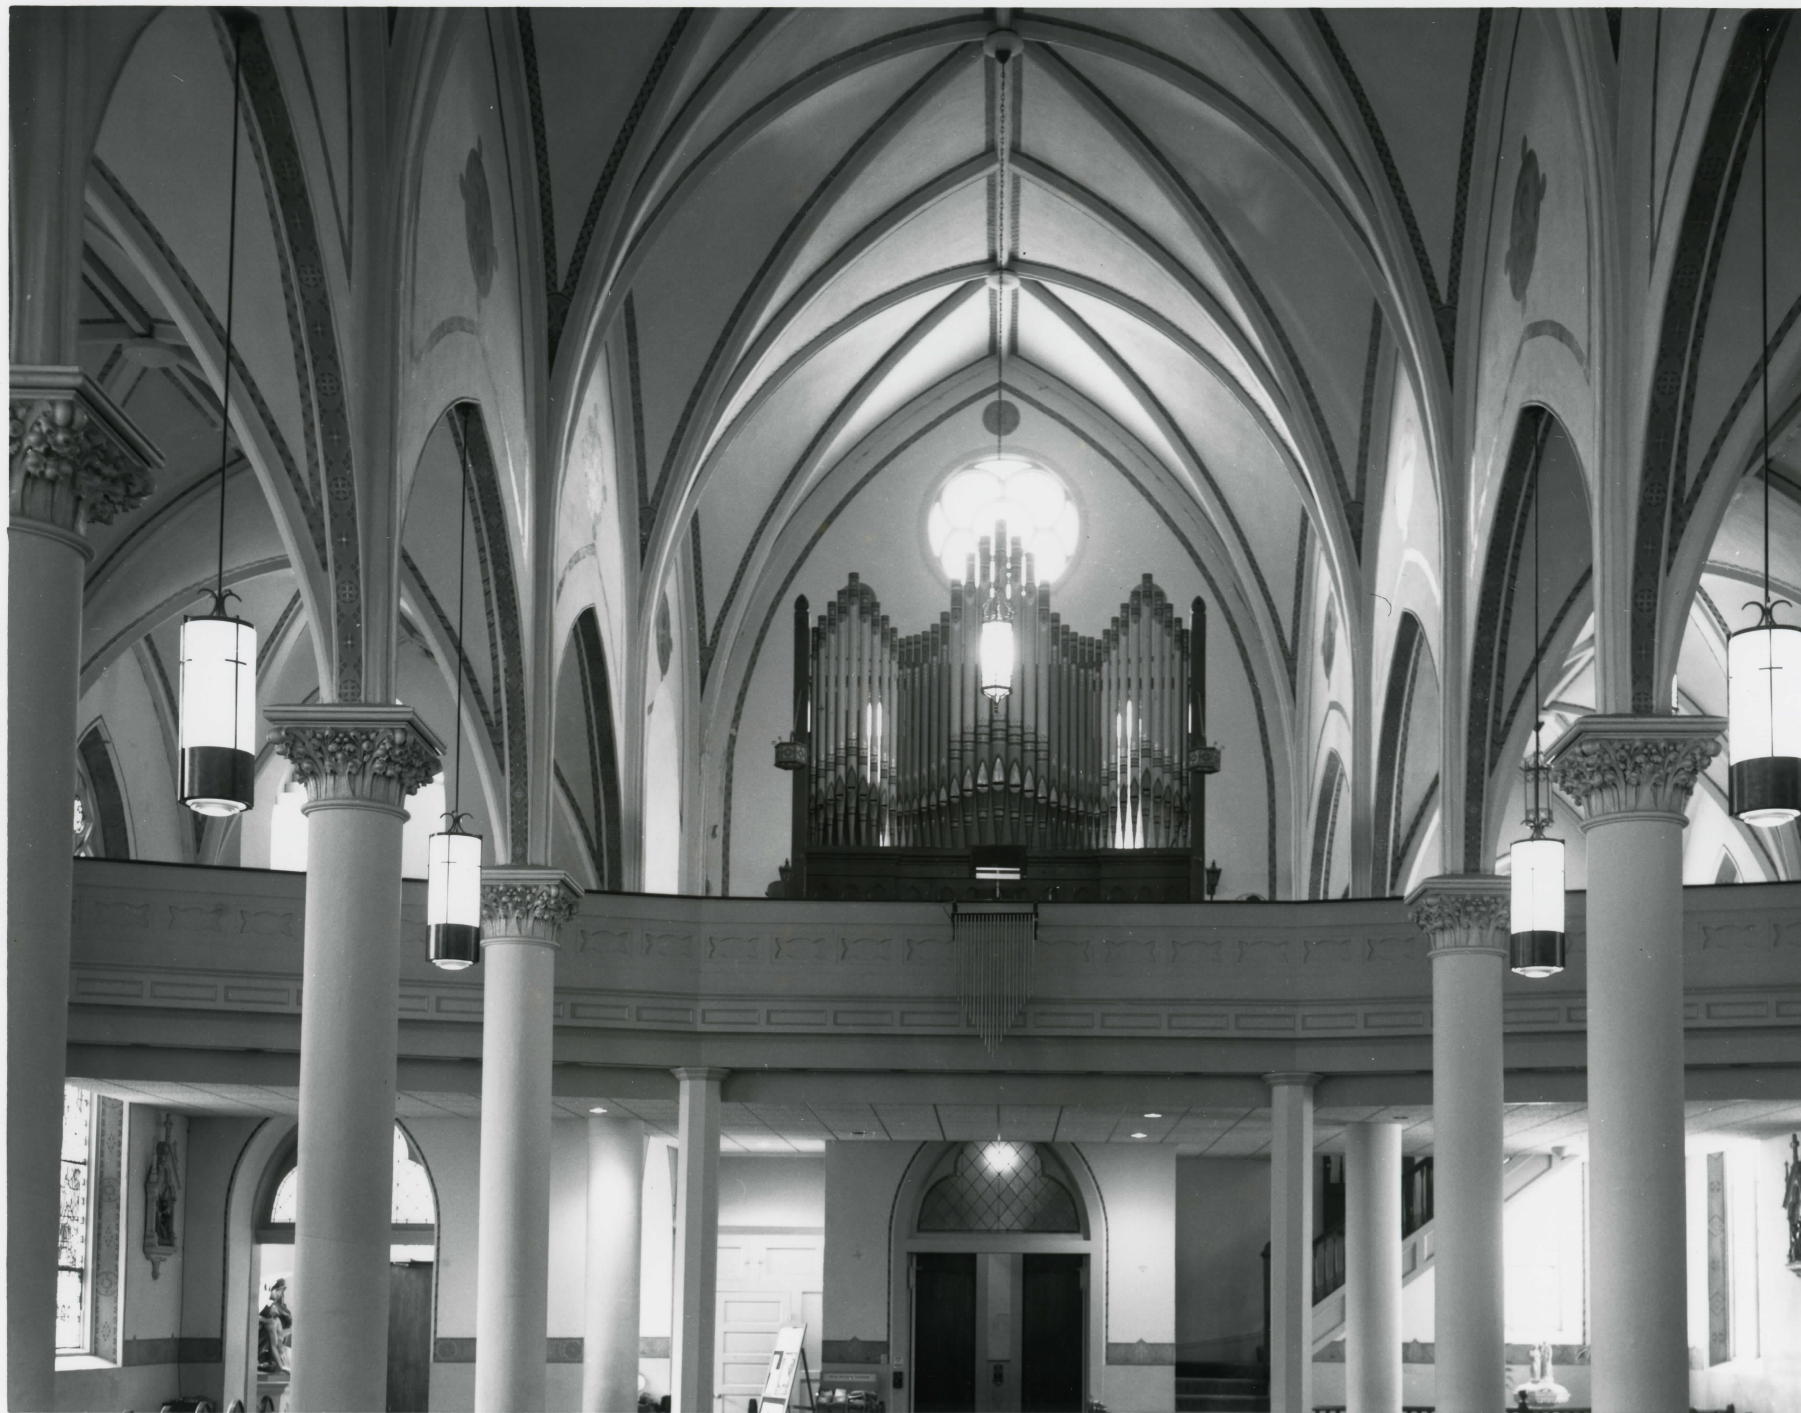
Photo #49 of 98

St. Mary's Catholic Church  
Churches in Texas with Decorative  
Interior Painting  
Fredericksburg, Gillespie County, Texas  
Linda C. Flory  
October, 1980  
Texas Historical Commission,  
Austin, Texas  
Interior, view facing choir loft

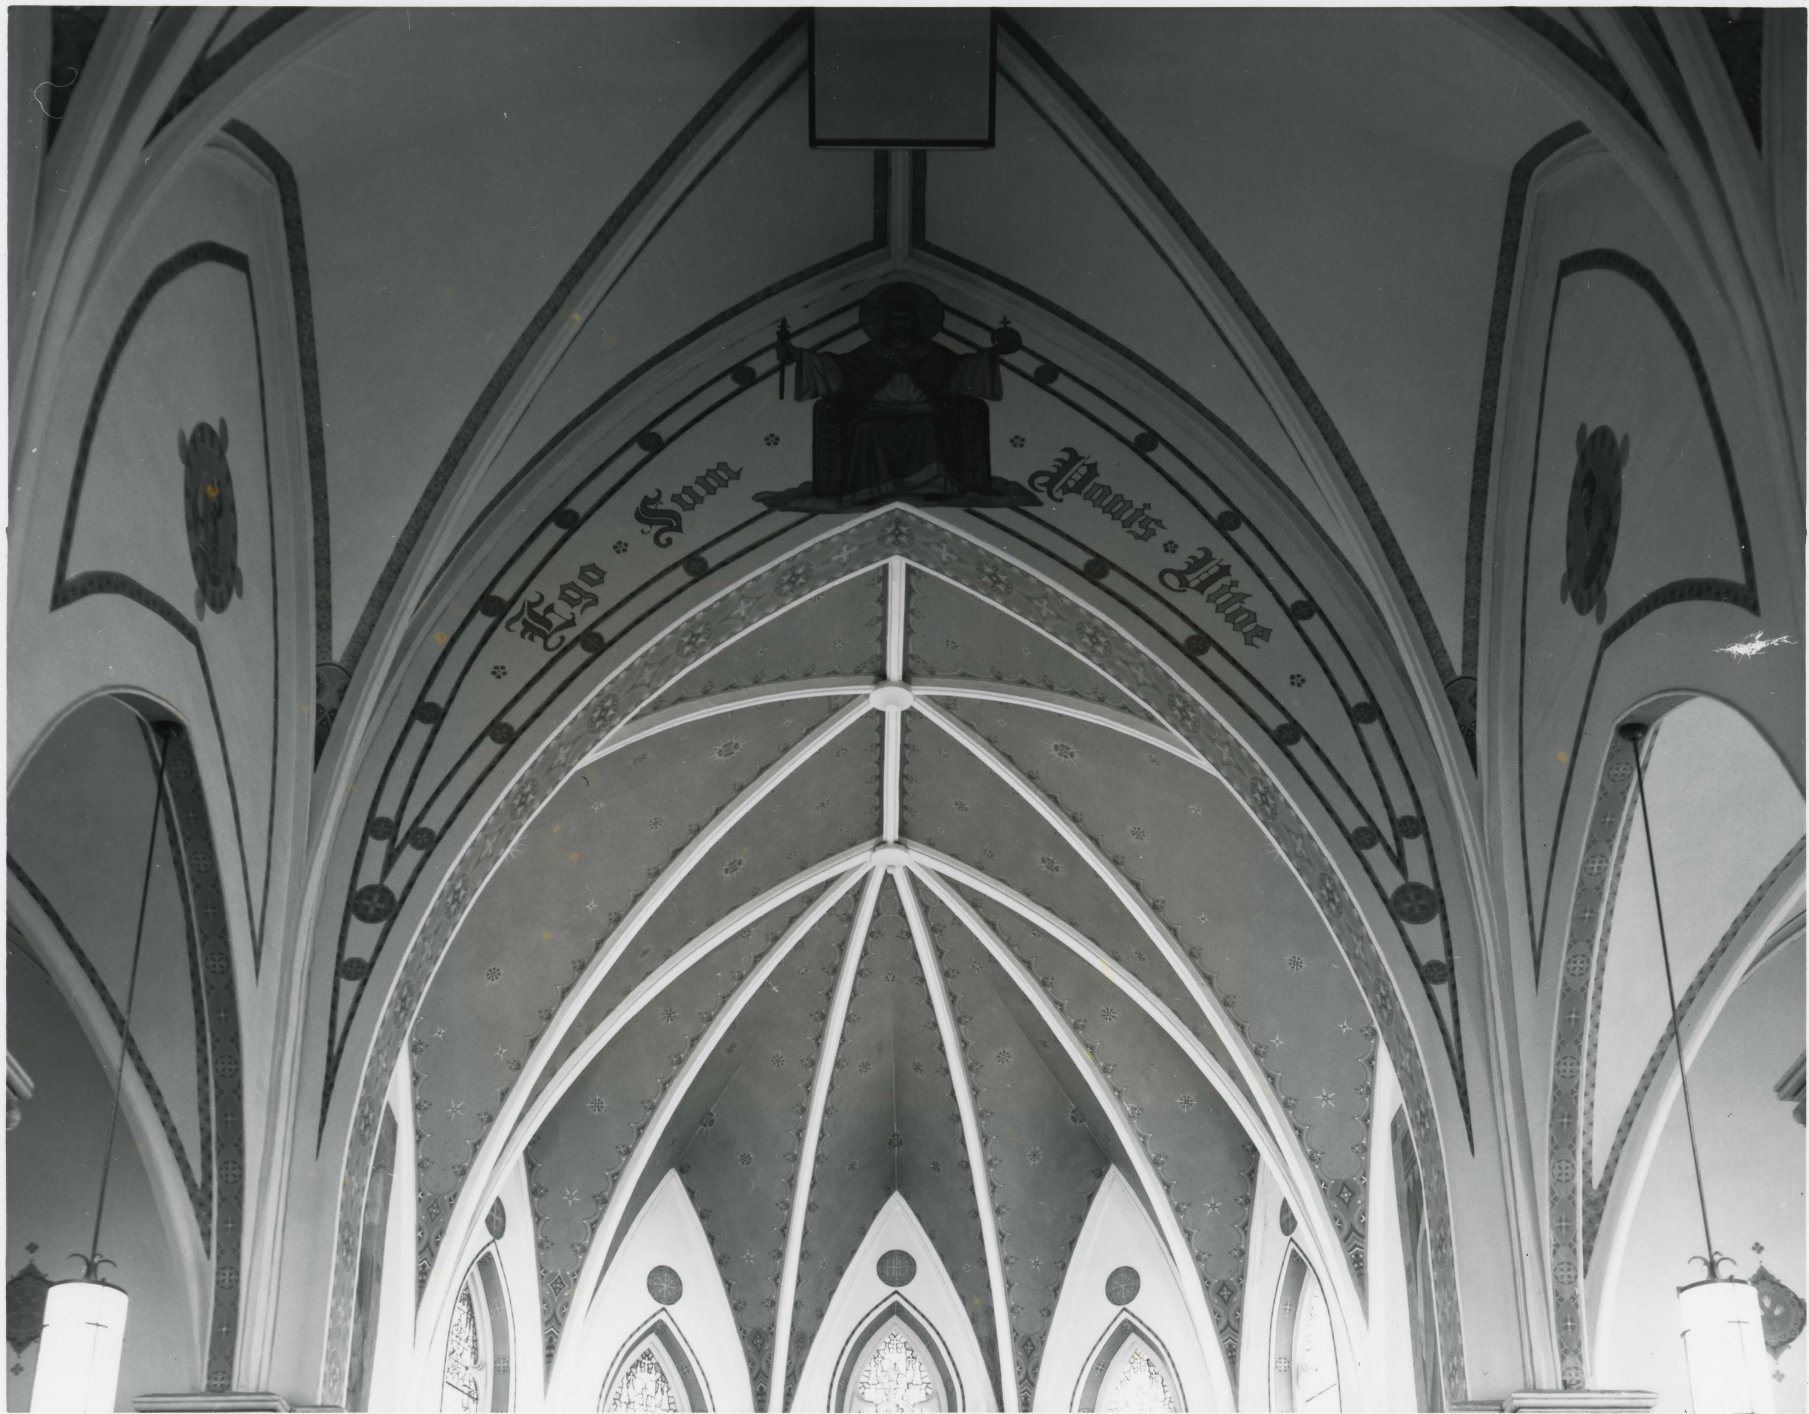
Photo #50 of 98

St. Mary's Catholic Church  
Churches in Texas with Decorative  
Interior Painting  
Fredericksburg, Gillespie County, Texas  
Linda C. Flory  
October, 1980  
Texas Historical Commission,  
Austin, Texas  
Interior, detail of apse spandrel

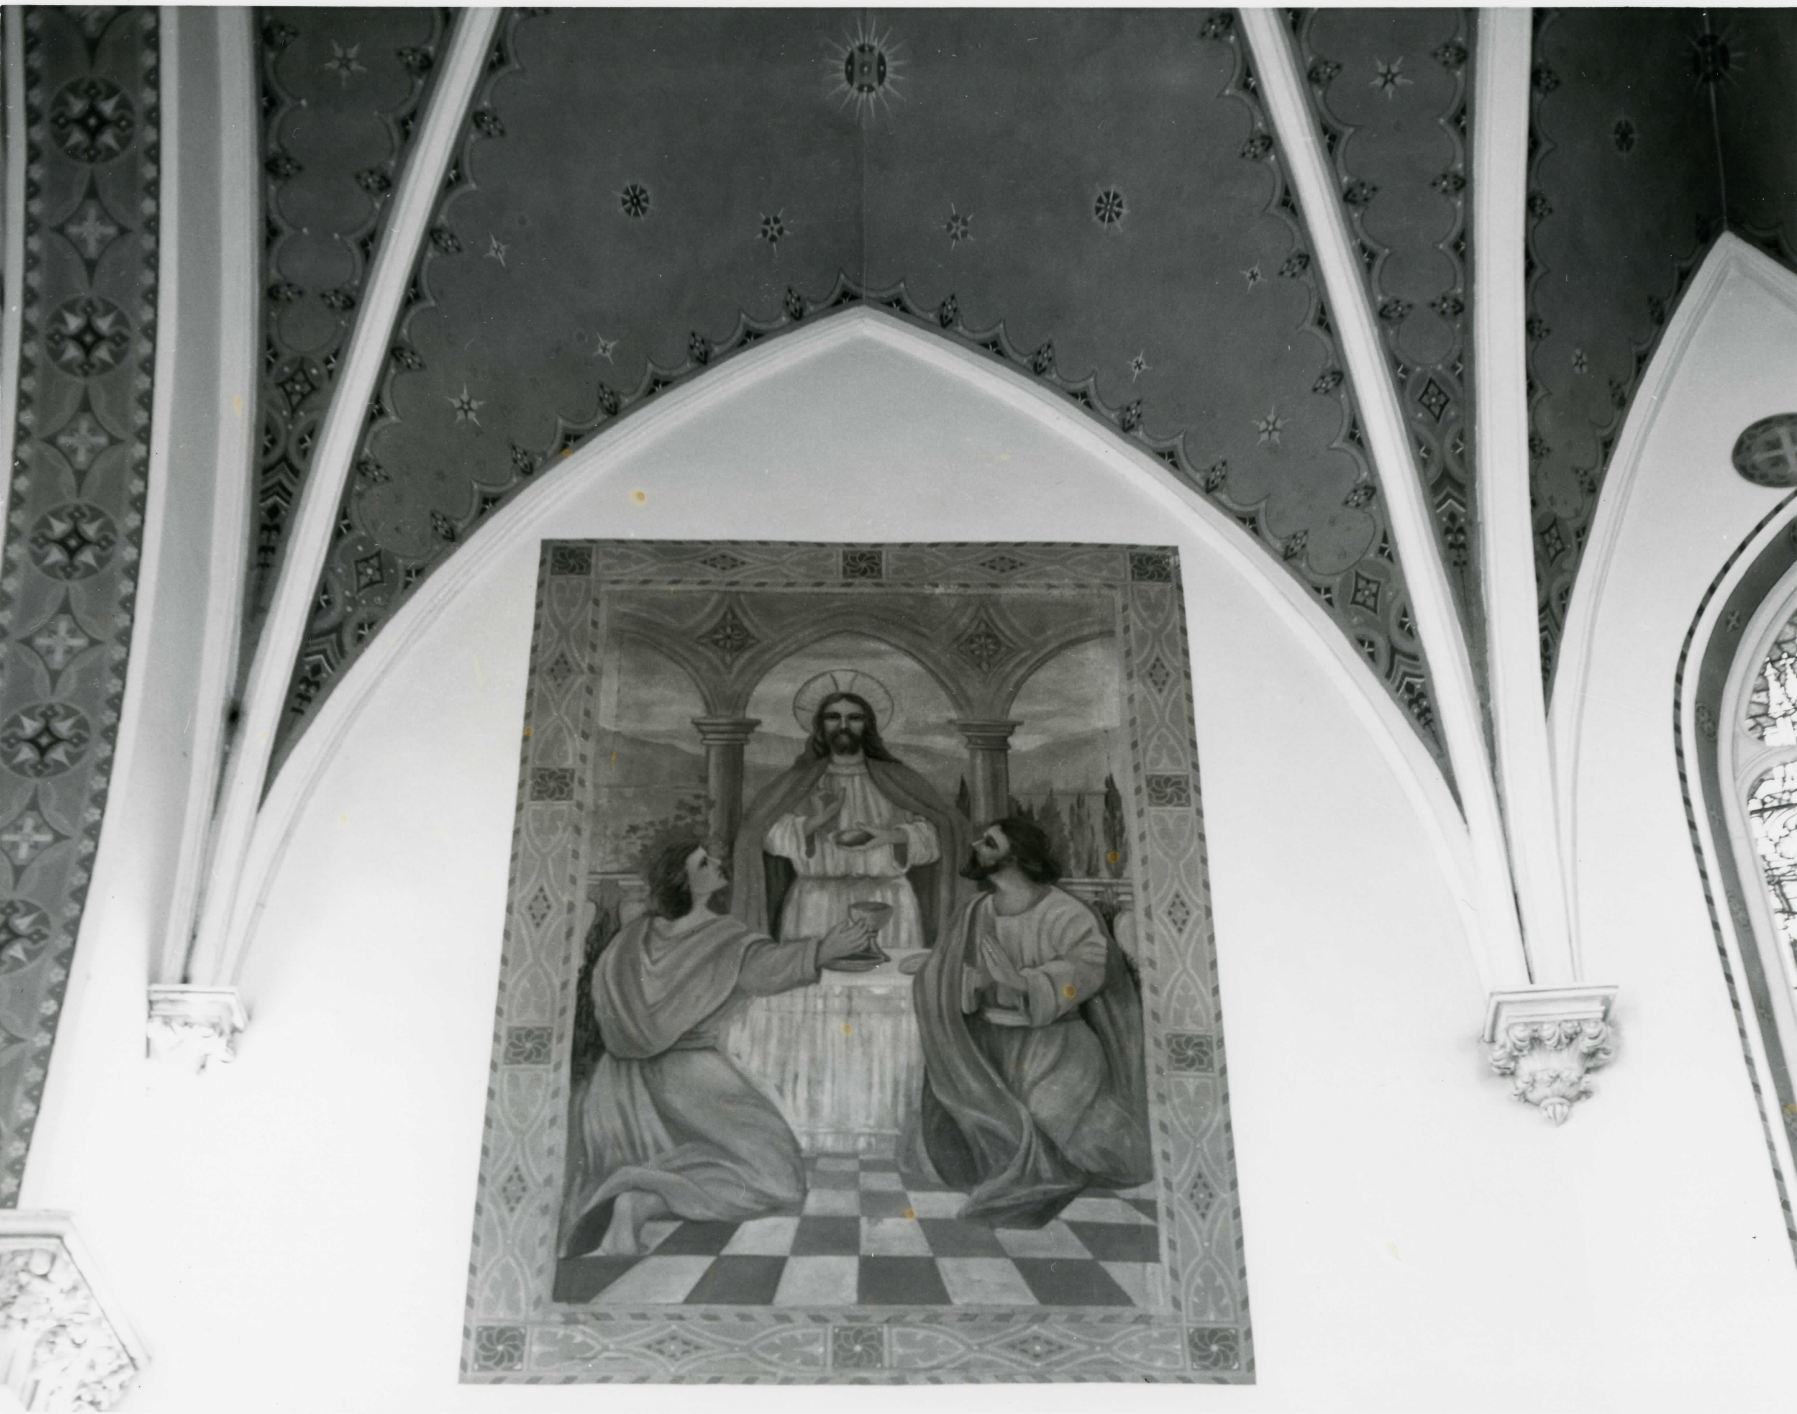
Photo #52 of 98

St. Mary's Catholic Church  
Churches in Texas with Decorative  
Interior Painting  
Fredericksburg, Gillespie County, Texas  
Linda C. Flory  
October, 1980  
Texas Historical Commission,  
Austin, Texas  
Interior, detail of apse wall
