# **National Register of Historic Places Inventory—Nomination Form**

Church of the Blessed Virgin Mary, the Queen of Peace

Sweet Home, Lavaca County, Texas

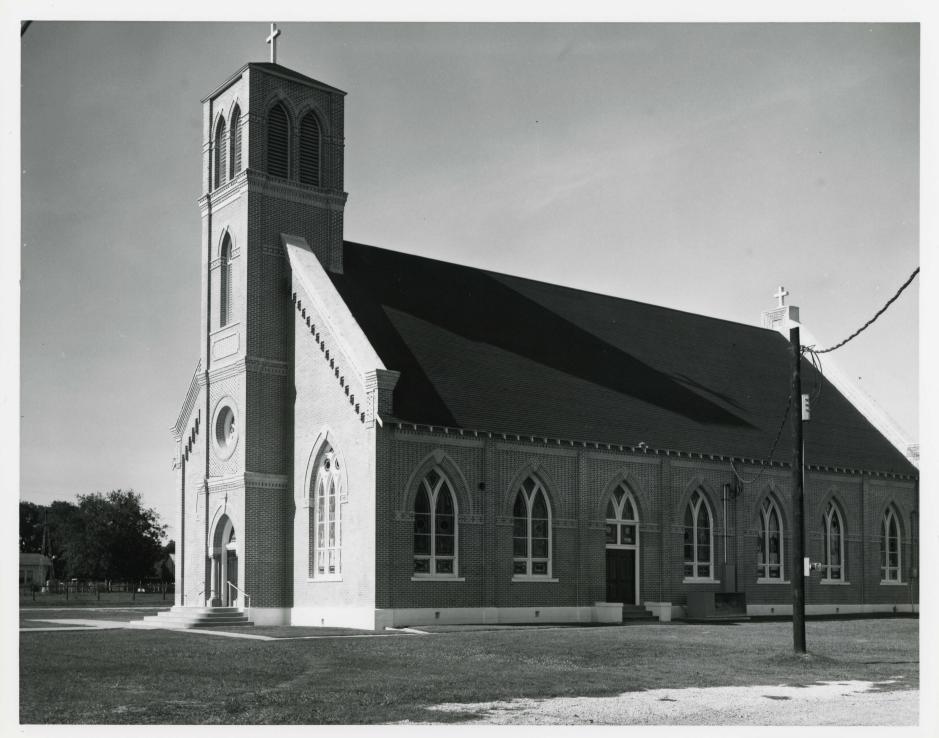
Church of the Blessed Virgin Mary,
the Queen of Peace
Churches in Texas with Decorative
Interior Painting
Sweet Home, Lavaca County, Texas
Carol Kennedy
October, 1980
Texas Historical Commission,
Austin, Texas
Exterior, Northwest oblique, camera
facing Southeast
Photo #79 of 98

Sweet Home's Church of the Blessed Virgin Mary, the Queen of Peace, stands as the prominent structure in this rural community. This 1918 building is rectangular with a massive truncated tower projecting forward from the front entrance. The exterior is constructed of red brick with a concrete water table, with accenting patterns of raised corbel tables of pitch-faced buff, gray, and green brick on the front facade and side

buttresses. Greek crosses in contrasting brick form string courses along the side walls, while checkerboard patterns are seen in the string courses along the tower and in sections of the tower face. Above the string courses, on the side walls, red stretchers and green headers are laid in Flemish bond. With the exception of a wheel window on the tower, all openings are immense lancets topped by red-brick hood molds delineated with lancets of buff brick and keystones. The windows are of stained glass placed in triplet and doublet lancets.

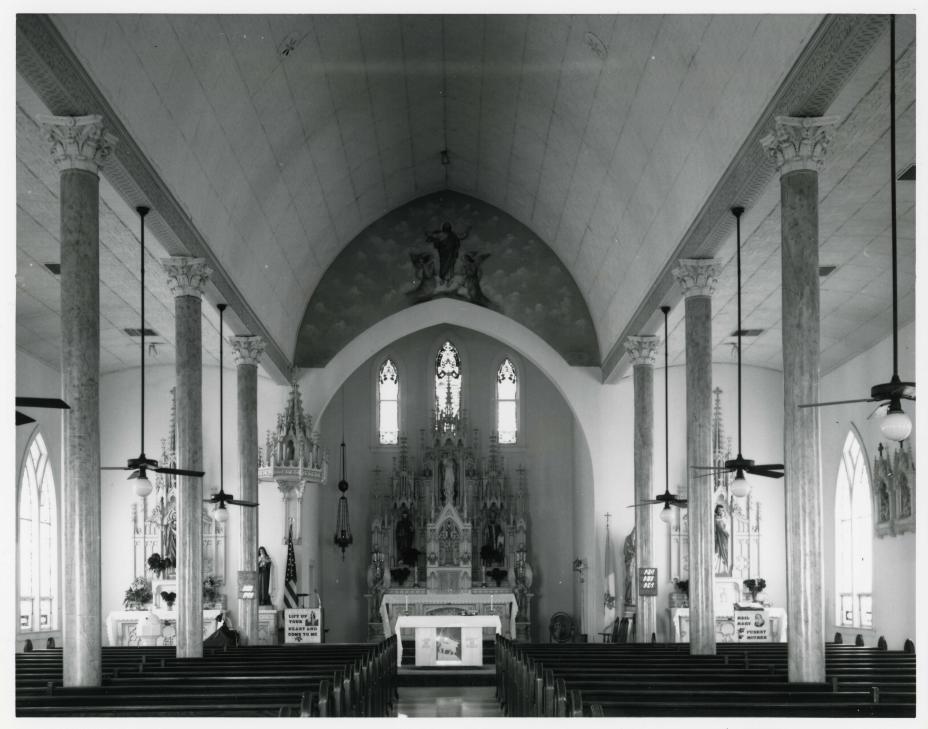
Church of the Blessed Virgin Mary,
the Queen of Peace
Churches in Texas with Decorative
Interior Painting
Sweet Home, Lavaca County, Texas
Carol Kennedy
October, 1980
Texas Historical Commission,
Austin, Texas
Interior, view toward altar
Photo #80 of 98

The interior is composed of a nave separated from two side aisles by wooden columns with Corinthian capitals that have been skillfully marbled in ochre and brown. The ceiling, which is finished in pressed metal with cross motifs, is arched slightly over the side aisles and forms a lancet arch over the nave. The ceiling beams which run the length of the nave are stenciled. Their horizontal (bottom) surfaces show interlocking circles in ochre and creme, while the upright (side) surfaces exhibit alternating snowflake motifs in creme, red, and blue.

On the apse spandrel is a freehand mural. Against a clouded-sky background is portrayed the Ascension of Christ with the figure cloaked in red. Two flanking angels in lavender and aqua robes face the Christ in a kneeling position. The slight distortion of figures proportions indicates either a rather unconvincing attempt to portray the scene as it should be viewed from below, or else a lack of skill by the painter. On the other hand, the painted column marbling of the columns is quite effective as a trompe l'oeil technique, and the stenciling shows a clear attention to accuracy.

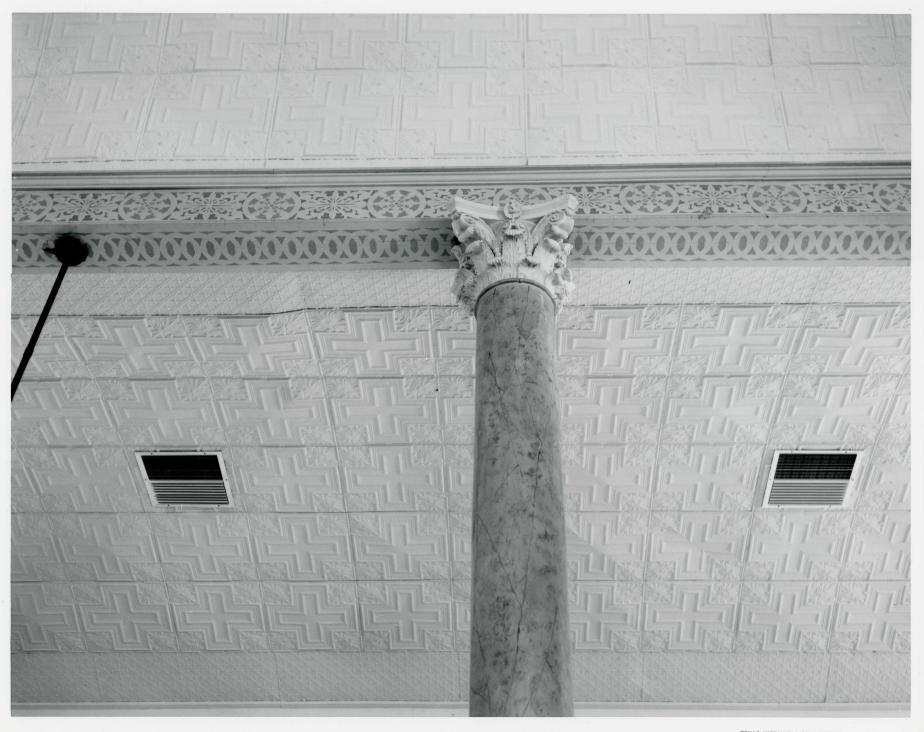
Church of the Blessed Virgin Mary,
the Queen of Peace
Churches in Texas with Decorative Interior
Painting
Sweet Home, Lavaca County, Texas
Carol Kennedy
October, 1980
Texas Historical Commission, Austin, Texas
Interior, detail of column and stenciled
ceiling beam
Photo #81 of 98

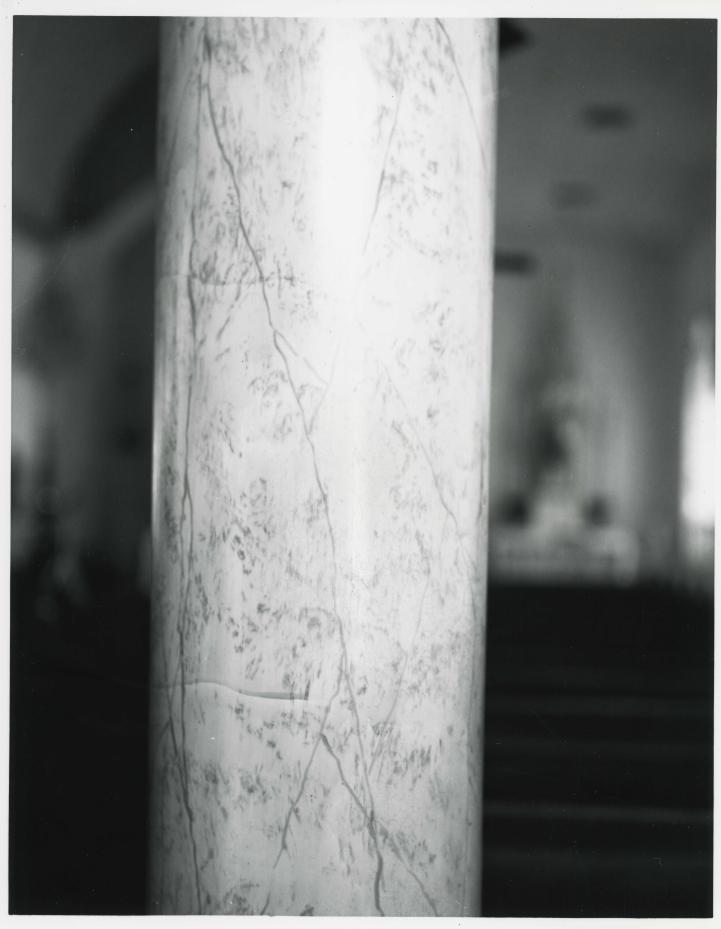
Church of the Blessed Virgin Mary, the Queen
of Peace
Churches in Texas with Decorative Interior
Painting
Sweet Home, Lavaca County, Texas
Carol Kennedy
October, 1980
Texas Historical Commission, Austin, Texas
Interior, detail of column painting
Photo #82 of 98

The simple interior painting consists of well-executed marbling and stenciling, combined with naive freehand painting. The names of the painters and the date of the painting have not been discovered. One document does state, however, that while repairs were being made to the exterior following the tornado of 1967, the interior was also redecorated.
