# National Register of Historic Places Inventory—Nomination Form

1. Nam	10						
historia	Te Tal and resemble		er nicul	To a Register on the con-	ally Baro.		
historic	Round Rock Commerc	lal Histori	c Distric	tiloni ne verili interiore			
and/or common	afaces month in the said	La California	grand di	in 5 teor (and trib)	and the second	Acces.

2. Loca	ation	E.					
	100 & 200 blocks	W. Main St	reet				
street & number	see continuation	sheet	A weeking	N/	A not for publica	ation	
city, town	Round Rock	N/Avic	inity of				
state Tex	as cod	de 048	county	Williamson	code	491

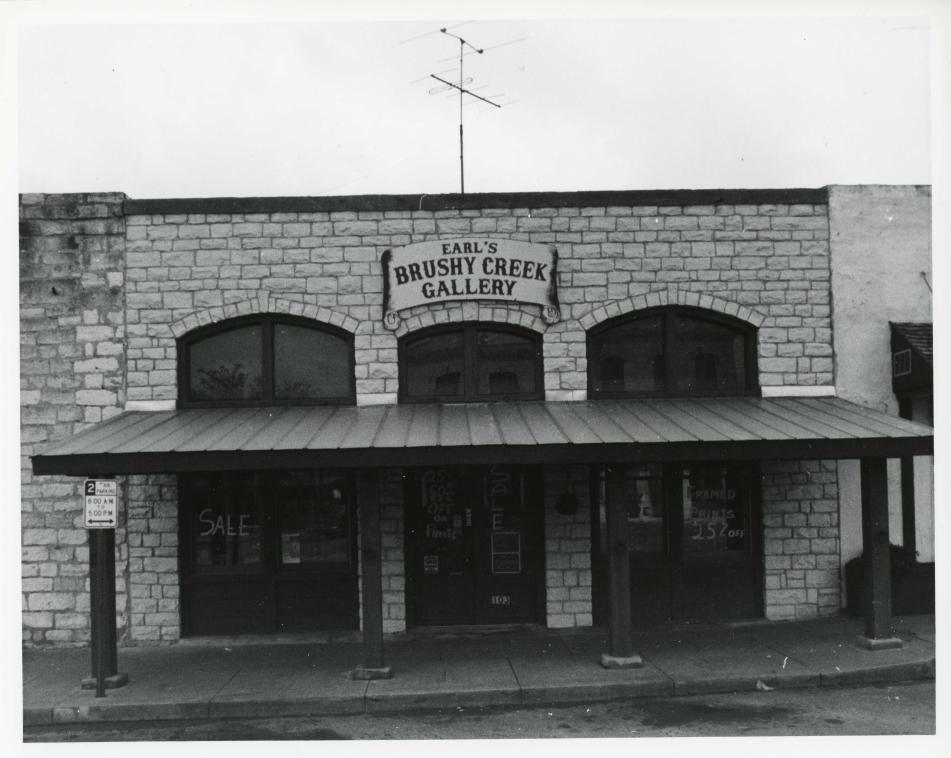
Photo 6 of 19
Site #2

Miller's Exchange Bank, 103 East Main Street Round Rock, Williamson County, Texas. Photograph taken November, 1982, by Ruth Parshall.

North (front) elevation.

- 2. Miller's Exchange Bank (Earl's Brushy Creek Gallery) 103 East Main Street. Built in 1876. Contributing. A small, one-story, stone-masonry building. The front elevation collapsed in the early part of the 20th century and was replaced with a wooden front. The present owner removed the wooden facade, and in 1972 built the existing masonry facade. Minor alterations have been made.

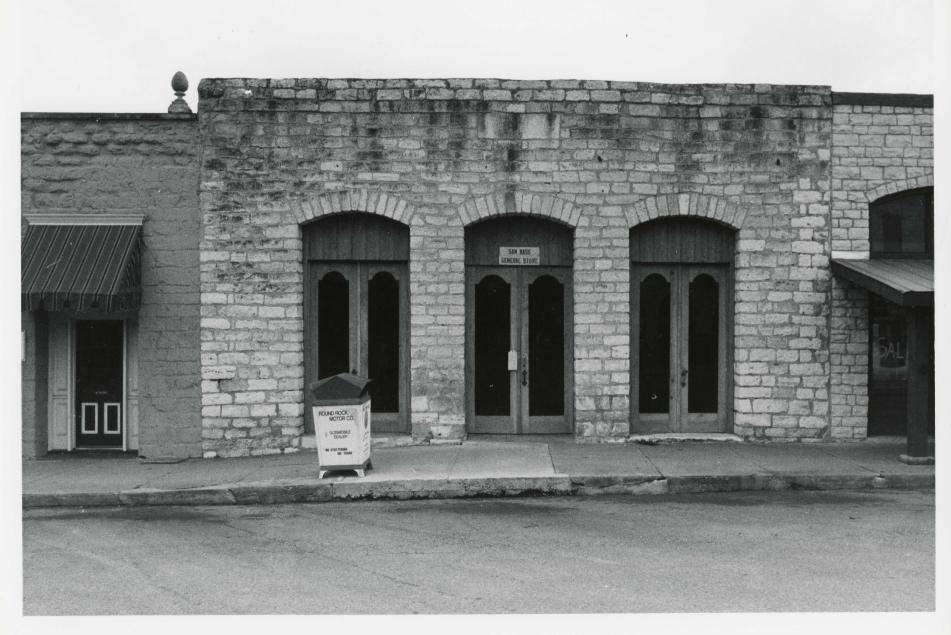
Photo 7 of 19 Site #3

Sam Bass General Store, 105 E. Main Street Round Rock, Williamson County, Texas. Photograph taken November, 1982, by Ruth Parshall.

Negative on file at the Texas Historical Commission.
North (front) elevation.

- 3. (Sam Bass General Store, vacant) 105 East Main Street. Built in 1876. Contributing. This store facade has undergone relatively little alteration. The three-bay front with segmental-arch openings and a simple cornice make this one of the best remaining one-story buildings.

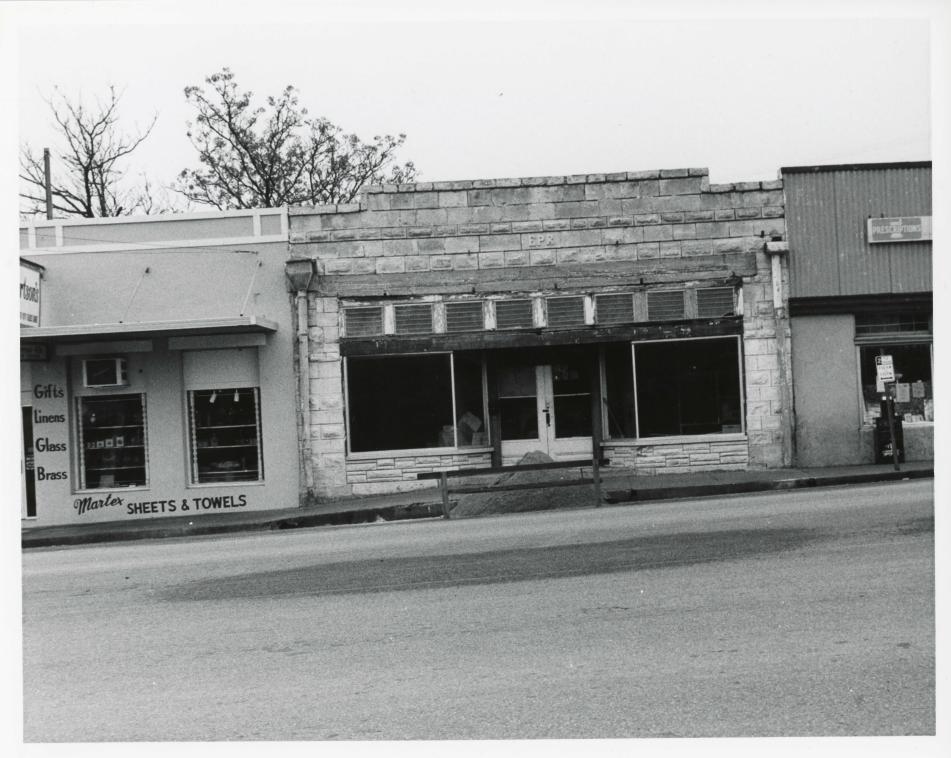
The Fair, 117 East Main Street
Round Rock, Williamson County, Texas.
Photograph taken November, 1982, by Ruth
Parshall.
Negative on file at the Texas Historical
Commission.
North (front) elevation.
Photo 8 of 19
Site #8

- 8. The Fair (vacant) 117 East Main Street. Built in 1891. Contributing. A long, one-story, stone-masonry building with handsome, arched openings on the alley elevation. The front has undergone alterations, including the addition of a concrete beam spanning the door and display areas, but the current owners are working with historic photographs to restore the three round-arch openings.

The Fair was built sometime between 1886 and 1890. E.P.M. Robinson, whose initials EPR appear on the cornice is the owner credited with having it built. The most significant and enduring ownership of the building started in 1900 when the Walsh family, whose lime-manufacturing laborers were paid with tokens to be exchanged for goods, operated a "company" store on these premises until 1950.

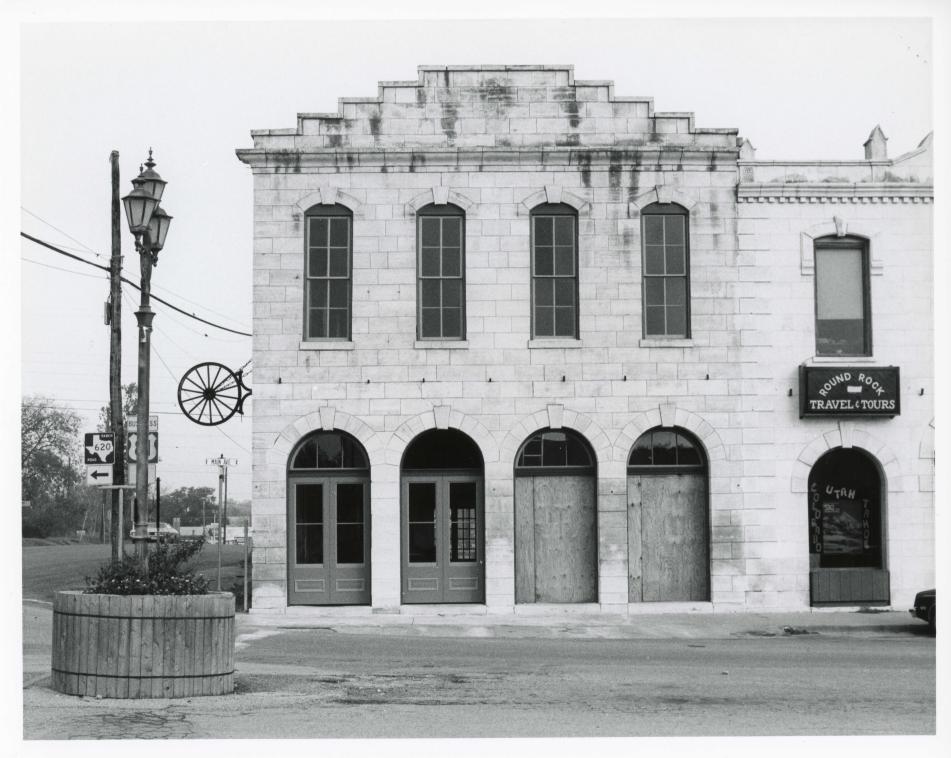
Photo 9 of 19 Site #11

Shuey's Furniture Store, 100 East Main Street
Round Rock, Williamson County, Texas.
Photograph taken, November, 1982, by Ruth
Parshall.
Negative on file at the Texas Historical
Commission.
South (front) elevation.

The Old Broom Factory is a two-story, limestone building in Italianate style prominently located on the northeast corner of Mays Street and East Main. On the front facade the arched openings of the first floor are semi-circular, while those of the second floor are segmental. The front facade is capped by a stepped parapet of stone. The stone around the openings is coursed, dressed ashlar with a drafted margin. The windows have a dropped keystone in the arch above, and four-over-four lights. The Sanborn Insurance maps indicate that the building was built in 1880. Currently the structure is being restored, and a missing arch has been rebuilt.

- 11. Shuey's Furniture Store; also known as Old Broom Factory (vacant) 100 East Main Street. Built in 1880. Contributing. This two-story, ashlar limestone building is one of the handsomest and most prominent in the district. It is undergoing restoration.

The original use of the building was as a dry goods, grocery, and general store. By 1885, Shuey's Furniture occupied the building. By 1896, the first floor was used by a confectionary and the second floor by an unamed lodge. There is conflicting information on the dates of occupancy by the Round Rock Broom Factory. By the turn of the century it was occupied by the broom factory,

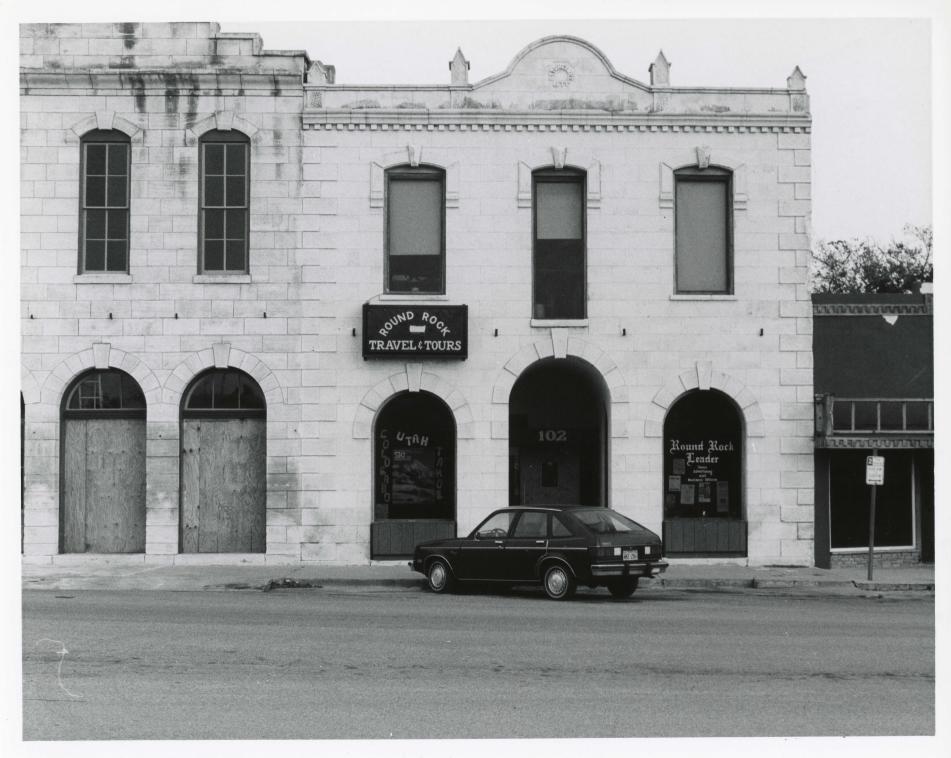
Photo 10 of 19

Otto Reinke Building, 102 East Main Street Round Rock, Williamson County, Texas. Photograph taken November, 1982, by Ruth Parshall.

The Otto Reinke Building is another prominent Italianate structure built in 1879. It was gutted by fire in 1963, leaving only the limestone walls. The

fire-damaged building remained vacant for some time, and in 1970 it was repaired and the interior modernized. Changes in glazing material and window sashes mark several deviations from the original appearance. The round-arch openings on the first floor, the segmentally arched openings on the second floor, the regular, smooth-coursed limestone front with rusticated, projecting quoins all survived the fire and were preserved. The full-width, dentilated cornice has a curved pediment in the center.

- 12. Otto Reinke Building (Round Rock Travel and Tours, and Round Rock Leader) 102 East Main Street. Built in 1879. Contributing. This is another prominent two-story building of the district.

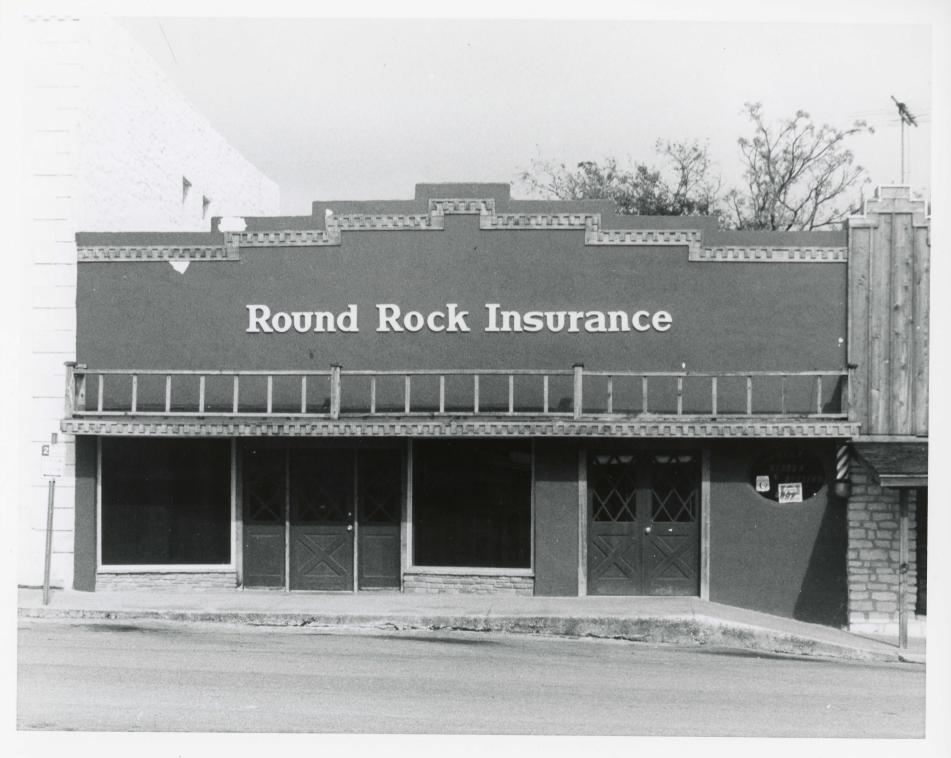
Round Rock Insurance and John's Barber Shop,
104 East Main Street
Round Rock, Williamson County, Texas.
Photograph taken November, 1982, by Ruth
Parshall.
Negative on file at the Texas Historical
Commission.
South (front) elevation.
Photo 11 of 19
Site #13

- 13. (Round Rock Insurance and John's Barber Shop) 104 East Main Street. Built in 1947. Contributing. Although this building is less than 50 years old, its use, scale, and parapet qualify it as contributing to the district.

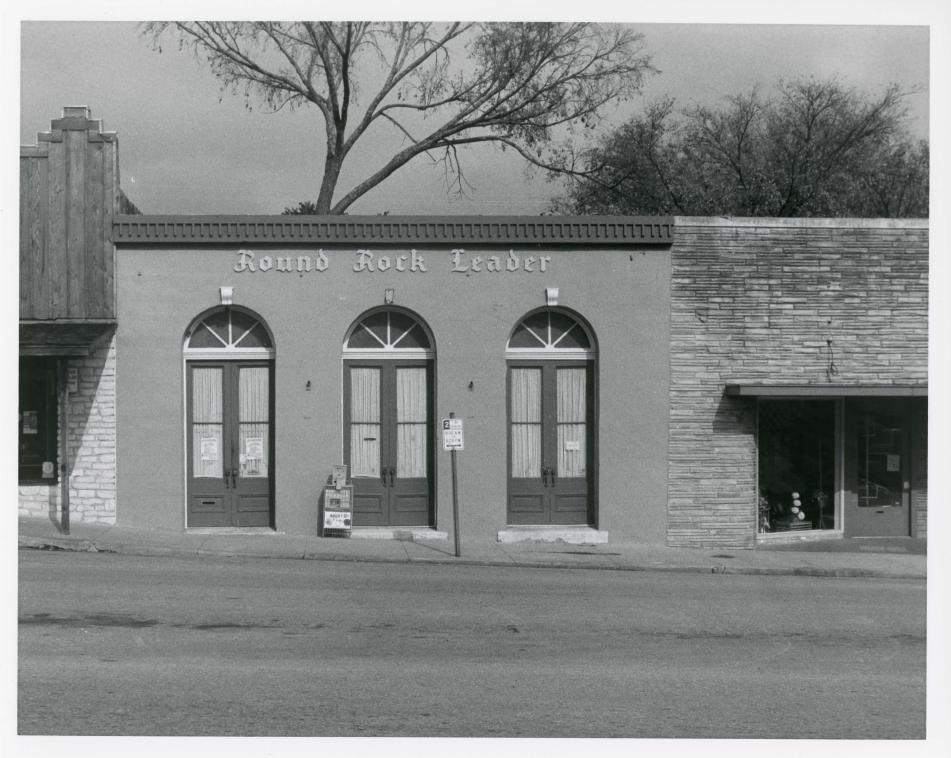
Round Rock Leader, 112 East Main Street
Round Rock, Williamson County, Texas.
Photograph taken November, 1982, by Ruth
Parshall.
Negative on file at the Texas Historical
Commission.
South (front) elevation.
Photo 12 of 19
Site #16

- 14 & 15. (White's) 108 & 110 East Main Street. Both were built in 1880. Non-contributing. Unsympathetic and recent board-and-batten upper facade.
- 16. (Round Rock Leader) 112 East Main Street. Built in 1881. Contributing. This building is one of the few buildings in the district where the openings have not been altered. For this reason the building is classified as contributing even though the cornice has been altered.

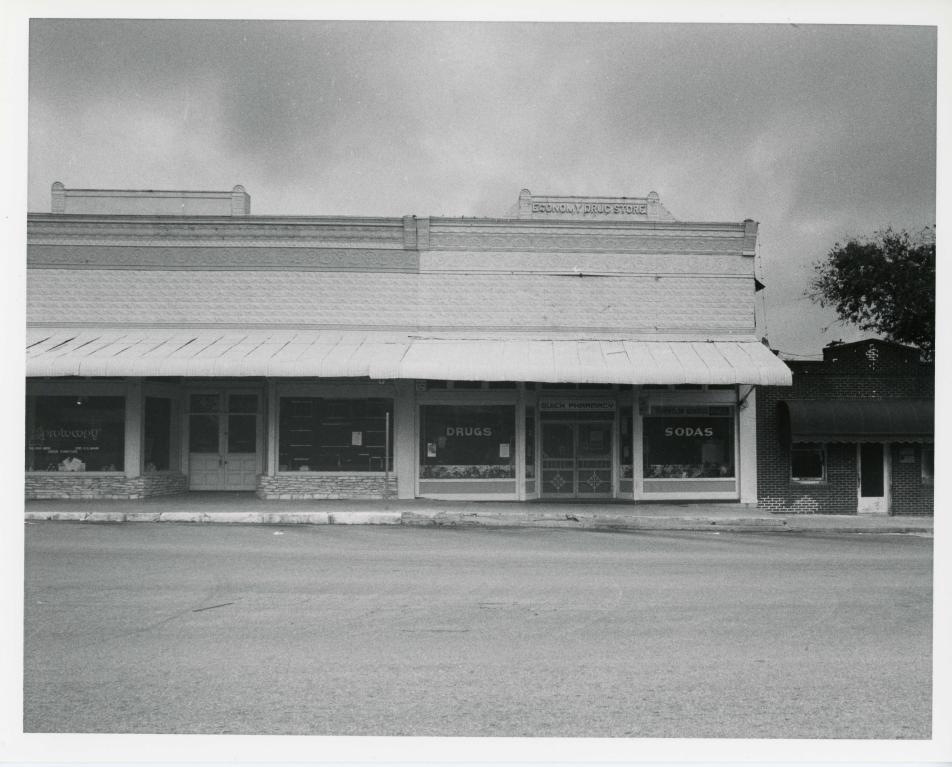
Site #21

Economy Drug Store, 204 East Main Street Round Rock, Williamson County, Texas.
Photograph taken November, 1982, by Ruth Parshall.
Negative on file at the Texas Historical Commission.
South (front) elevation.
Photo 15 of 19

The Economy Drug Store Building is a singular specimen, for it is a totally unaltered commercial building in downtown Round Rock. It is a one-story, stone building with a cast-iron and pressed-tin facade. The large expanses of glass were undoubtedly progressive for the time and place. The a-b-a rhythm of its openings is repeated in the cornice. The interior balcony, an oak pharmaceutical desk, oak shelving, oak display cases and pressedmetal ceilings are all intact interior features, making it one of the few unaltered interiors in the district.

- 21. Economy Drug Store (Quick Pharmacy) 204 East Main Street. Built between 1902 and 1909. Contributing. This building has been in continual use as a pharmacy since it was built. There have been no interior or exterior alterations. The store-front canopy is intact, and many pharmaceuticals from the earliest years of operation are displayed inside.

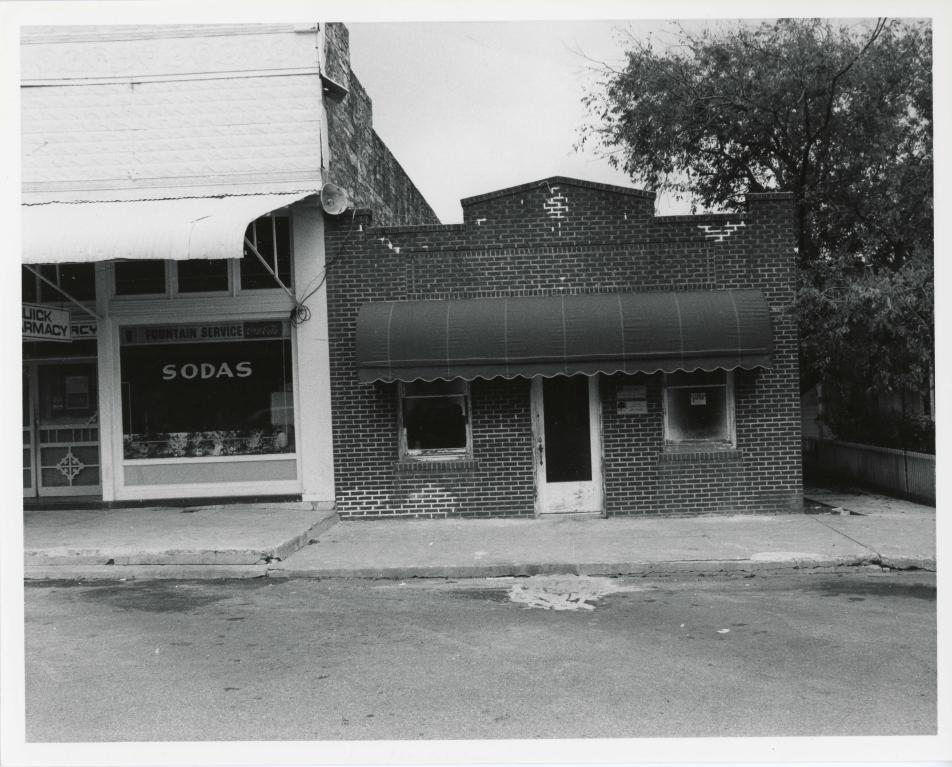
Photo 16 of 19 Site #22

Dr. Gregg's Office, 206 East Main Street
Round Rock, Williamson County, Texas.
Photograph taken November, 1982, by Ruth
Parshall.
Negative on file at the Texas Historical
Commission.
South (front) elevation.

- 22. Dr. Gregg's Office (vacant) 206 East Main Street. Built in the 1930s. Contributing. This structure is more than 50 years old, and makes a positive contribution to the entire district because of its use, style, and scale.

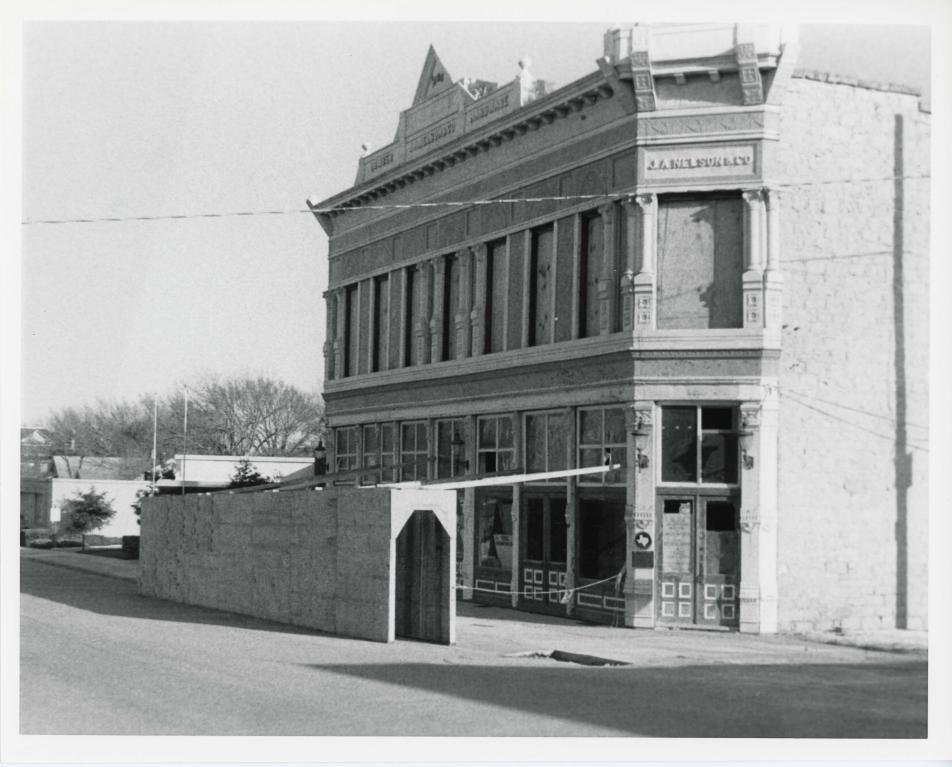
Photo 17 of 19 Site #24

Nelson Hardware, 203 East Main Street Round Rock, Williamson County, Texas. Photograph taken December, 1982, by Ruth Parshall. Negative on file at the Texas Historical Commission. Oblique view from the northwest.

The Nelson Hardware Building is a two-story, stone, Italianate commercial structure on a prominent corner at East Main and Lampasas streets. The castiron and pressed-tin front elevation is a splendid example of the way turn-of-the-century retailers in Central Texas, using standard catalog items, enhanced the appearance of their stores. There is a prominent cornice with brackets and a triangular pediment with the date 1900 stamped on it. The corner entrance to the store is marked by a less prominent pediment. The openings on the stone-masonry portions of the buildings are generally segmentally arched. The building is currently undergoing restoration, and most of the sashes have been removed. The elevation facing the alley is all of stone masonry and is capped by a stepped stone parapet.

- 24. Nelson Hardware; "The Co-op" (vacant) 203 East Main Street. Built in 1900. Contributing. This two-story limestone building is architecturally important because of its pressed-tin facade.

This structure was originally built to house a private banking, hardware, and lumber business owned by several prominent families in Round Rock, including J.A. Nelson, C.A. Nelson, W.E. Henna, O.L. Brady, O.A. Voight, and J.E. Gustafson. John A. Nelson's bank was successful from the beginning, although the bank was discontinued in 1922. Later occupants of the building include a chicken hatchery, and a milk producers' cooperative (whence the recent common name, "The Co-op"). There is conflicting information on when this building was built. The front of the building clearly bears the date 1900, but the Sanborn maps indicate a stone building there, built in 1881. Architecturally the most pretentious structure in the district, the Nelson Hardware Building retains its finely detailed cast-iron and pressed-tin facade, fabricated by the Mesker Brothers of St. Louis. This lively interpretation of the Italianate style represented the most up-to-date taste, and was sure to attract the attention of the passerby.

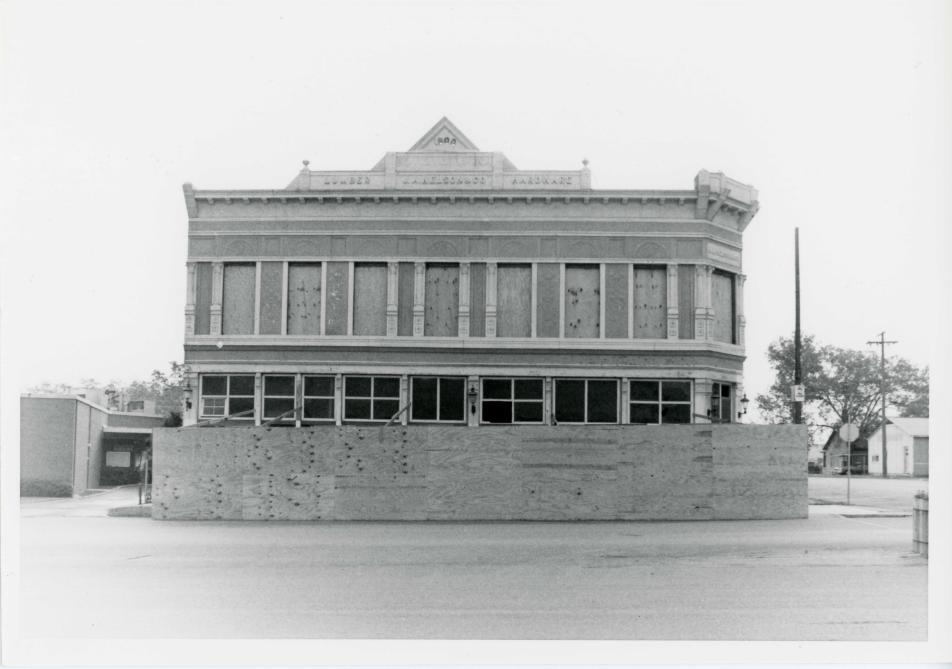
Photo 18 of 19 Site #24

Nelson Hardware, 203 East Main Street
Round Rock, Williamson County, Texas.
Photograph taken November, 1982, by Ruth
Parshall.
Negative on file at the Texas Historical
Commission.
North (front) elevation.

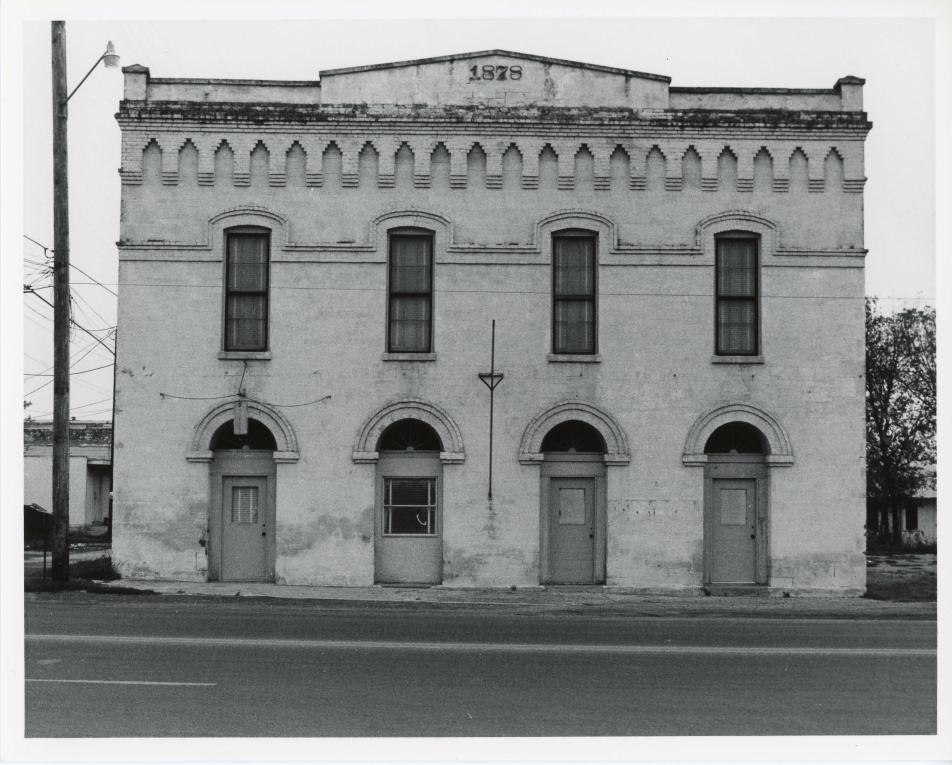
Old Post Office Building, 107 South Mays Street Round Rock, Williamson County, Texas.
Photograph taken November, 1982, by Ruth Parshall.
Negative on file at the Texas Historical Commission.
West (front) elevation.
Photo 19 of 19
Site #25

- 25. Old Post Office Building (Masonic Lodge #227) 107 South Mays Street. Built in 1878. Contributing. This two-story building has ashlar limestone on the front and a handsome corbeled brick parapet above. The first-floor openings have round arches, while the openings on the second floor are segmentally arched.

The Masonic Lodge #227 built the structure at 107 South Mays in 1878. The two-story, stone-masonry building was apparently built to house the lodge meeting space on the second floor while the first floor served as lease space. The fine quality of the brickwork detailing of this building represents an imaginative interpretation of the Italianate style, and contrasts with the austere limestone walls. One long-term tenant was the United States Post Office. To this date the Masons continue to meet in the building. The first floor is vacant now.
