National Register of Historic Places  
Inventory—Nomination Form

historic The Plehwe Complex

and/or common The Plehwe Stagecoach Inn

street & number 1/2 mile west of Leon Springs on Boerne Stage Road, N/A not for publication

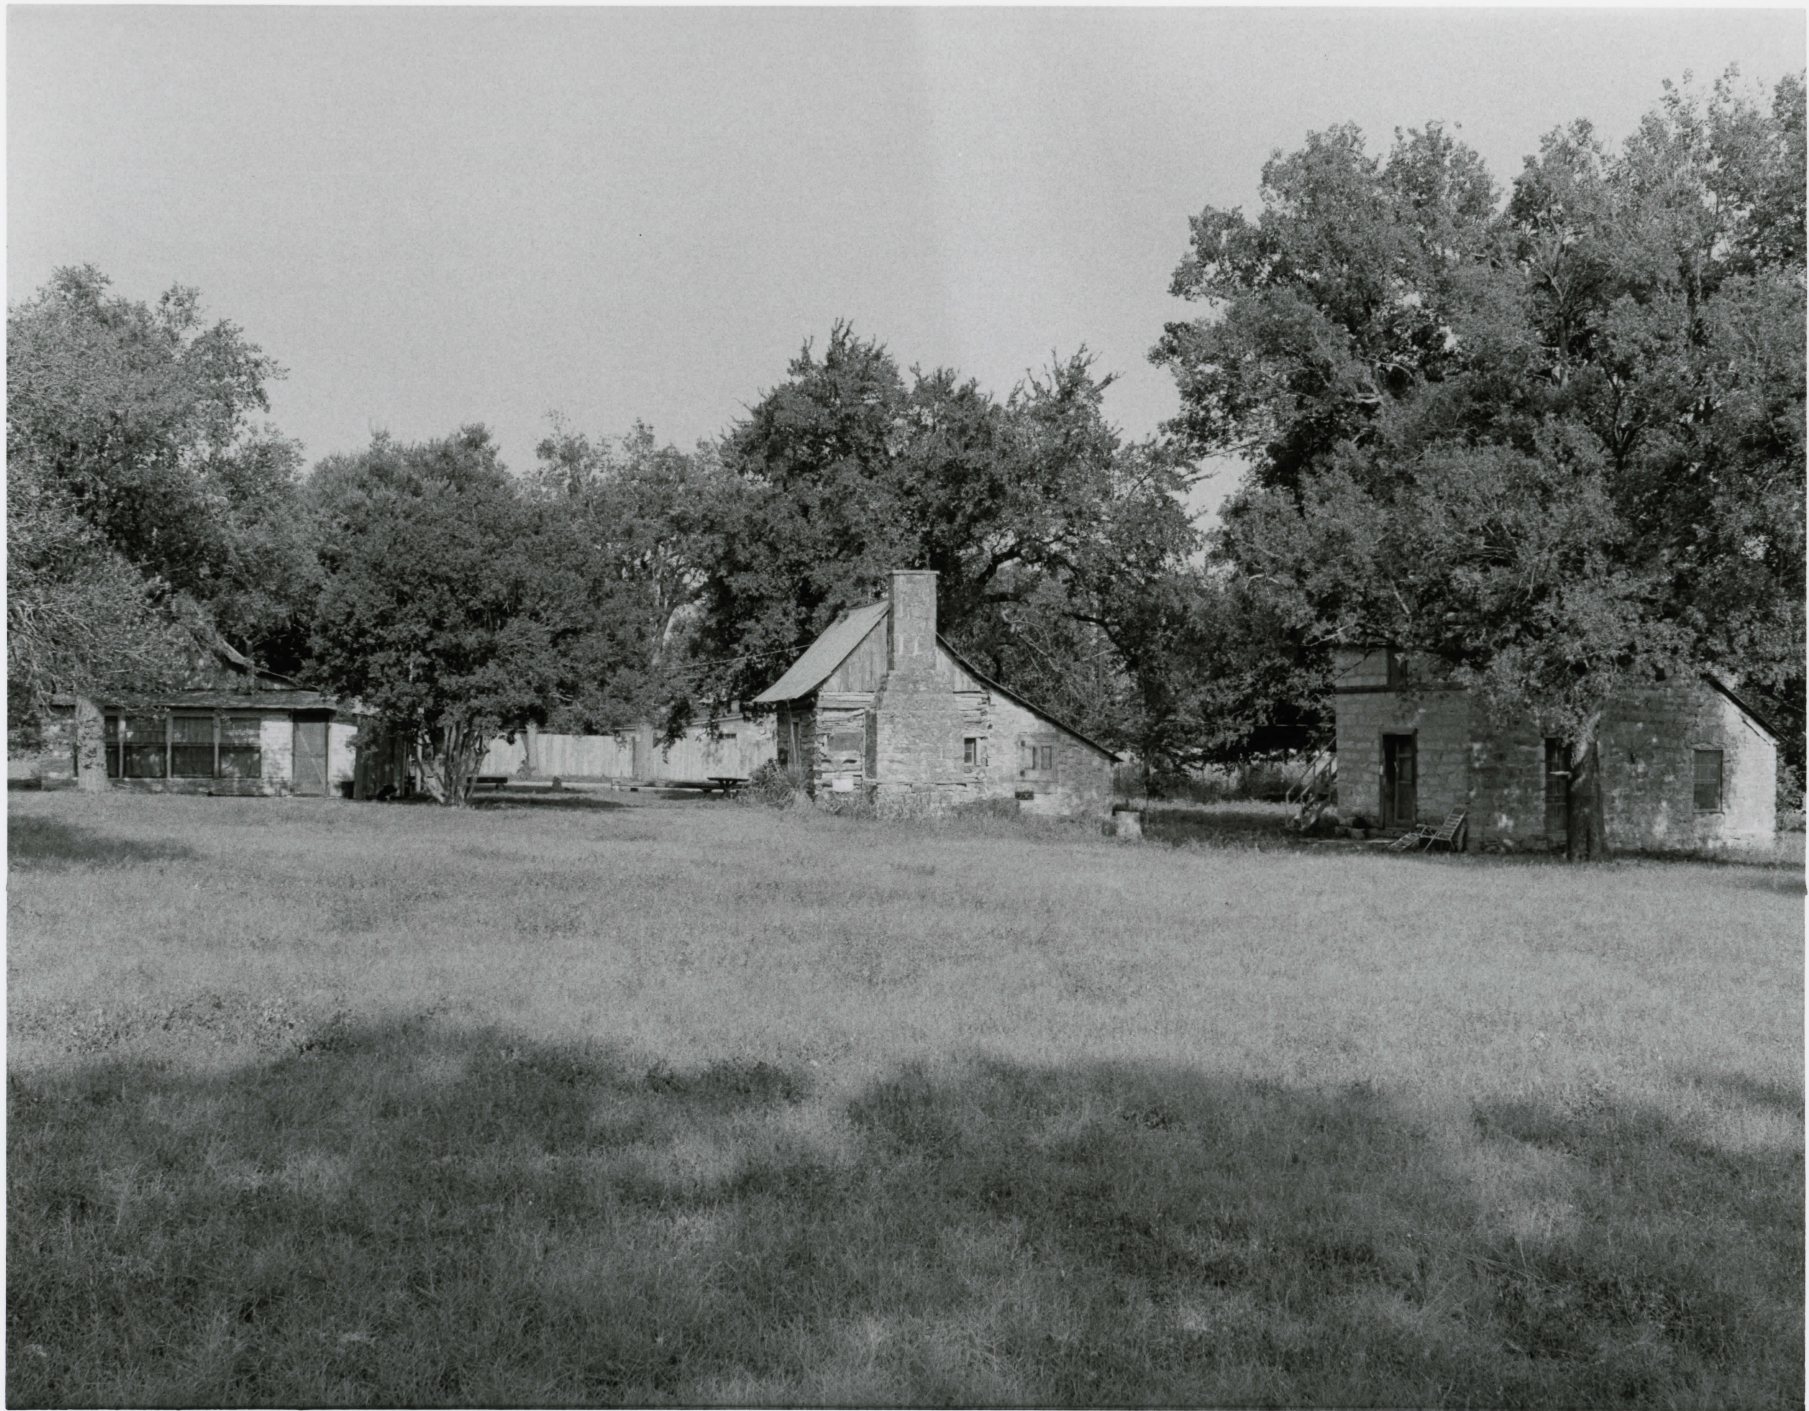
Photo 1 of 5

View of the Plehwe Complex, looking west; structure  
No. 1 to right, No. 2, center, No. 3 to left.

The Plehwe Compound is comprised of three structures: two diminutive residences and a detached kitchen building. Built using a mixture of timber and masonry construction techniques, the structures reflect the vernacular building traditions of central Texas architecture of the mid-19th century.

The three structures that form the Plehwe Compound stand in a rural setting to the west of the unincorporated town of Leon Springs, and are situated on wooded land which slopes gently from north to south. The largest of the three buildings is built entirely of limestone masonry, while the other structures combine timber frame, log, and masonry work. All have recent standing-seam metal roofs.

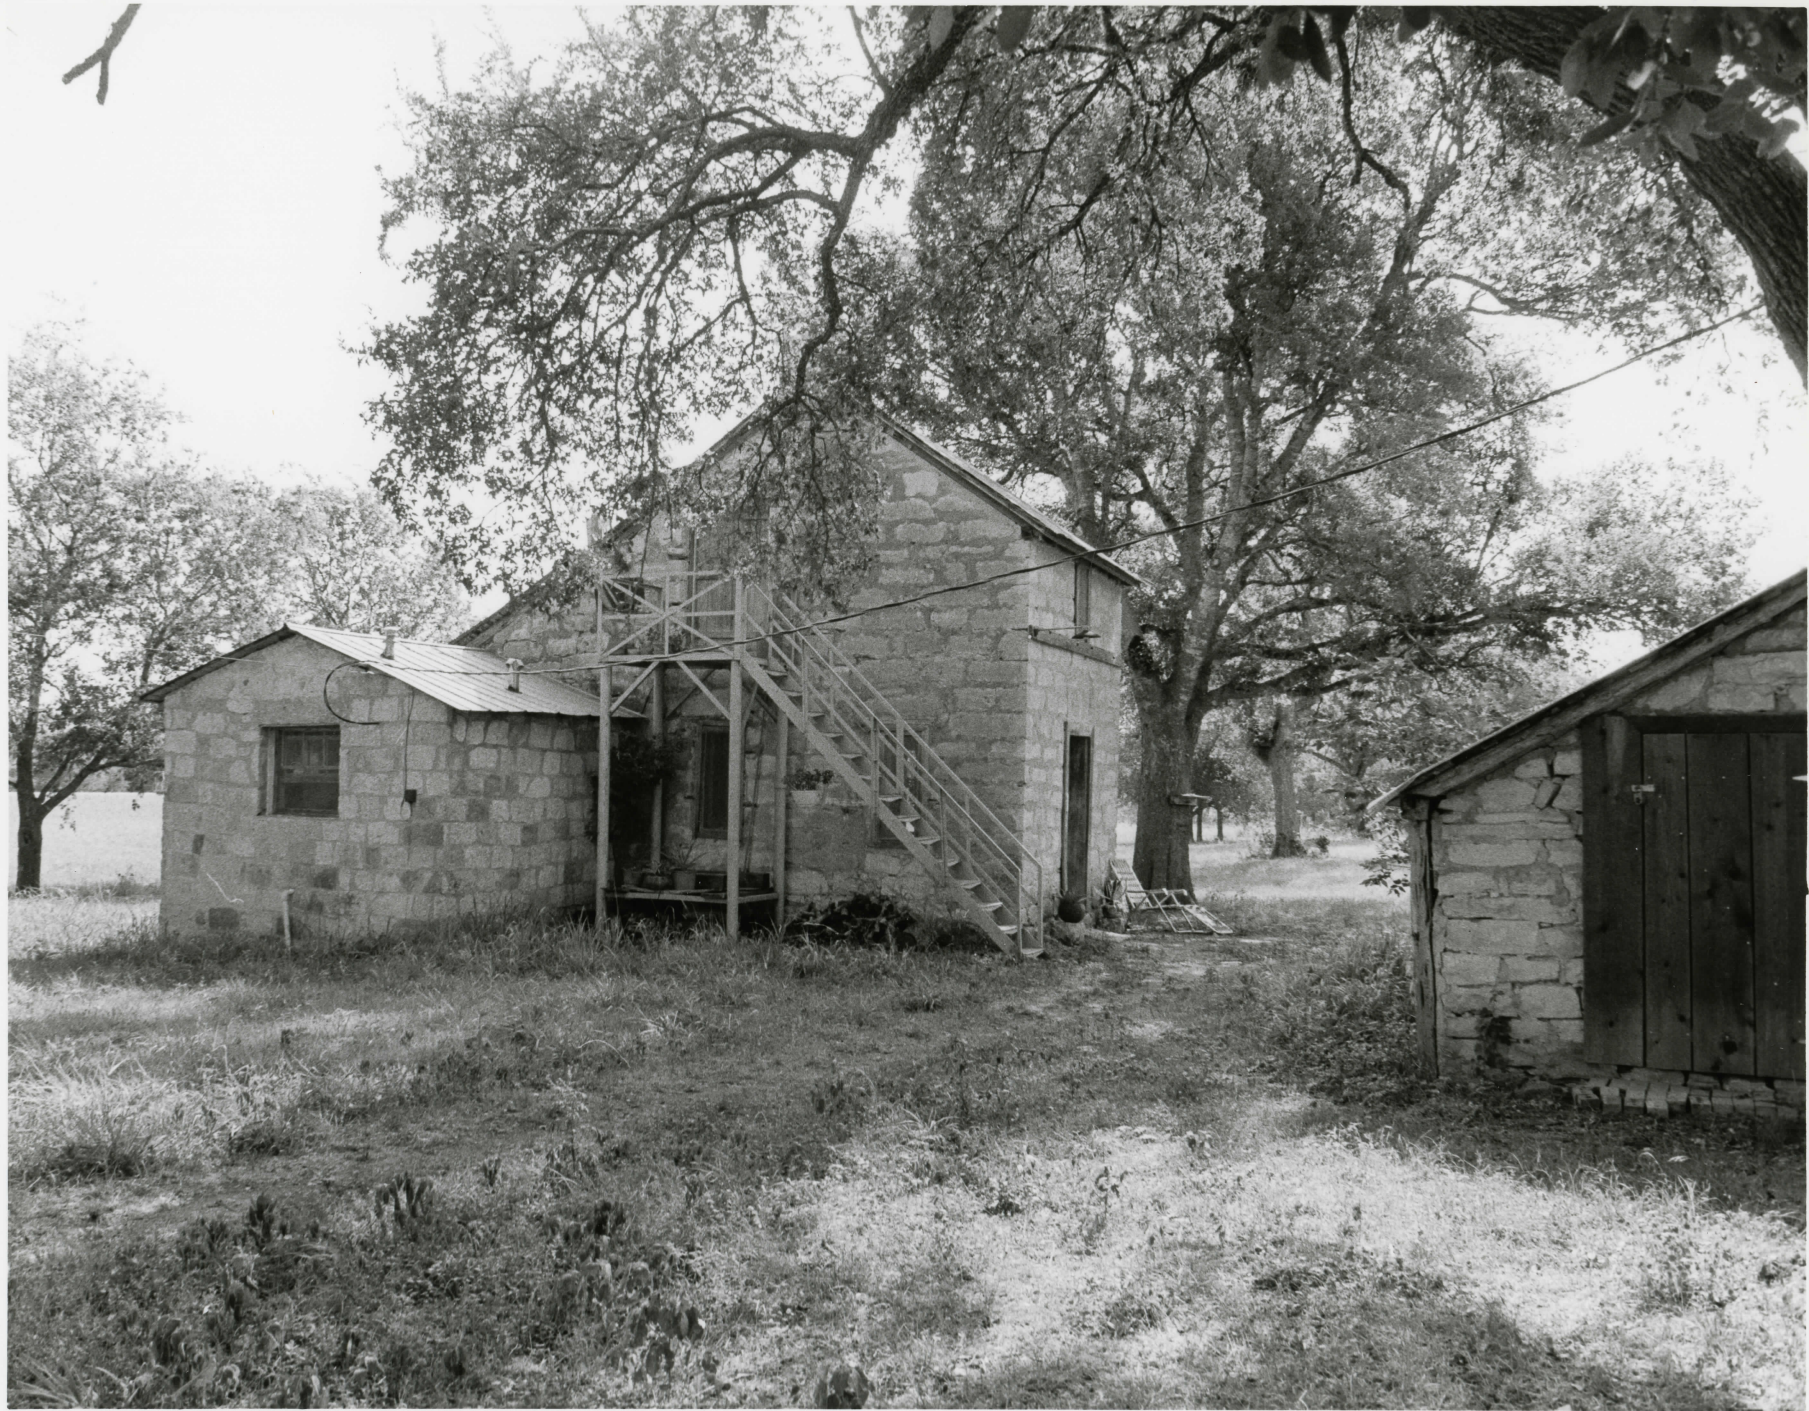
Photo 2 of 5

West elevation of Sophie Plehwe House, looking east

The largest of the structures, No. 1 (see plan of site), is the northernmost of the group. It is built of limestone, and believed to be the residence of Mrs. Sophie von Plehwe. The entry facade of the house faces almost due south. A single doorway breaks the first floor of the south front, with a very small window centered above it in the upper half story. The east elevation also features a single doorway for access to the ground floor, with a window toward the north end opening into a small room under the downward-sloping, north face of the roof. The north elevation contains a single doorway opening; this face of the house extends off to the west with a single story wing whose only detailing is a window opening on its west wall. The west face of the one-and-a-half story structure features two narrow openings on the ground floor, and a doorway on the upper half-story wall, access to which is provided by a steel stair. The interior is characteristically spartan, with two chimney flues, one in the large south room, and another in the smaller northern room. They are the only elements of ornament. The original wooden floor of the structure, heavily worn, is now covered by another. There have been some changes to the structure over time, the most apparent being the replacement steel stair to the upper story. This stair is located in the same spot as an early, and possibly original, wooden stair that appears in a 1925 newspaper article on the property. The small single-room wing on the west side of the house is of stone veneer construction, thus it is probably a 20th-century addition, although in keeping with the character of the earlier stonework. The north slope of the roof is broken by a shed dormer which is clearly a more recent addition. The wooden strip attached to the south facade of the structure marks the point of attachment of a simple lean-to porch that once shaded the entrance. This porch is also visible in the 1925 newspaper photo.

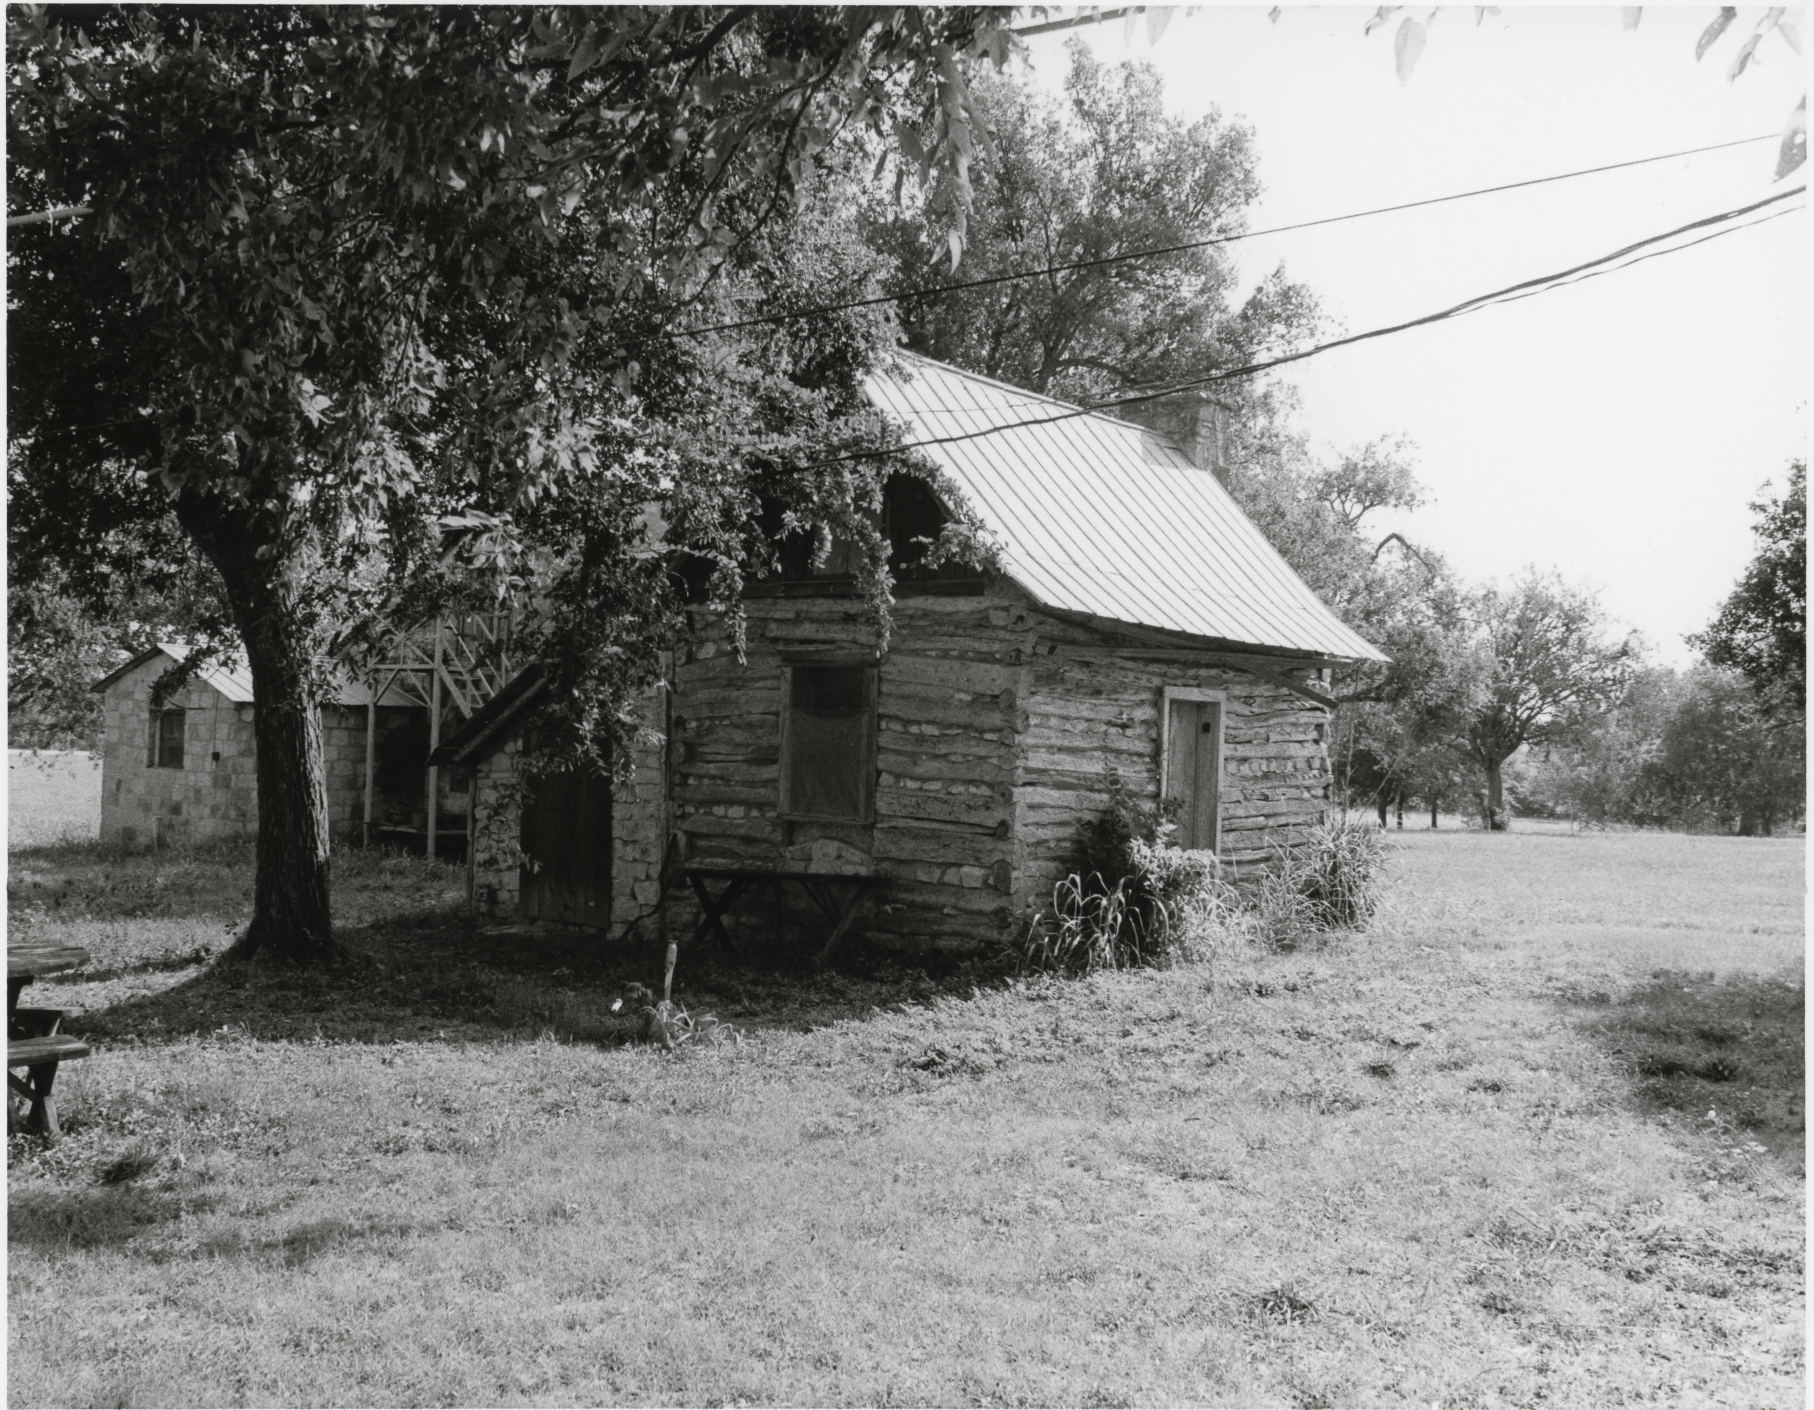
Photo 3 of 5

Southwest oblique view of Plehwe Kitchen, No. 2,  
looking northwest

The central of the three structures, No. 2, is the original kitchen building. Considerably smaller than either of its neighbors, it combines both timber and masonry construction beneath its gable-ended roof. The majority of the walls of this one-room structure are of hewn logs, smoothed on their sides. The lean-to rear, or north, section of the structure is of limestone, and there are spaces between the logs filled in with limestone chinking. The faces of the gables are faced with wood planking. The roof is of sheets of tin, as are those of the two residences. The interior is dominated by the large cooking hearth on the east wall. The hearth opening is now spanned by a series of steel and iron bars required by the collapse of some of the stonework. The chimney shaft has been repaired and now shows no sign of structural problems. Externally, on the

east elevation, the chimney is the dominant feature, stepping inwards and narrowing as it rises past the peak of the roofline. The building can be entered by doors located on the south, east, and west elevations, with a single window opening in the log wall section of the west face. It is apparent from both the 1925 photographs already noted, and by inspection of the structure, that it was originally faced with a coat of stucco, with the nail holes for the armature of sticks still readily visible on the outer faces of the logs. The window opening on the west elevation is obviously the result of the shortening of a doorway, with rough limestone filling the lower half of the original opening. The loss of the protective stucco is detrimental in the sense that the hewn logs are showing the effects of rot, termites, and powder-post beetle damage.

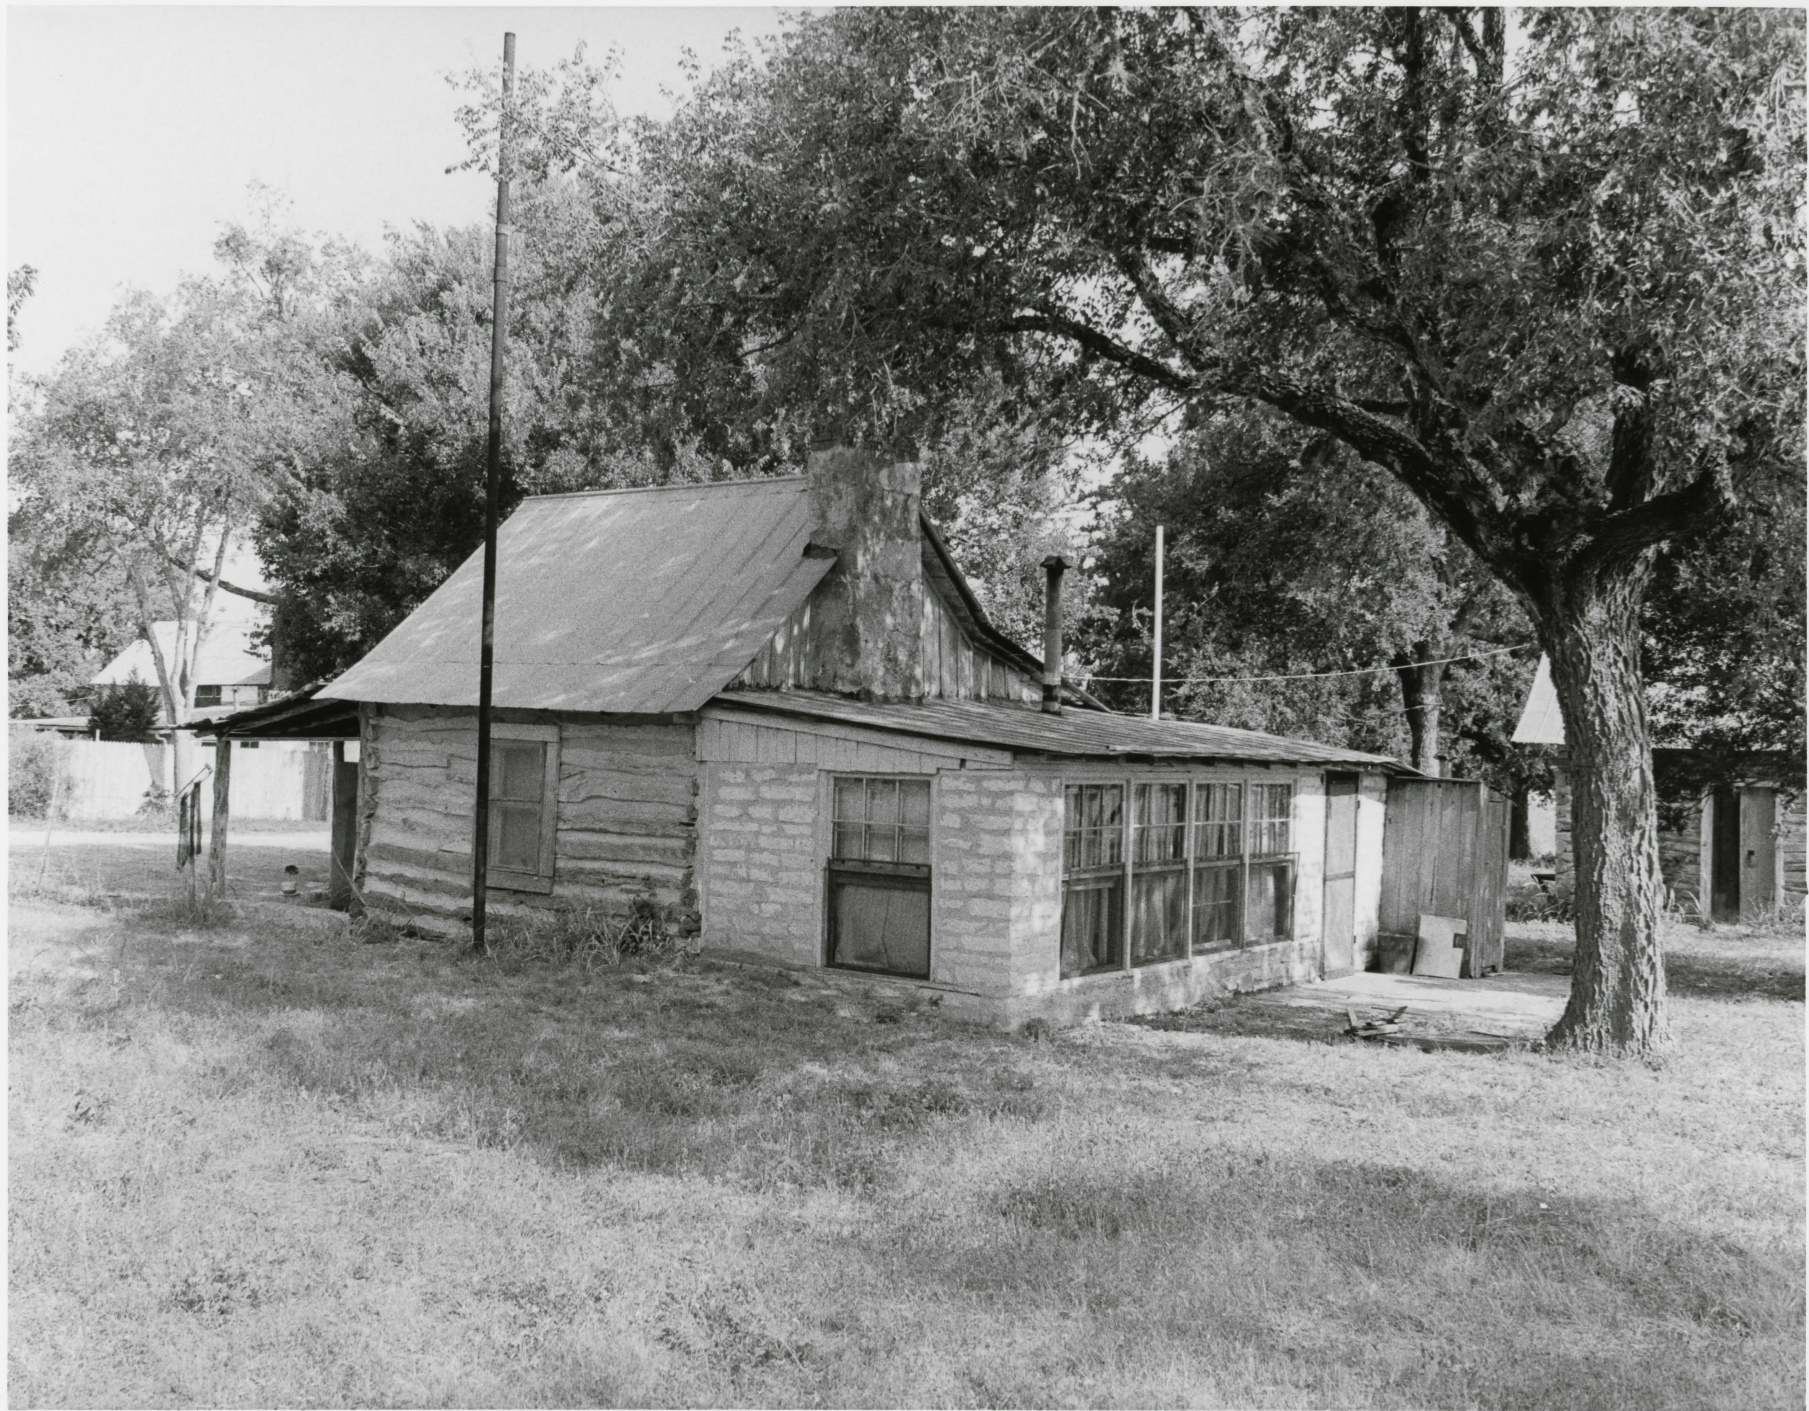
Photo 4 of 5

Southeast oblique view of George Plehwe House,  
Structure No. 3, looking northwest

The southernmost member of the compound, No. 3, is the structure believed to have been the residence of Charles Felix George von Plehwe. As in the case of the kitchen building, this structure combines limestone masonry and timber framing. The profile of the original residence can be seen most easily from the west, where the combination of hewn-log and limestone walling is clearly visible. There are two doors on the west side of the building, one each in the limestone and log sections. A porch canopy supported by cedar logs, shades this side of the house. The north elevation is nearly solid, with one small window opening. The west side of the structure is largely a result of a 20th-century renovation of uncertain date. Typical double-hung windows are placed side by side to create a sort of sun porch on that side of the house. The original roofline is still quite apparent, along with the original chimney shaft. The south elevation also combines new and original work, with the two periods of construction clearly visible. The principal change to this structure comes in the form of the east addition, with its limestone walls and large group of windows. The stone-walled lean-to on the north side appears to be either original or an early addition, and hence is part of the historic fabric.

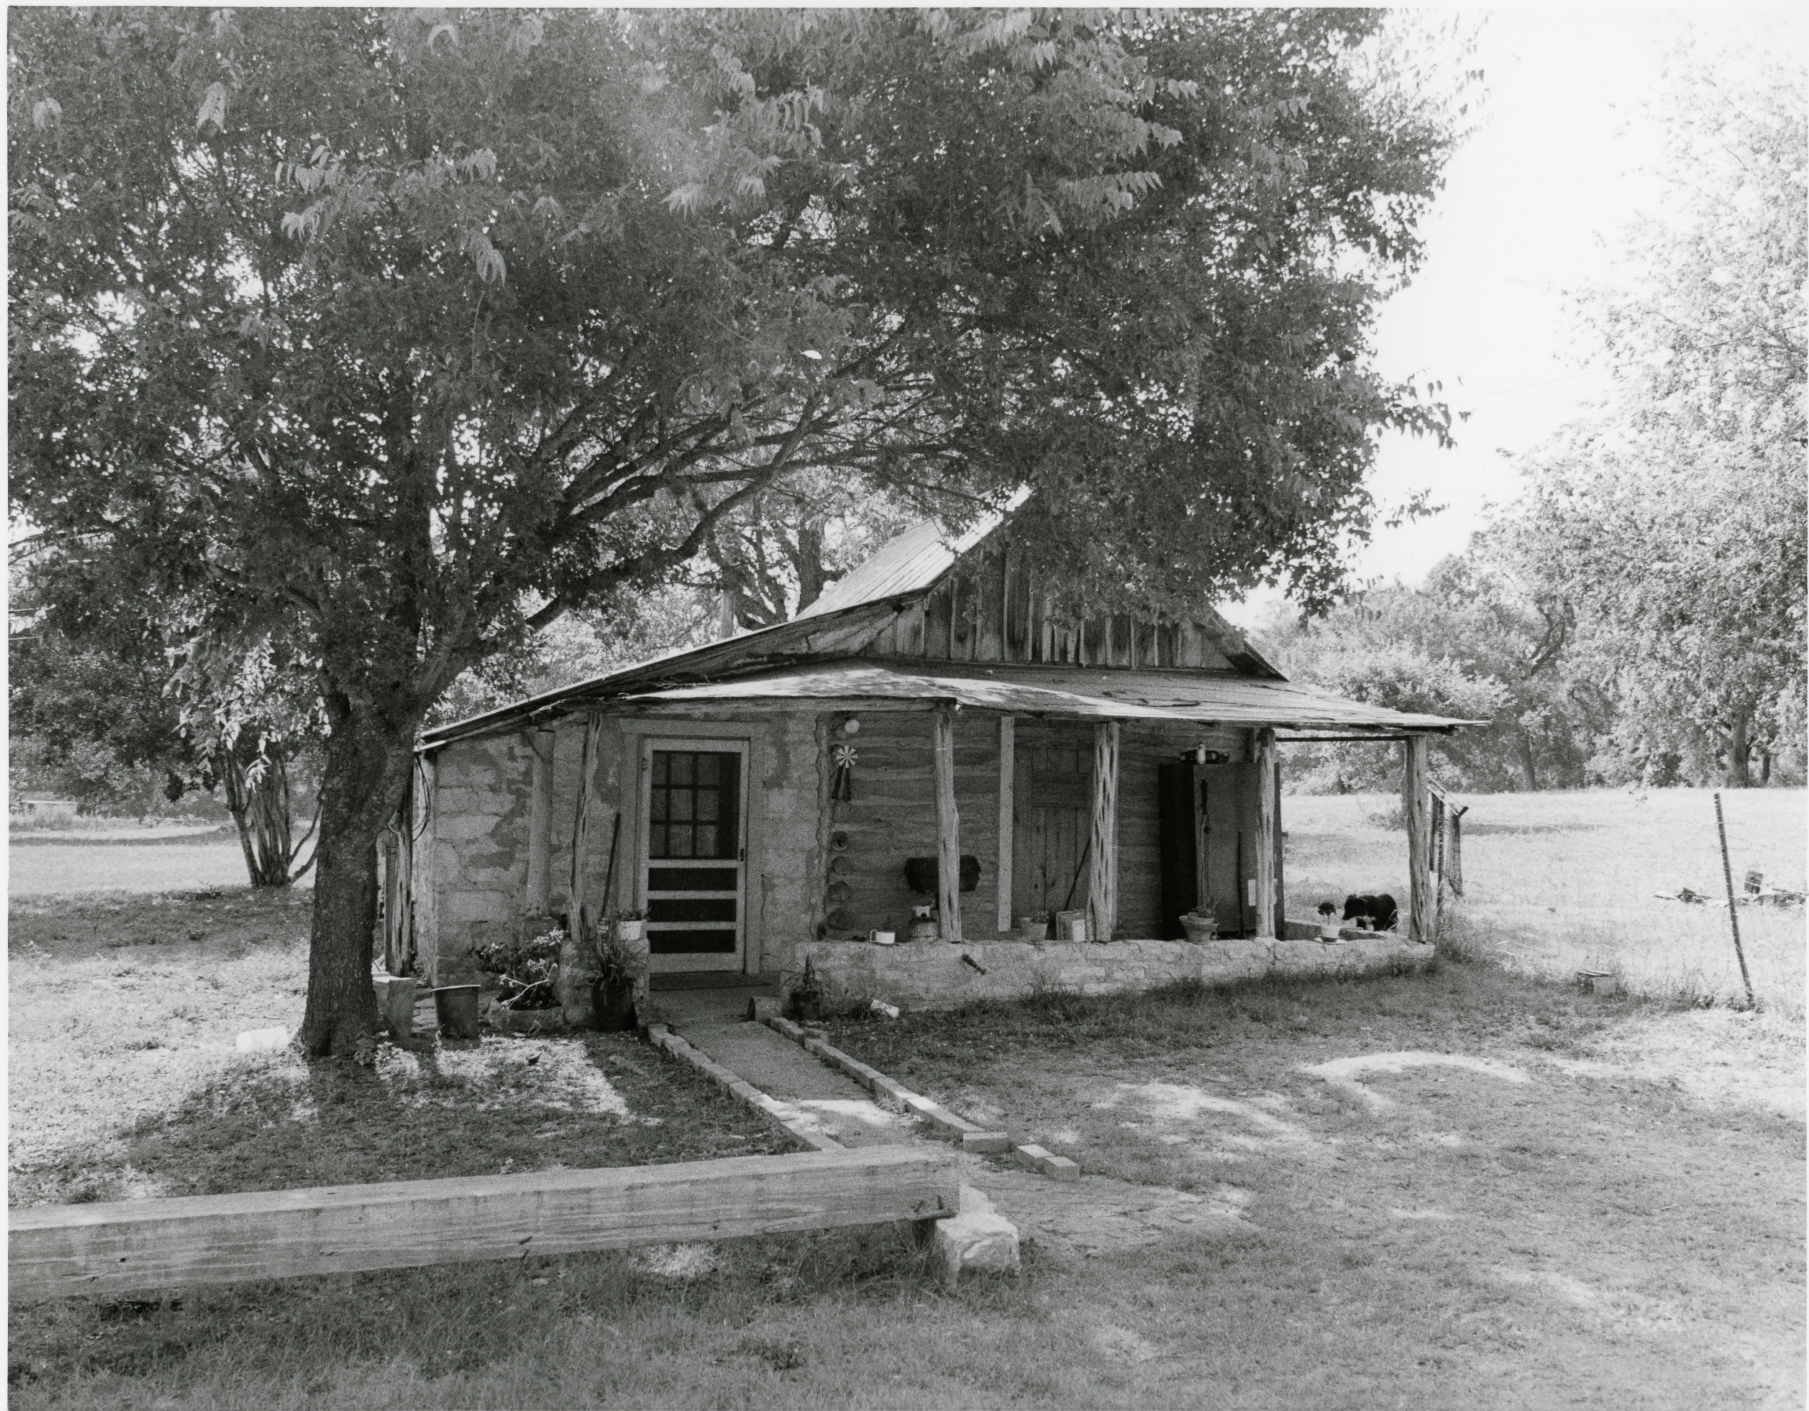
Photo 5 of 5

West elevation of George Plehwe House, Structure  
No. 3, looking east
