National Register of Historic Places
Inventory—Nomination Form

22. Name: [✓]Kone-[✓]Cliett House

Location: 724 Burleson Street

Historic Resources of San Marcos
San Marcos, Hays County, Texas

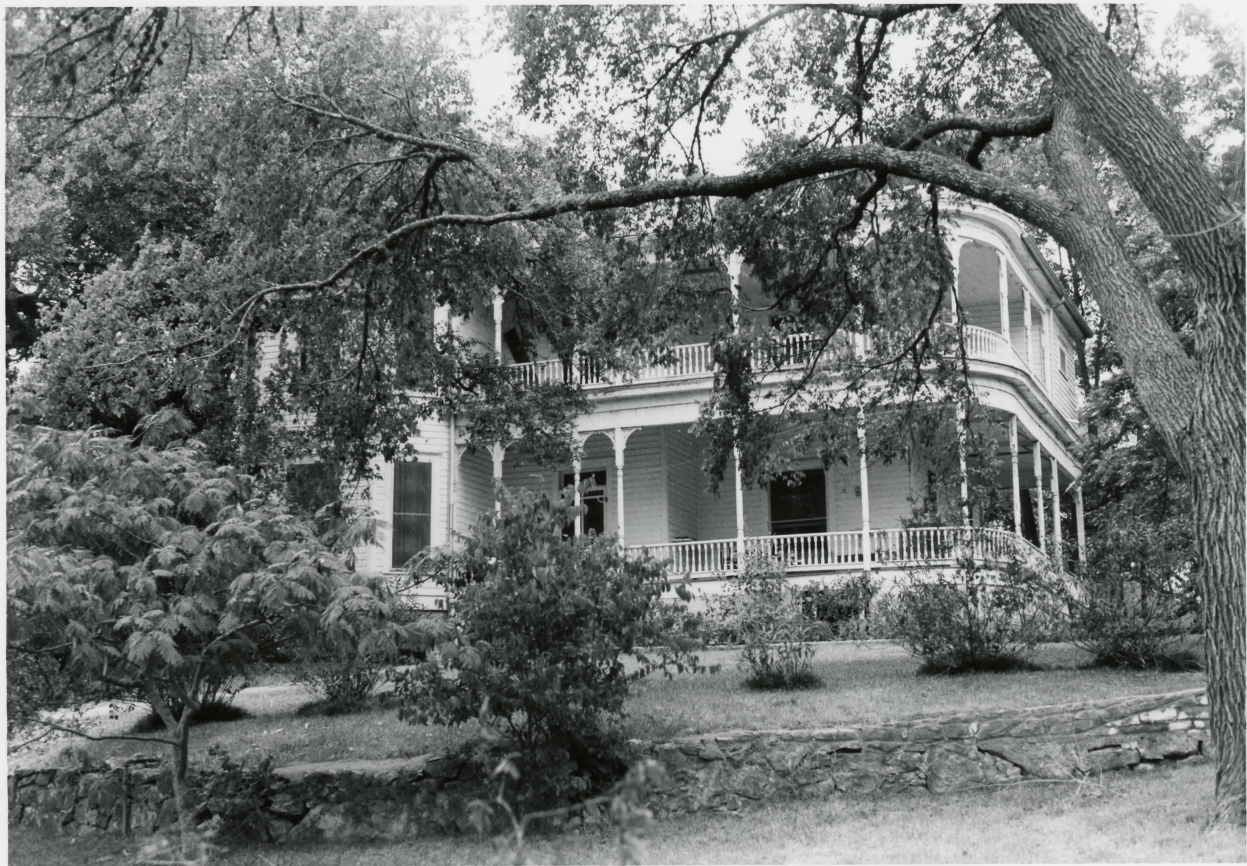
Photo 90 of 150.

East oblique, camera facing west.

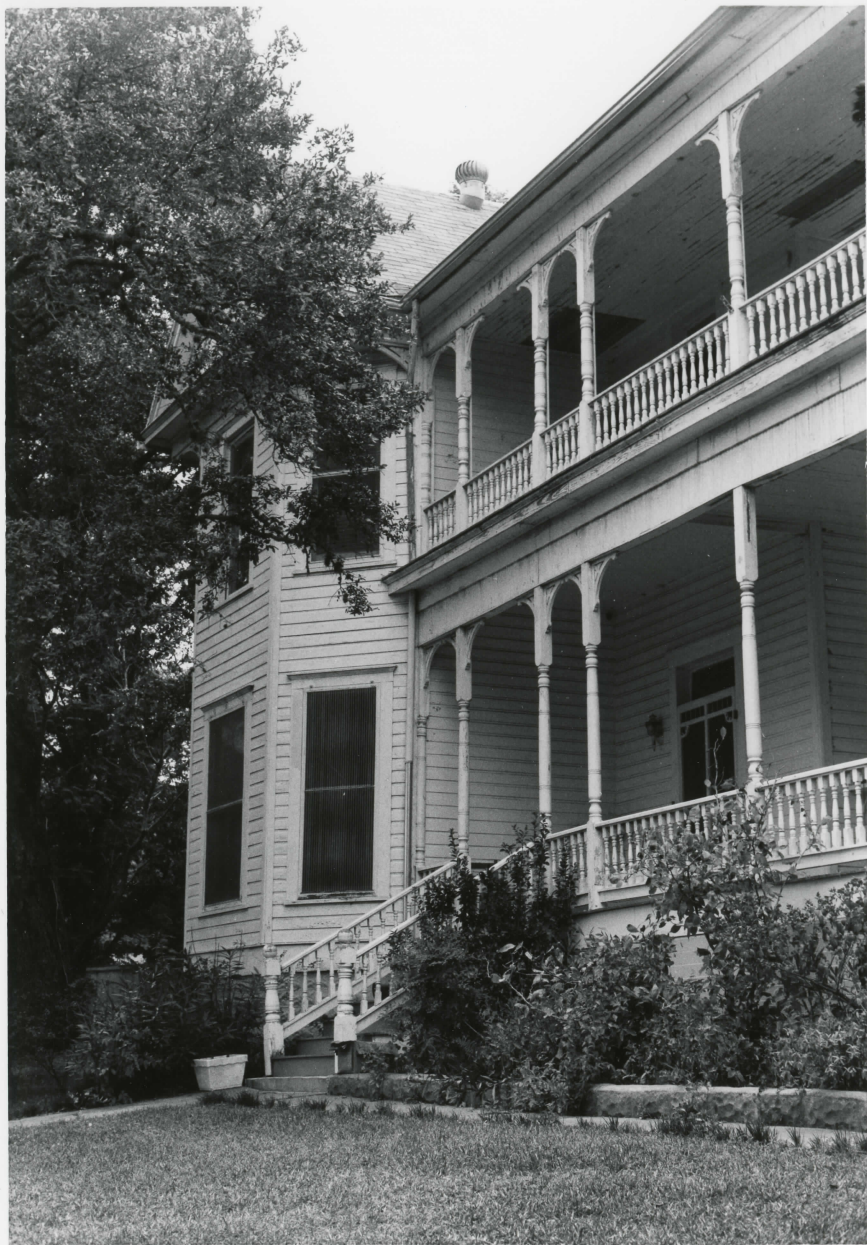
Photo 91 of 150.

East oblique of southeast facade, camera
facing west.

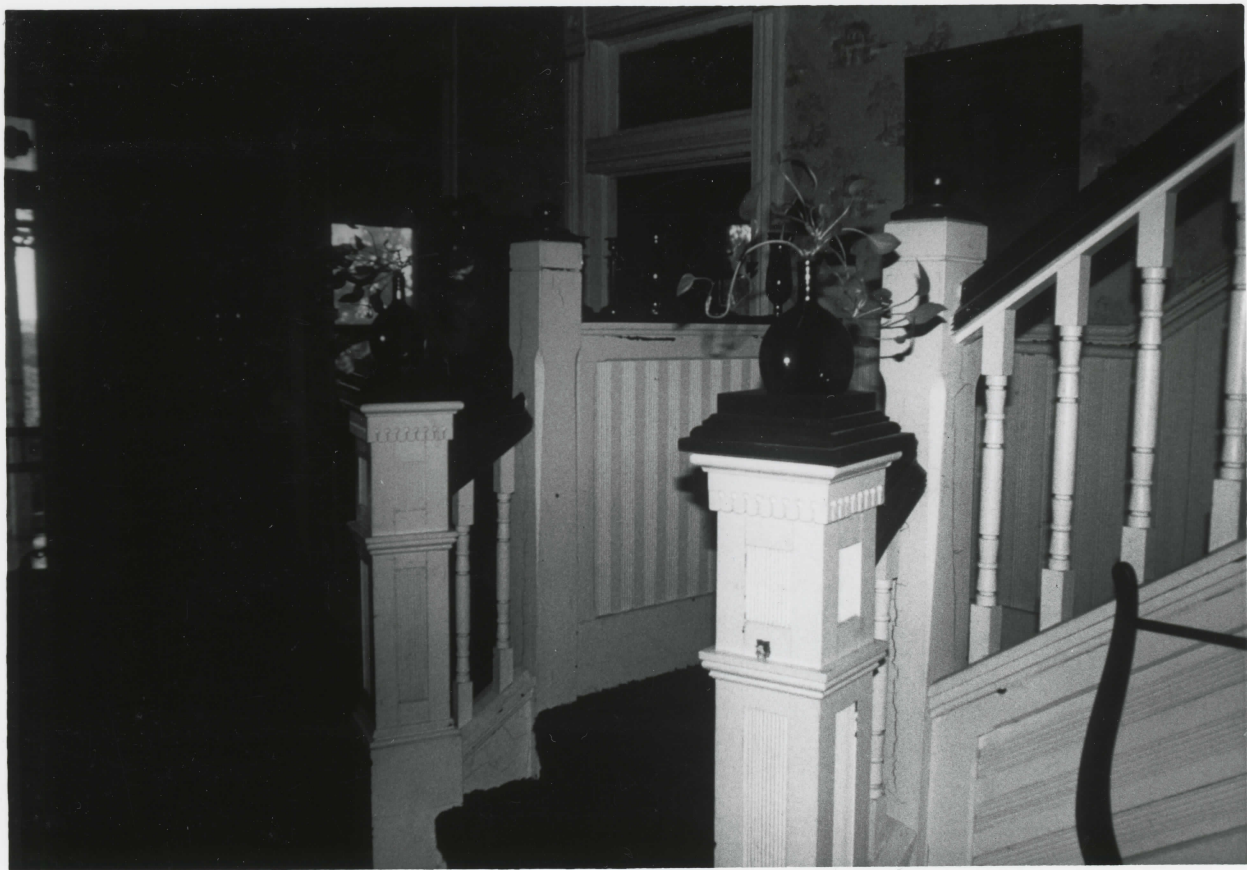
Interior, detail of stair.
Photo 92 of 150.

The centerpiece for the interior is a double stair that converges from the front entry and rear den to a common landing. Each stair is in several different sections, creating an interesting interplay of planes, and is decorated with beading and carved newels. Beading is used liberally for walls and ceilings. Bullseye moldings are common in the front part of the house, plain frames in the back. A built-in gun rack is a feature upstairs.

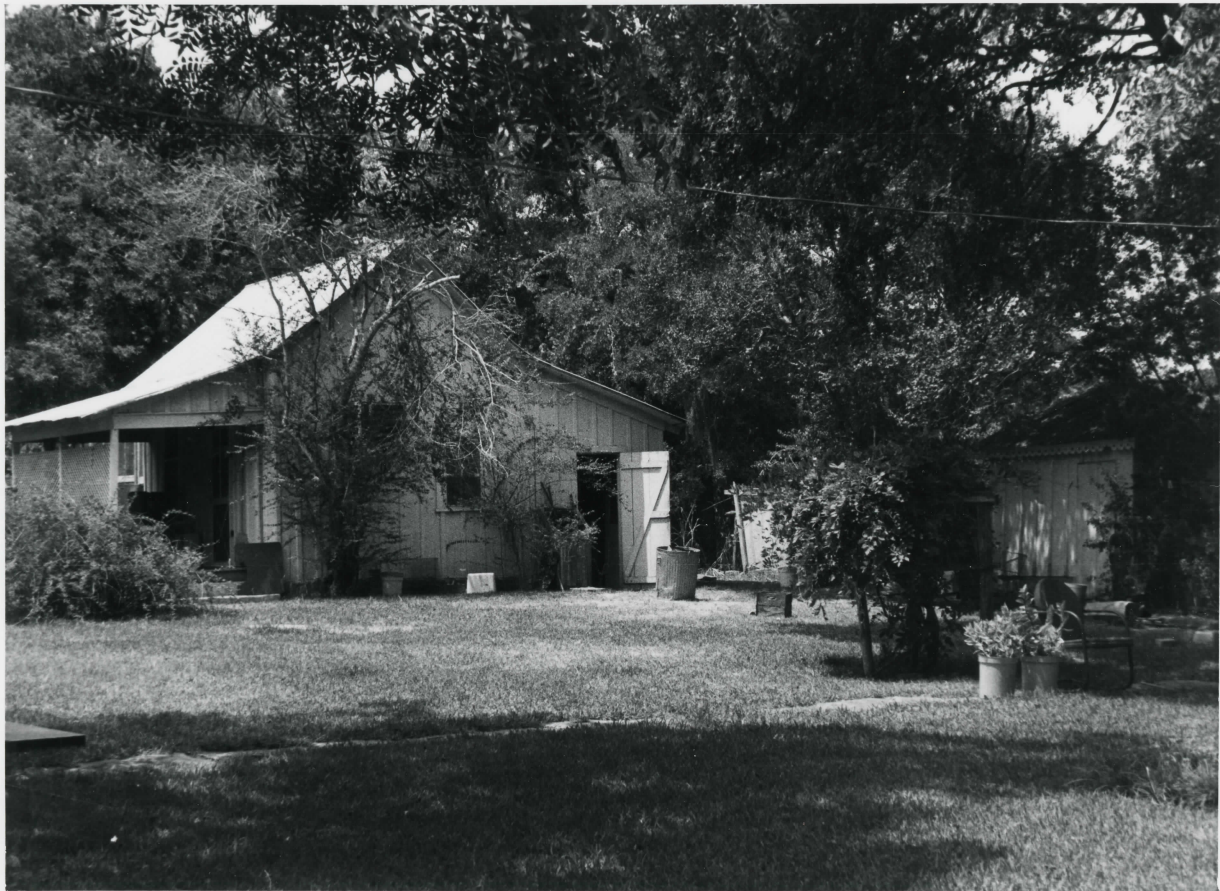
Photo 93 of 150.

Fortunately, several outbuildings have survived, and should be considered as contributing to the property. They are (1) a saltbox-shaped, board-and-batten servants' quarters, with V-crimp metal roof and inset porch; (2) a well house with a diagonally laid, V-crimp roof and scalloped eyelet trim under the eaves; (3) a board-and-batten garage with hipped roof; (4) a board-and-batten stable with corrugated metal roof and concrete floor; (5) and a three-holer outhouse. The structures are near the front of the lot, which reaches deep into a wooded area.

East oblique of servants' quarters and well-
house, camera facing west.
