National Register of Historic Places  
Inventory—Nomination Form

23. Name: Barber House

Location: 1000 Burleson Street

#23. Barber House

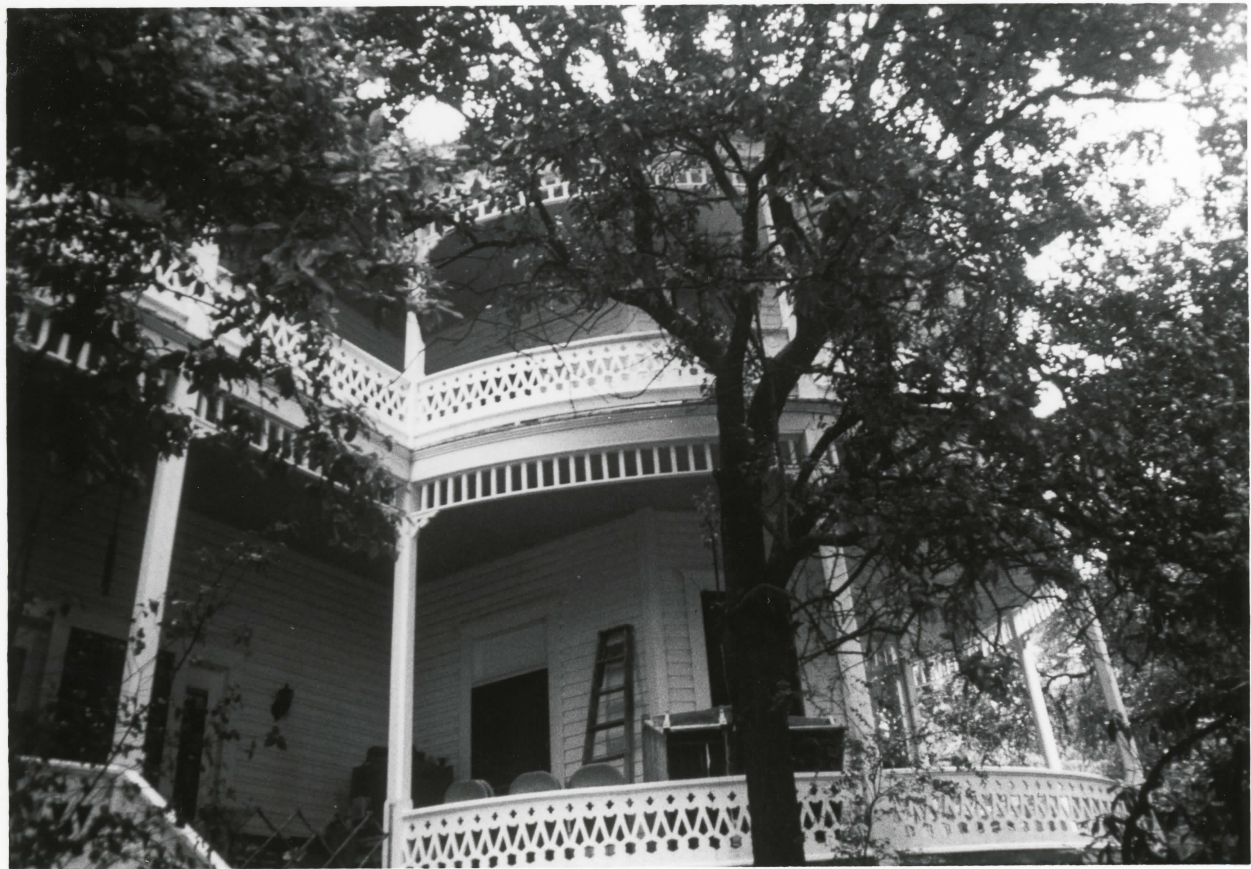
Photo 95 of 150.

Southeast **facade**, camera facing north.

Of many beautiful views in San Marcos, that from the Barber House may be the loveliest. The setting on the wooded Balcones Fault bluff is perfect for the asymmetrical, two-story, white, frame Victorian house. Dominating the front, southeast facade is a double gallery extending the entire length and around the eastern section that surrounds a five-sided ell bay. The flat part of the porch is composed of three bays. Porch rails on both levels are jigsaw panels. The under-eave trim is simple little sticks in a double row on the second floor, in a single row on the first. Chamfered posts support the porch and sport sawn brackets. The wooden steps and porch floor remain intact.
