**National Register of Historic Places
Inventory—Nomination Form**

18. Name: ☒ Episcopal Rectory

Location: ☒ 225 West Hopkins Street

Episcopalian Rectory (San Marcos MRA)
Hays County
TEXAS

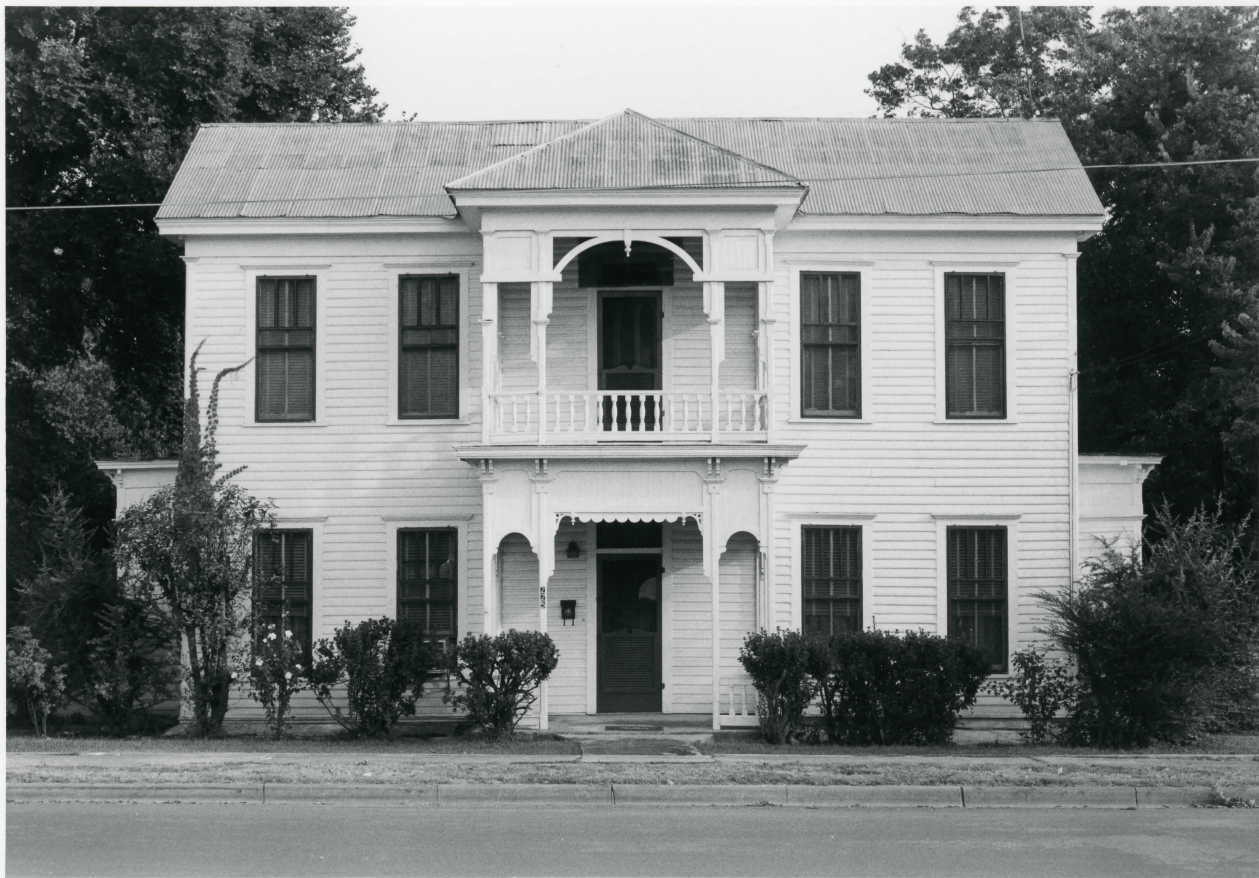
Historic Resources of San Marcos
San Marcos, Hays County, Texas
#18. Episcopal Rectory

North facade, camera facing south.
Photo 75 of 150.

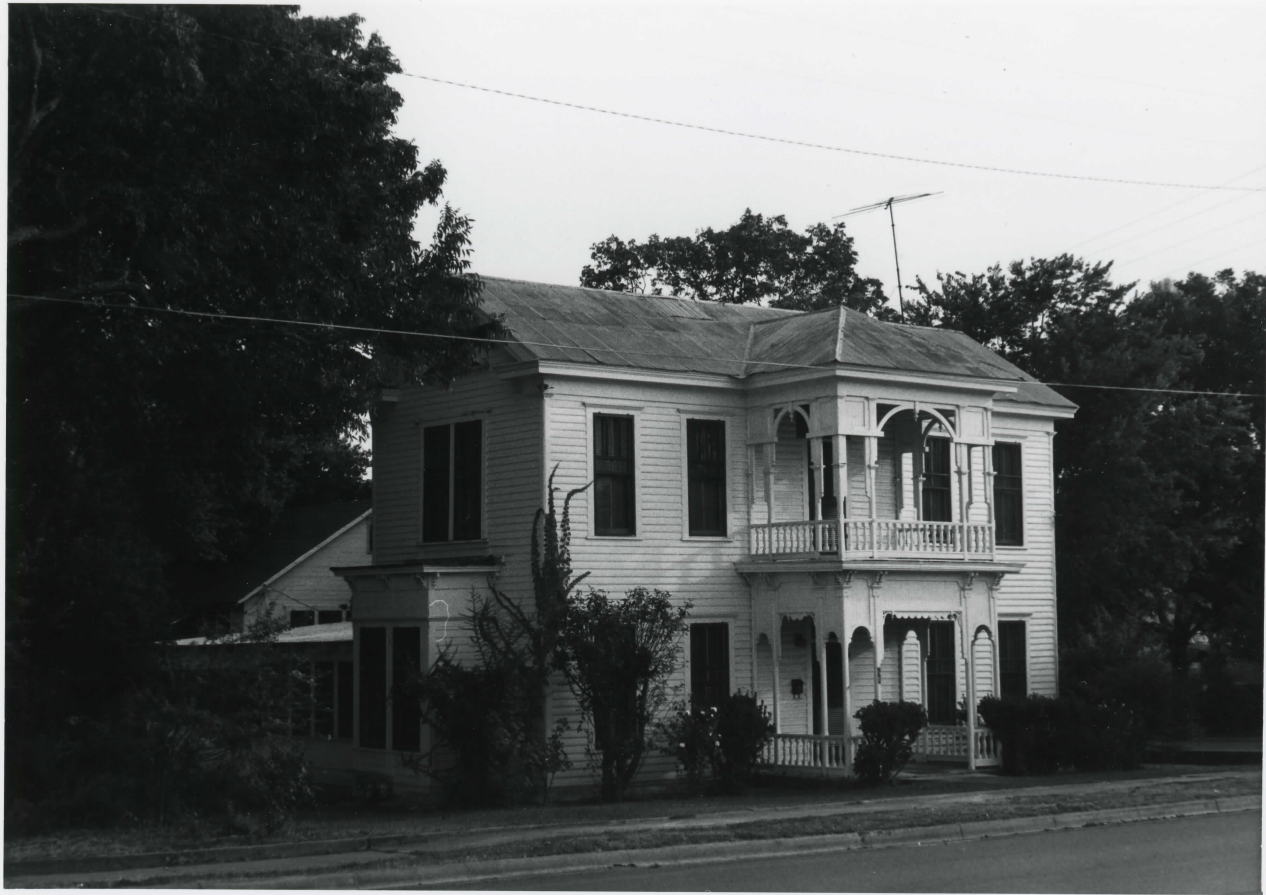
#18. Episcopal Rectory

Northeast oblique, camera facing southwest.
Photo 76 of 150.
