**National Register of Historic Places
Inventory—Nomination Form**

3. Name: Farmers Union Gin Company

Location: 120 Grove Street

Historic Resources of San Marcos
San Marcos, Hays County, Texas
#3. Farmers Union Gin Company

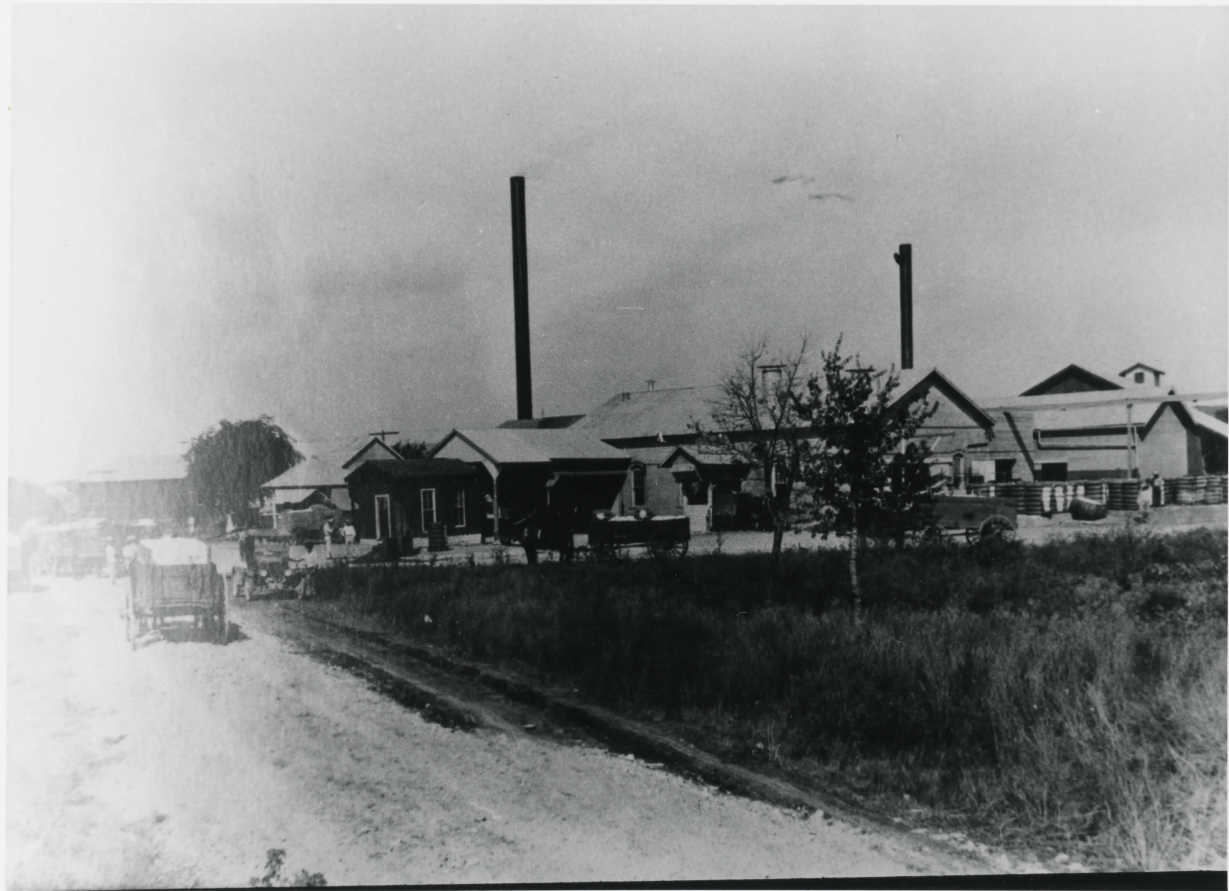
Negative property of HASM, on file at SMPL.
Southeast oblique, camera facing northwest.
Photo 13 of 150.

Photo courtesy of Randall Morris, taken c.
1919-1920. Copy photo by Sally S. Victor,
July, 1982.
