National Register of Historic Places
Inventory—Nomination Form

7. Name: Fisher Hall (~~also known as Boy's Dorm, Coronal Institute. Common name~~ Pi Kappa Alpha Fraternity House)

Location: 1132 Belvin Street

Historic Resources of San Marcos
San Marcos, Hays County, Texas
#7. Fisher Hall

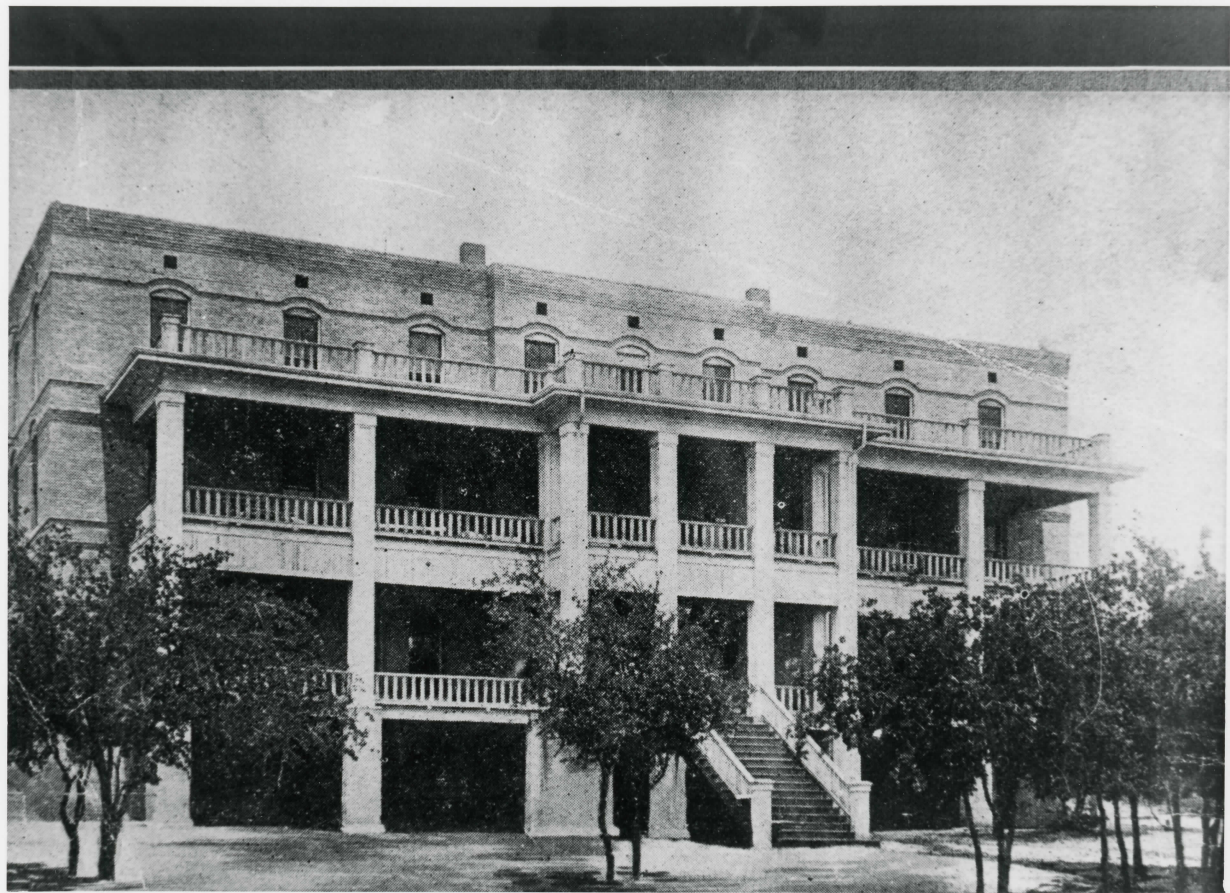
Photo 31 of 150.

Photo courtesy of PKA Fraternity, dated 1928.
Copy photo by Sally S. Victor, negative
property of HASM, on file at SMPL.

Southeast facade, camera facing north.

As constructed, the dorm had no front porch, but did have pointed caps at its corners, resembling stylized anathemia. When they were removed is not known, but it was prior to 1928 when a photo was taken that shows a square, pillared gallery with a three-bay entrance pavilion that extended almost to the end walls (built 1923). The present porch was built between 1928 and 1931. These changes, although dramatic, should not be considered inappropriate alterations. They were the natural result of the building's changing uses and have gained their own significance with the passage of time.

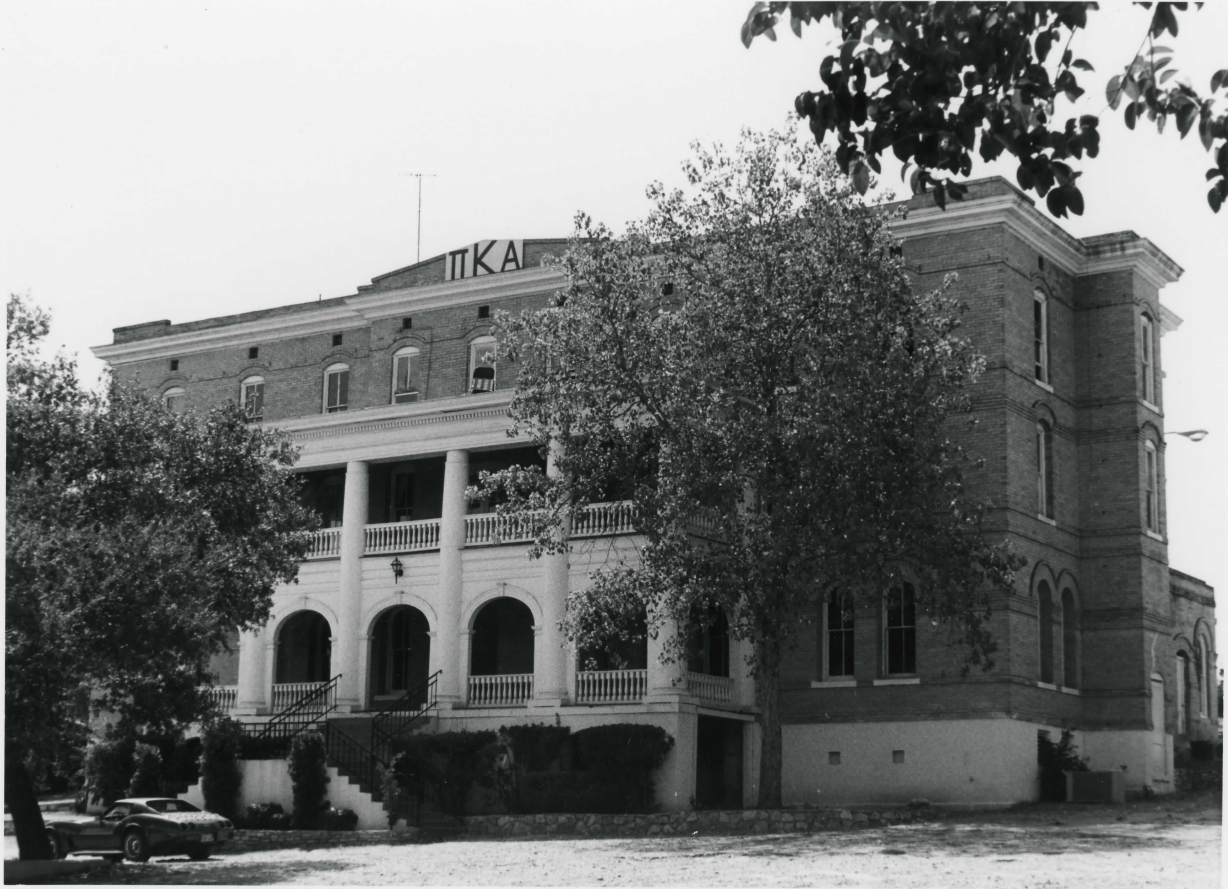
East oblique, camera facing west.
Photo 32 of 150.

Set at the end of a large yard that was originally used as a parade ground is the three-story, buff-brick Fisher Hall. The dominant feature of the building is the substantial five-bay frame porch on the primary, or east facade. The porch is framed by massive unfluted columns, and has pilasters at the point where the porch frame joins the wall. While the columns have lost their capitals the pilasters still retain their Ionic caps. The first floor of the porch features broad, round arches between the columns, each with a simple keystone element. The entire porch is topped by a simple entablature with a dentiled cornice. The porch railings are formed by turned spindles. The majority of the windows on the first floor are paired under round-arch openings formed by rowlock arches. The windows of the second and third floors are set in openings formed by segmentally arched rowlock arches. All of the windows have sashes with two-over-two lights. Double doors open on to the porch on both the first and second floors. The walls are articulated by string courses, the majority of which serve to connect the window sills and arches to one another.

The east elevation features a central bay that projects from the wall plane and rises the full height of the structure. The west elevation is a flush wall to which a fire escape is attached. The north elevation features a two-story extension that appears to be original, but has had some alterations, including the addition of a frame utility shed. The south, east, and west elevations are topped by a plain brick parapet with a molded metal cornice.
