**United States Department of the Interior
National Park Service
National Register of Historic Places
Inventory—Nomination Form**

12. Name: Green and Faris Buildings
(~~Common names - First National Bank Building, San Marcos Title Company Building~~)

Location: 136-144 ~~East~~ San Antonio Street

Historic Resources of San Marcos
San Marcos, Hays County, Texas
#12. Green and Faris Buildings

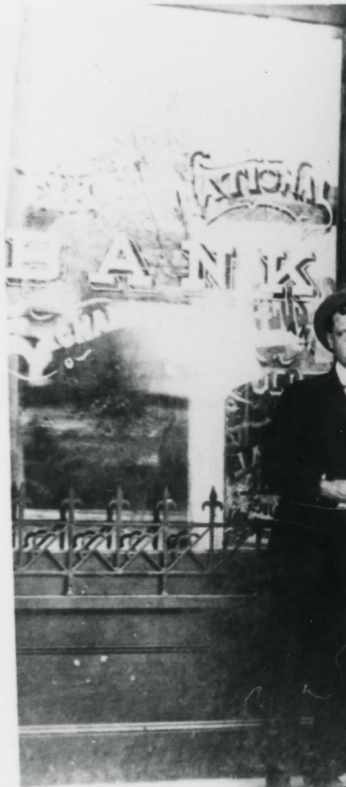
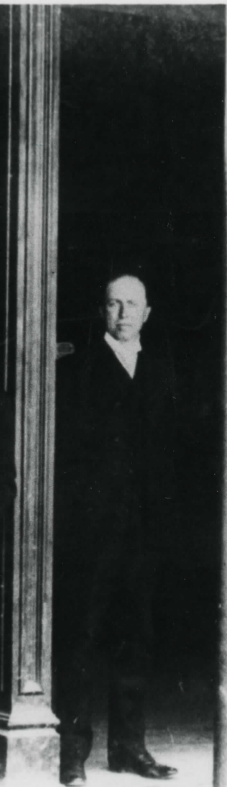
Photo 54 of 150.

North facade, camera facing south.

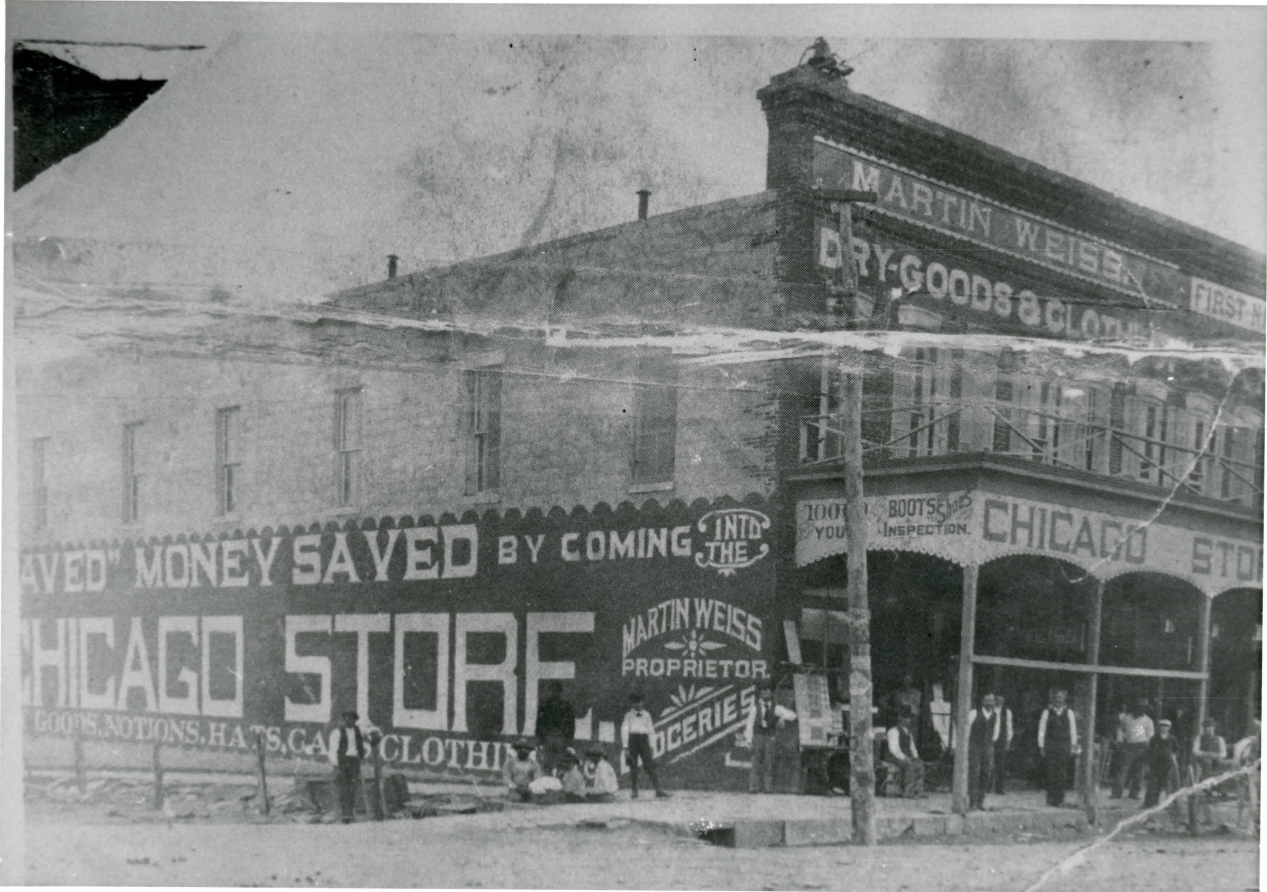
Northeast oblique, camera facing southwest.
Photo 55 of 150.

Photo courtesy of San Marcos Public Library,
c. 1900. Copy photo by Sally S. Victor,
negative property of HASM, on file at SMPL.

As built, the window panels at 140-144 were set back from the posts and trimmed with wrought iron. A photo taken about 1900 shows the unpainted dark brick in contrast to the limestone and lighter segmental arches. The canopy at that time appears to be wood, with a scalloped "eyelet" edging and a railed balcony above. This configuration was probably original, and is barely visible in an 1881 bird's eye map. No photos have been found of the 136-138 section.
