National Register of Historic Places
Inventory—Nomination Form

13. Hardy-Williams Building (~~Common names - Williams Pharmacy, Hillburn's Pharmacy~~)

Location: 127 East Hopkins Street

Historic Resources of San Marcos
San Marcos, Hays County, Texas
#13. Hardy-Williams Building

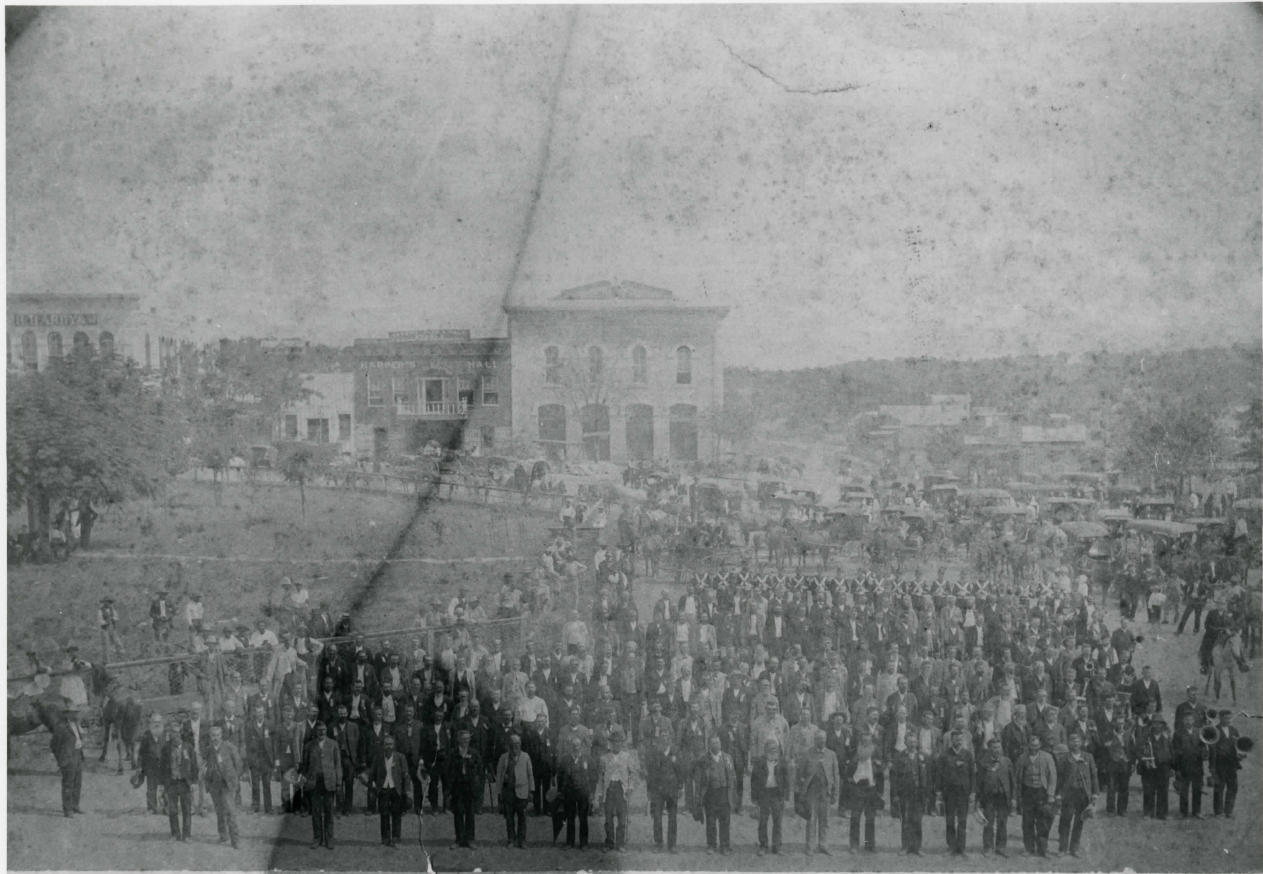
Photo 59 of 150.

Photo courtesy of San Marcos Public Library,
dated 1886, negative on file at SMPL.

Subject is at far left. South facade,
camera facing north.

The front facade is defined by a slight indentation back from its corners and cornice. An early photoshow that a more elaborate cornice, probably metal, once capped the structure. It was removed sometime between 1916 and the 1940s. A double door for horse carts is remembered by an informant, but its exact location is not. It may have been at the rear, to which was added a one-story addition in 1920. This addition, although unattractive, is effectively hidden and connected directly inside.

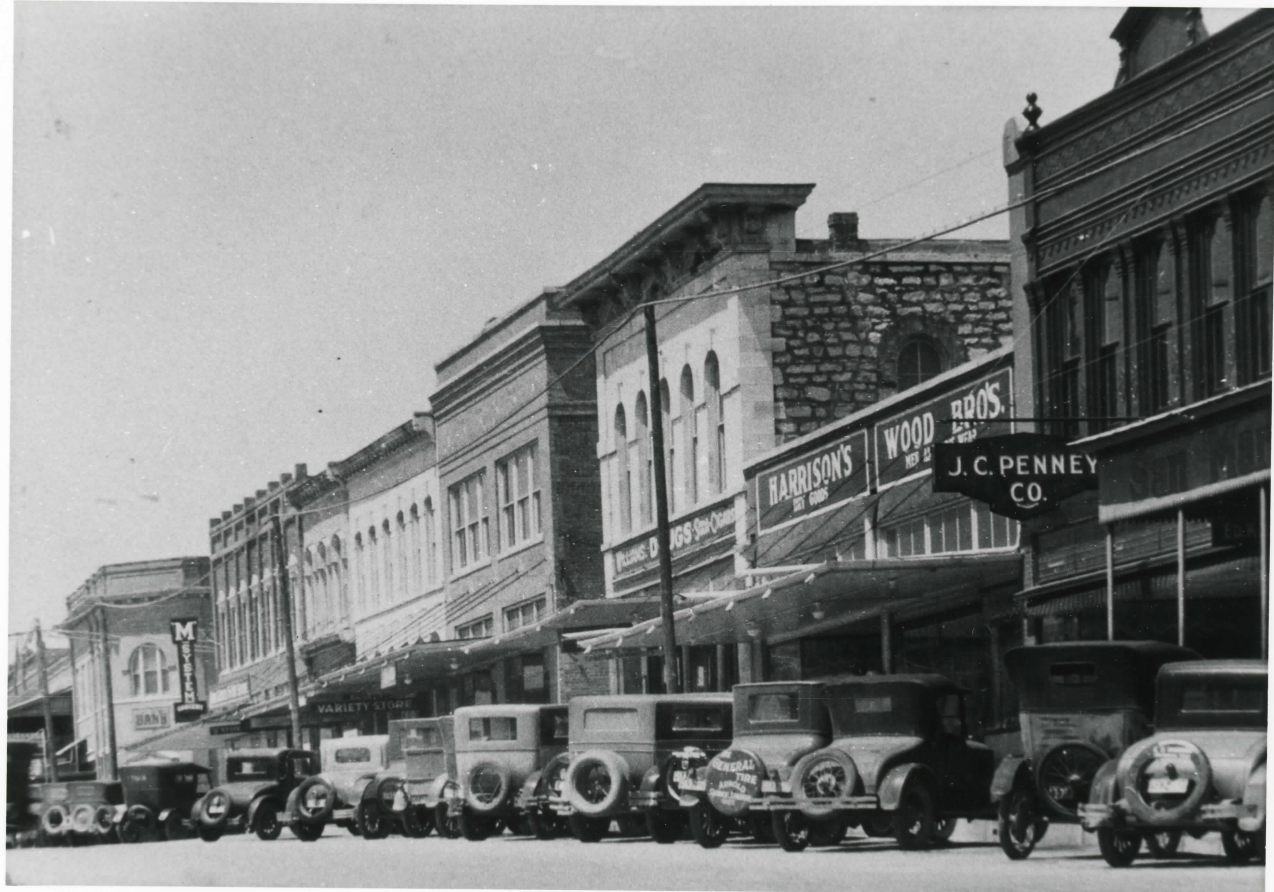
Photo 60 of 150.

Photo courtesy of Tula Townsend Wyatt, dated
1916 (?). Copy photo by Sally S. Victor,
negative property of HASM, on file at SMPL.

Subject is at center. Southeast oblique,
camera facing northwest.

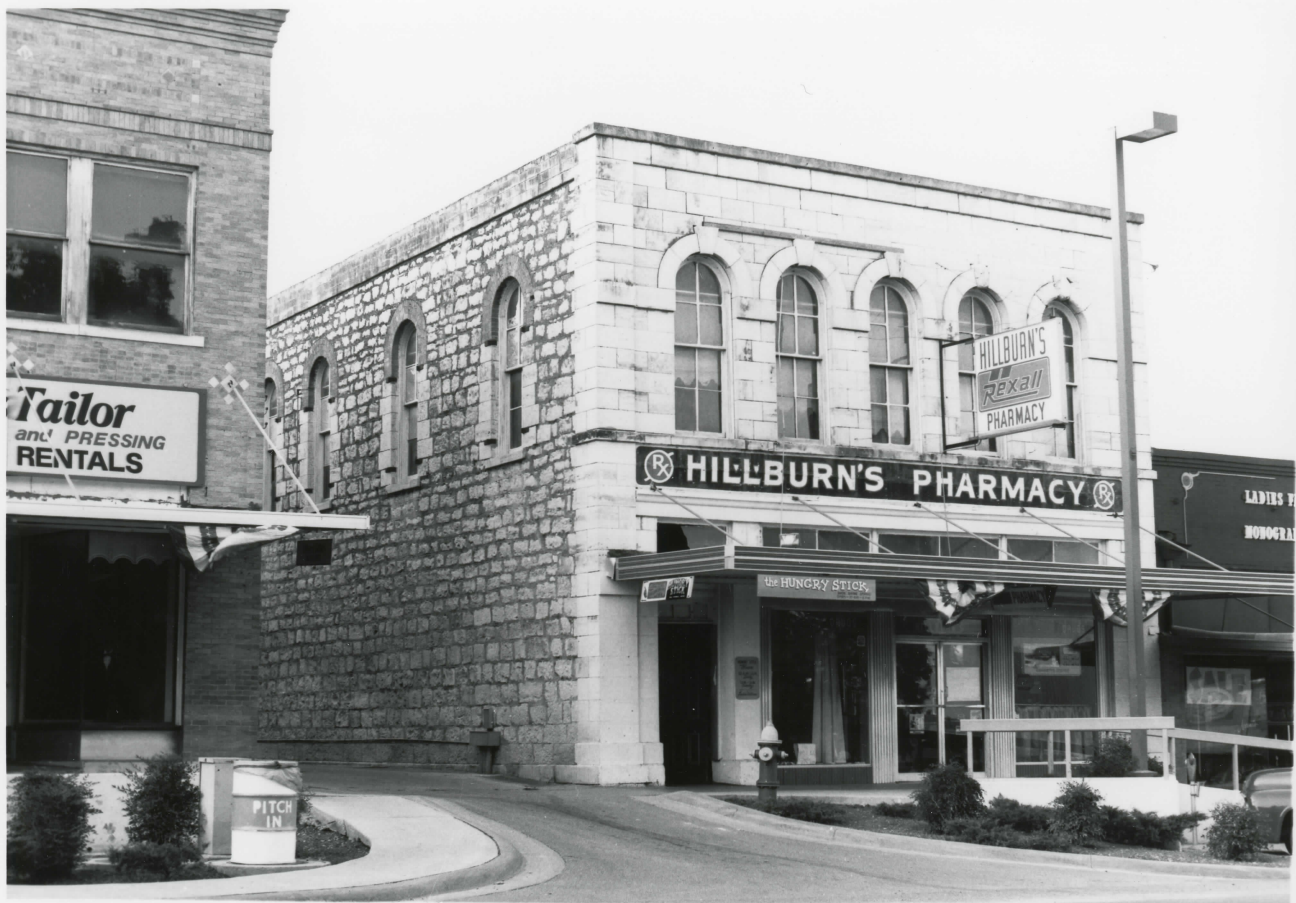
Photo 61 of 150.

Photo by Marian Oles, June, 1982.
Negative property of Marian Oles, Studio II.

Southwest oblique, camera facing northeast.

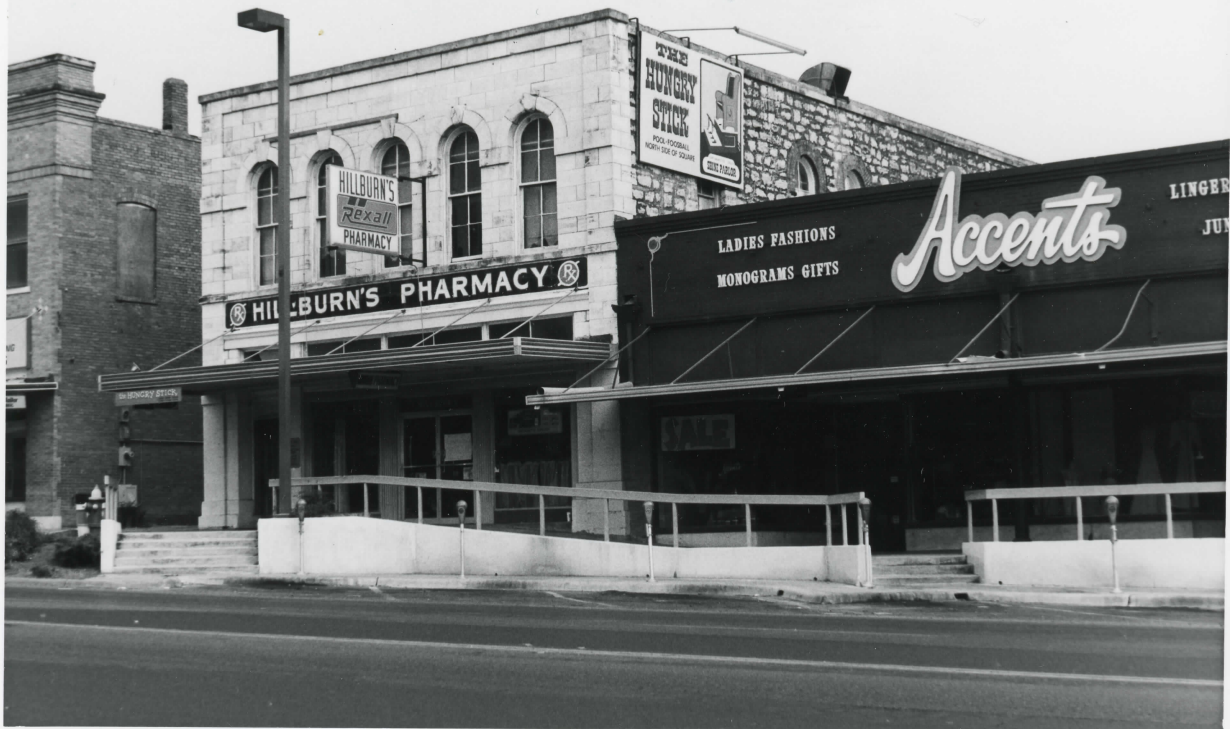
Photo by Lissa Anderson, July, 1982.
Negative property of HASM, on file at SMPL.

Southeast oblique, camera facing northwest.
Photo 62 of 150.
