National Register of Historic Places  
Inventory—Nomination Form

28. Name: Hofheinz, Augusta, House

Location: 1104 West Hopkins Street

Significance: Period - 1900- ; Areas of significance - architecture;  
Specific dates - 1908-09. Mead and Eastwood, architects,  
Horace Leffingwell and sons, contractors.

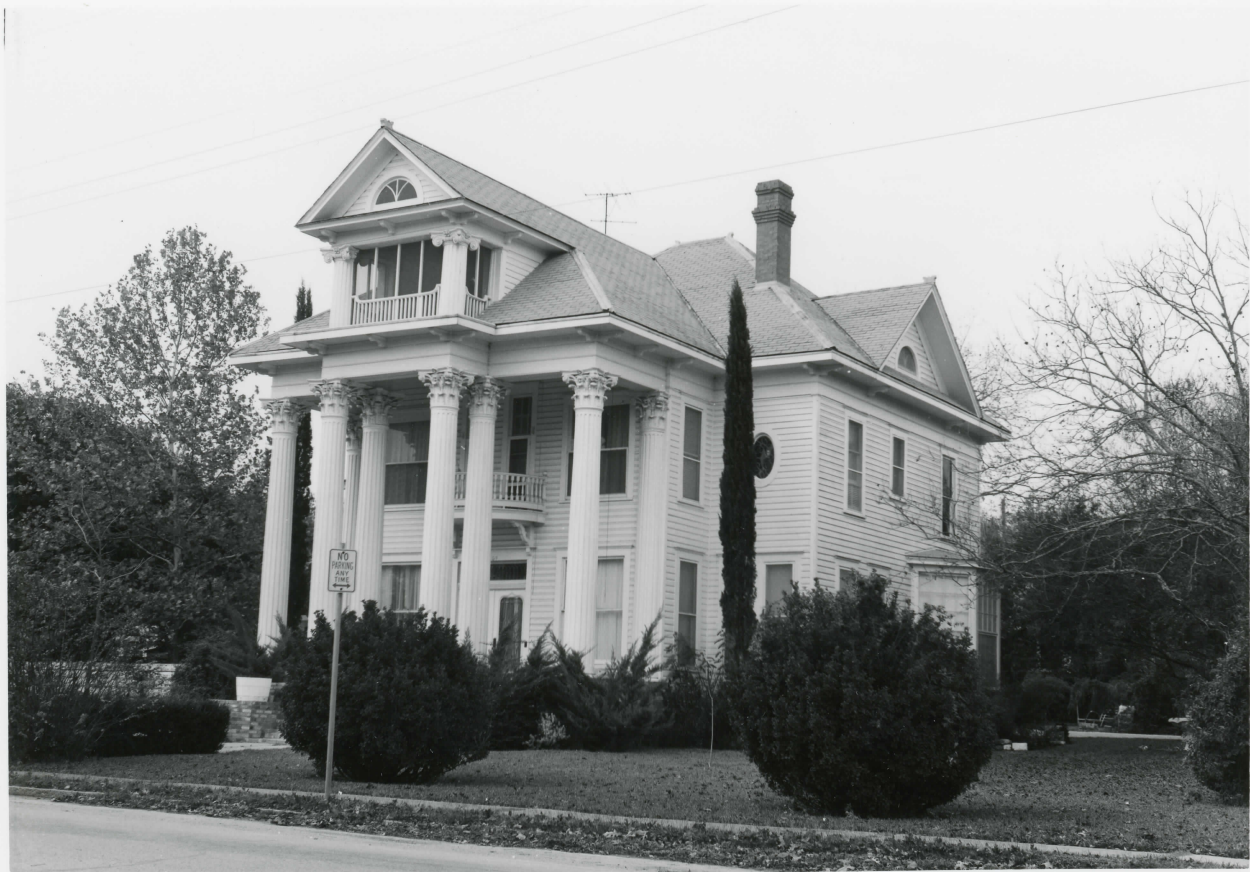
#28. Hofheinz, Augusta, House

East oblique, camera facing west.  
Photo 112 of 150.

Reflecting the impact of the Beaux Arts-style exposition buildings on domestic architecture, the August Hofheinz House is a two-and-a-half-story, white, frame residence dominated by eight colossal Corinthian columns that hold up a hipped portico, and by short Ionic columns above that support a small, gabled, pedimented dormer. The appearance of a full extra floor is achieved by the dormer, which has been screened in flush with its post rail, and opens to the spacious attic floor. There is a small fanlight within the pediment. Attached to the second floor is a semicircular balcony on carved brackets with a spindle rail. Architraves occur below the bracketed eaves of both the dormer and the main roof. The facade is symmetrical in effect.

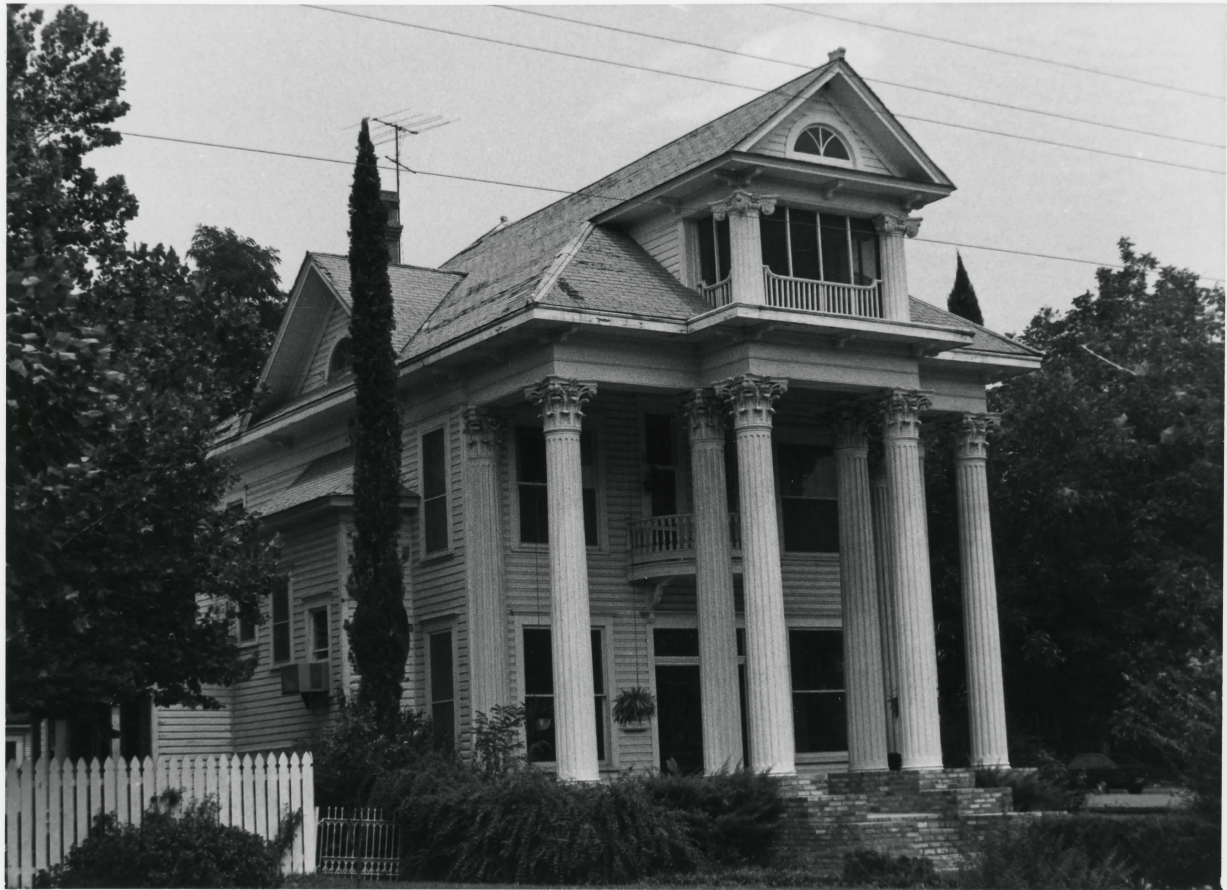
#28. Hofheinz, Augusta, House

South oblique, camera facing north.  
Photo 113 of 150.

The only disruptive exterior alteration is the brick porch which replaced a wooden one. The present owners may paint the brick white, while contemplating further restoration of it.

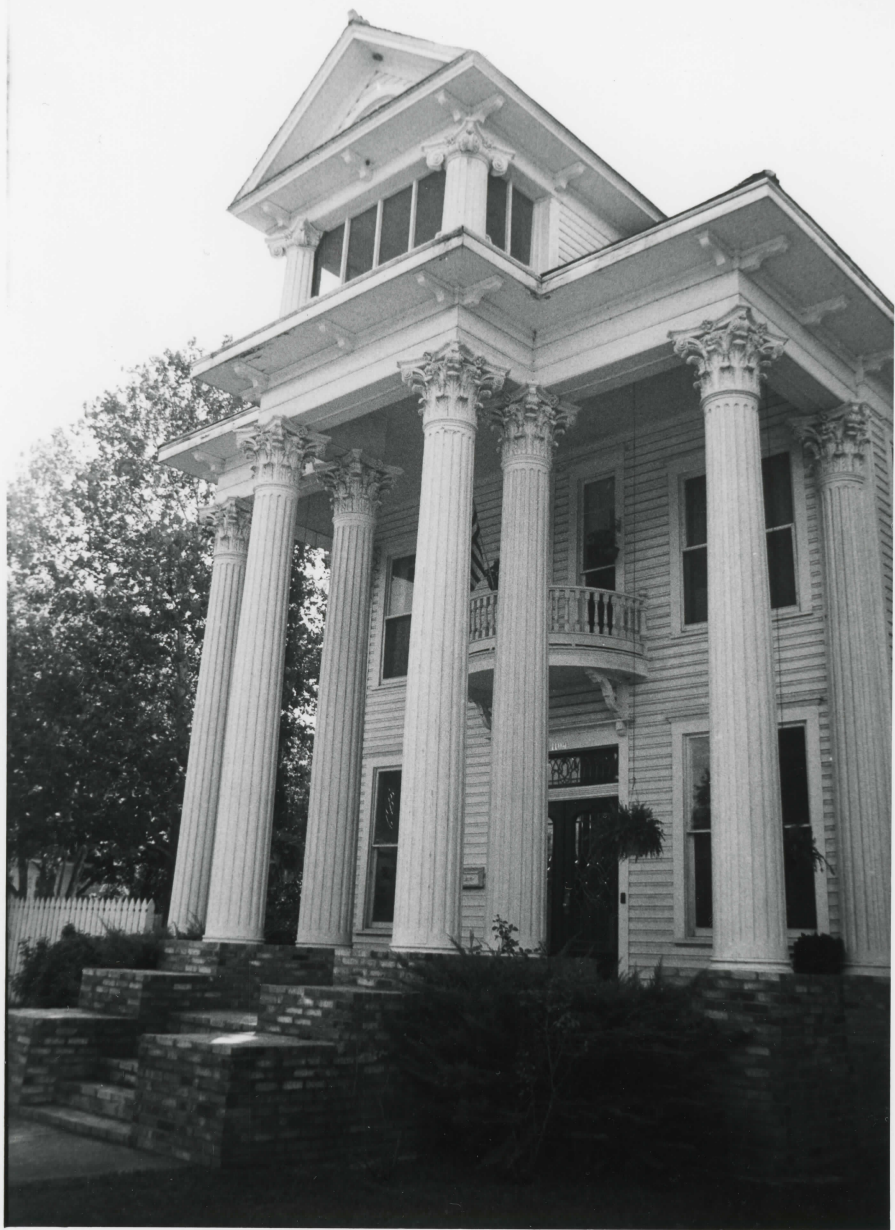
#28. Hofheinz, Augusta, House

Detail of southeast facade, camera facing west  
Photo 114 of 150.

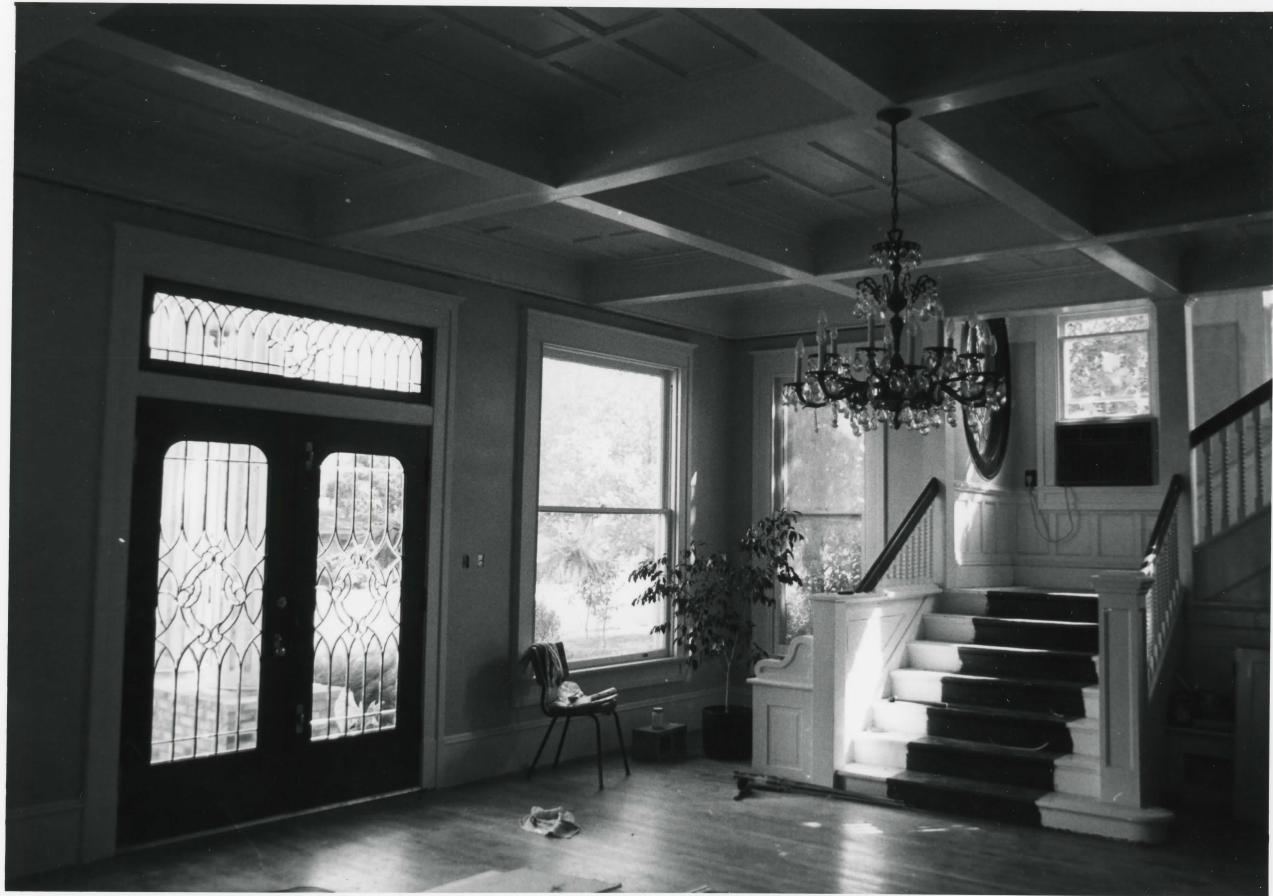
#28. Hofheinz, Augusta, House

Livingroom interior, camera facing west.

To the southeast of the living room is a stair embellished with a small egg-and-dart molding, and with lathed balusters of a stick-and-ball configuration. The ceiling of the large room is deeply coffered, with moldings creating rectangular shapes within the coffers. A freestanding fireplace leads to one of the two red brick chimneys. Window lifts and doorknobs are original brass and copper.

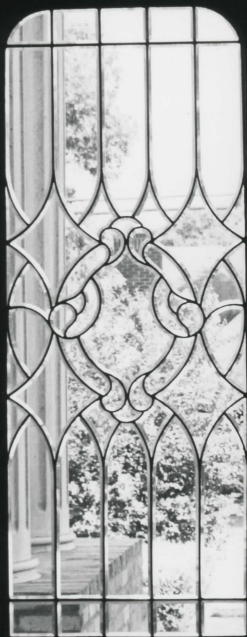
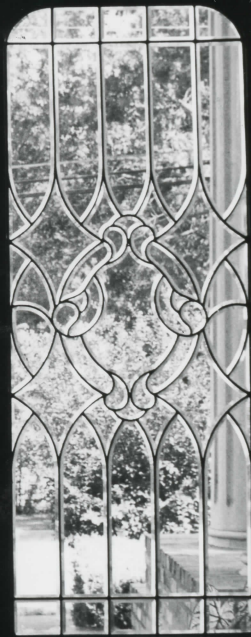
#28. Hofheinz, Augusta, House

Detail of livingroom - front door.

The hipped roof, with its cross gables, was once covered with wooden shingles, but is now under composition shingles. Extensions from the side walls are decorated with large oval windows filled in with a curvilinear beveled-glass design. Two rectangular beveled windows pierce the dining room's northwest wall. Other windows have one-over-one lights, those on the front facade being extra wide. A bay window on the northeast wall has twelve-over-twelve lights but is modern. The double front door contains long panels of beveled glass and is topped by a beveled transom.
