United States Department of the Interior
National Park Service
National Register of Historic Places
Inventory—Nomination Form

21. Name: Hutchison House

Historic Resources of San Marcos
San Marcos, Hays County, Texas

#21. Hutchison House

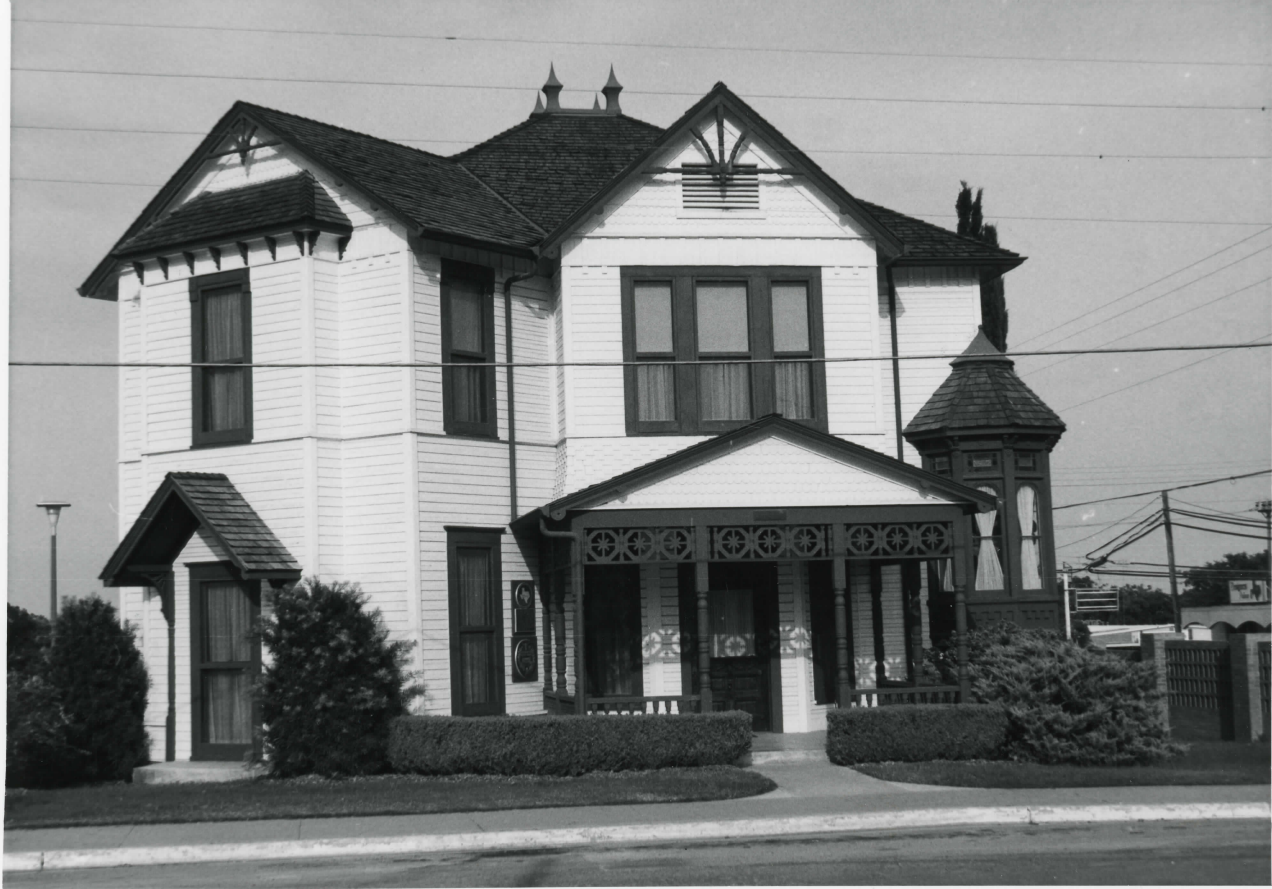
#21. Hutchison House

West facade, camera facing east.
Photo 86 of 150.

The front facade on LBJ Drive includes a one-story, low-pitched porch with pediment and turned posts. An unusual, cut-out medallion design, spaced between small spindles, forms the under-eave trim. The second-floor triplet of sash windows with one-over-one lights is set below a spindle bargeboard in the gable end, and above a course of decorative square-sawn shingles. The diagonal bay carries a two-story square bay with curved brackets and a small gable over a small porch on the first floor. Each little roof shelters a window with one-over-one lights. A similar squared bay is found on the south wall, where there are two window triplets,

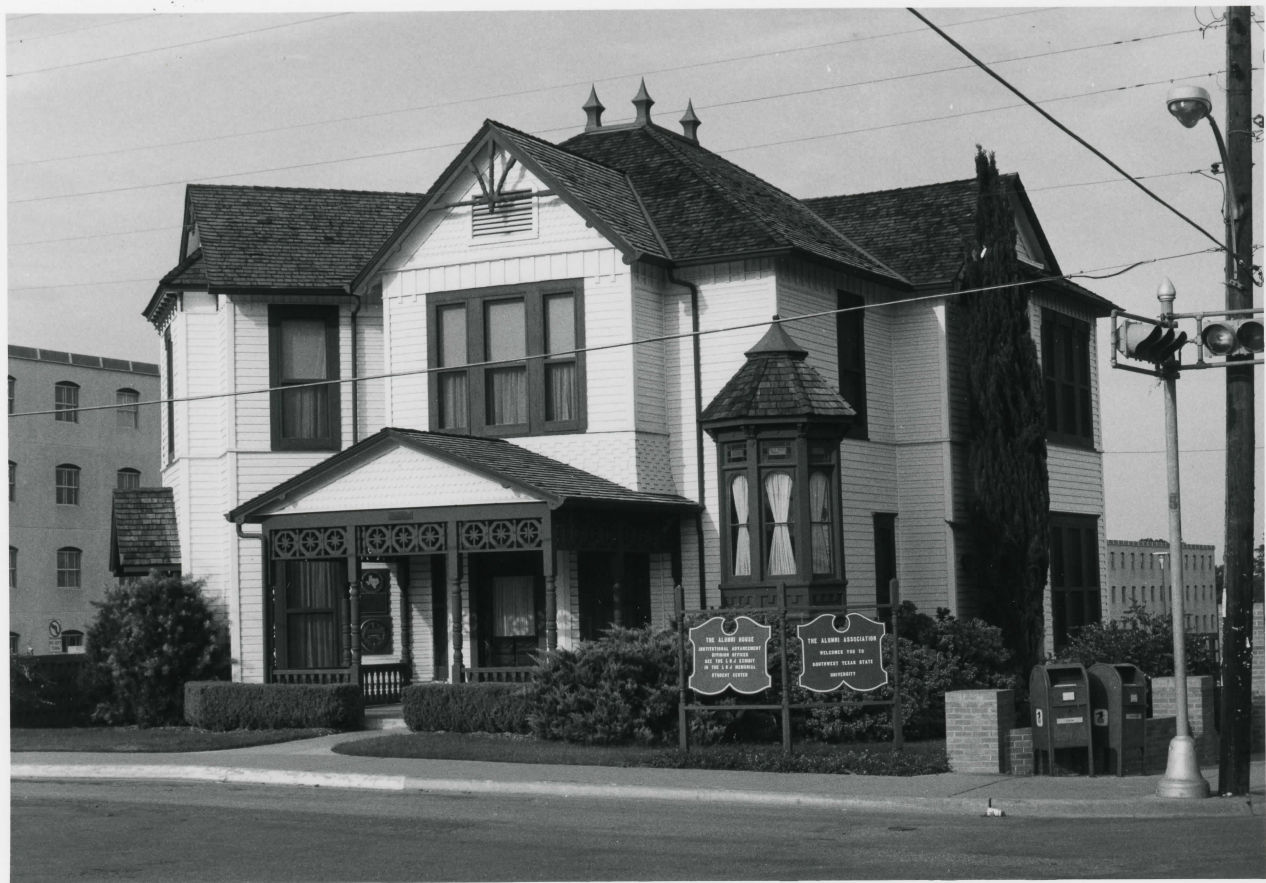
#21. Hutchison House

Southwest oblique, camera facing northeast.
Photo 87 of 150.

A myriad of angles and surfaces characterize the two-story frame Hutchison House. Under a hipped roof topped by four pointed finials, gables, some with their own dormers and bays, protrude in all four main directions and the northwest. A hexagonal oriel at the southwest corner under a pyramidal roof completes the general layout.

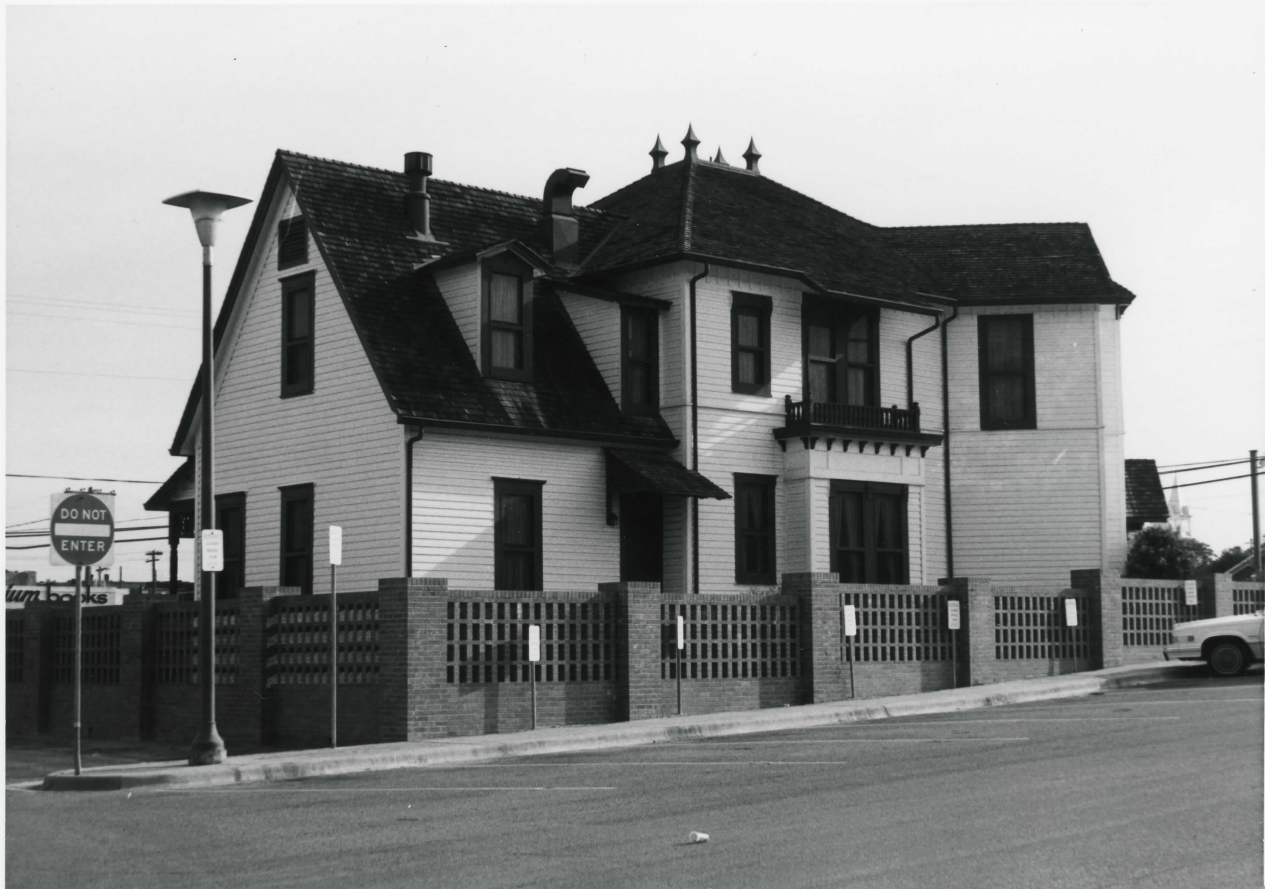
#21. Hutchison House

Northeast oblique, camera facing southwest.
Photo 88 of 150.

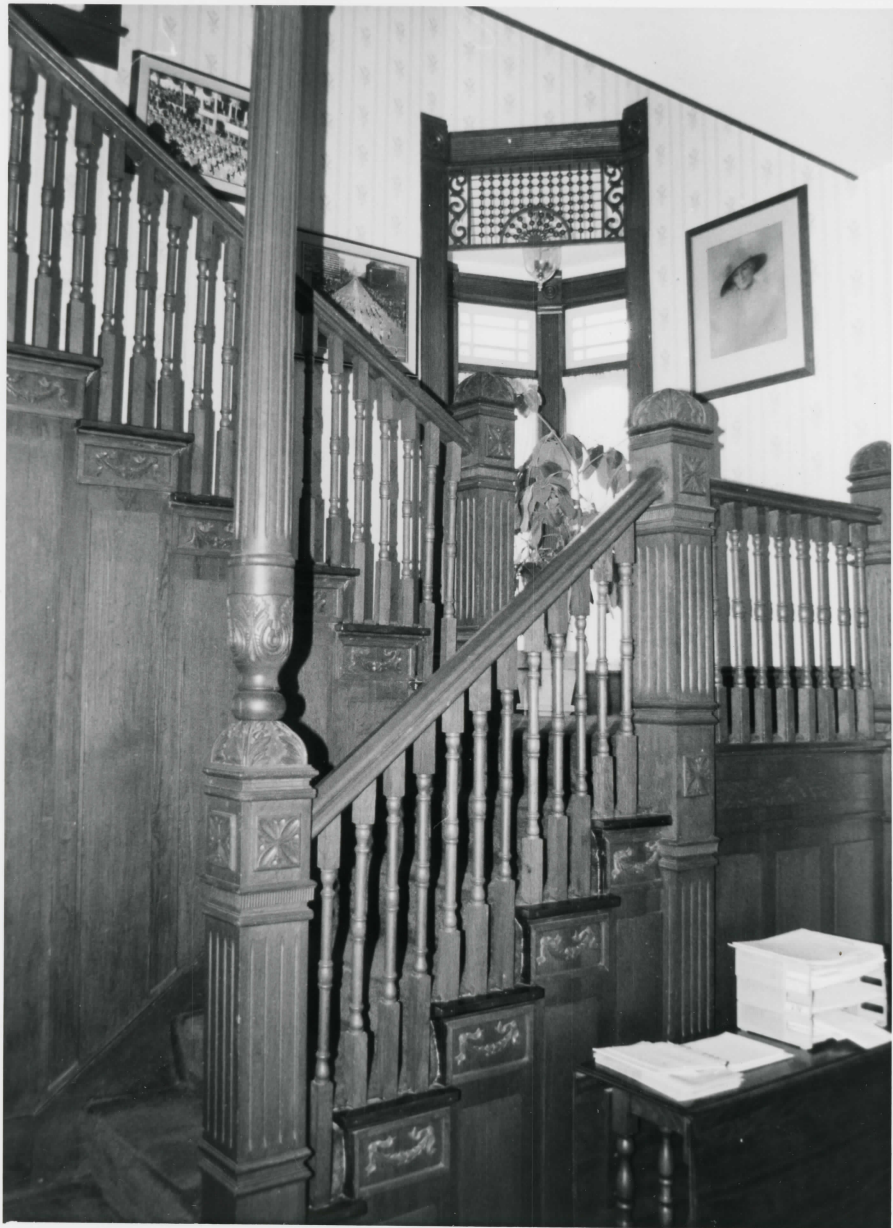
#21. Hutchison House

Interior, showing stair and oriel.
Photo 89 of 150.

The interior was converted for office space, but its major features are preserved. Upon entering, a carved walnut stair on one's right leads first to the oriel, which is lit by colored glass windows, and then to the second floor. The stair's bottom newel extends to the ceiling to form a pillar. Moldings surrounding doors and windows consist of nine rounded ridges between flat edges and are slightly convex. Ball and dowel fretwork decorates the ornate fireplace in what was the dining room and the transom area of the oriel entrance. There is another fine fireplace in the living room. The front door appears to be original.

During the Hutchison residence, the home was the epitome of late Victorian elegance. The floorplan is irregular, reflecting the faceted exterior appearance. A tiny room within an oriel at the stair landing is a feature unique to the town. Other items are comparable: the walnut panelling on the stair spandrel, deeply incised newels, bullseye moldings, pocket doors, and walnut mantels embellished with ball and dowel trim that is echoed on the fretwork at the oriel.
