National Register of Historic Places
Inventory—Nomination Form

6. Name: Main Building, Southwest Texas Normal School
(Common name - Main Building, or Old Main, Southwest Texas State University)

Historic Resources of San Marcos
San Marcos, Hays County, Texas
#6. Main Building, Southwest Texas Normal
School.

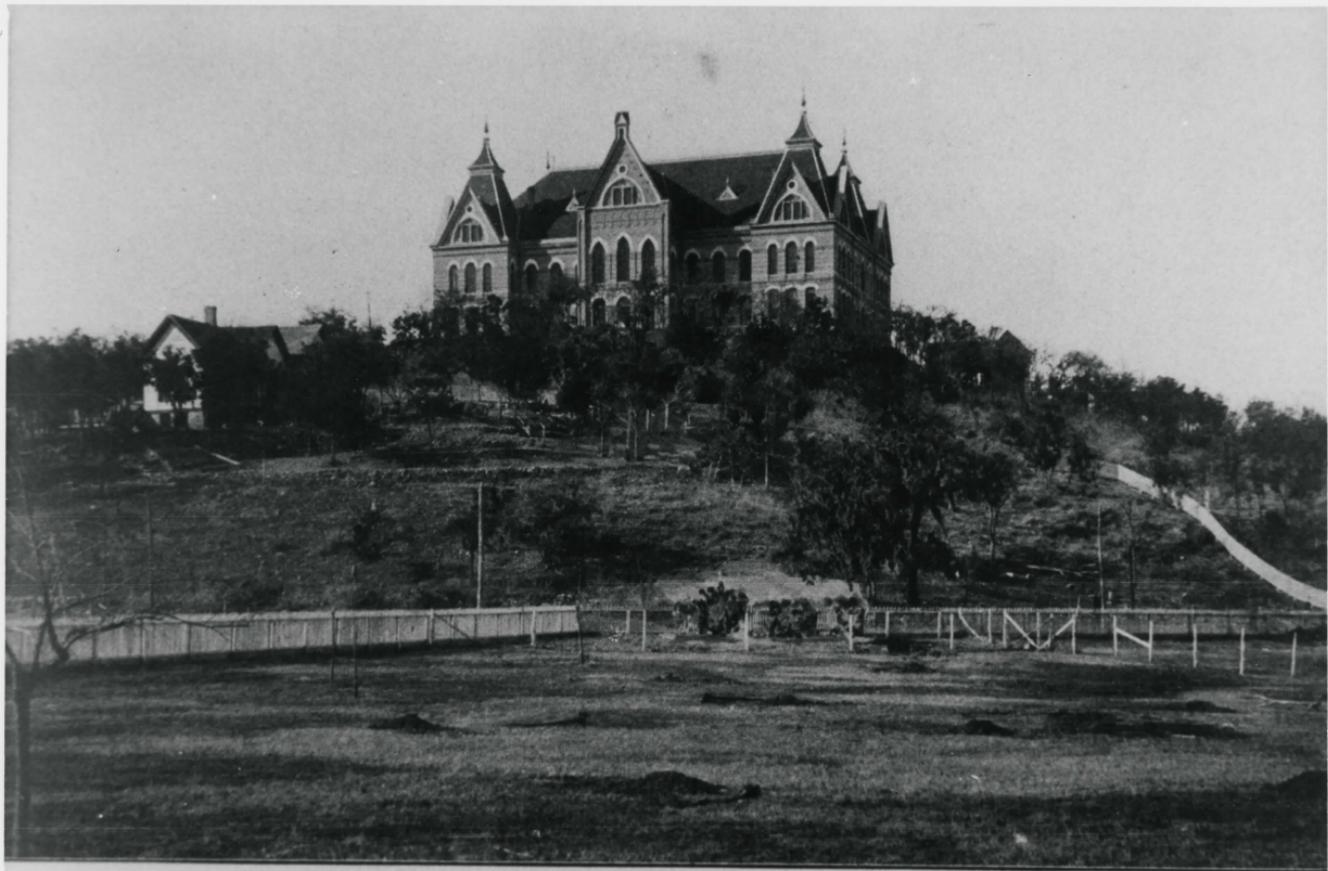
Photo 24 of 150.

South facade, camera facing north.

The south front is the primary facade, and is divided into five bays containing three windows each. The two end pavilions feature windows with two-over-two lights in segmentally arched frames on the first floor, with round-arch openings on the second floor. This pattern of fenestration is repeated on the recessed second and fourth bays of this facade. The central pavilion features round-arch window openings on the first floor, and pointed-arch openings on the second. All of the window openings of the building are formed by limestone arches. The walls are articulated with a corbel table under the cornice of the gable end, multiple brick stringcourses (six for each floor), stone stringcourses that double as window sills, brick dentil and zigzag courses, and indented panels. Each of the wall dormers of the attic floor contains a double window set within a broad, pointed-arch frame. A limestone roundel is set above the apex of this arch. The roofs of each of the four corner pavilions rise up from the wall dormers in flat planes towards a cornice which marks the base of the upper pyramidal section of the roof, the sides of which are concave. Tall finials rise from the peaks of these uppermost roof elements.

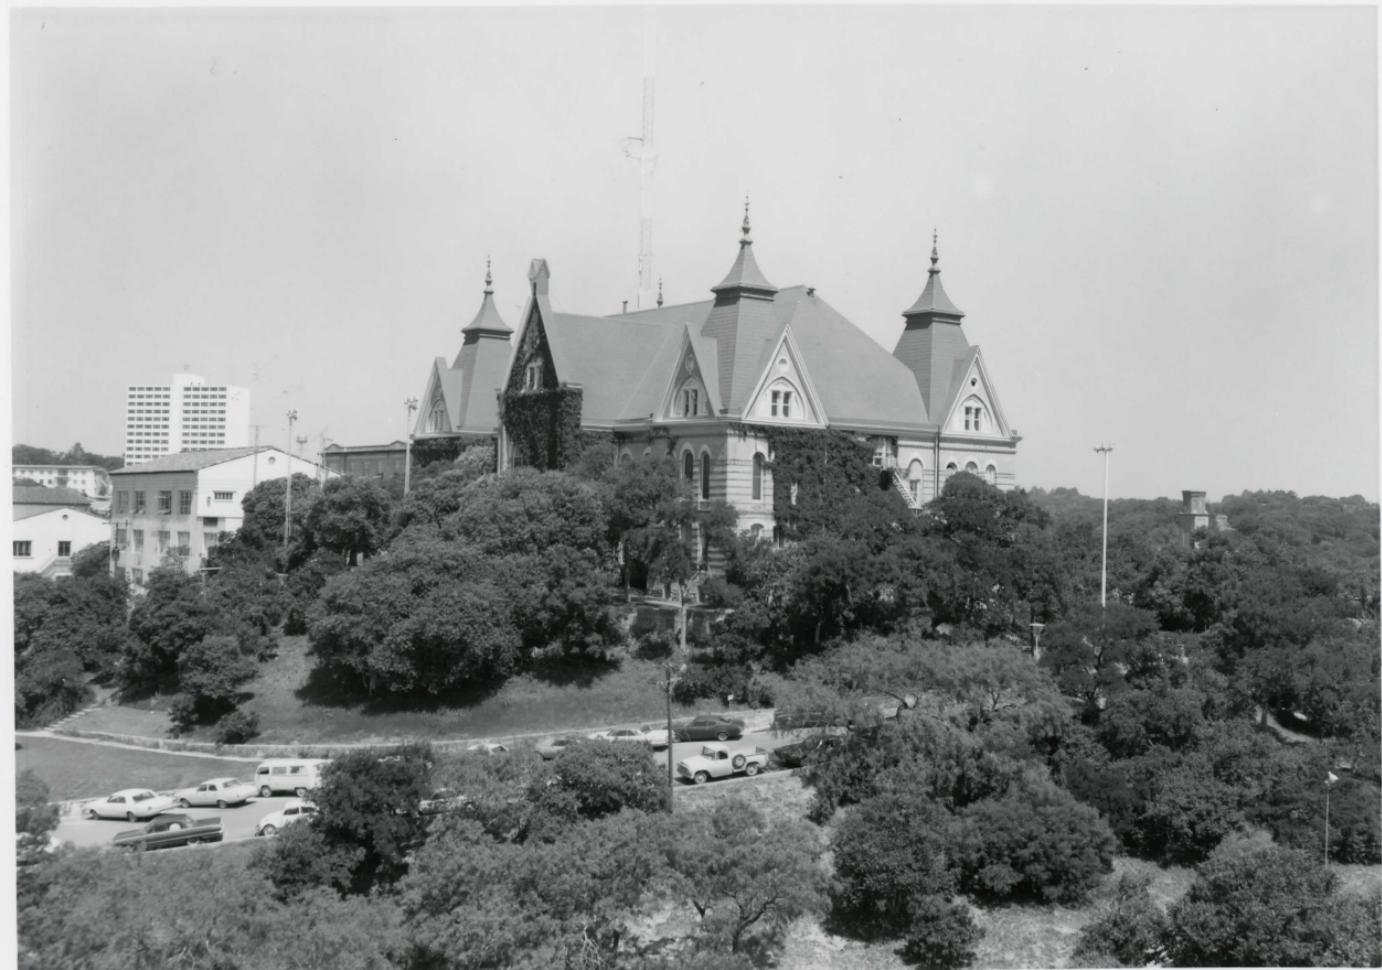
Southeast oblique, camera facing northwest.
Photo 25 of 150.

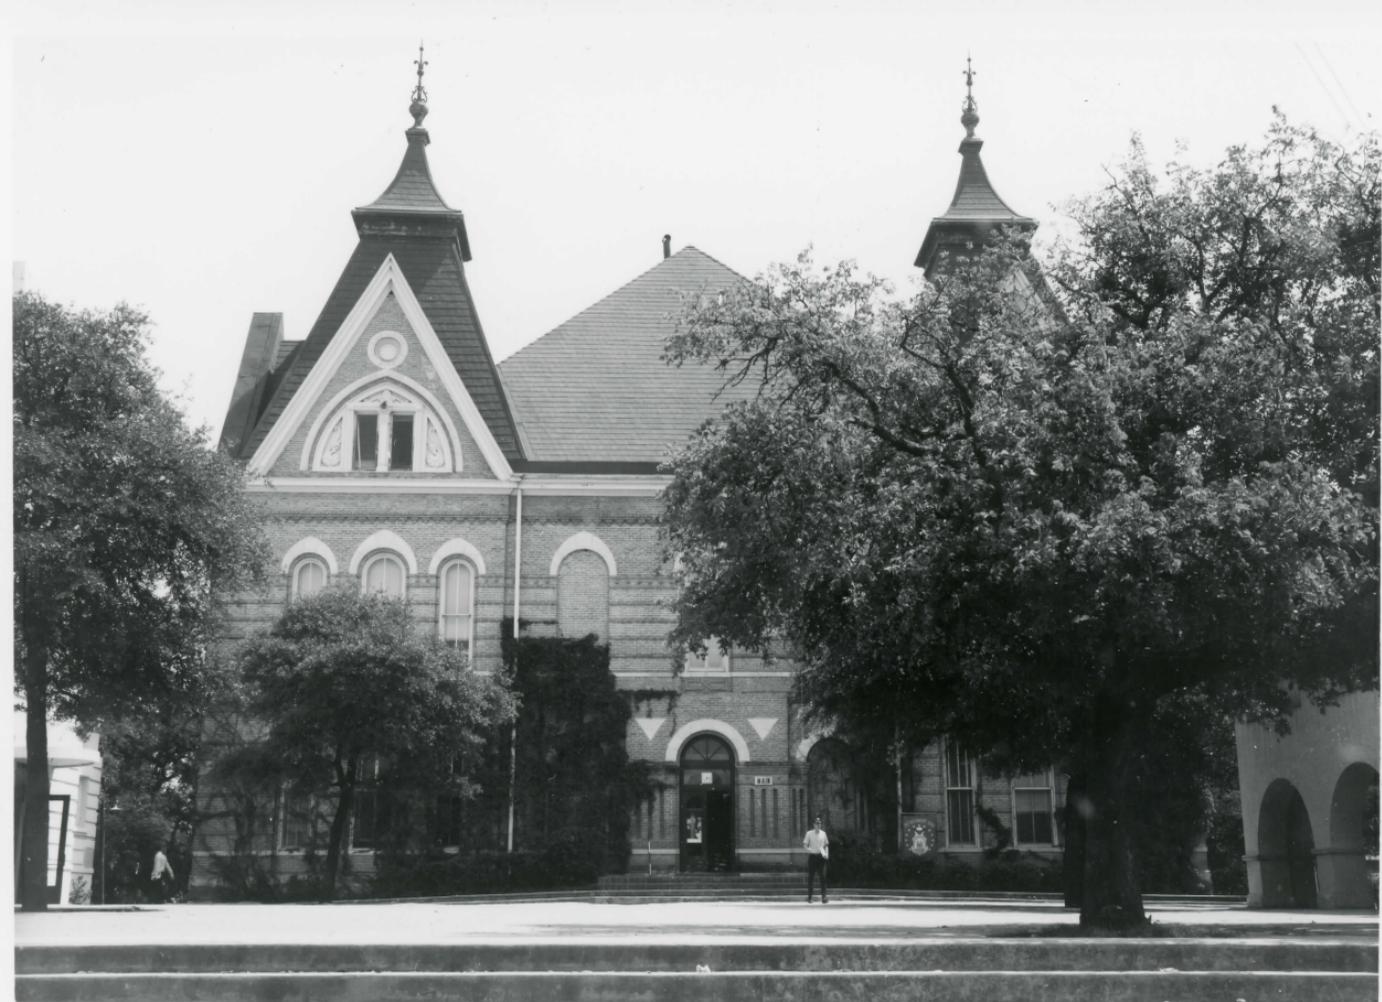
West facade, camera facing east.
Photo 26 of 150.

The other facades feature similar decoration, but are less complex in their design. The east and west walls are flat, but show a slight projection of the bays. The north front has no central pavilion, but brick piers define the central bay, and the end pavilions project slightly. This wall is covered with a heavy growth of ivy. A fire escape is attached to the east facade.

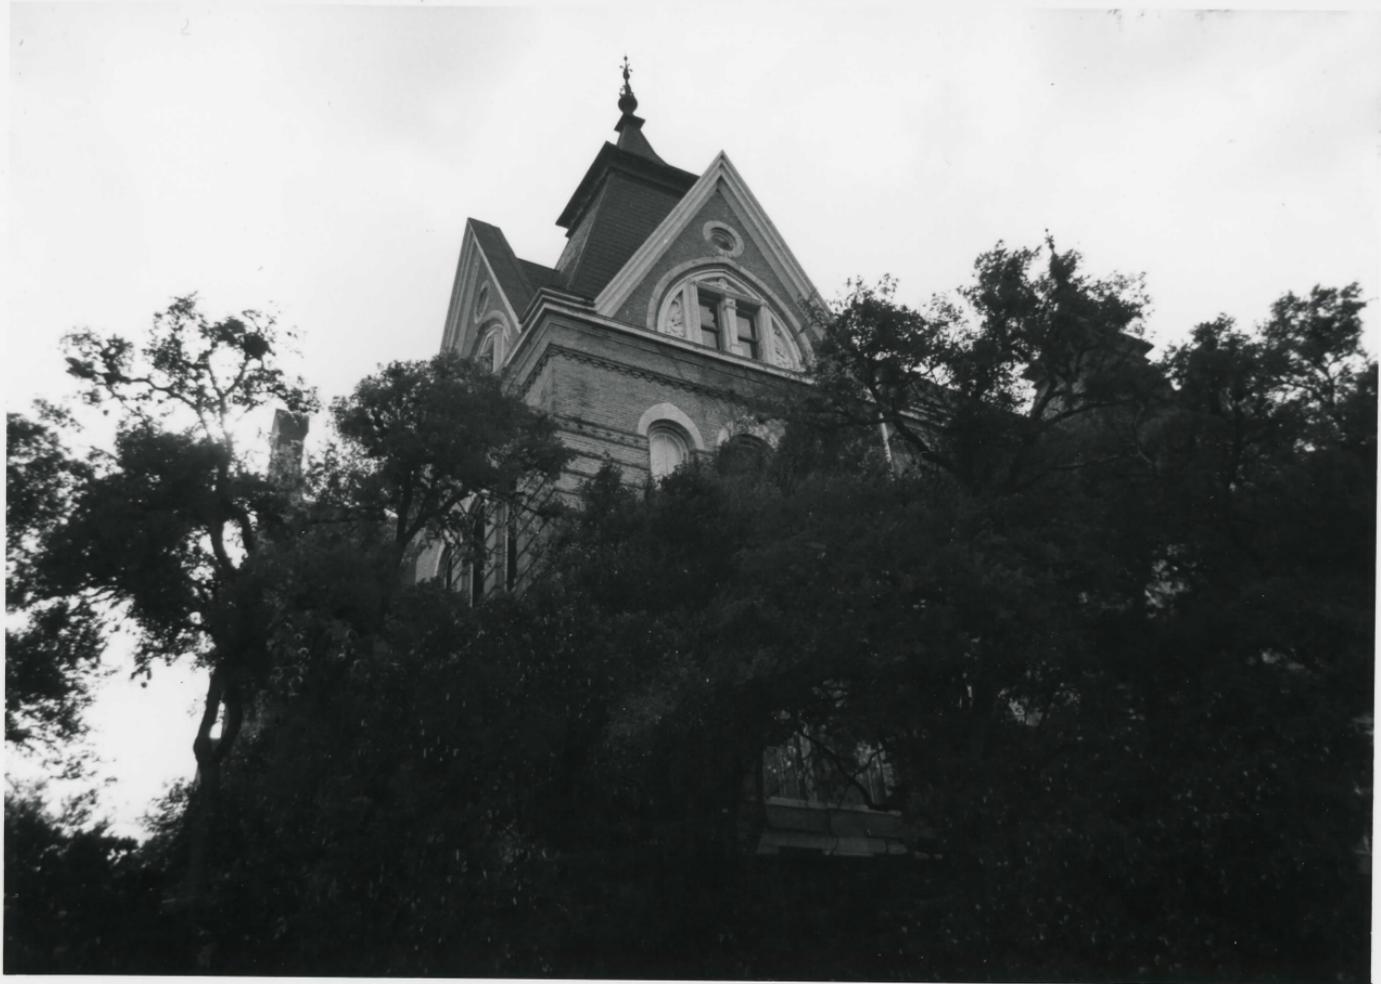
Photo 27 of 150.

Detail, southeast oblique, camera facing
northwest.

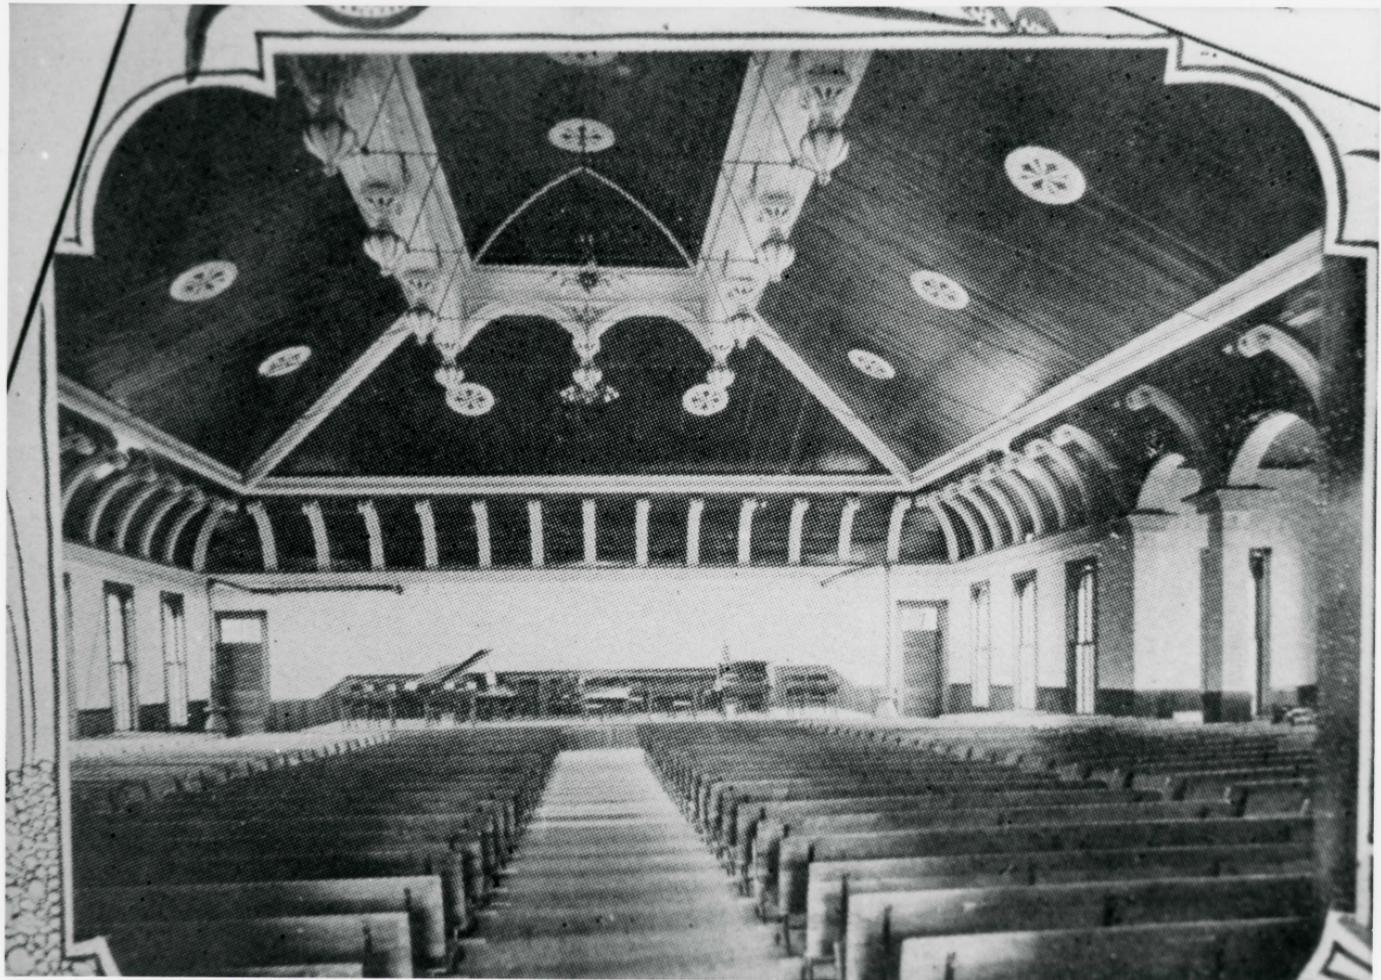
Photo 28 of 150.

Interior of second floor auditorium.

More alteration shows inside. The long wooden ceiling of the first-floor hall has been covered by dropped acoustical tile, and the vaulted ceiling of the second-floor auditorium has been largely obscured. Wooden details, including sawn cutouts under each stair tread and beaded wainscoting, have been painted light brown. The stairs remain important features; the eastern one sends a single flight to a landing where it branches in two, and the western flights are hidden behind side walls from where they converge at a landing where there is a single flight to the second floor. University officials and Texas Antiquities Committee staff are working together on a major restoration plan.

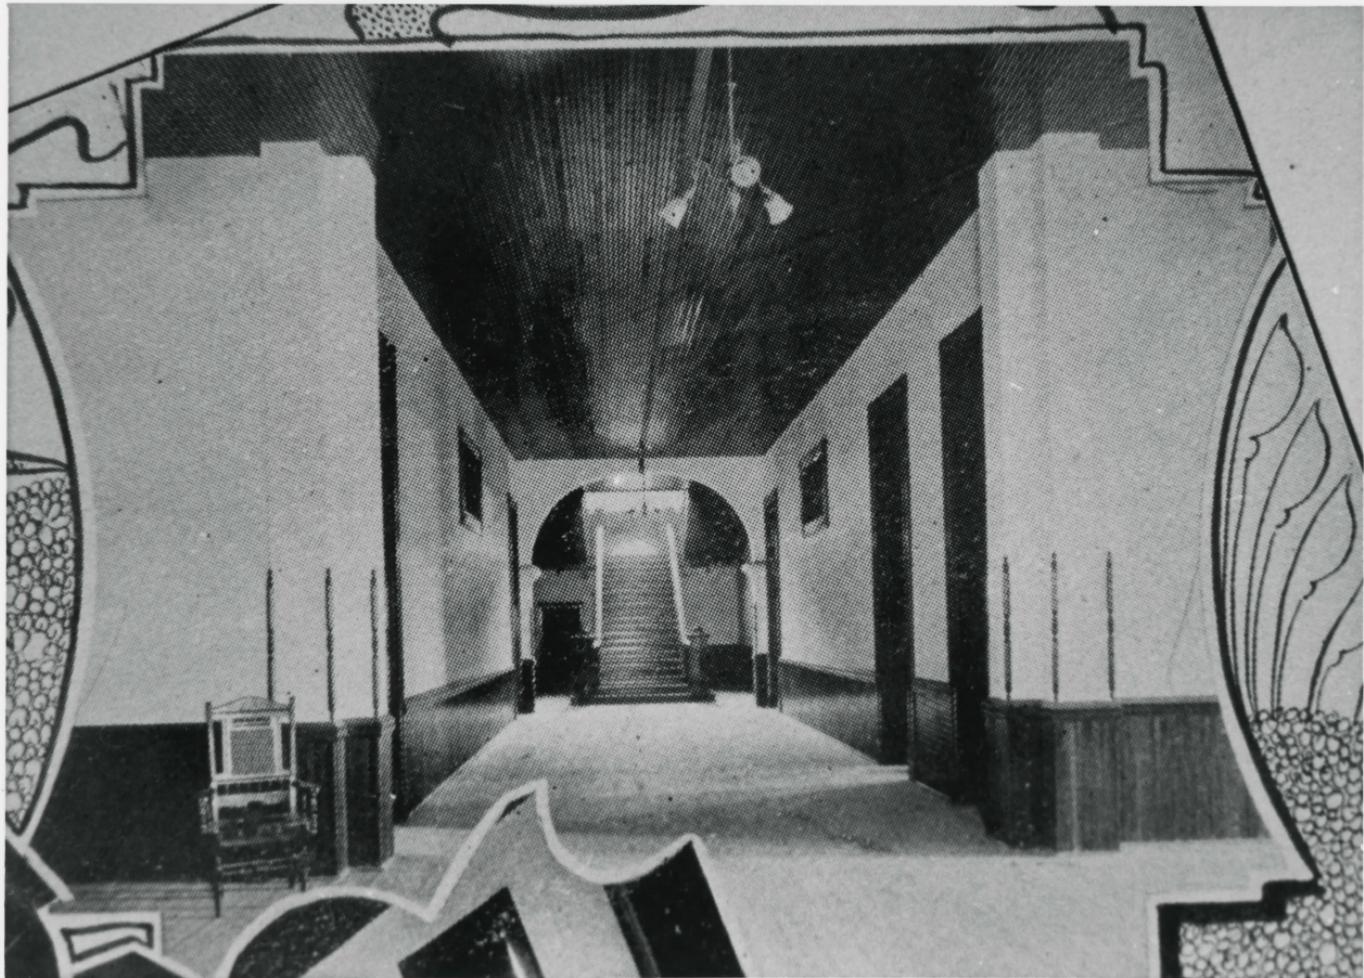
Interior of first floor hall, camera facing
east. Photo 29 of 150.
