National Register of Historic Places  
Inventory—Nomination Form

4. Name: <sup>✓</sup>Moore Grocery Company (~~Common name, King Feed Company~~)

Location: 101 South Edward Gary Street

Historic Resources of San Marcos  
San Marcos, Hays County, Texas  
#4. Moore Grocery Company

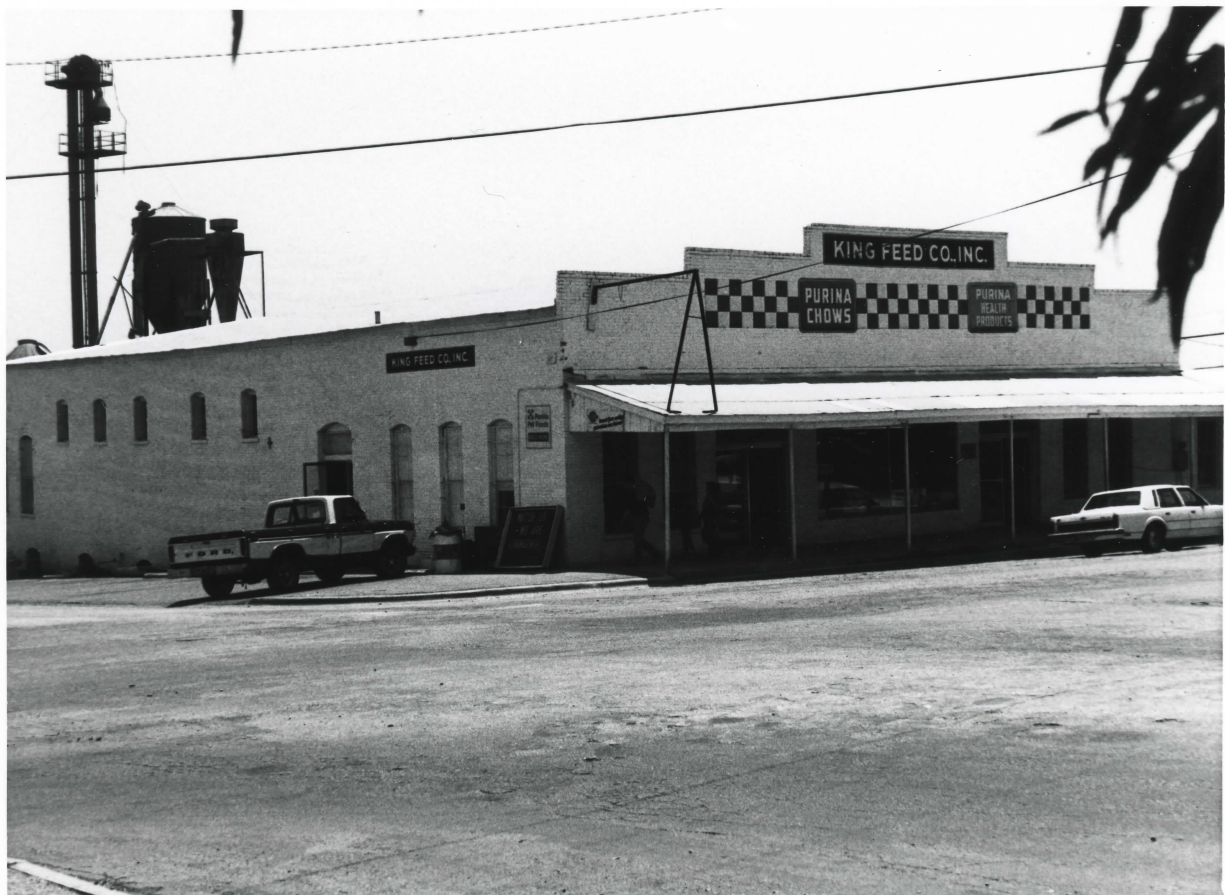
Northwest oblique, camera facing southeast.  
Photo 17 of 150.

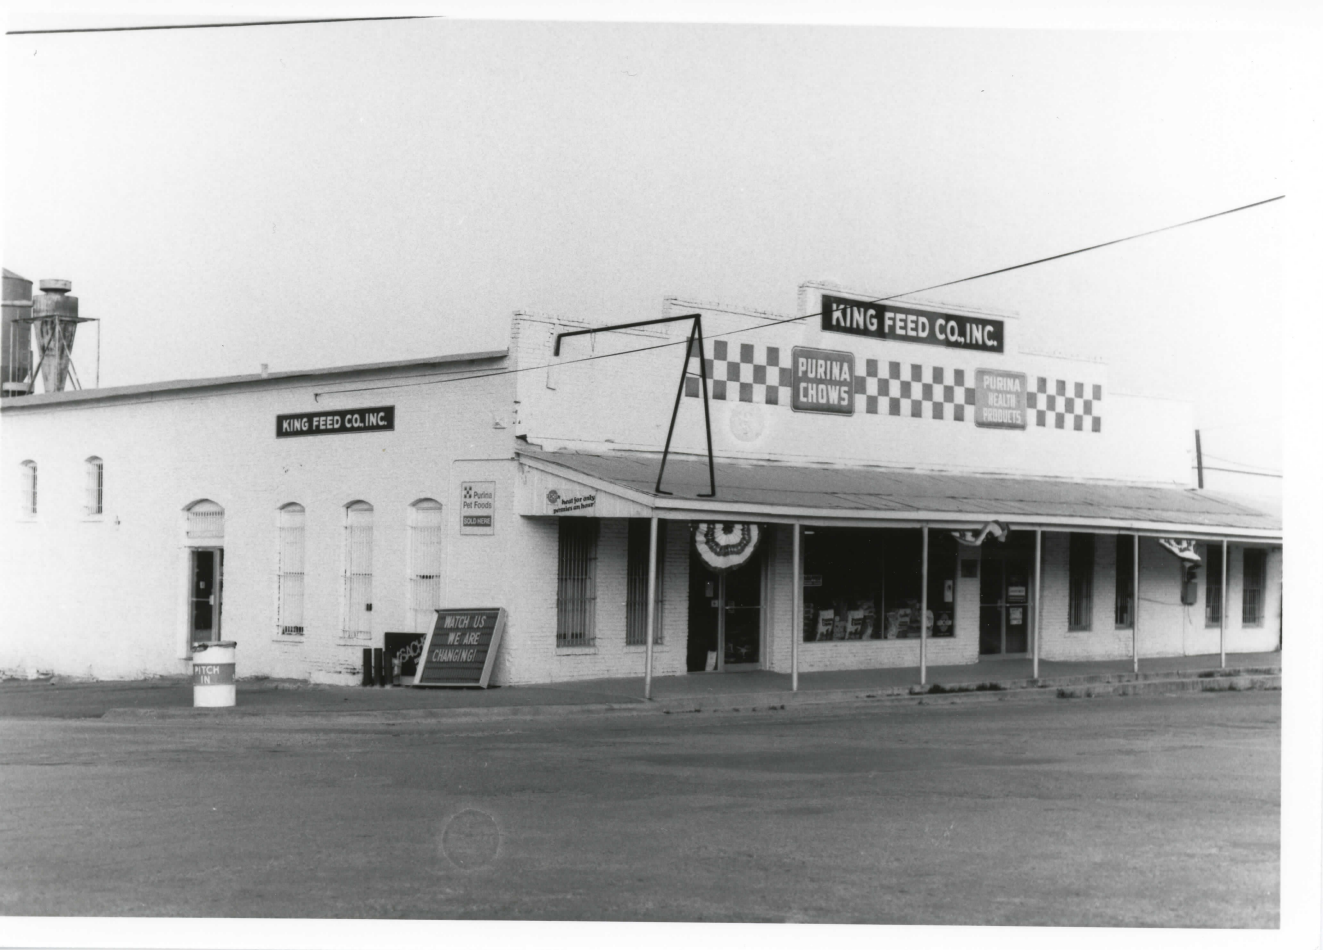
Historic Resources of San Marcos  
San Marcos, Hays County, Texas  
#4. Moore Grocery Company

Northwest oblique, camera facing southeast.  
Photo 18 of 150.

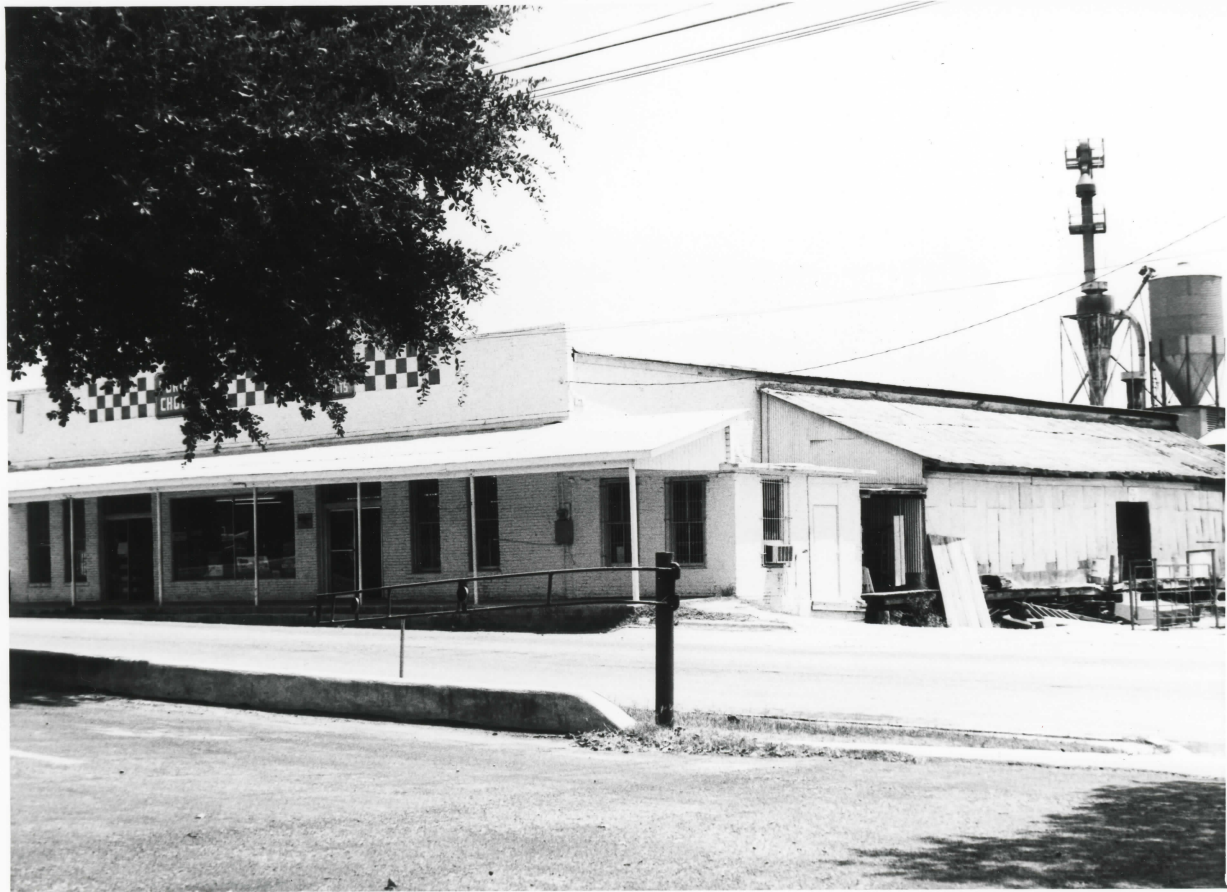
Historic Resources of San Marcos  
San Marcos, Hays County, Texas  
#4. Moore Grocery Company

Southwest oblique, camera facing northeast.  
Photo 19 of 150.
