**National Register of Historic Places
Inventory—Nomination Form**

27. Name: Rylander-Kyle House (~~Common name - Henry Kyle, Jr., House~~)

Location: 711 West San Antonio Street

Rylander-Kyle House (San Marcos MRA)
Hays County
TEXAS

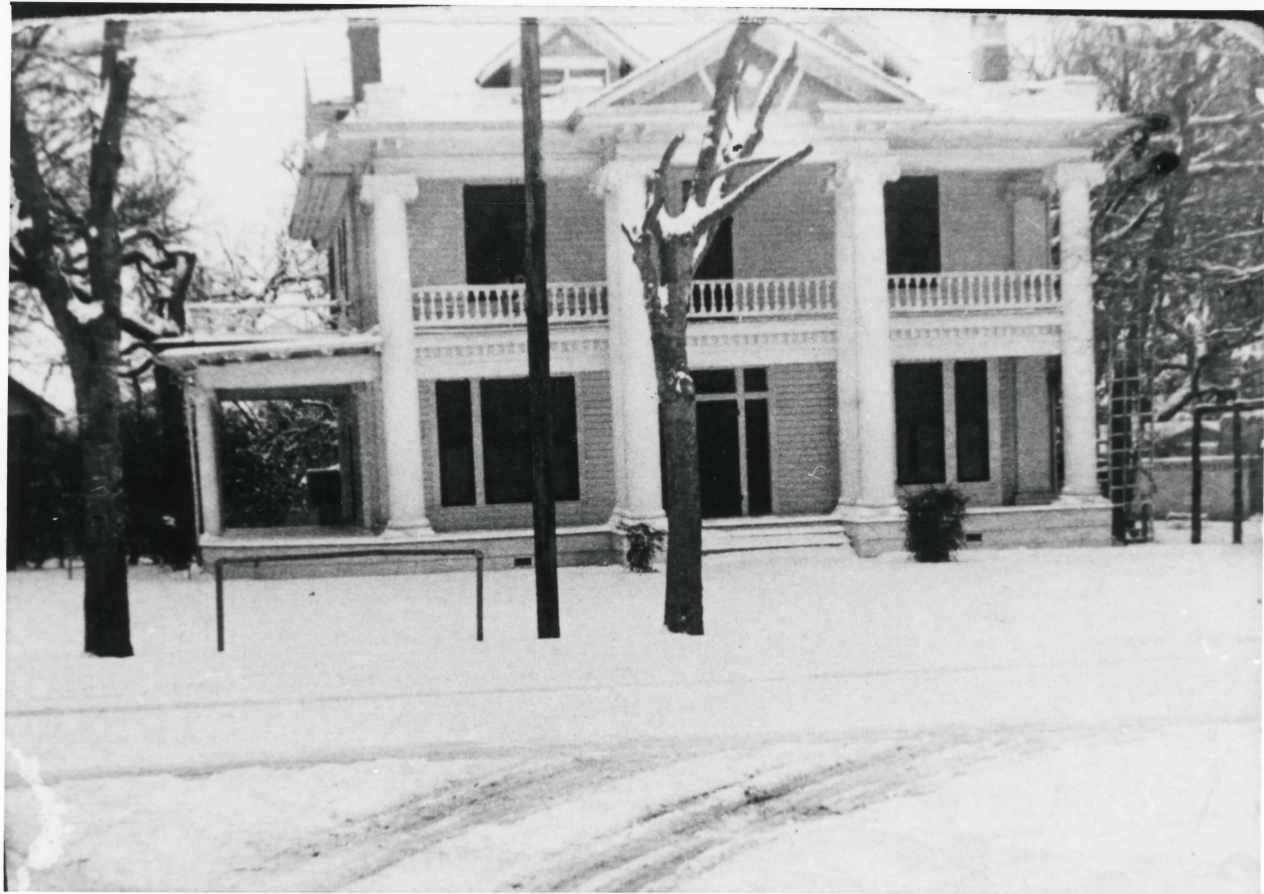
#27. Rylander-Kyle House

Northwest facade, camera facing southeast.
Photo 108 of 150.

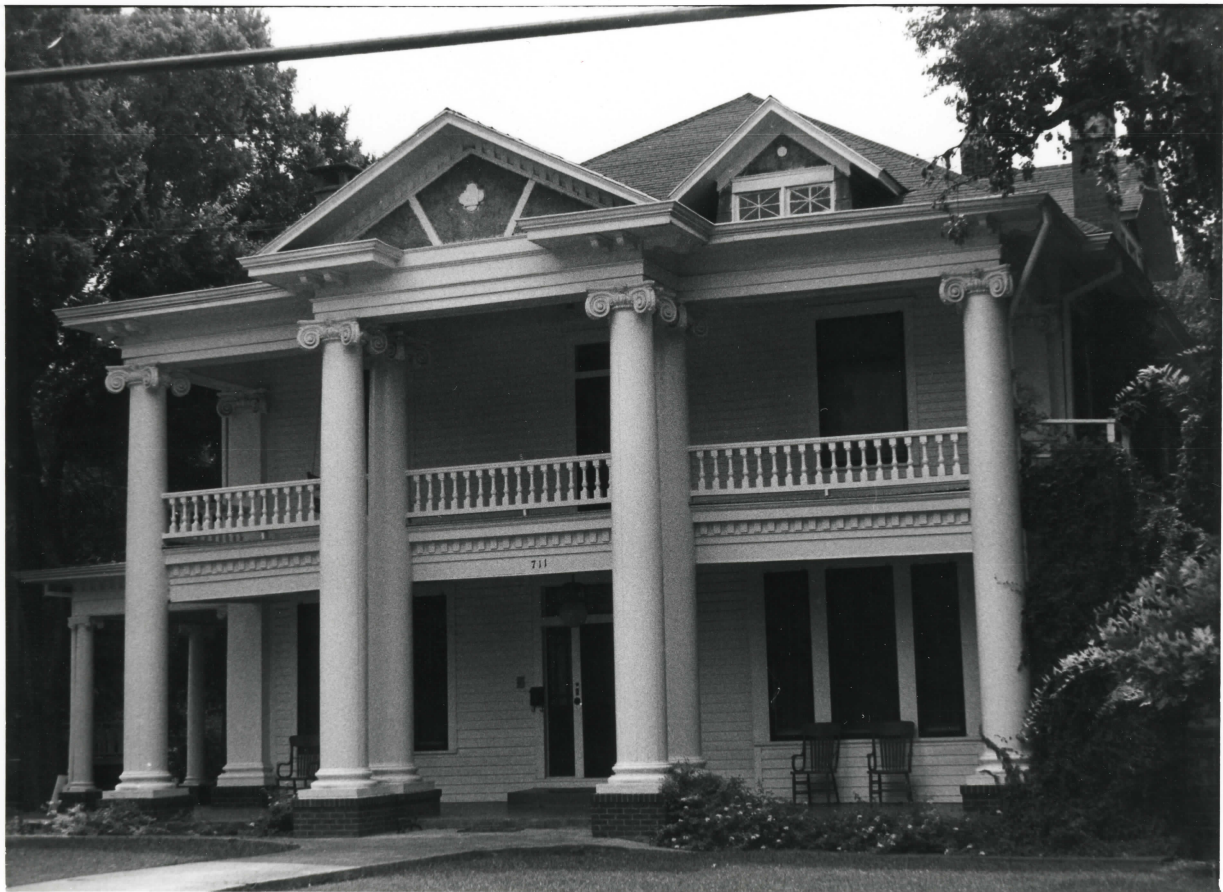
#27. Rylander-Kyle House

Classical details grace the sedate, two-story Rylander-Kyle House, a basically symmetrical frame edifice of carefully balanced horizontal and vertical lines. Beneath a low-pitched pyramidal roof broken by two large gabled dormers, the front facade is centered on a shallow pedimented portico, which leads onto a double-level porch supported by six colossal, unfluted Ionic columns.

The front porch is in a three-bay arrangement and divided horizontally by a spindle rail on the second floor. There is no rail on the first floor, nor was there ever, but originally there was a second rail on the roof cornice. Two unfluted flat pilasters echo the columns. Porch ceilings are beaded. In the pediment's tympanum are plaster and stick detailing and dentils. The dormer gable ends are finished similarly. Brackets under the heavy architrave complete the elegance of the front facade.

Northwest facade, camera facing southeast.
Photo 109 of 150.

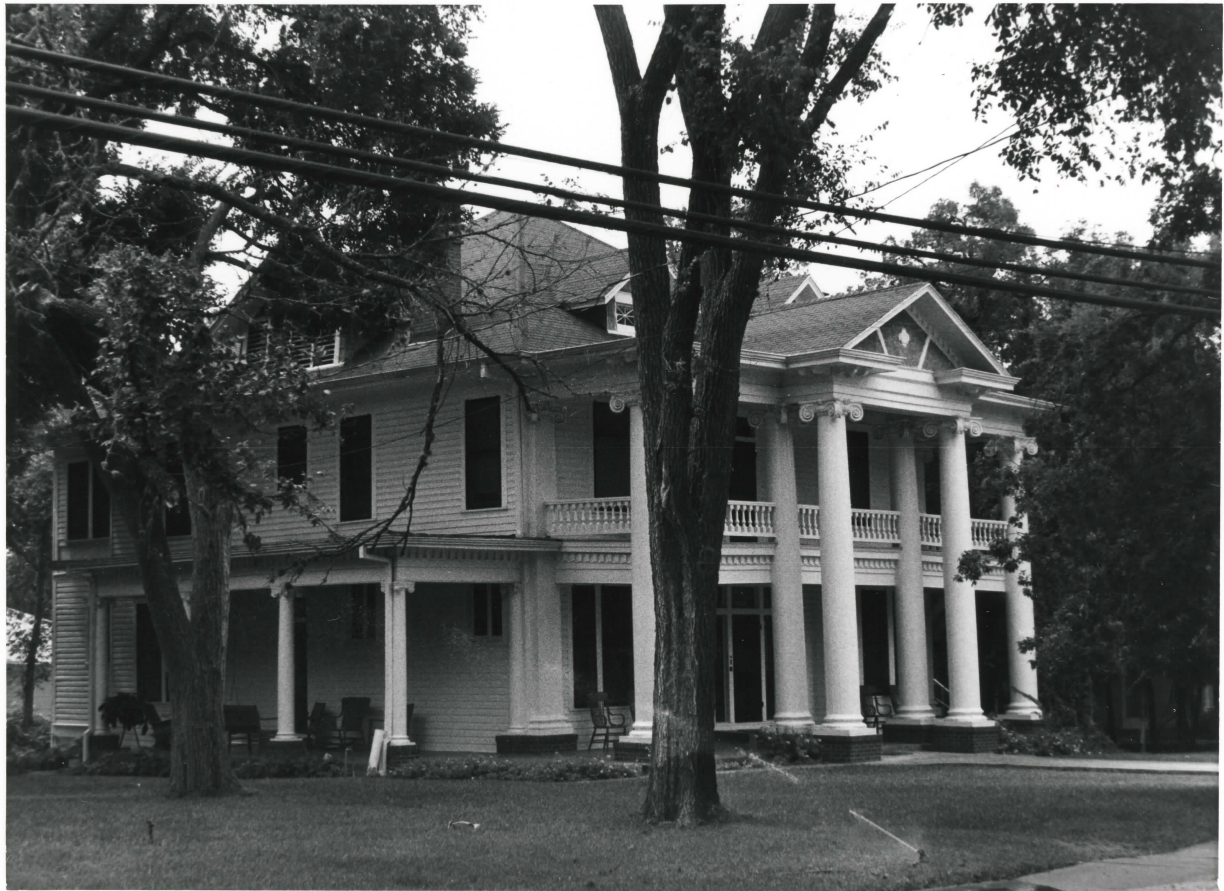
#27. Rylander-Kyle House

Except for the small northeast porch, which once had an open, arbor-like arrangement of boards for a roof, the other facades cede prominence to the front. Additional dormers point to northeast and southwest. Also on the southwest wall is a wood stair to the second-floor porch. The rear wall is flat, since the small porch that was once there has been filled in. There are two brick chimneys with plaster caps.

North oblique, camera facing south.
Photo 110 of 150.

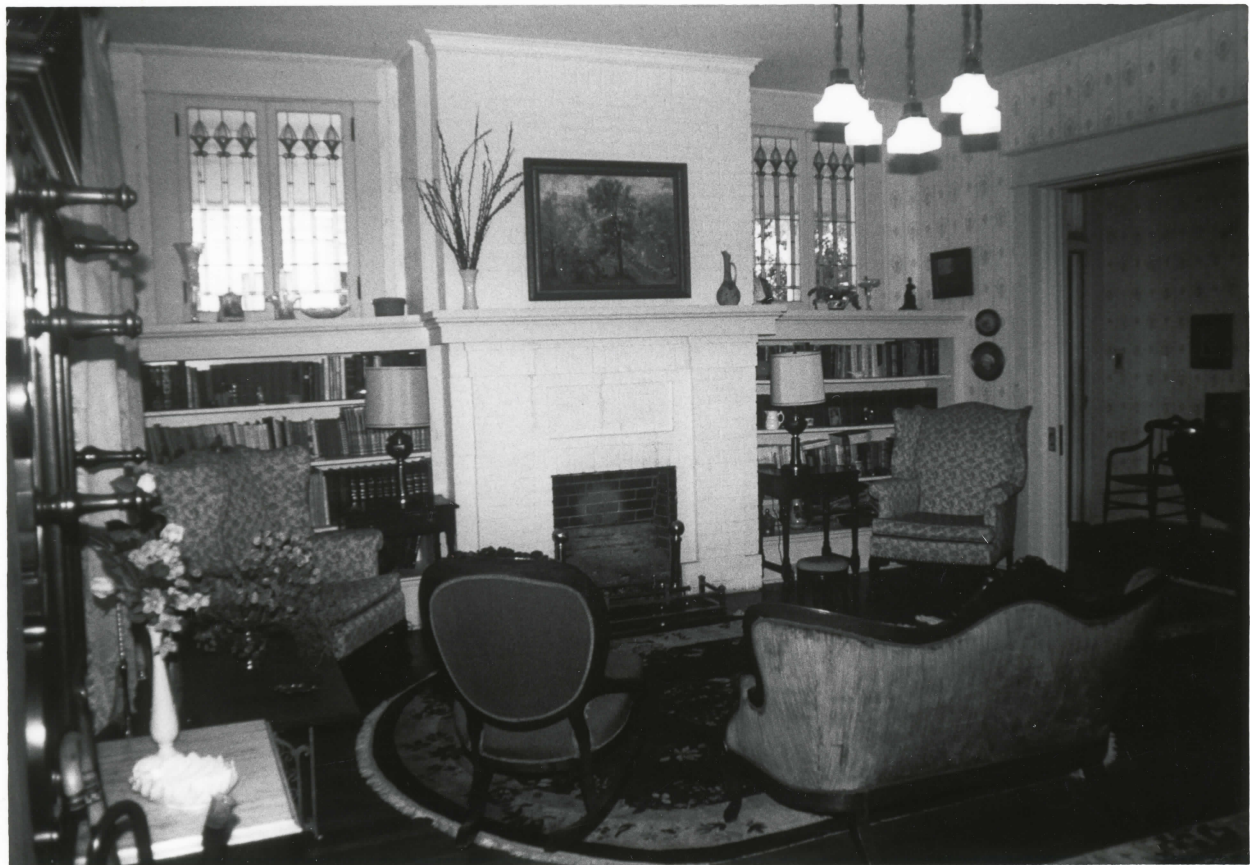
#27. Rylander-Kyle House

The Kyles have an exceptional collection of handmade and antique furnishings which are suitable props for the beautiful, but restrained, interior. Stained-glass windows flank the fireplace. Original brass light fixtures hang in the living room and dining room, which are joined by a pocket door.

Interior of livingroom, camera facing north-
east.
Photo 111 of 150.
