**National Register of Historic Places  
Inventory—Nomination Form**

✓  
15. Simon Building (~~Common name - The Bakery~~)

Location: 124-126 West Hopkins Street

Historic Resources of San Marcos  
San Marcos, Hays County, Texas  
#15. Simon Building

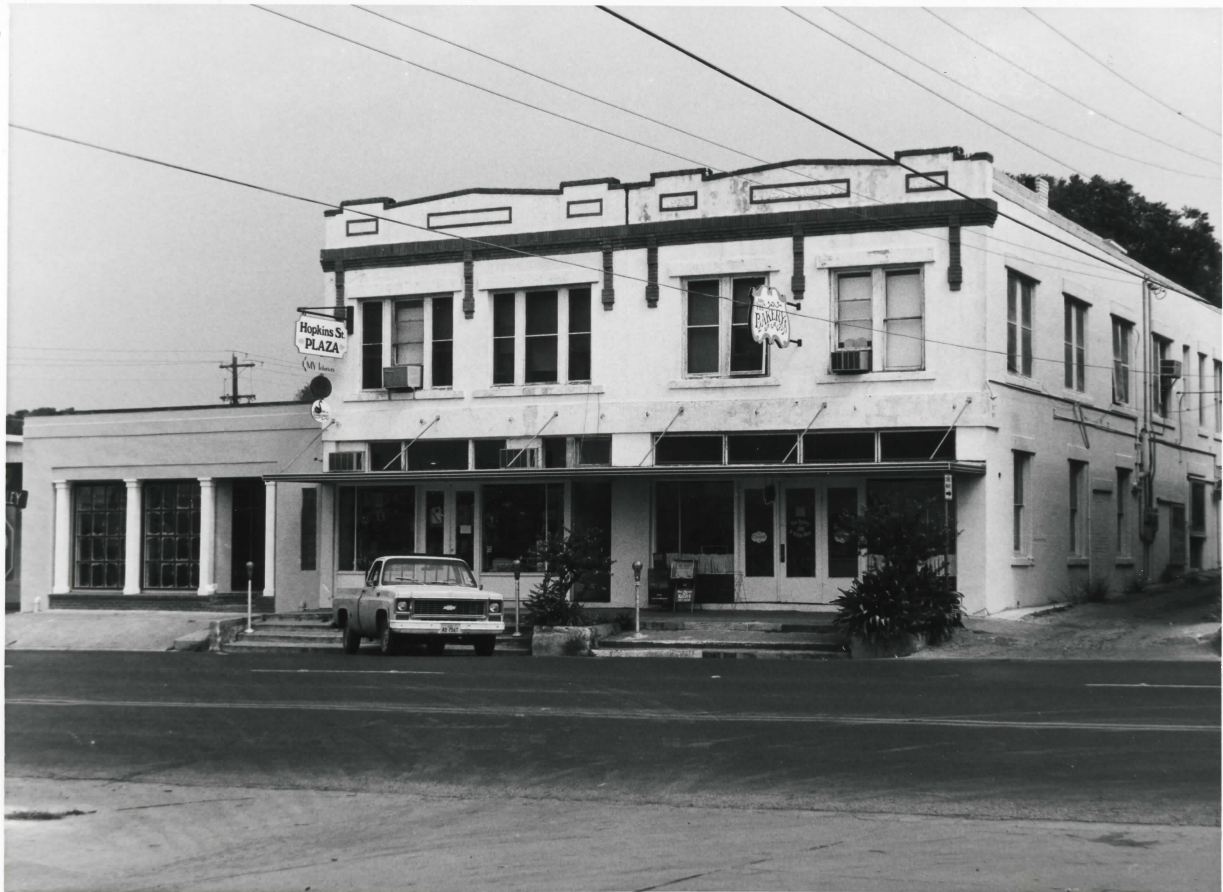
Southeast oblique, camera facing northwest.  
Photo 67 of 150.

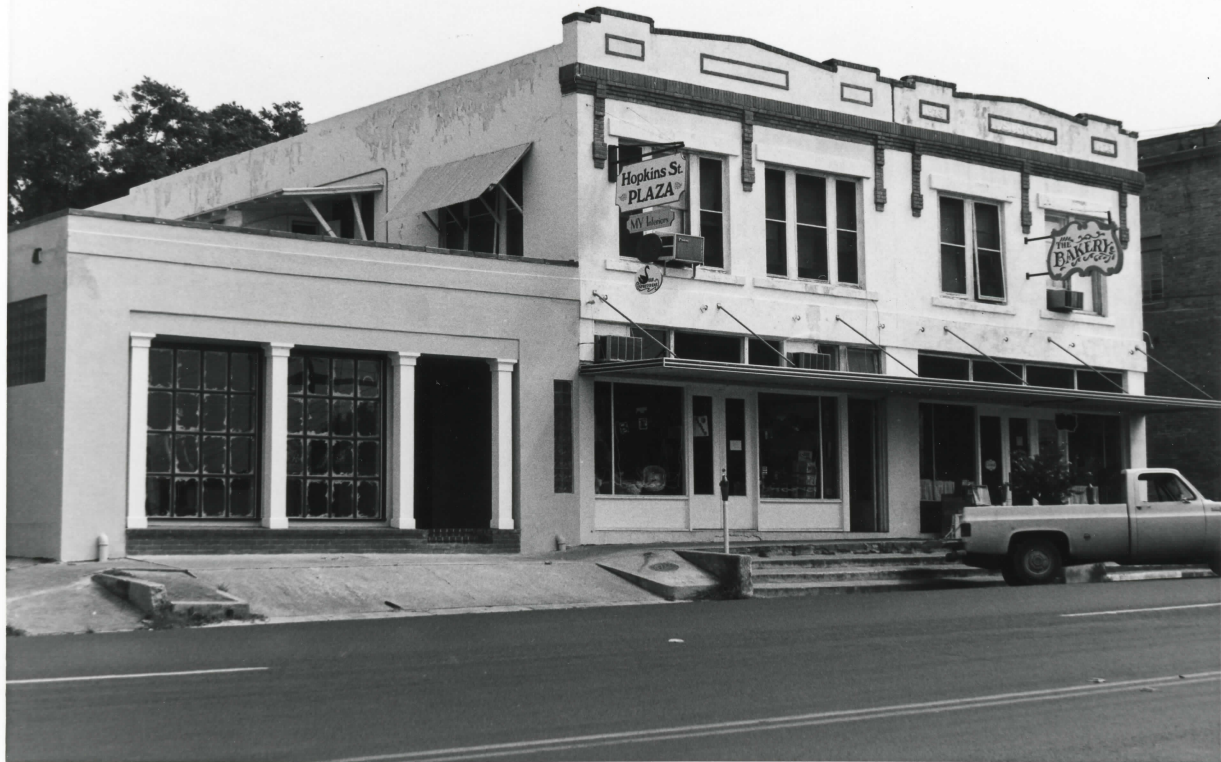
Historic Resources of San Marcos  
San Marcos, Hays County, Texas  
#15. Simon Building

Southwest oblique, camera facing northeast.  
Photo 68 of 150.

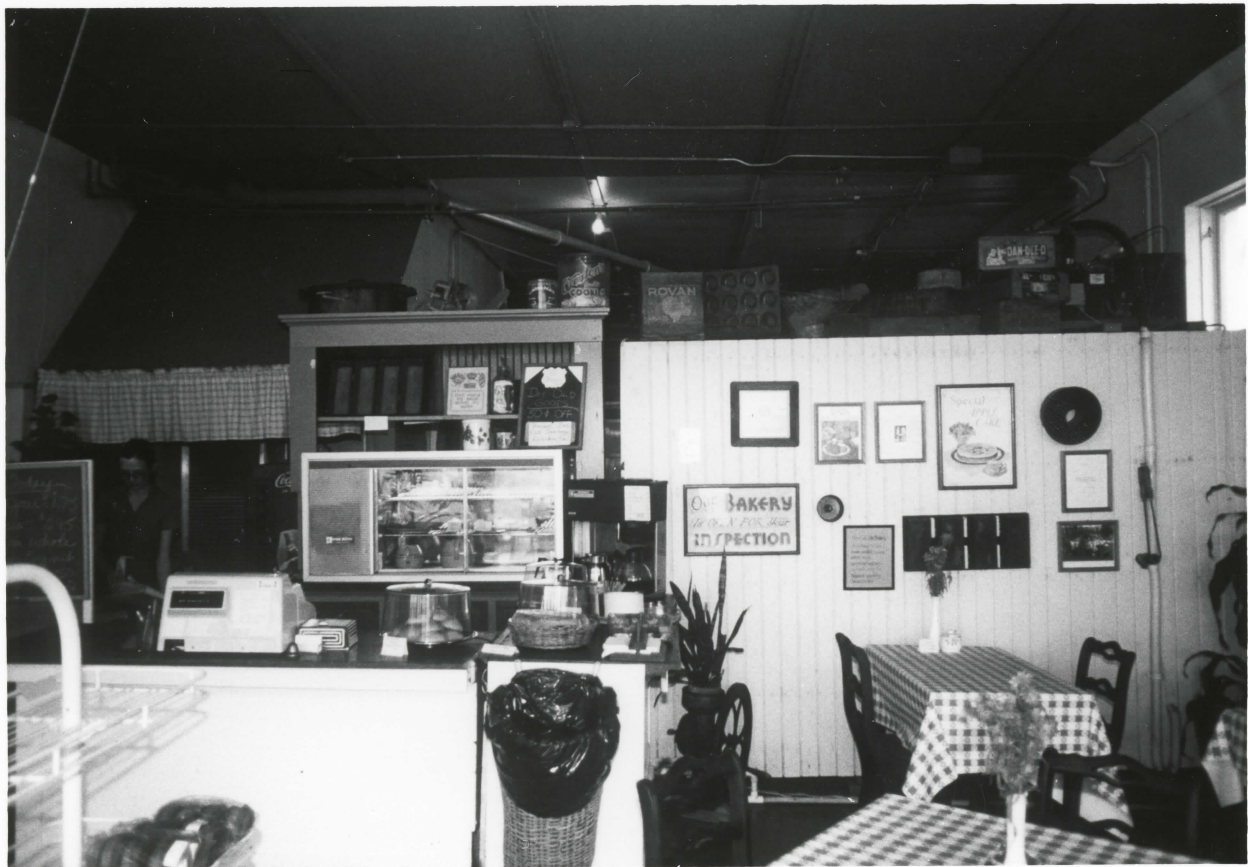
Historic Resources of San Marcos  
San Marcos, Hays County, Texas  
#15. Simon Building

The Bakery occupies the first floor in the half toward the square, where the Simon Bakery began its production. Many old fixtures are in place or still in use, such as a 1916 dough divider, the floor drain, a massive oven, and a myriad of pans and implements.

Interior of The Bakery, camera facing north.  
Photo 69 of 150.
