National Register of Historic Places  
Inventory—Nomination Form

25. Name:  Smith House (Common name - ~~Smith-Storey House~~)

Location: 322 Scott Street

Smith House (San Marcos MRA)  
Hays County  
TEXAS

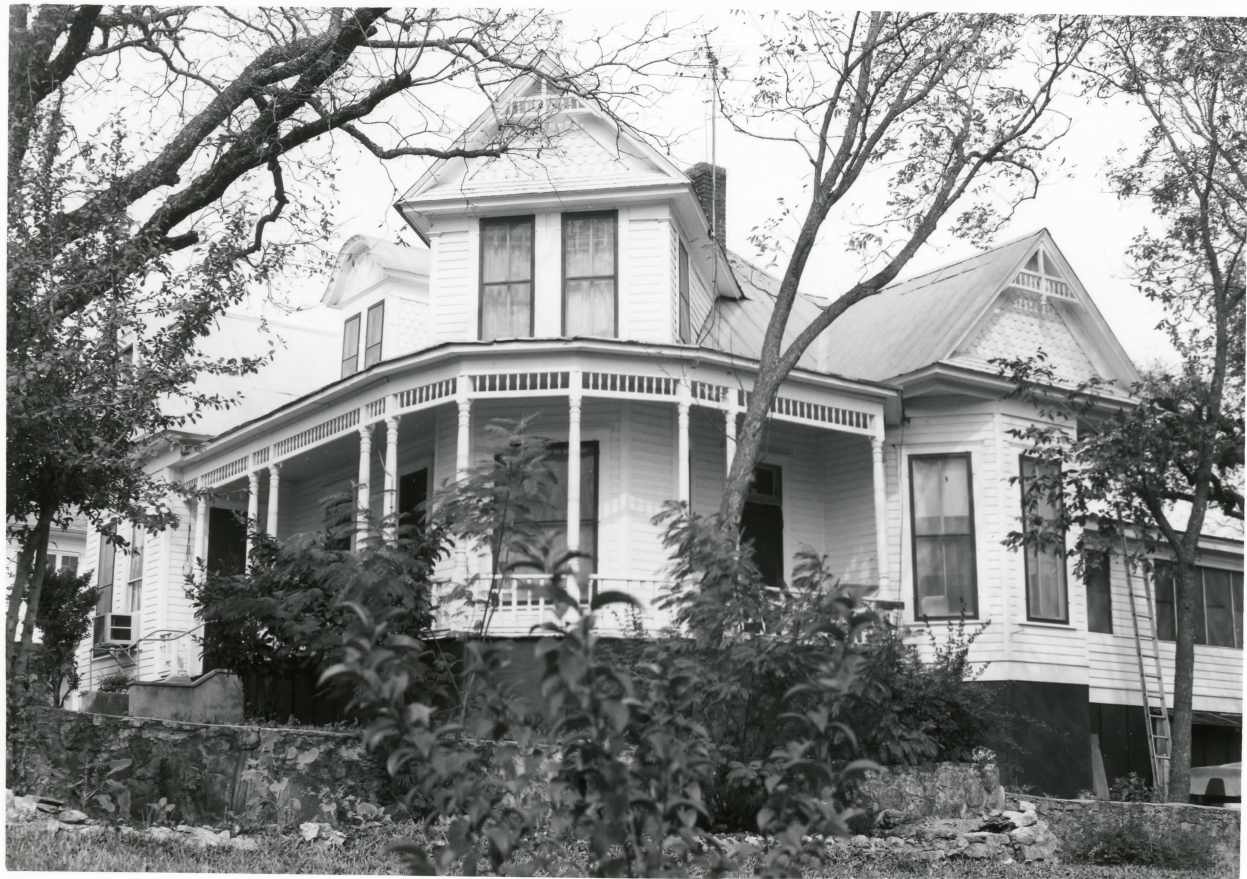
#25. Smith House

South oblique, camera facing north.  
Photo 100 of 150.

Dominating the one-and-a-half-story frame Smith House is a dormer set at a 45° angle to the main axis of the house. A profusion of cross gables and dormers projecting from the V-crimp, metal, hipped roof make the roofline complex. Besides the southern dormer, other gable ends are located at the northwest, southwest (front facade), southeast, and northeast. A small dormer with a bell-shaped roof is also found on the front facade. Curving from the southwest ell to the southeast ell is a one-story porch supported by paired lathed posts. A kitchen wing extends to the northeast, and a brick chimney rises from the norhtwest gable.

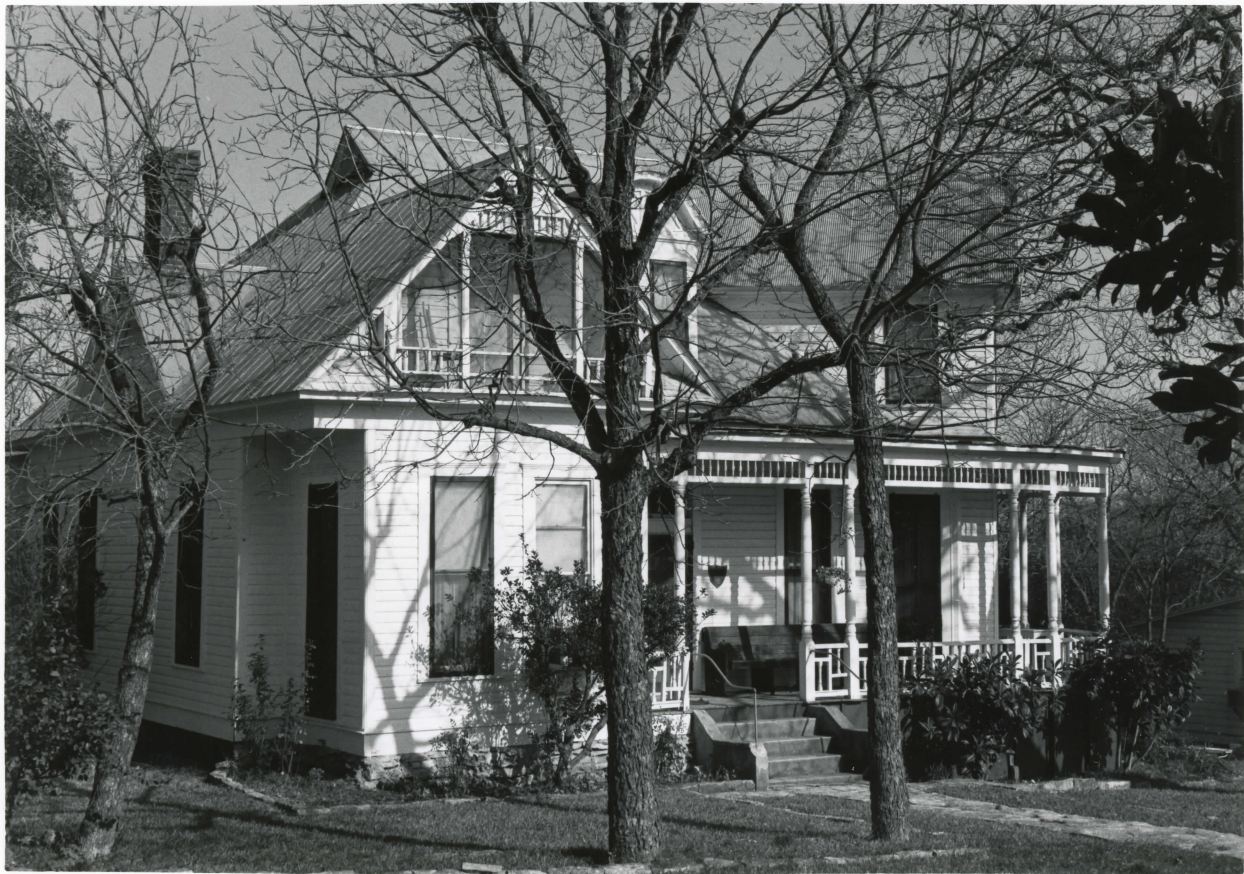
#25. Smith House

West oblique, camera facing east.  
Photo 101 of 150.

Long narrow windows with two-over-two lights pierce the southwest facade. A floor-length window with one-over-one lights occurs at the left of the front door, which is of original carved wood and etched glass. Other windows are of regular dimensions, and either have one-over-one or two-over-two lights.

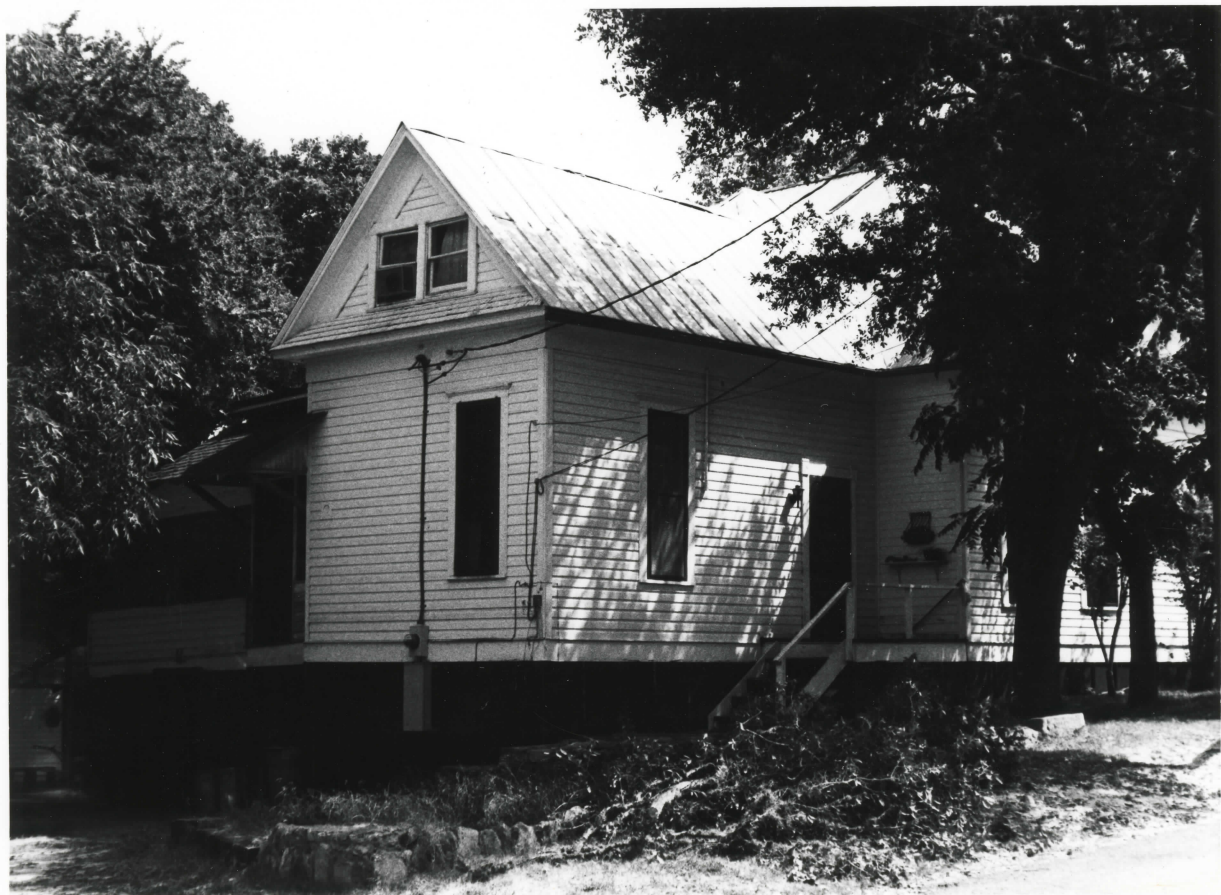
#25. Smith House

North oblique, camera facing south.  
Photo 102 of 150.

Part of the northeast section of the exterior was filled in with canvas windows by the previous owner. Also in that area is a greenhouse addition. Neither of these changes is visible from the main approaches nor mars the general appearance of the house.

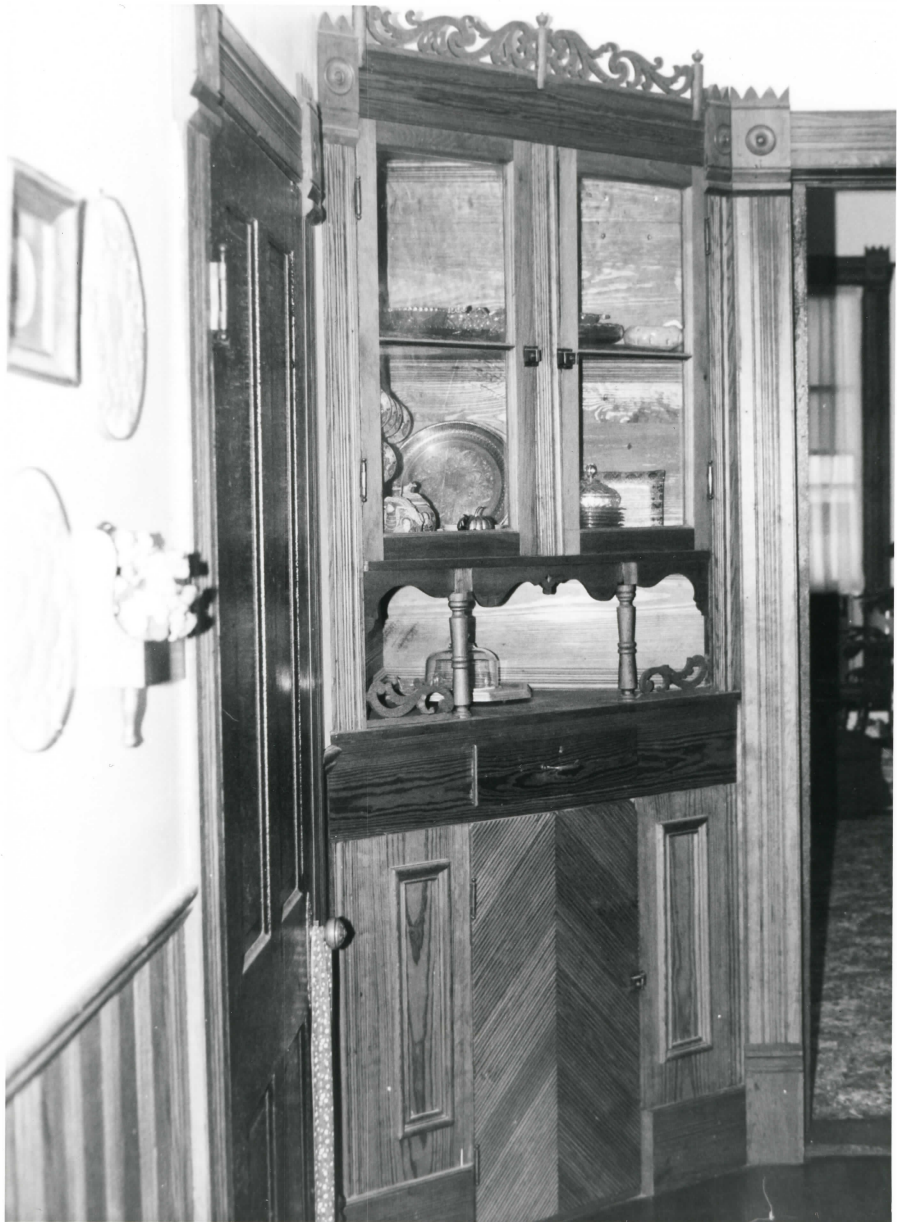
#25. Smith House

Detail, door and cabinet in diningroom.  
Photo 103 of 150.

The stair has been turned around to allow a separate entrance to the second floor, and the dining room has been converted into a kitchen. Otherwise interior alterations are minimal and do not detract from the exquisite wood details, some of them executed by the first owner and builder. In the living room crowned bullseye moldings cap the window frames and accent the wooden curtain rods. The same room boasts an oak and tile mirrored mantel. The southeast bedroom has a wood-burning fireplace. Mr. Smith's artistry is best displayed in the kitchen, where his pencil lines are still visible on an unfinished but exquisite, built-in, diagonal china cabinet.

Carrie Kone Smith, sister of Judge Ed R. Kone, bought the land in the McGehee Addition, one of the oldest subdivisions in town, from her sister L. Janie Kone Harper. She and her husband Byron Wynne Smith built the present house in 1897. Mr. Smith was a noted cabinet maker. Pieces of his work that remain in the house testify to his skill, although not all the details can be attributed to Smith with surety. Among the many embellishments that make the interior attractive are the crowned bullseye moldings, a carved oak and tile fireplace, wainscoting, and the original, etched-glass, front door. Intricacy of interior detail reflects the many angles and decorative features of the exterior.
