National Register of Historic Places
Inventory—Nomination Form

historic Hiram Partee Residence House

and/or common Wilen Building

street & number 605 Belknap Place

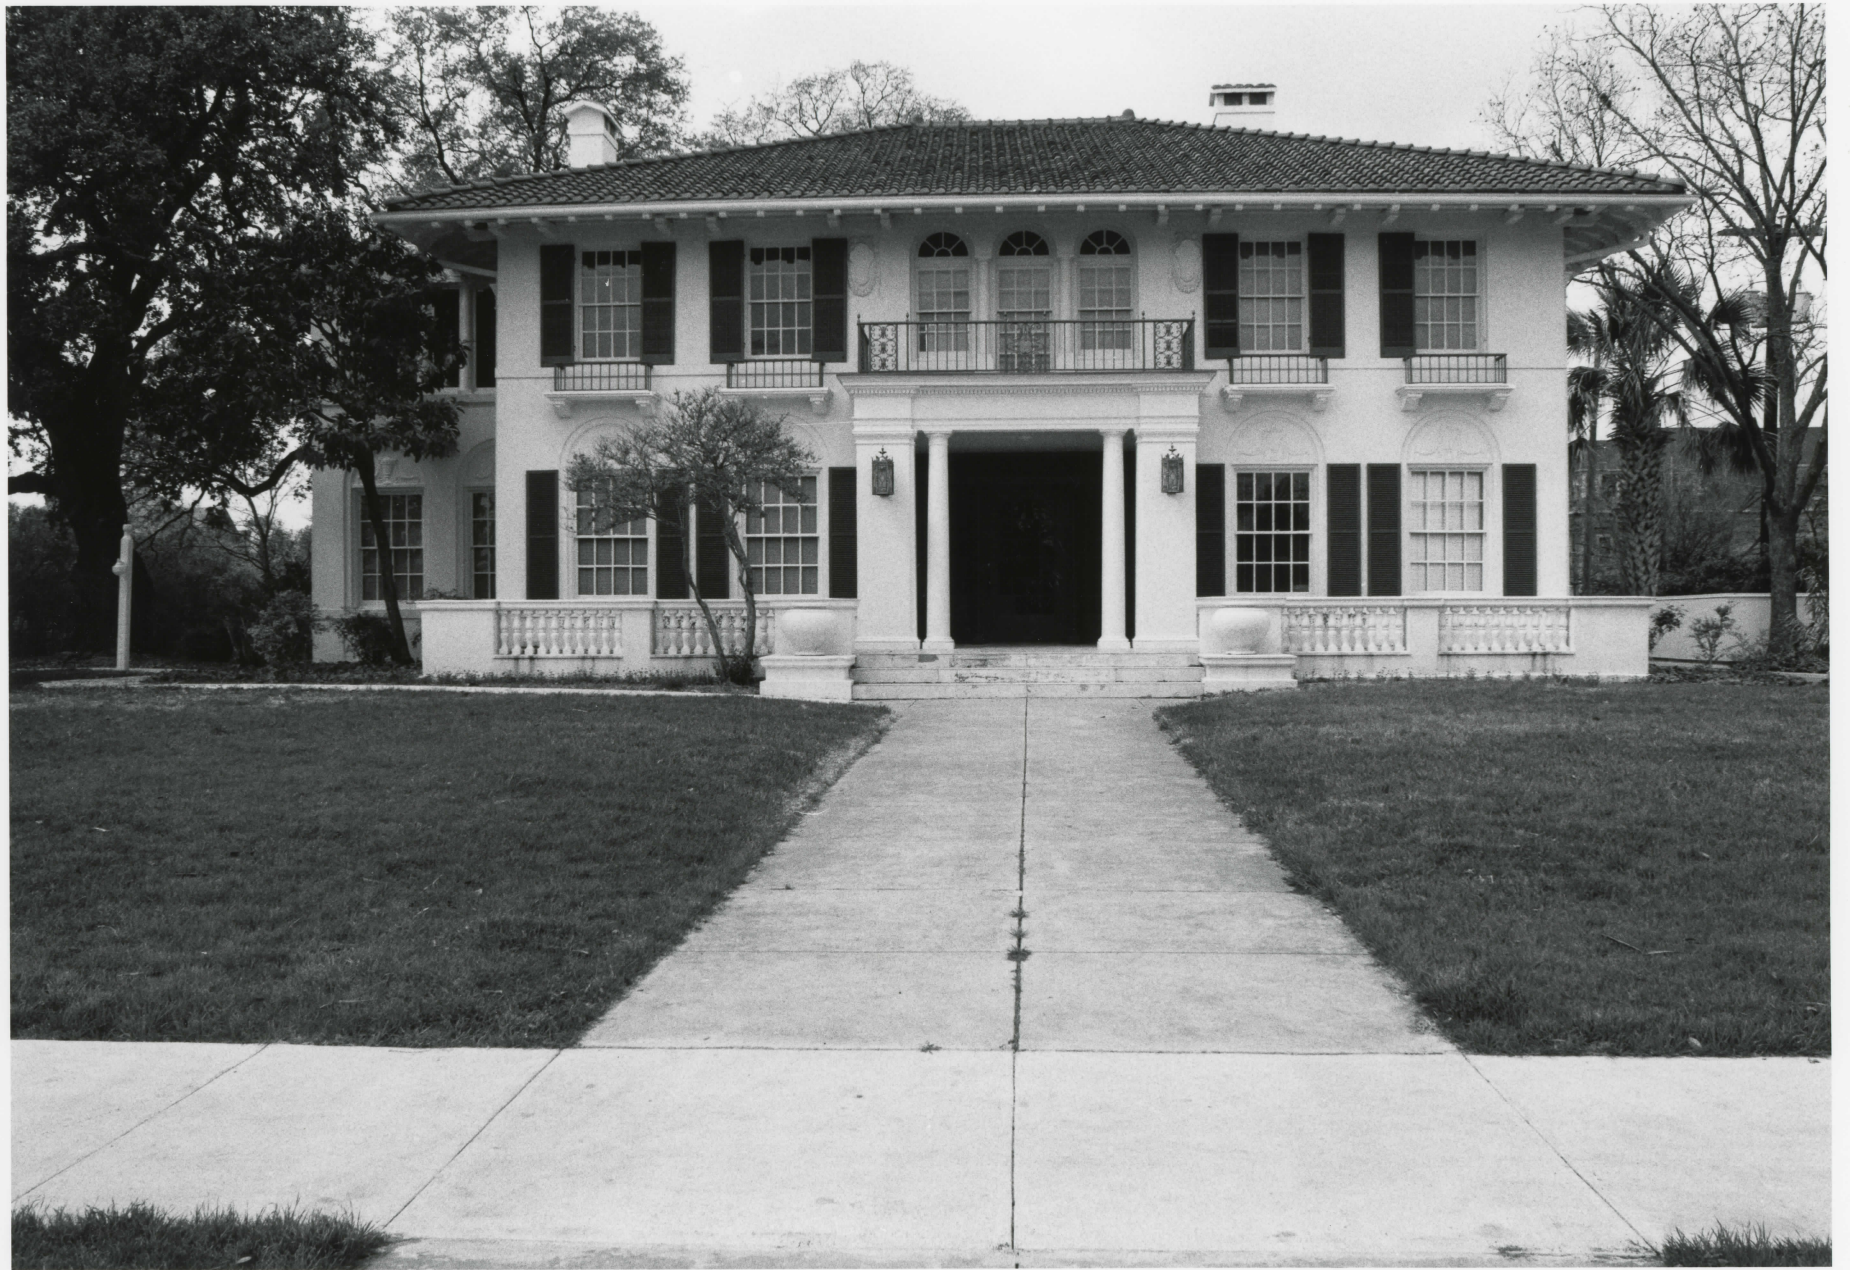
Photo 1 of 10

Main (east) facade, looking west

Approaching the east, or primary, facade are marble steps with urns and an ornate balustrade railing on each side of a tiled plaza running the length of the facade. Strictly symmetrical, the east facade has a five-bay configuration, with two bays on each side of the central entrance. The entrance portico is classically Beaux Arts, with slender Doric columns set inside much larger square piers. On each square pier hangs a fanciful brass light fixture with florentine glass. A dentil string course runs along the upper edge of the heavy cornice. The second-story porch of the portico is defined by a wrought-iron railing. A triple round-arch opening provides access to the porch, with the center opening fitted with floor-length sash. On each side of this opening is a molded plaster relief depicting a shield with banners at the top and a garland of fruits and flowers framing the bottom. The deep roof overhang is supported by ornate frame brackets. Below the four, shuttered, second-floor window openings are balconies with simple cast-iron railings. Each is supported by two ornate plastered brackets. These balconies are strictly decorative, as the window openings behind them are not designed for easy access. The four first-floor windows on the east facade as well as other original double-hung windows on the first floor, are crowned by an ornate molded plaster arch with an embossed Grecian urn with banners and leaf garlands.

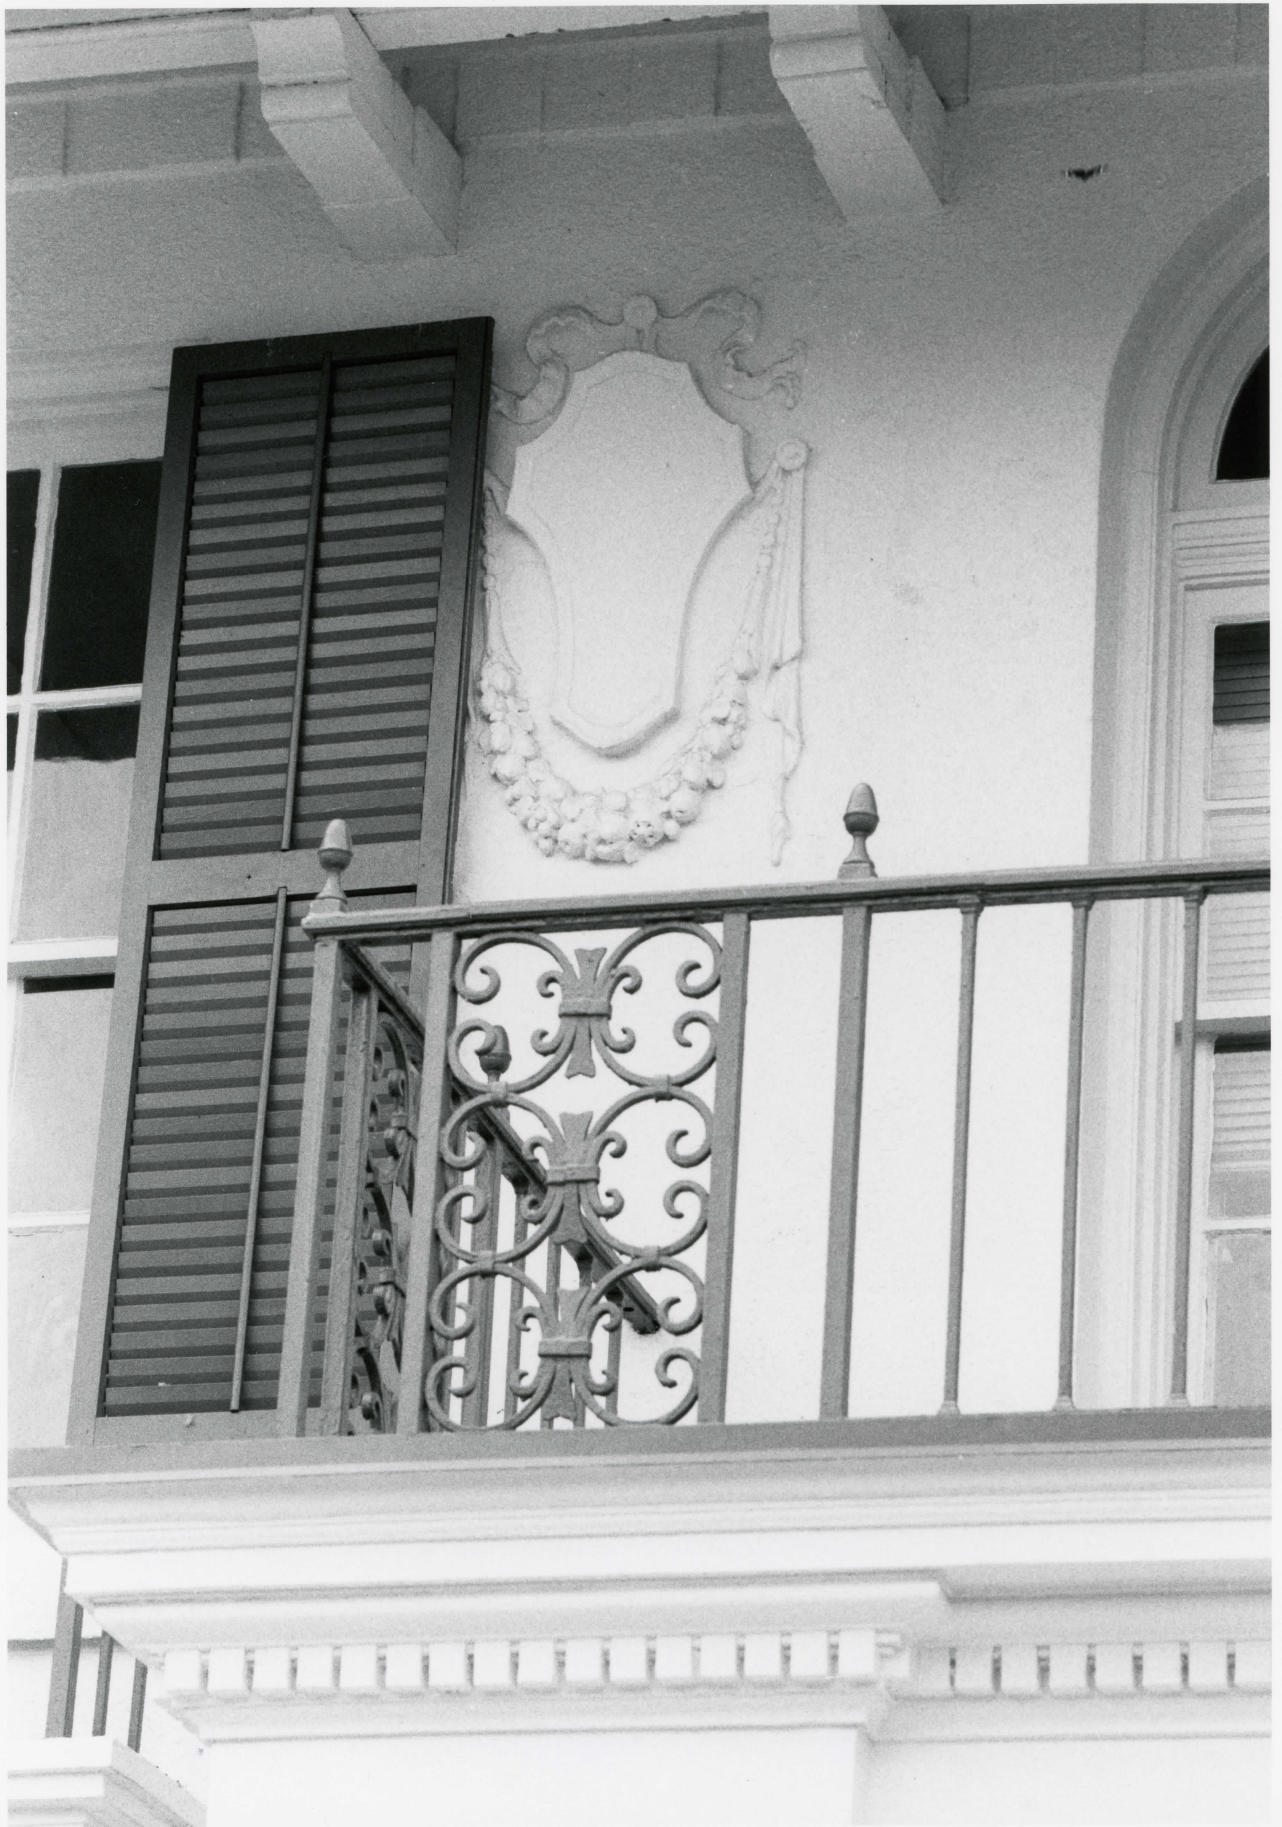
photo 2 of 10

Detail of cast iron, molded plaster relief, and
brackets on east facade; looking west

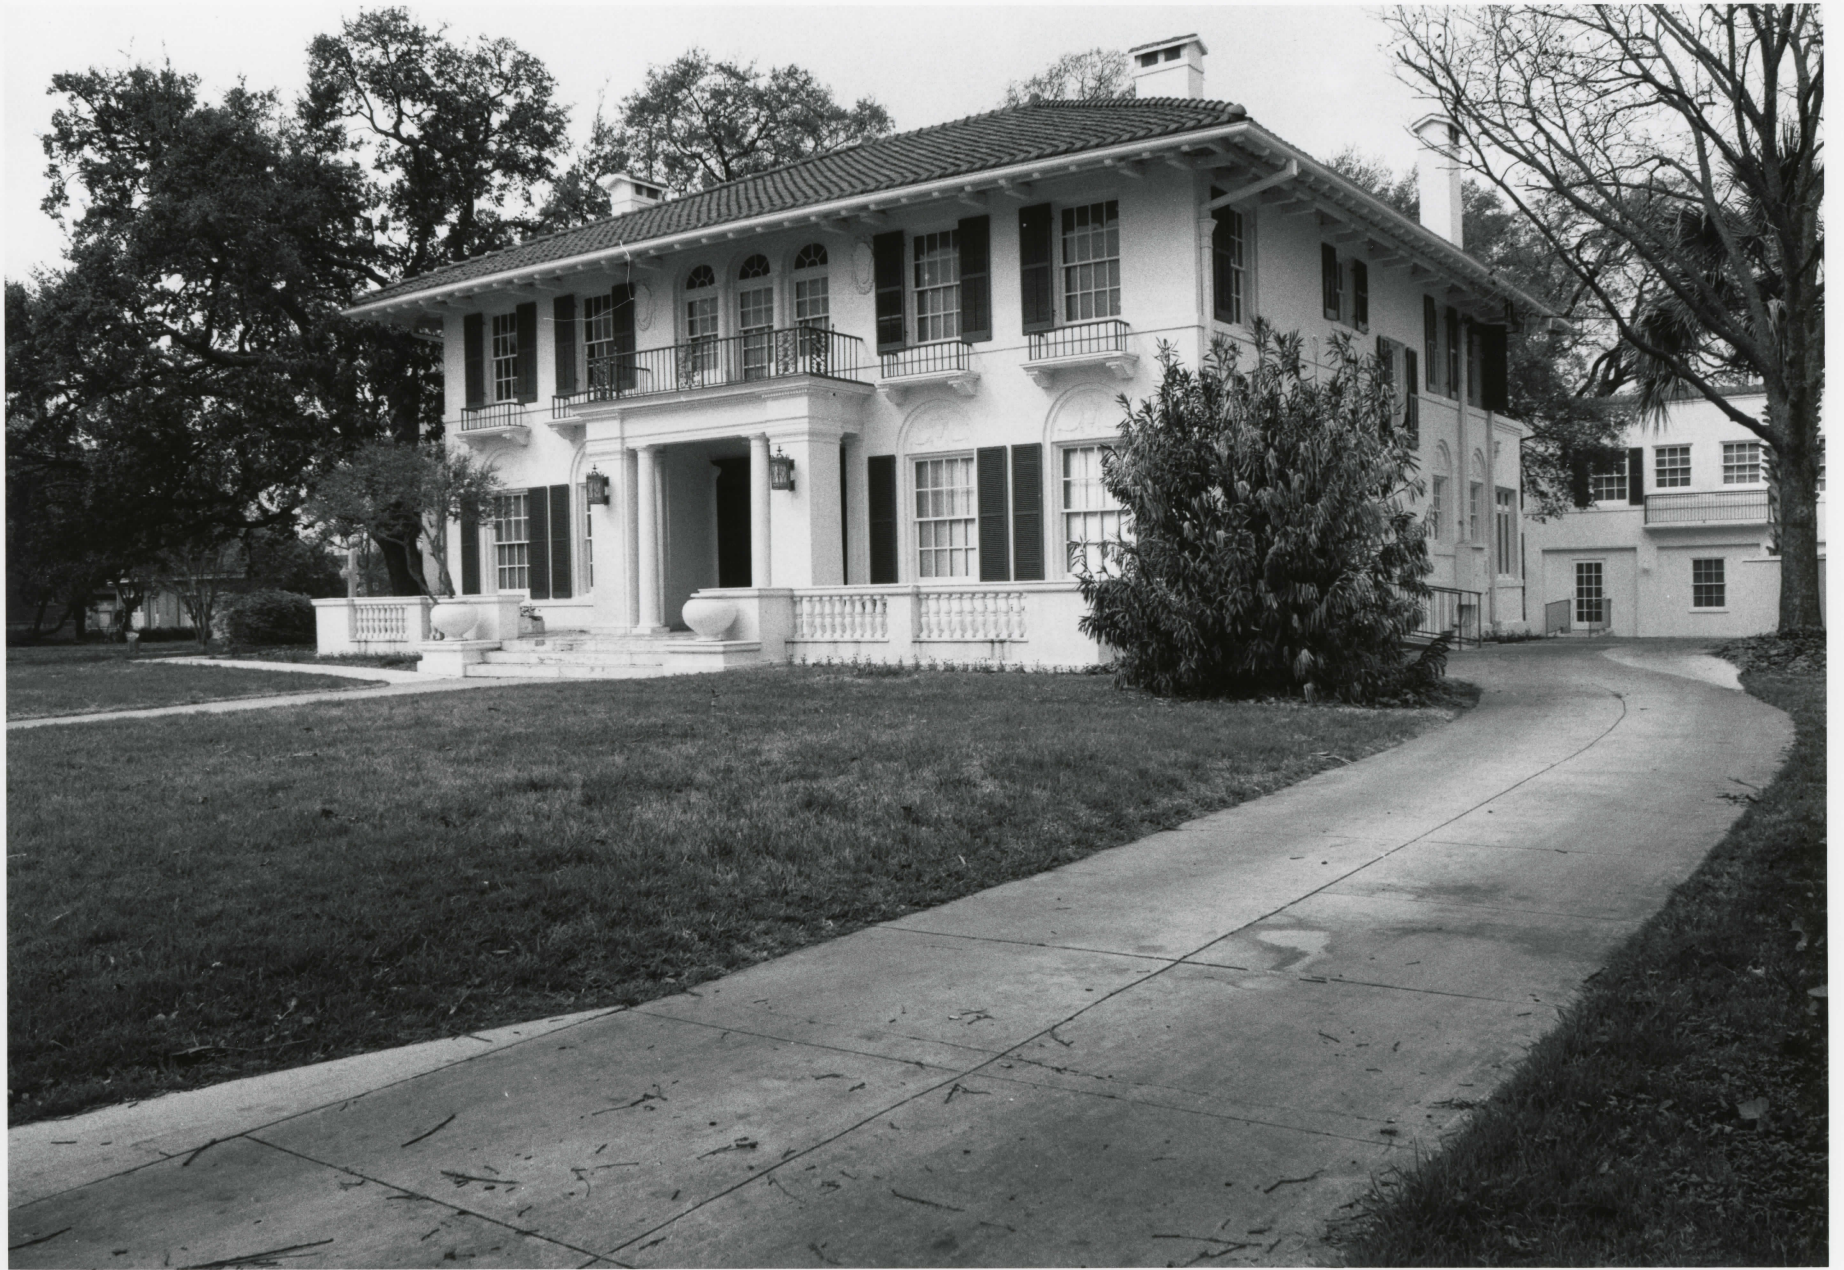
photo 3 of 10

Viewed northeast corner of main house, with
servants' quarters in rear; looking southwest

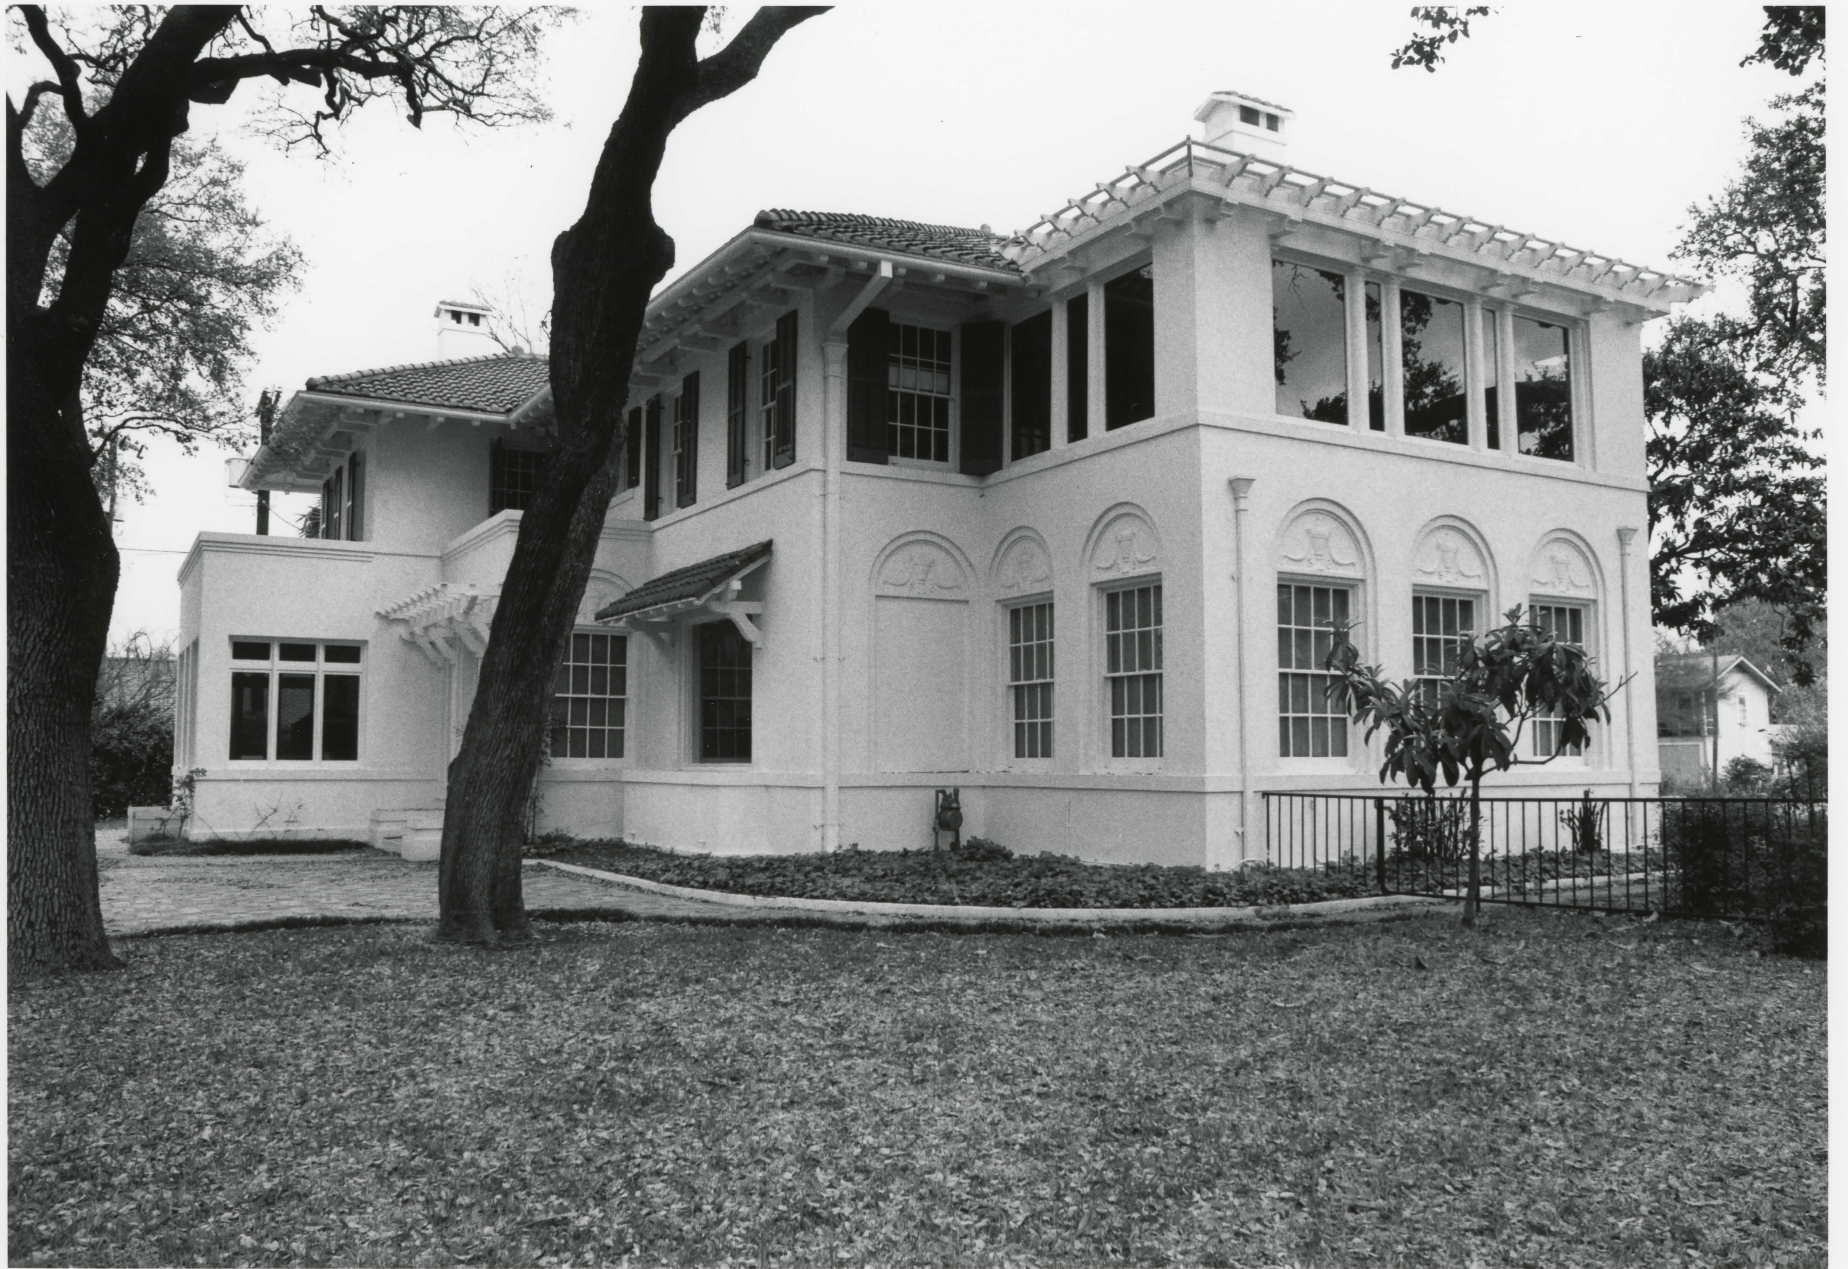
photo 4 of 10

View of southwest corner of house, looking
northeast.

The surviving original landscaping consists primarily of large sprawling live-oak trees. A polychrome tile patio among the oaks at the southwest corner of the structure survives intact.

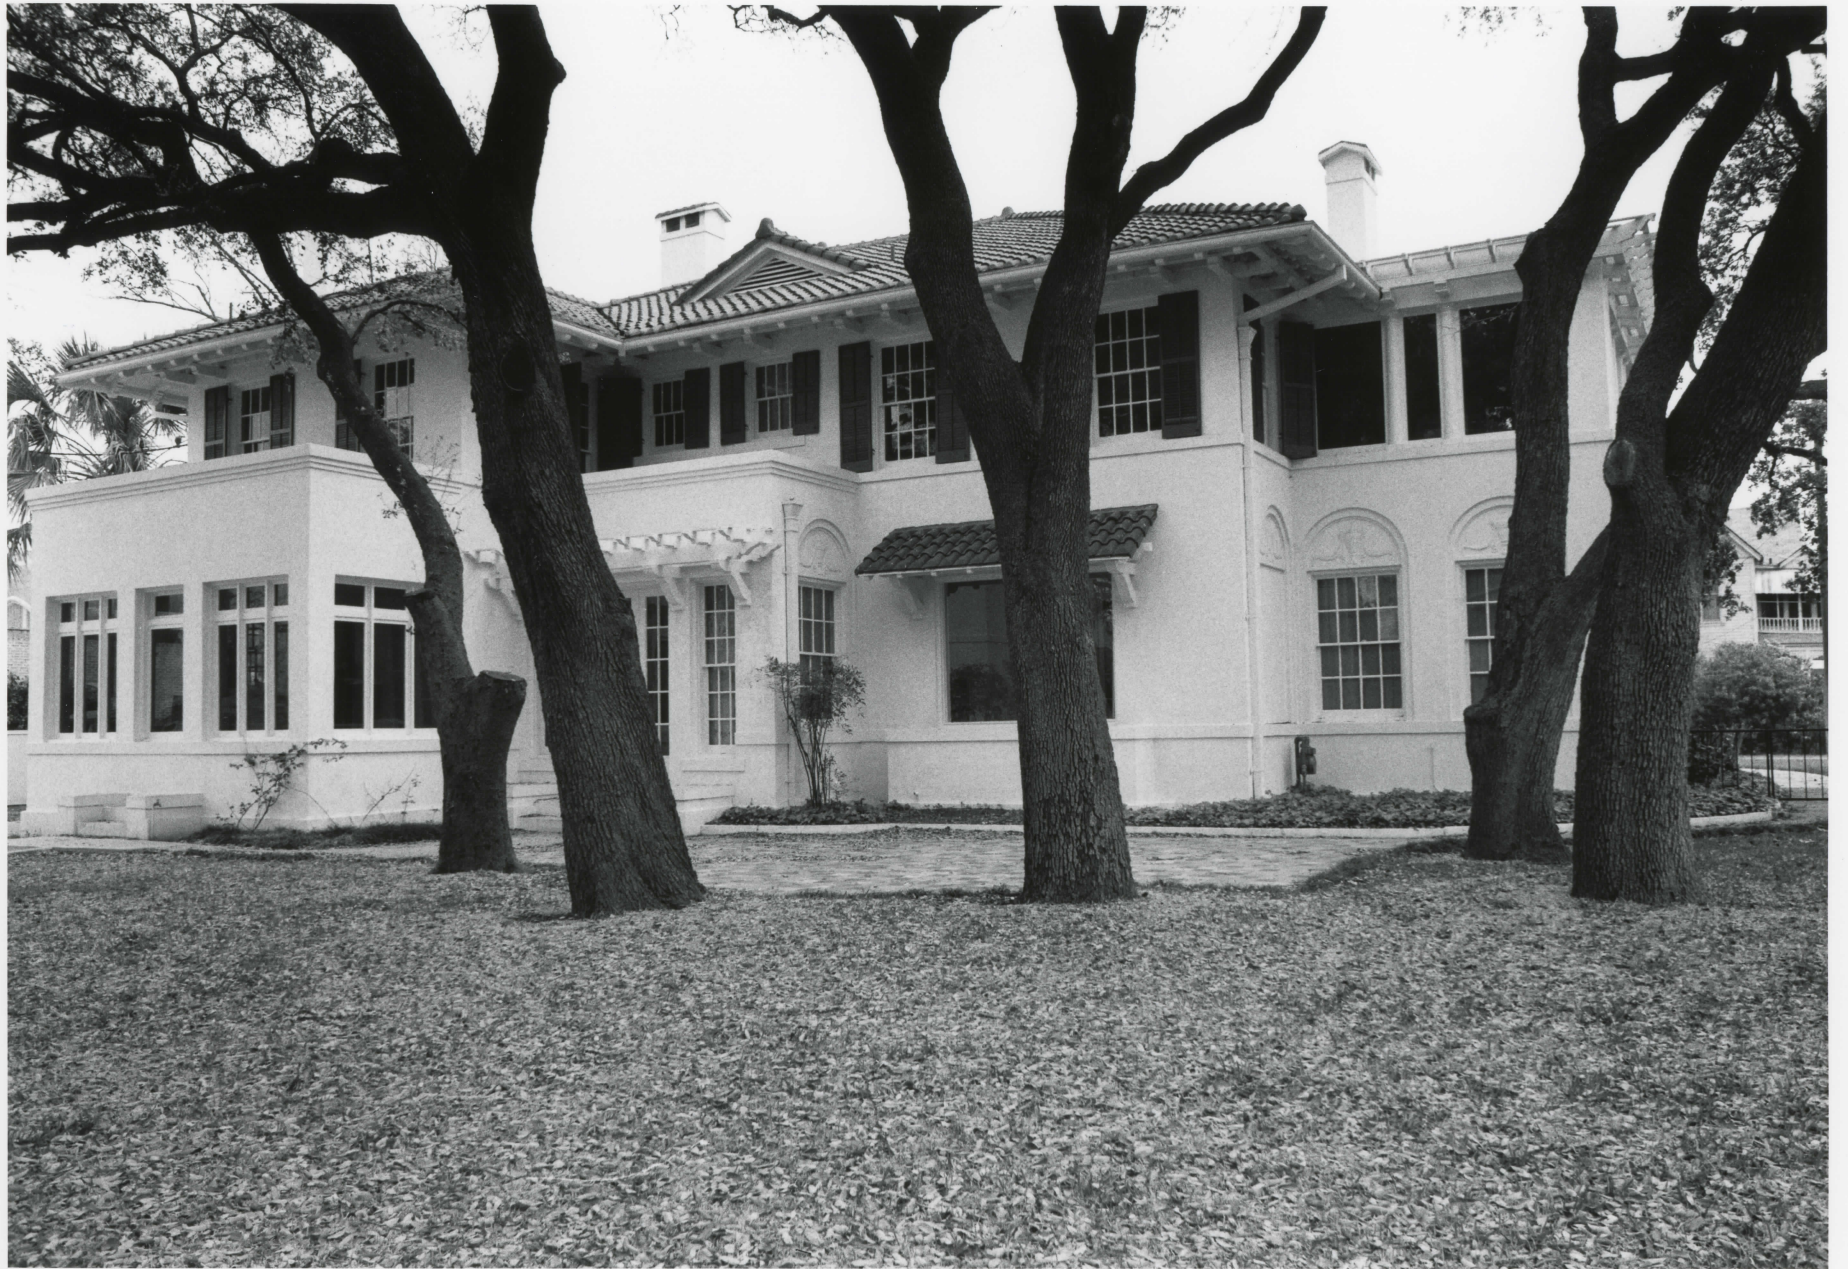
photo 5 of 10

View of west (rear) facade, looking ENE

The west or rear facade is asymmetrical with two projections on the first floor and one on the second floor. A red clay-tile awning supported by brackets covers a wide, tinted, plate-glass picture window. The current owner installed the plate glass into an existing picture window opening. It has not been documented whether or not the original picture opening had divided lights, but such would be consistent with the other openings in the structure. A previous owner installed a single sheet of glass. Another ornamental rafter bracket covers the French doors leading into the interior central hallway. The casement windows and the exterior doorway into the nurses office have been altered for security purposes. Set-in glass has replaced the operating casement windows with screens and the doorway has been removed. On the second floor of the west facade there are five, eight-over-eight, double-hung windows and two small four-over-four double hung windows. The room on the northwest corner projects out approximately half as far as the nurses office on the first story. A gable vent occurs over the smaller double-hung windows on the second story. The north facade is also asymmetrical. On the first floor there are four, eight-over-eight, double-hung, shuttered windows with the same ornamental plaster relief as on the east facade. The entry door has been altered to accommodate a handicap ramp and handrail. The original shape of the doorway, however, has not been altered. There are five second-floor windows, three of which are of the eight-over-eight double-hung type to the ones on the east facade. Two windows are not aligned with the other three. One is an eight-over-eight double-hung window on the interior stairway, placed between the first and second floors. The other is a small six-over-six double-hung window above the tile wall in an upstairs bathroom.

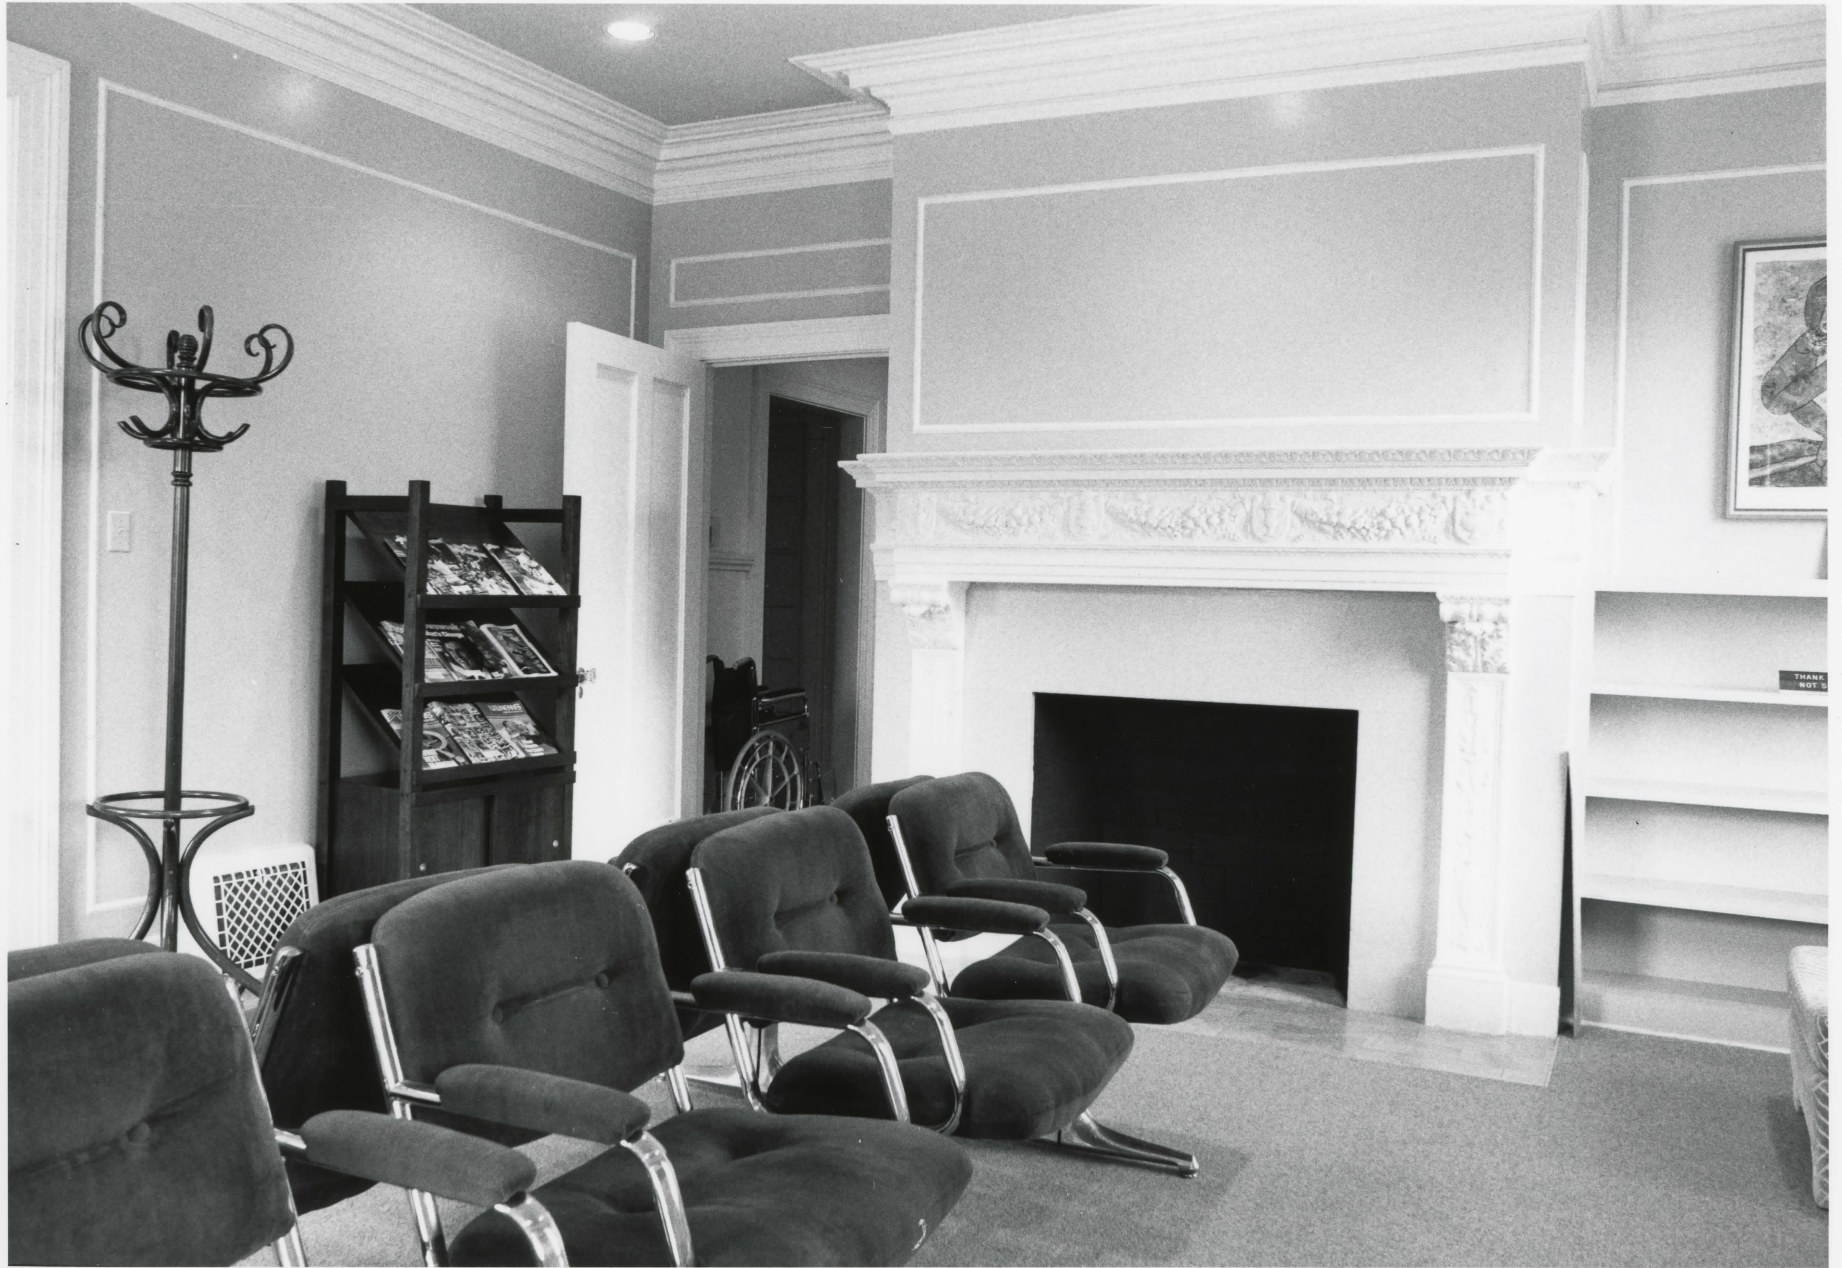
photo 7 of 10

Waiting room interior

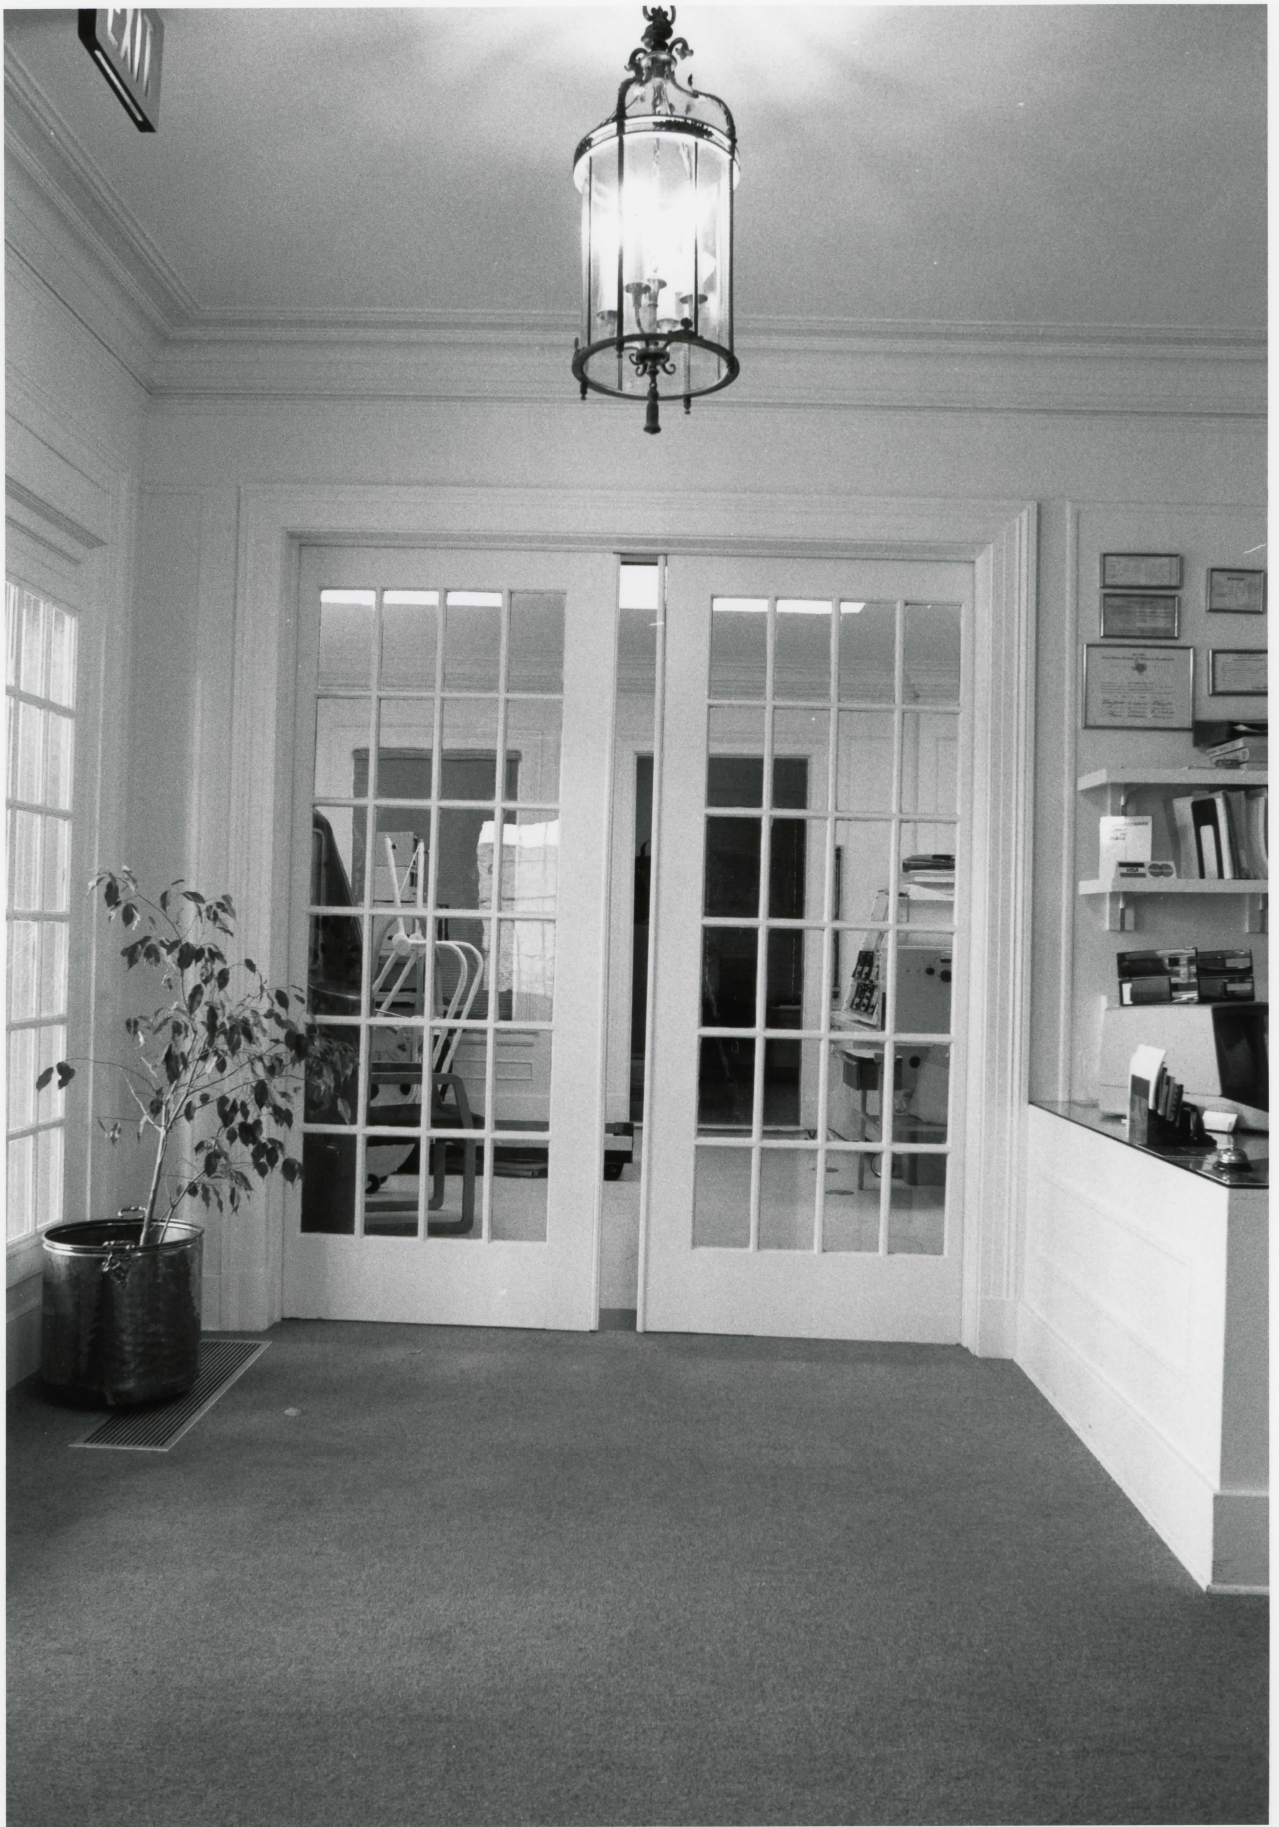
photo 8 of 10

Pocket door leading from entry hall to south
end of first floor

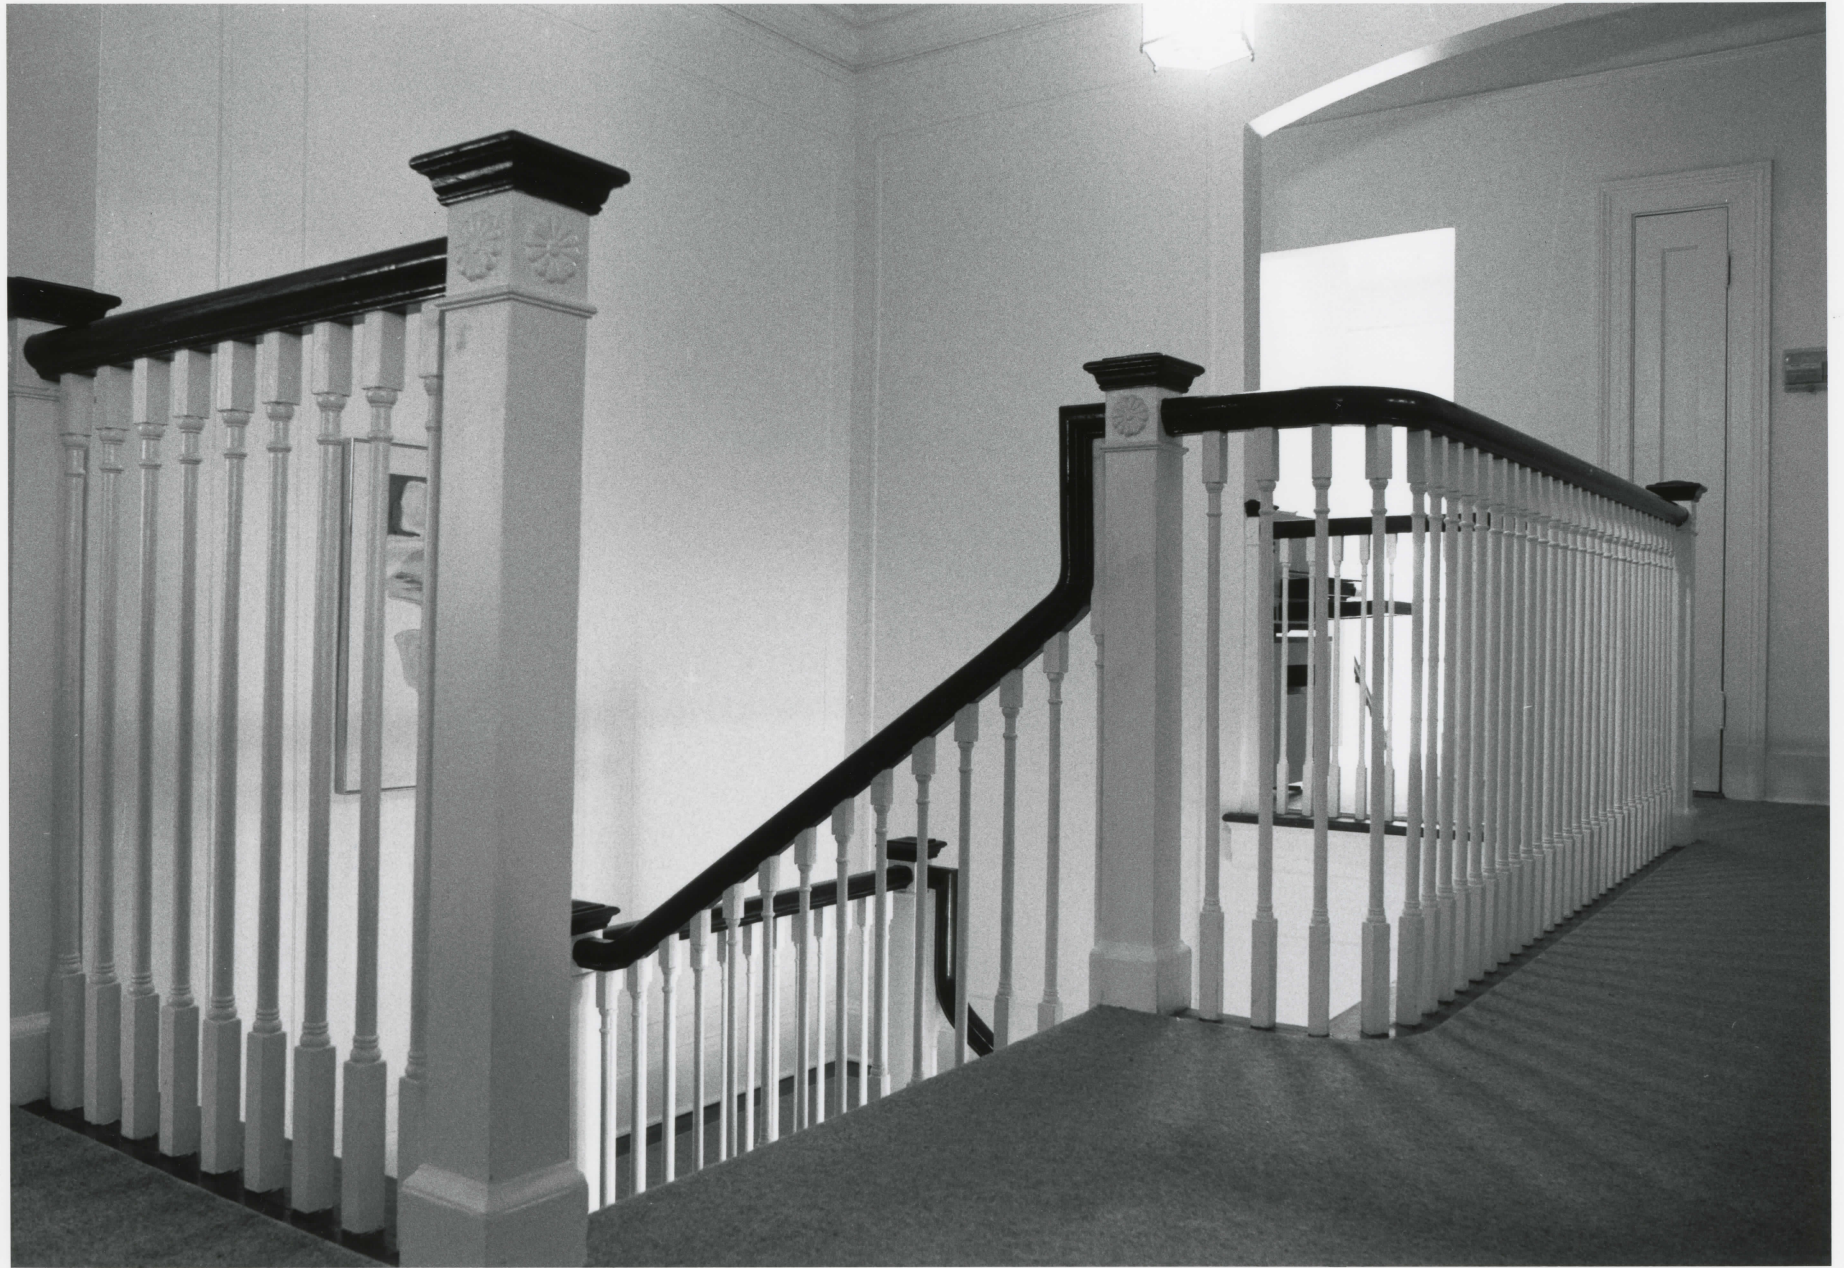
photo 9 of 10

Stairway, second story

The central stair continues to the second floor designated as offices and computer room. The ballusters and newels are intact. A Grecian urn crowns the newel post on the first floor, while ornate medallions decorate those of the second-floor. Secondary stairways within the structure include one which connects the north entry hall with the second floor, and another which connects the nurses' office to the basement below it.

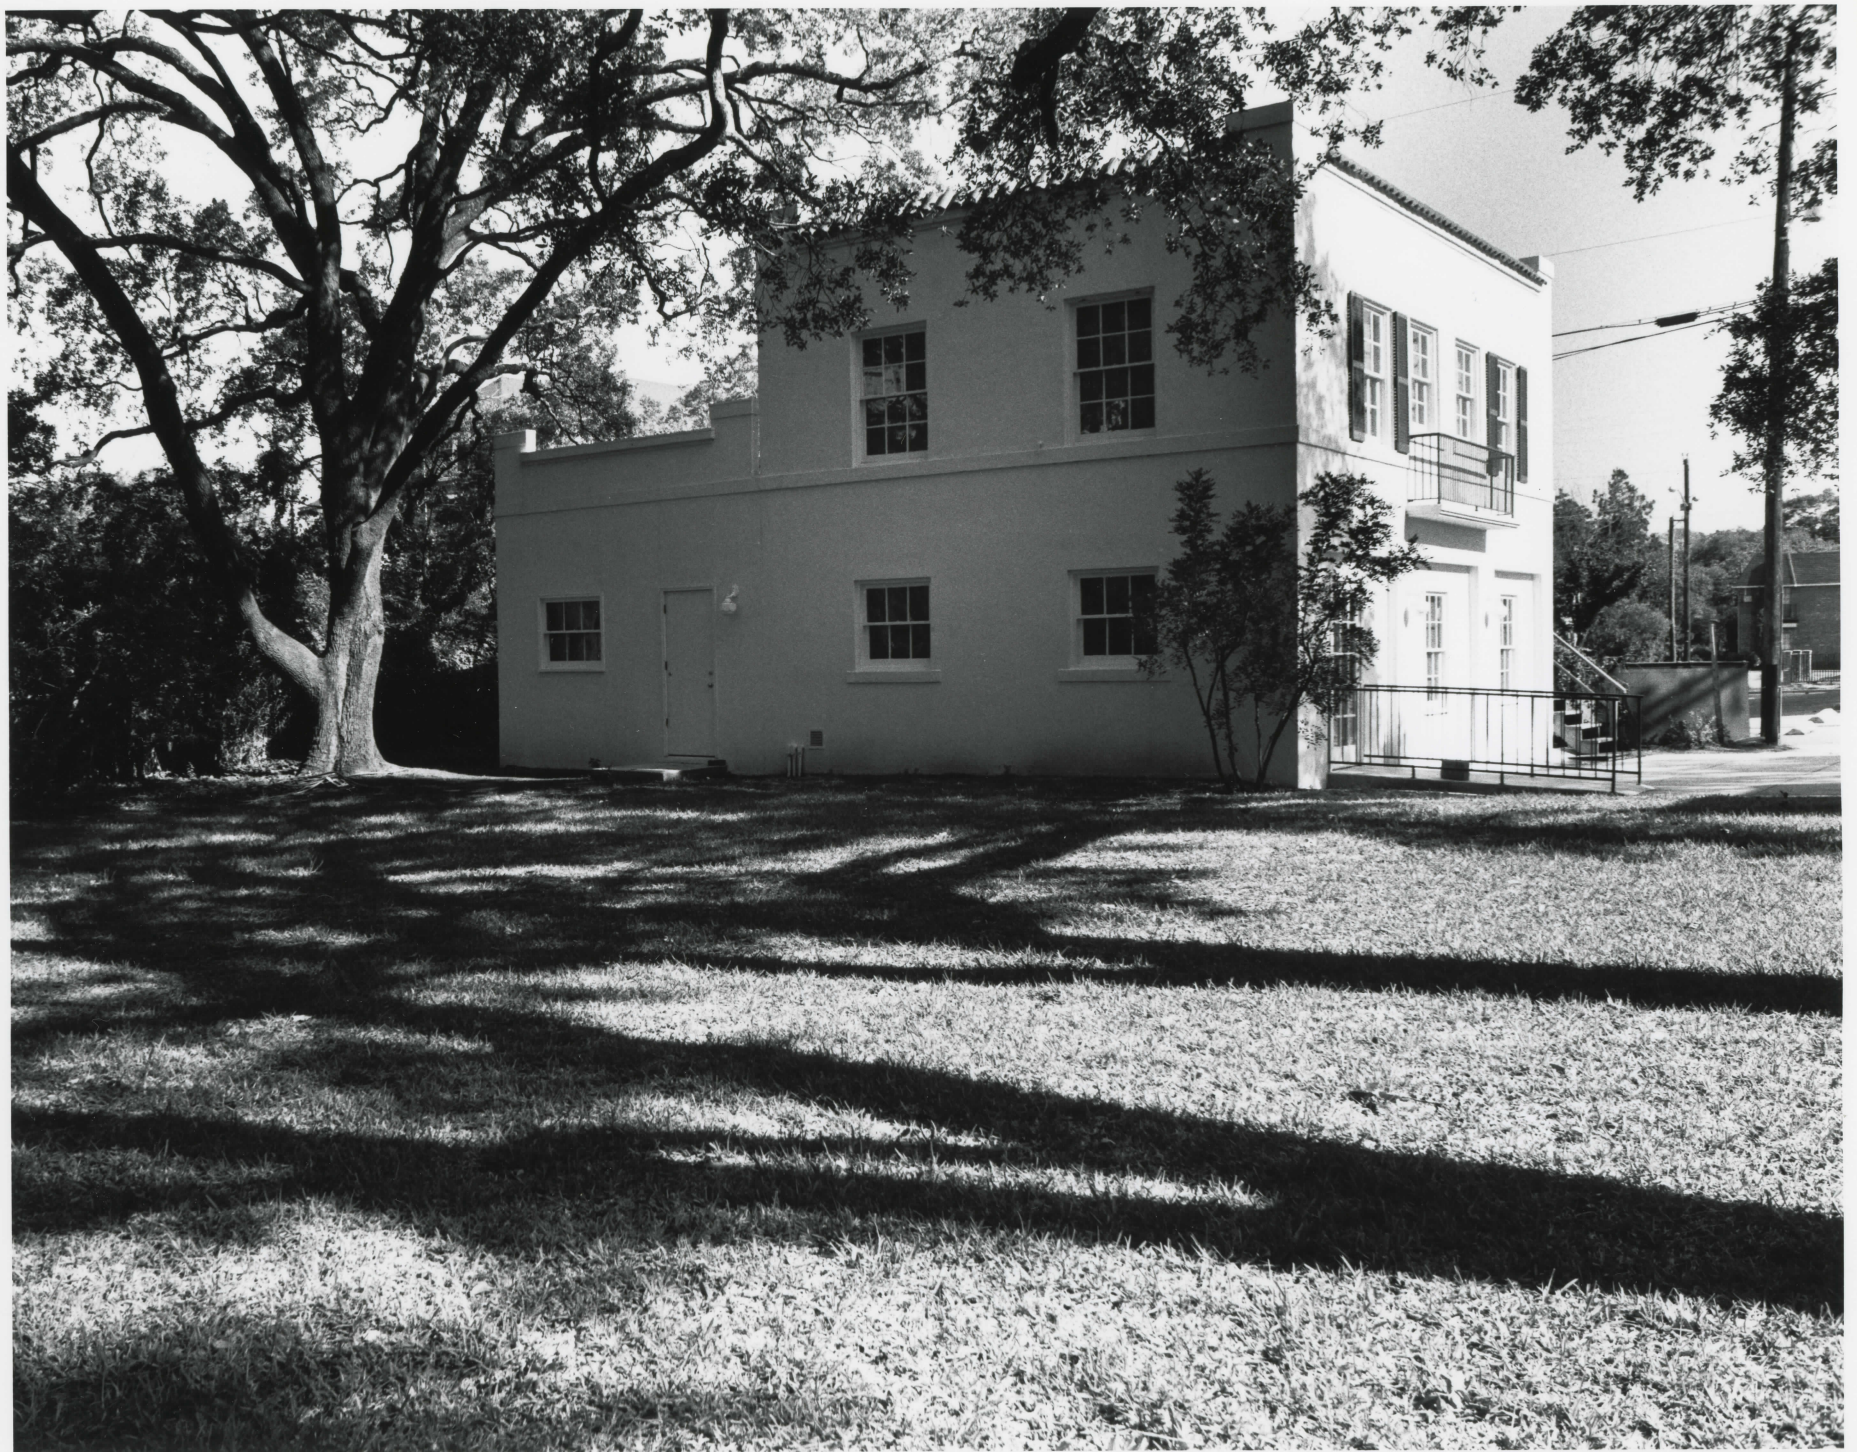
photo 10 of 10

Servants' building, looking NNW

One ancillary building exists on the grounds. It was originally a three-car garage with servants' quarters above. It is a one and three-quarter story structure with white stucco and red Spanish tile roof to match the main house. The windows on the first floor are six-over-six or three-over-three double hungs and six-over-six double hungs on the second floor. One window on the east facade has a cast-iron balcony similar to those on the east facade of the main house but without the plaster brackets. The stairway to the second floor is on the exterior of the north facade.

The original interior spaces of the first floor have been demolished. New walls, floors, and cabinetry suitable to meet the building code for an X-ray and laboratory clinic have been installed. All interior walls remain intact.
