National Register of Historic Places  
Inventory—Nomination Form

10. Name: Fort Street Presbyterian Church

Location: 516 West Hopkins Street

Historic Resources of San Marcos  
San Marcos, Hays County, Texas  
#10. Fort Street Presbyterian Church

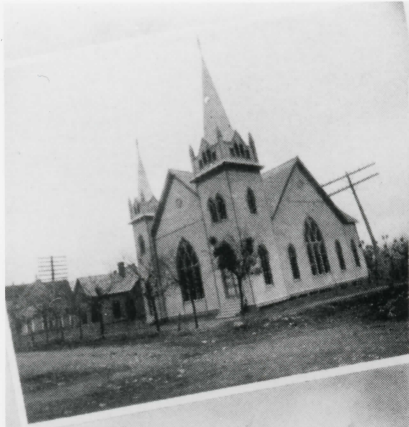
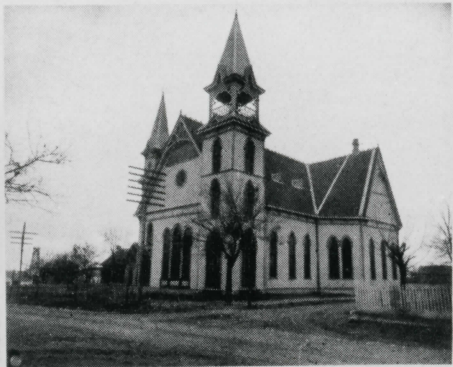
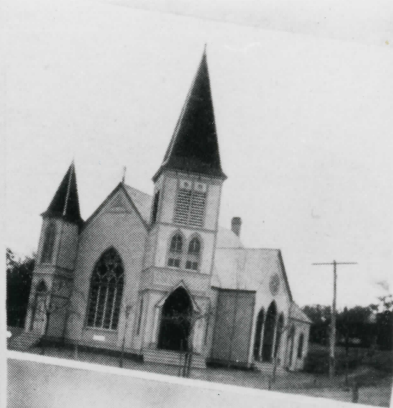
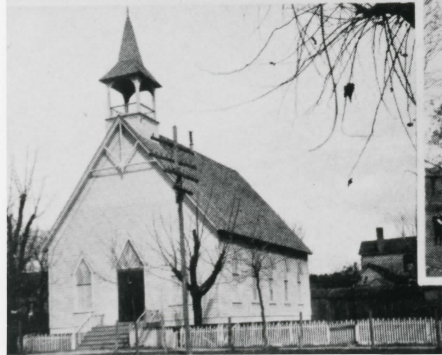
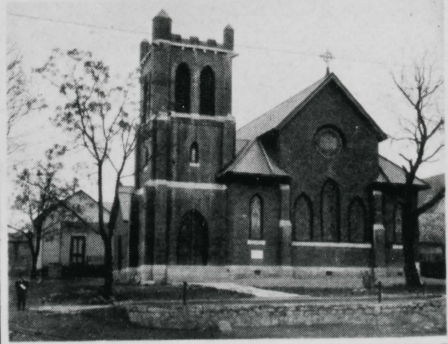
Photo courtesy San Marcos Public Library,  
taken 190... Copy photo by Sally S. Victor,  
negative property of HASM, on file at SMPL.

The Fort Street Presbyterian Church is a modest, white, frame vernacular Gothic building distinguished by two octagonal towers within the arms of its cruciform plan. A gable over the sanctuary is intersected by another over the chancel. Both are covered with standing-seam metal roofing. A similarly styled and finished educational wing spans the building's rear, but the half-pyramid roof of the apse is visible above it.

The towers rise from square bases, although the transition is smoothed in shingling. Above the wood louvres that comprise the walls are steep pyramidal roofs of plain sheet metal, supported by small carved brackets. The northern tower is about six feet higher than the southern. Other exterior features are triangular, carved, corner brackets at the chancel's front walls and bands of decorative shingles on the gable end.

Three bays of upward-sliding doors separate the sanctuary and chancel. Their frames are detailed with bullseye and trefoil moldings. The sanctuary's hardwood floor curves down toward the altar. Most of the curved pews are still in place. Church records from 1901 state that the pews installed in the new building were "antique." Thus they pre-date the church, but their exact date is not known. Panelling from 1941 or 1957 obscures the altar's apse, but there are reports that stained glass is in place behind.

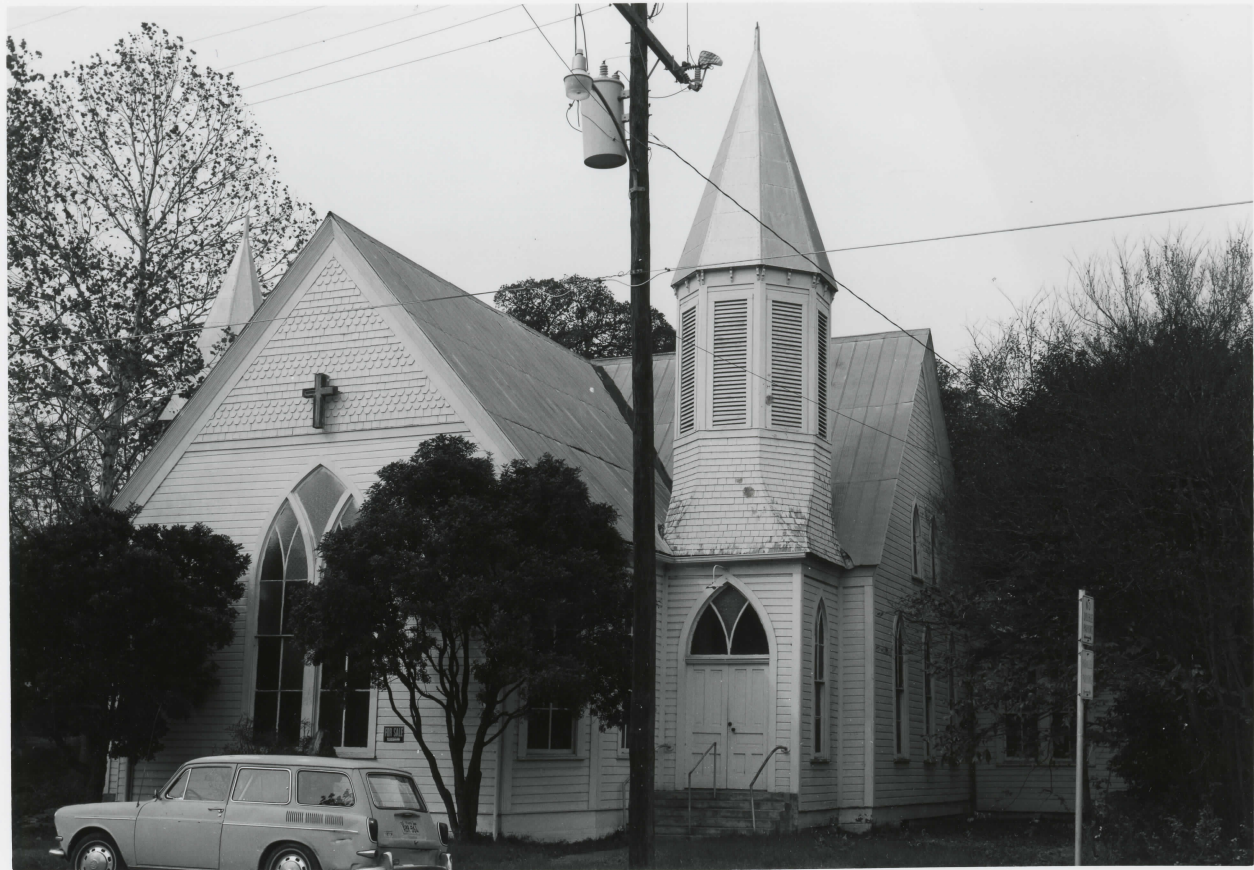
East oblique, camera facing west.  
Photo 46 of 150.

Photo by Melinda Koester/Stuart Strong, 1978.  
Negative on file at Texas Historical Comm.

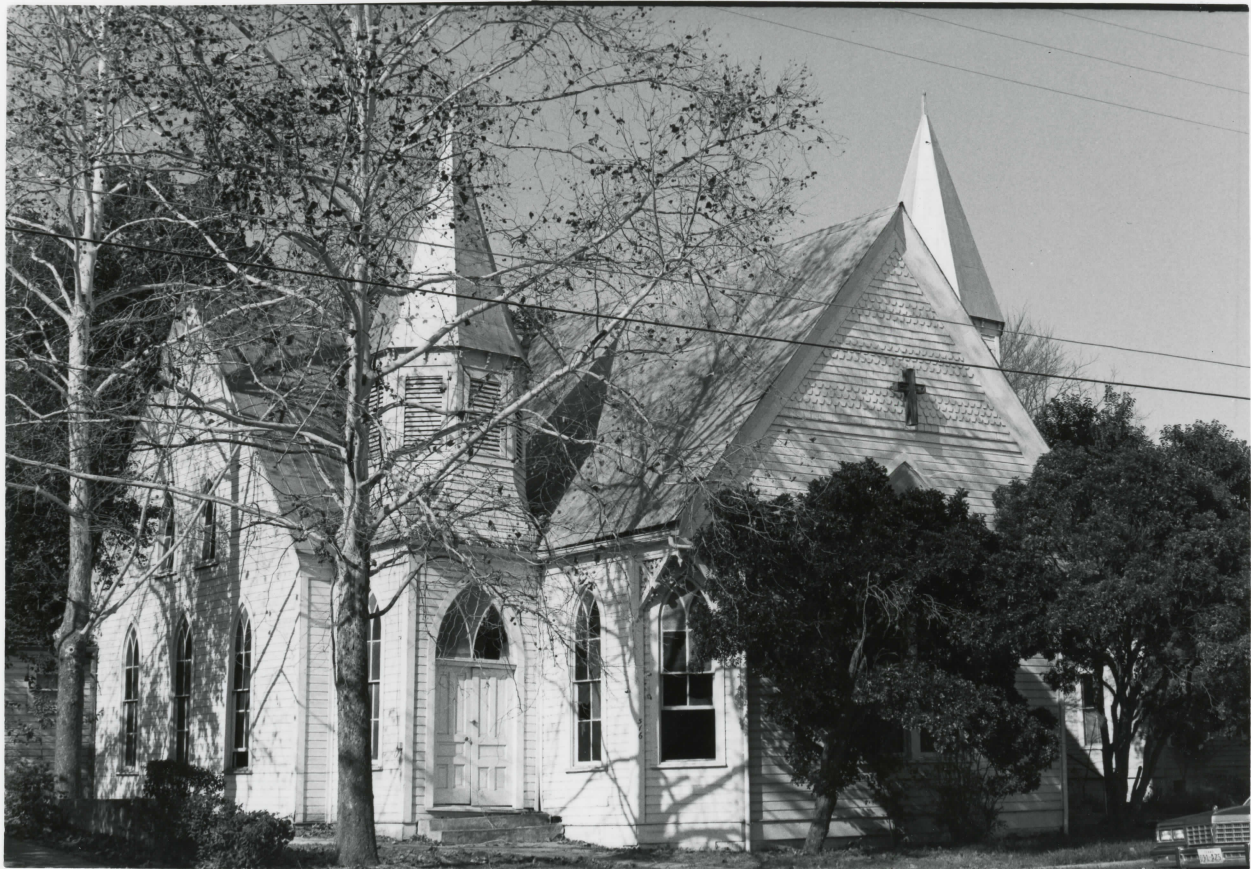
South oblique, camera facing north.  
Photo 47 of 150.

Photo by Lissa Anderson, January, 1983.  
Negative property of HASM, on file at SMPL.

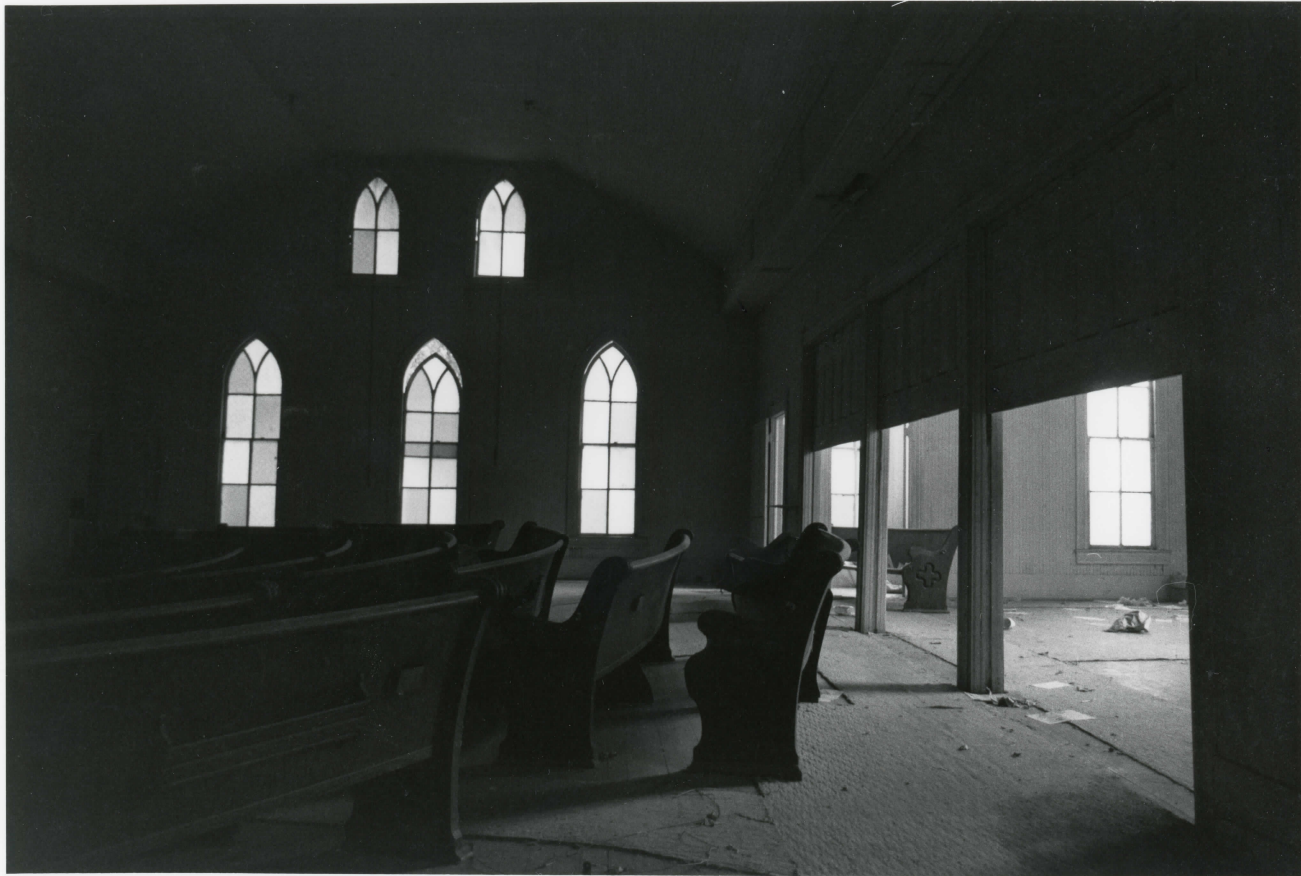
Interior, camera facing northeast.  
Photo 50 of 150.

Photo by Lissa Anderson, April, 1982.  
Negative property of HASM, on file at SMPL.
