**National Register of Historic Places
Inventory—Nomination Form**

✓ Name: Hillsboro Cotton Mills

✓ Address: 220 North Houston St.

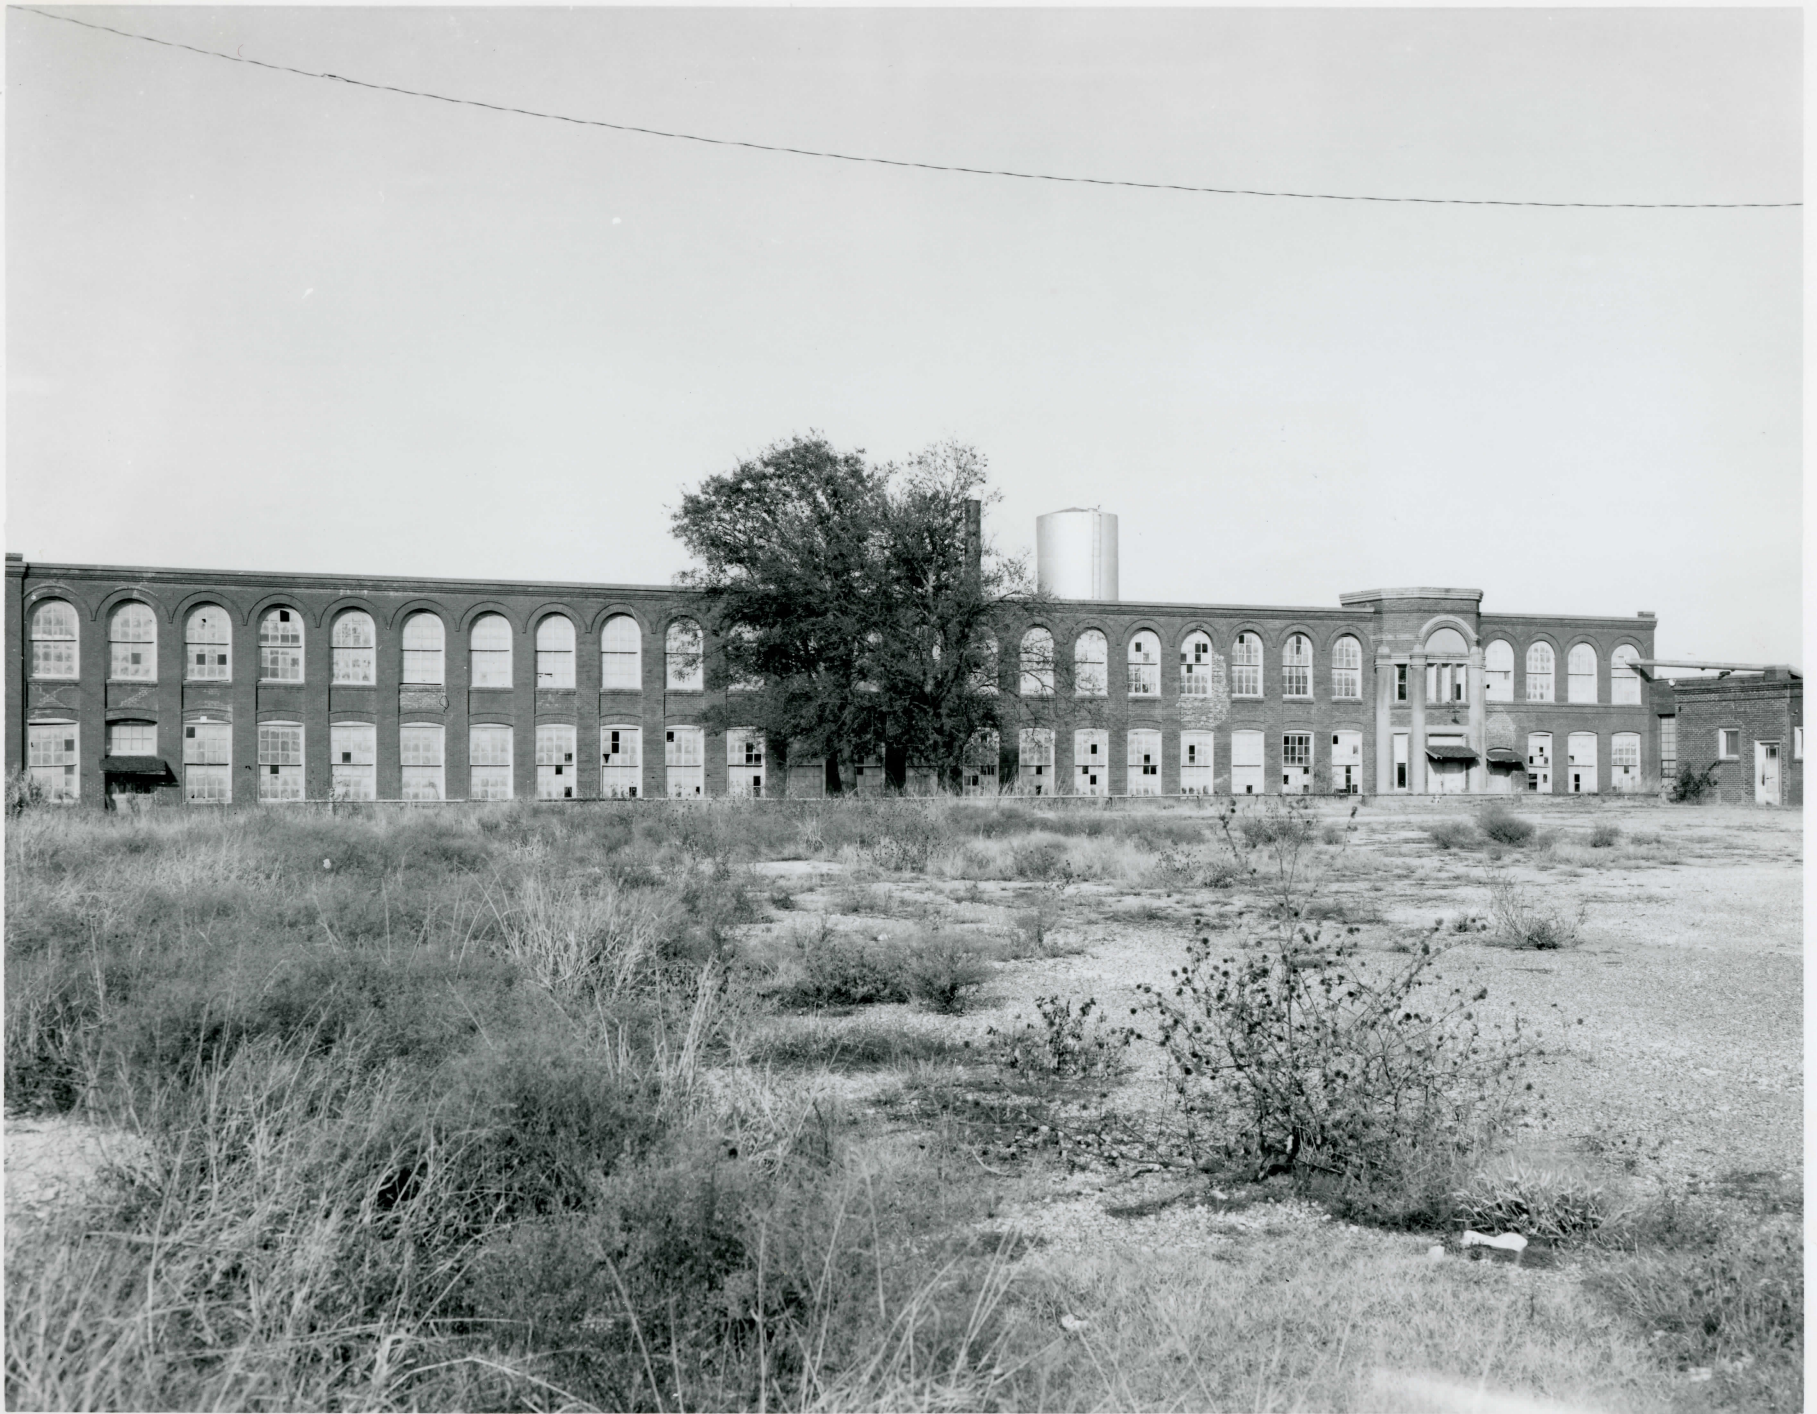
Site 9
9 HILLSBORO COTTON MILL COMPANY
Historic Resources of Hillsboro
Hillsboro, Hill County, Texas
Site No. 9, Hillsboro Cotton Mill Co., north
Houston Street

View: oblique of south elevation, camera facing
northeast
Photo 9 of 23

The main building of the Mills Complex is a two-story, vernacular, industrial building of brick with a rear north ell. It exhibits Romanesque Revival and Victorian Romanesque detailing. The structure consists of load-bearing masonry walls and a roof of plank-and-timber construction. The arcade of semicircular arched windows (12/12 lights) is crowned with brick trim on the upper level, while the row of 12/12 light windows on the first level exhibits brick relieving arches. Arcade windows are painted with a blue "blackout" screen originated during World War II. The exterior features a brick corbeled cornice, brick relief work between the upper and lower window bays, and cast-concrete details contrasting with the predominate red-brick exterior. The three-sided, two-story, bay entrance with four attached, cement, half-columns features concrete detailing such as belt courses, cornices, and window sills and lintels. The open bays of the interior are supported by chamfered wooden piers and beams, while an inverted metal king-post-truss arrangement runs the entire length of the building.
