**National Register of Historic Places
Inventory—Nomination Form**

Name: "Old Rock Saloon"
W. Elm St.

Name Hillsboro Multiple Resource Area
State Hill County, TEXAS

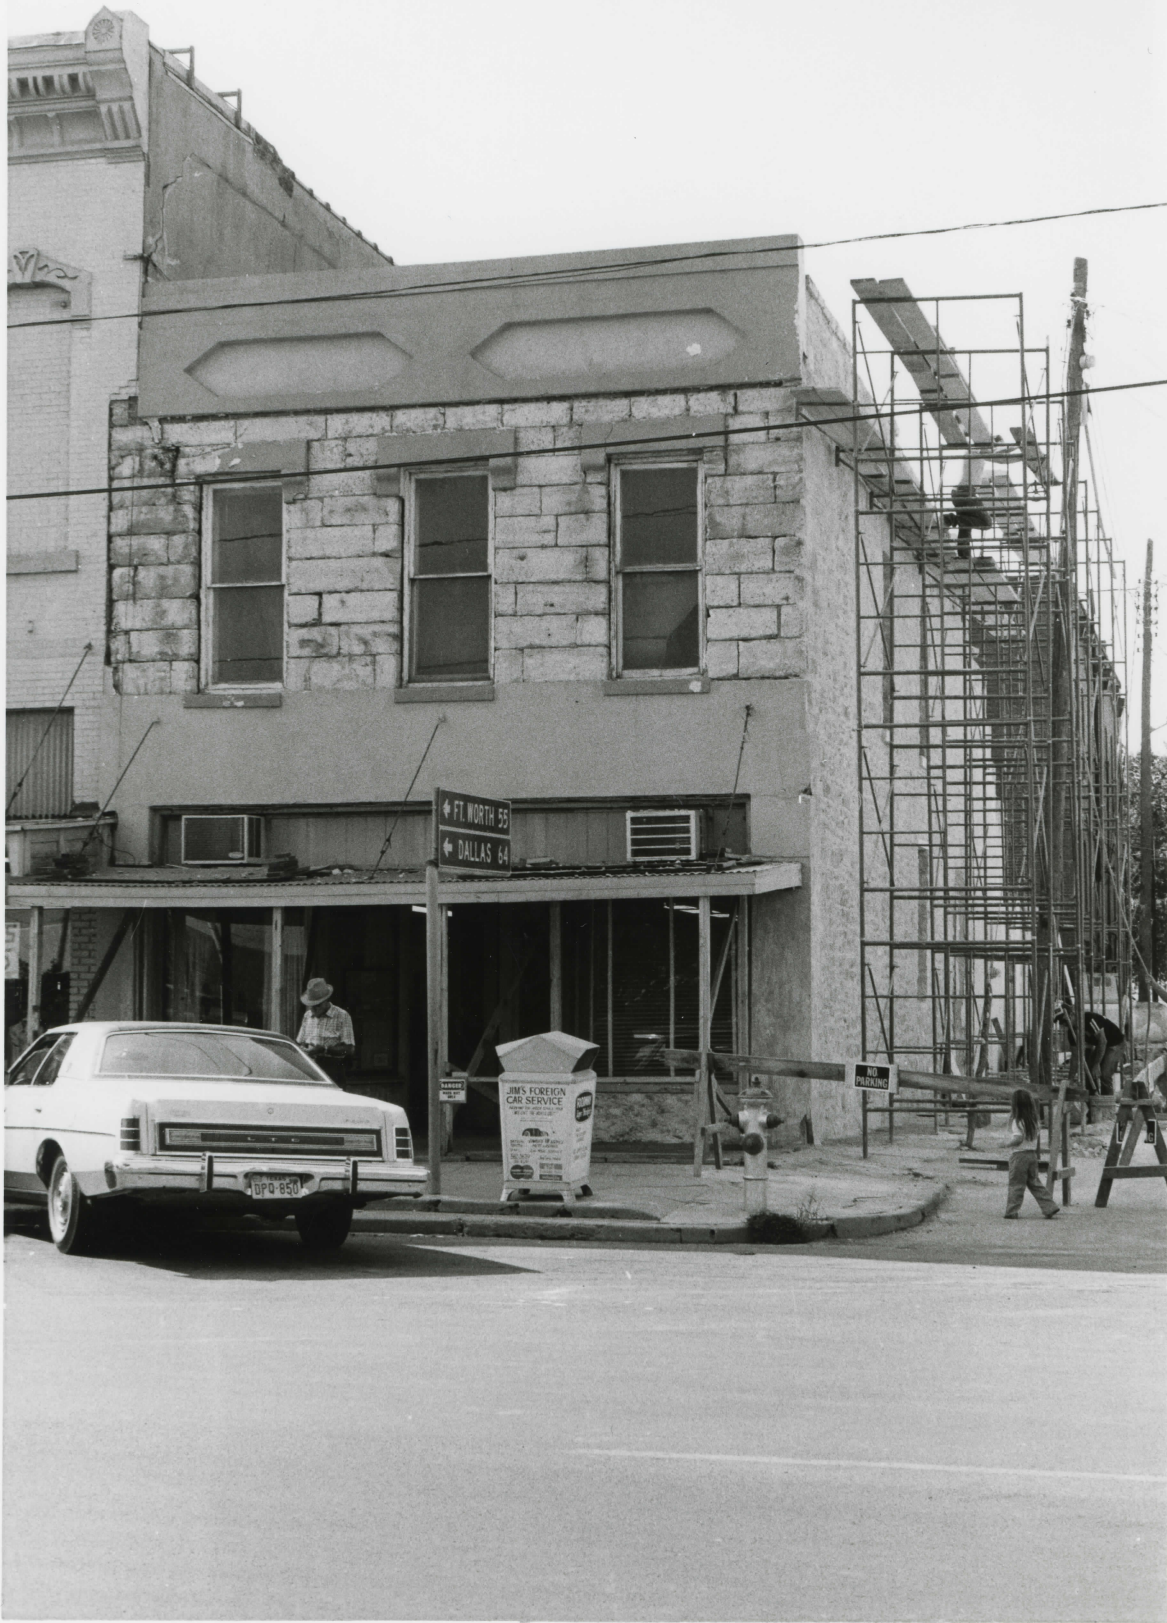
Photo No. 4

This two-story, three-bay, vernacular commercial building, constructed of limestone rubble and large cut blocks with partial stucco application on the facade, displays a rectangular plan and symmetrical floor arrangement. Three upper-level, 1/1, double-hung, wood-sash windows with bracketed hood molds contain stone sills. A gabled roof rises behind the built up parapet. The fixed-glass transom strips above the wood and fixed-glass storefront canopy are now blocked. During restoration and renovation in 1980-81, some plaster was removed. This was the first building to be restored under the Texas Main Street Program.

Historic Resources of Hillsboro
Hillsboro, Hill County, Texas
Site No. 4, Old Rock Saloon, 58 W. Elm
Photographer: Ellen Beasley, Spring 1982
Negative on file, Texas Historical Commission,
Austin
View: northwest oblique, camera facing southeast
Photo 4 of 23

Date(s) of Alterations: 1980-81; restored
