**National Register of Historic Places
Inventory—Nomination Form**

Name: Windmill Realty Co.

✓ Historic Name: Western Union Building

✓ Address: 107 ~~South~~ Covington Street

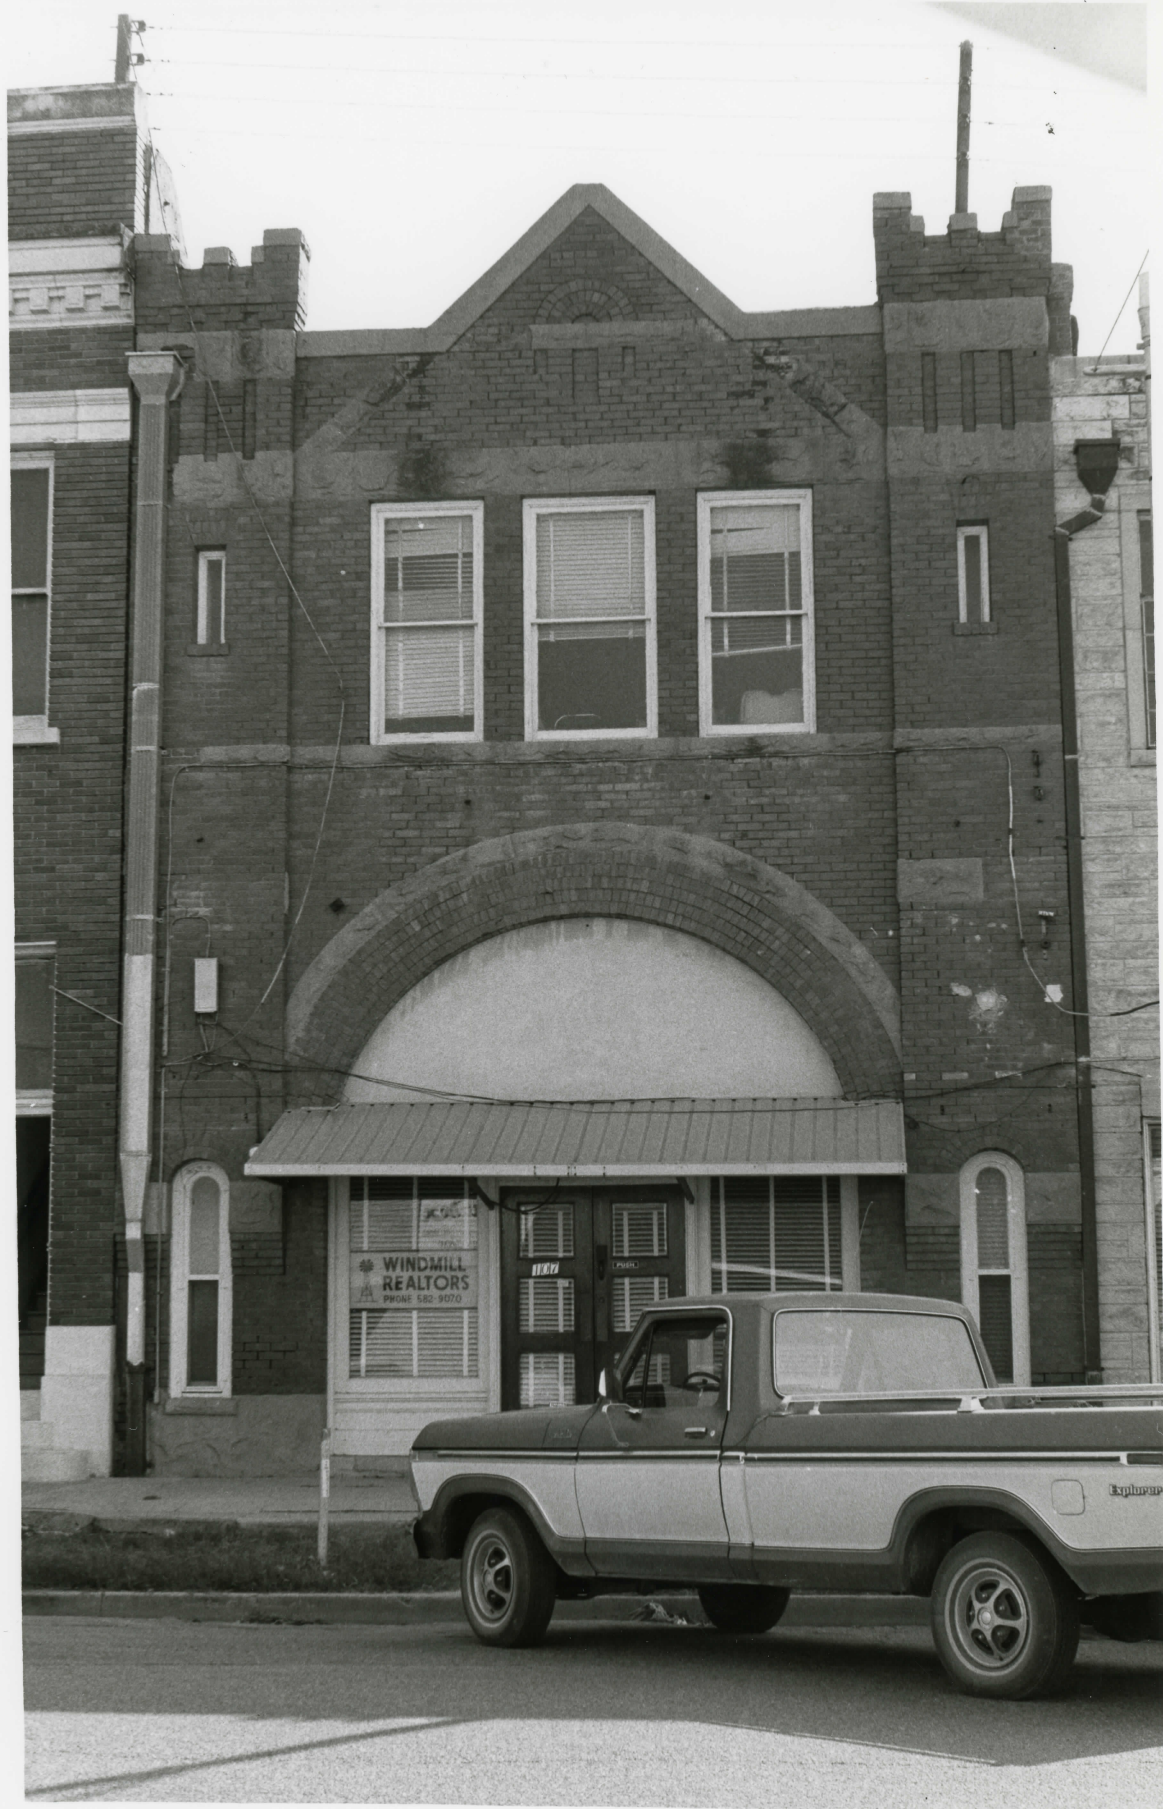
View: west facade, camera facing east
Photo 10 of 23

Historic Resources of Hillsboro
Hillsboro, Hill County, Texas
Site No. 10, Western Union Building, 107 South
Covington

This two-story brick and cast-stone commercial building is prominently marked by a yawning Richardsonian Romanesque arch on the ground floor. Above this, three windows are set below a high triangular gable. This entire central part of the building is framed by two tall, tower-like buttresses accented with thin, round lights at the base and a castellated cornice. With the exception of the closed off transom arch and a later canopy, the building remains essentially as it appeared in the early 20th century.
