**National Register of Historic Places
Inventory—Nomination Form**

Willow-Spence Streets Historic District

Name: Willow-Spence Streets Historic District, Austin, Travis County, Texas

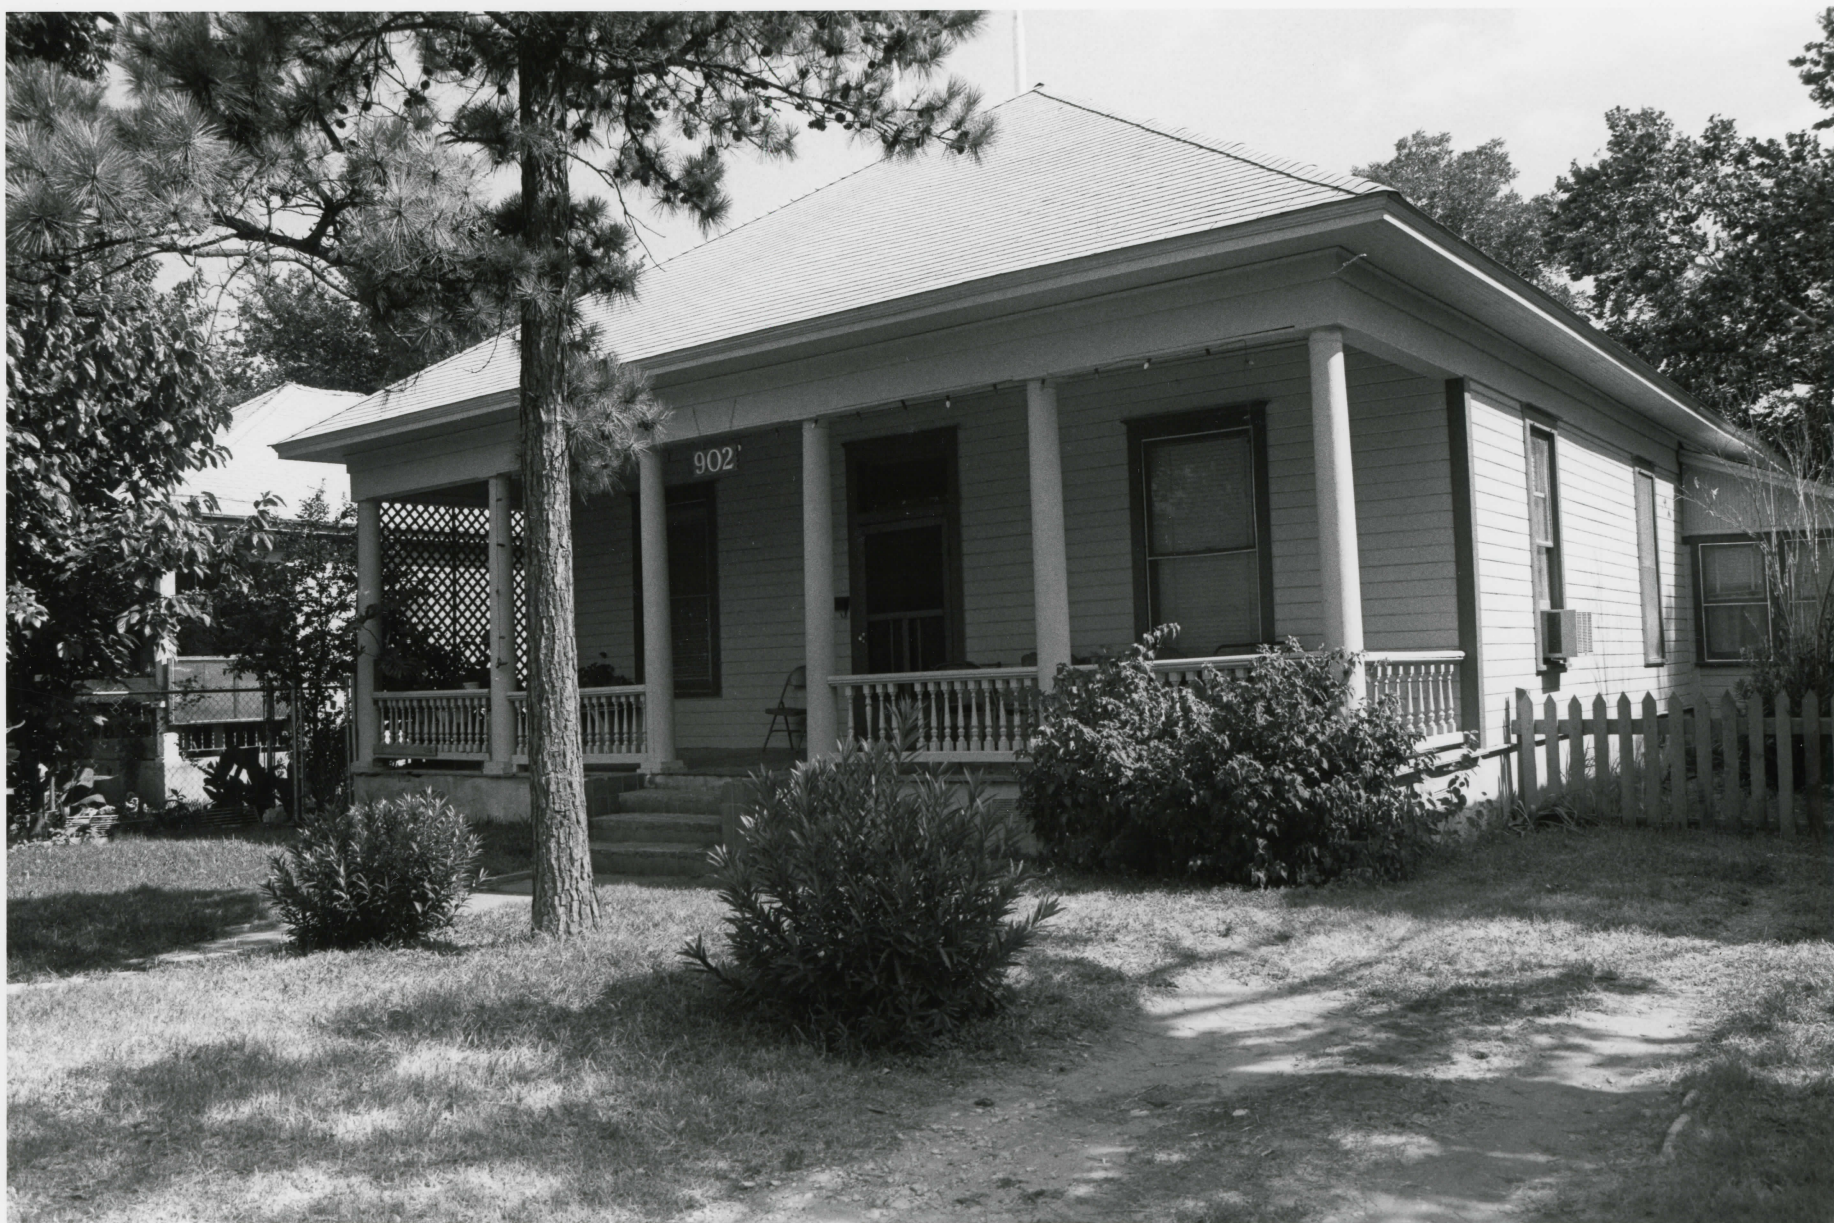
Site 65
Photo 39

Description and Significance: One-story, wood-frame house with a hipped roof and central entrance. A generous porch extends the width of the front facade and is punctuated by six wooden columns. Decorative balusters between each column are largely intact.

Southeast view
camera facing northwest

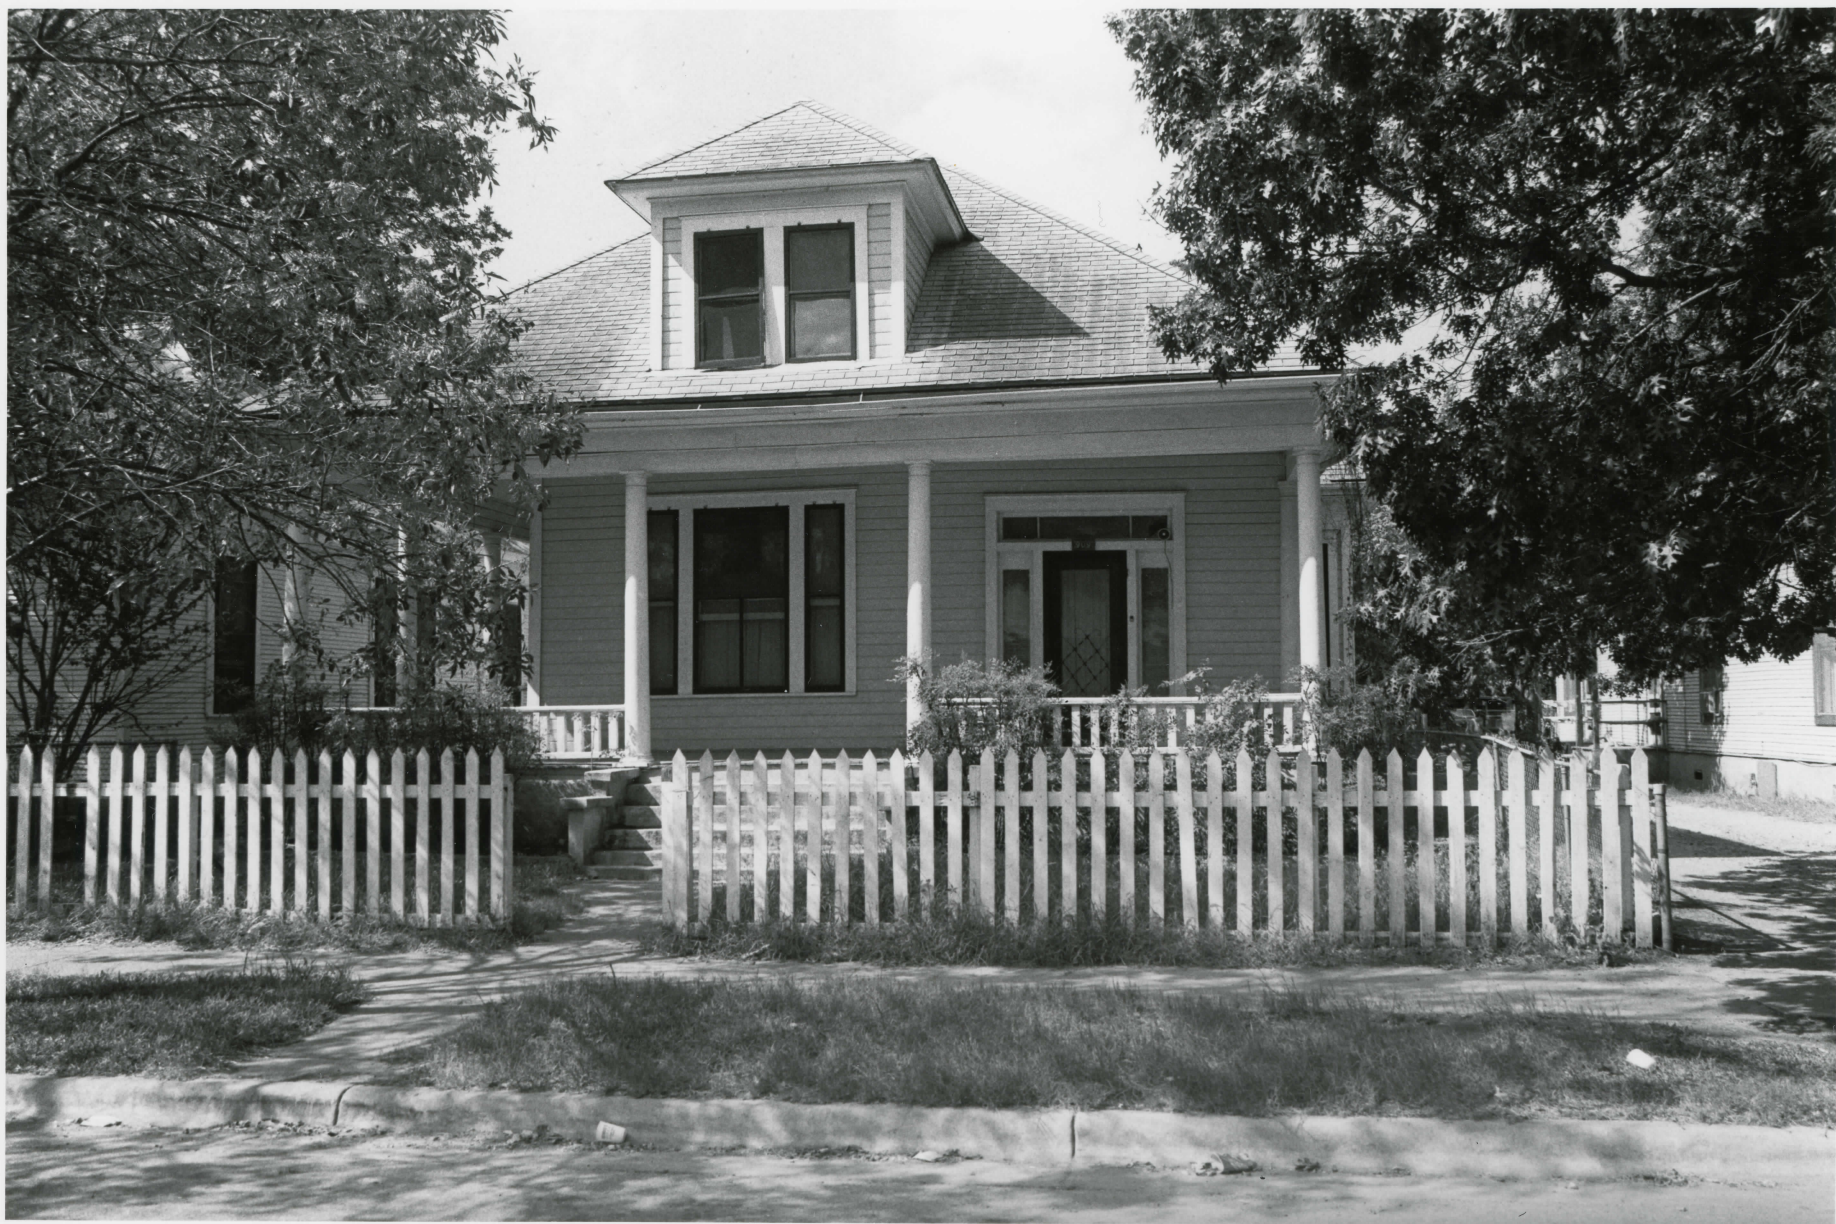
Site No. 70
Photo 40

Description and Significance: One-and-a-half-story, wood-frame residence with generous front and side porches on the first floor and a dormer over the front entrance.

North view
camera facing south

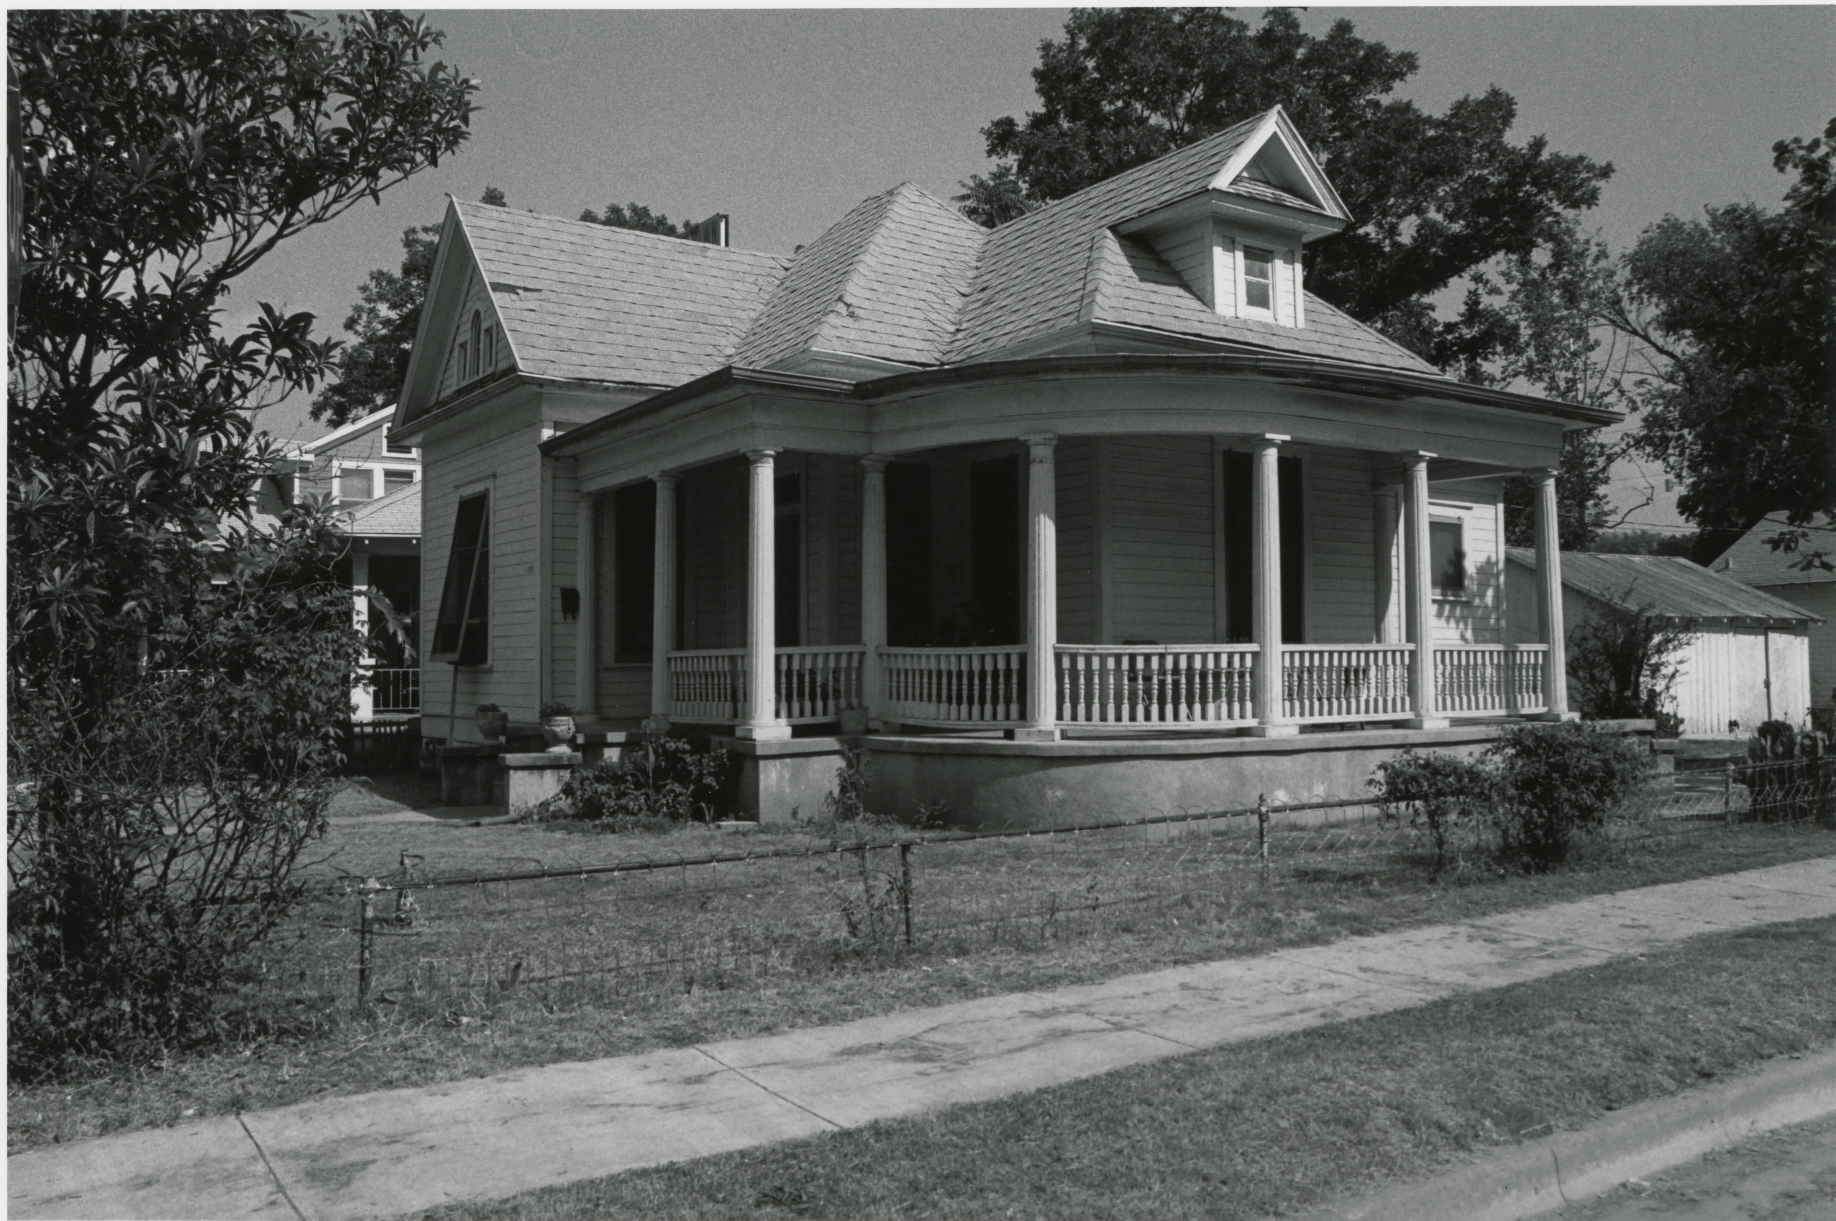
Site 71
Photo 41

Description and Significance: One-and-a-half-story, wood-frame, late Victorian house with a complex hipped roof and wraparound porch. The building strongly expresses its important position at the corner of two streets; almost all significant architectural details appear to be complete.

Southeast view
camera facing northwest

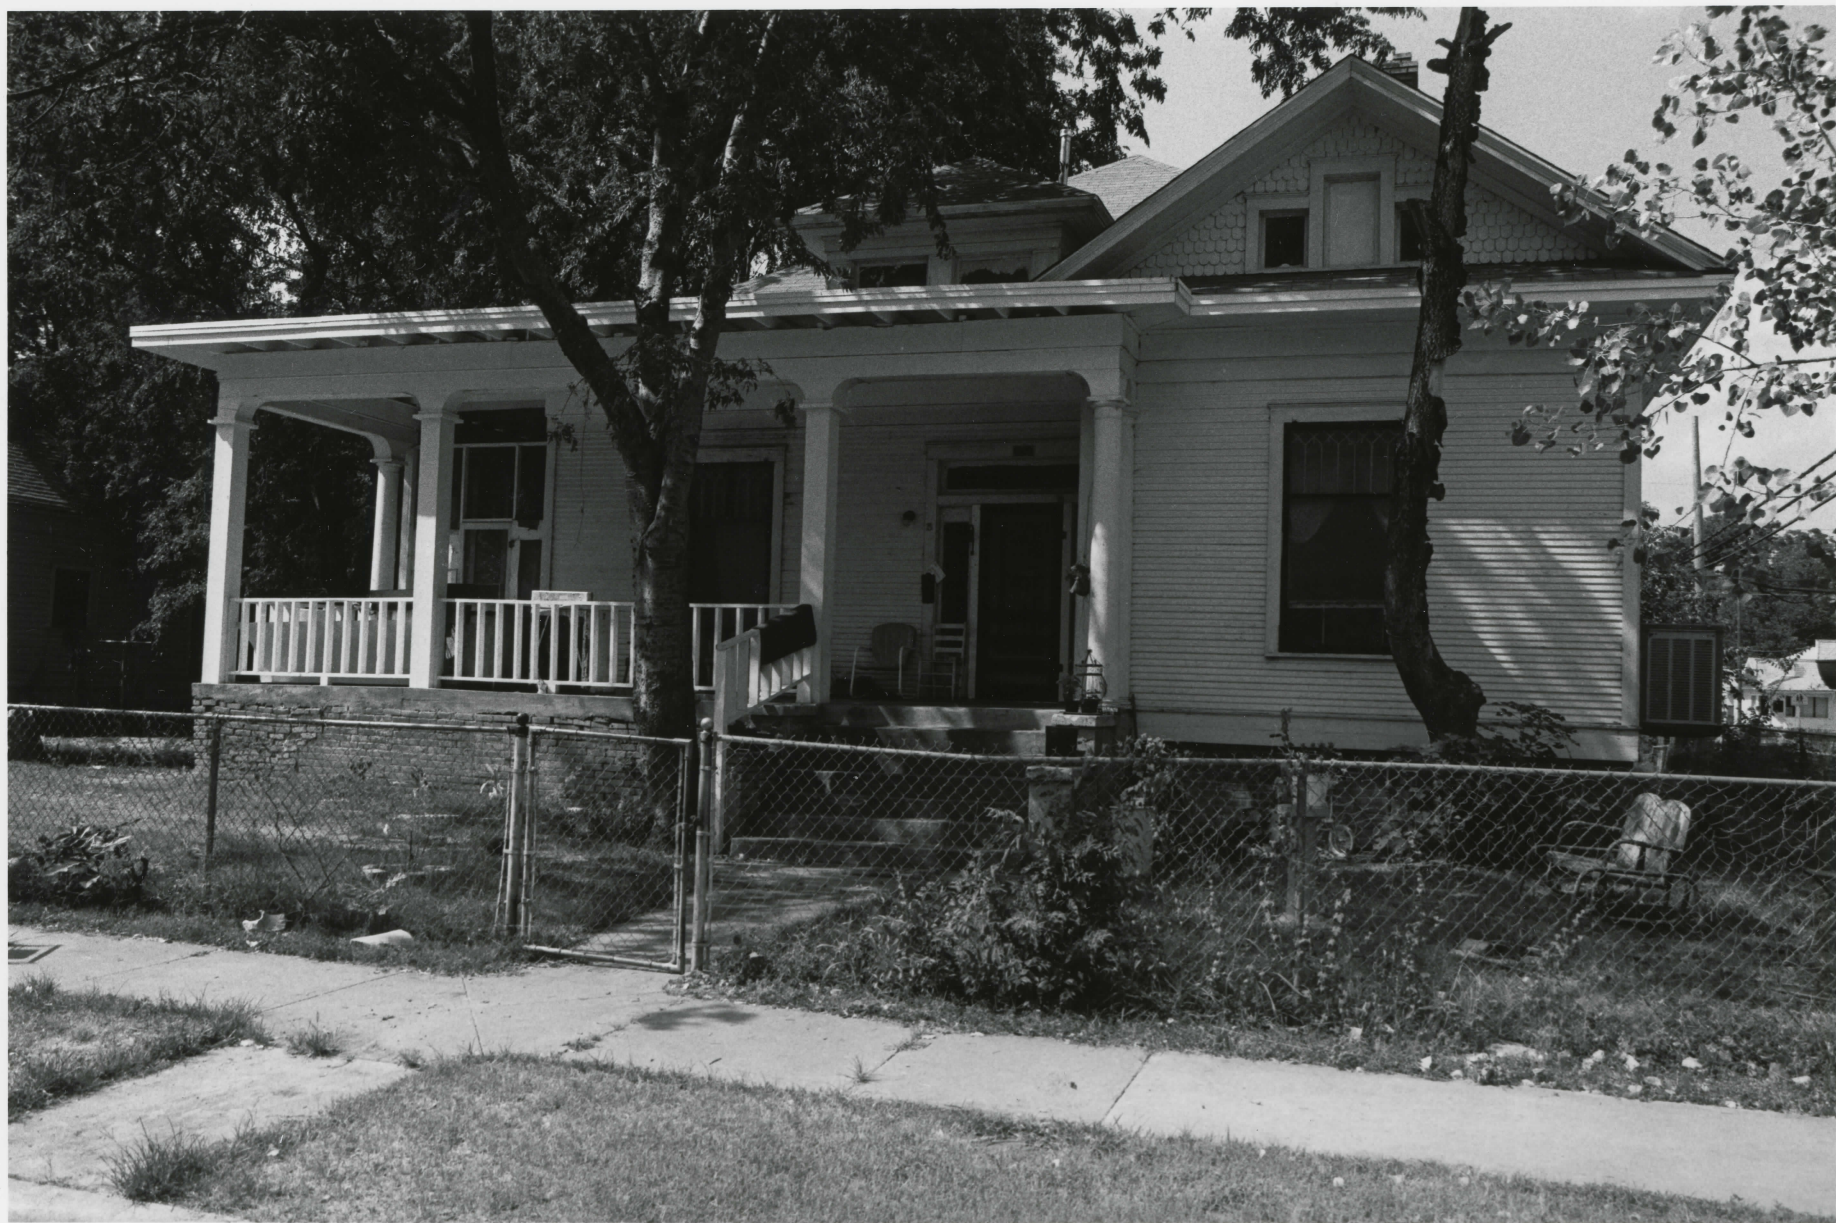
Site 74
Photo 42

Description and Significance: One-story, late Victorian, wood-frame house with generous porches on the north and east sides. Metal columns at the front facade have been replaced recently with more compatible wooden columns. Other original architectural details are intact. Like Site No. 71 (910 Willow Street), the Jones House relates well to its location on the corner of an intersection, being larger and more architecturally complex than many other nearby residences.

North view
camera facing south

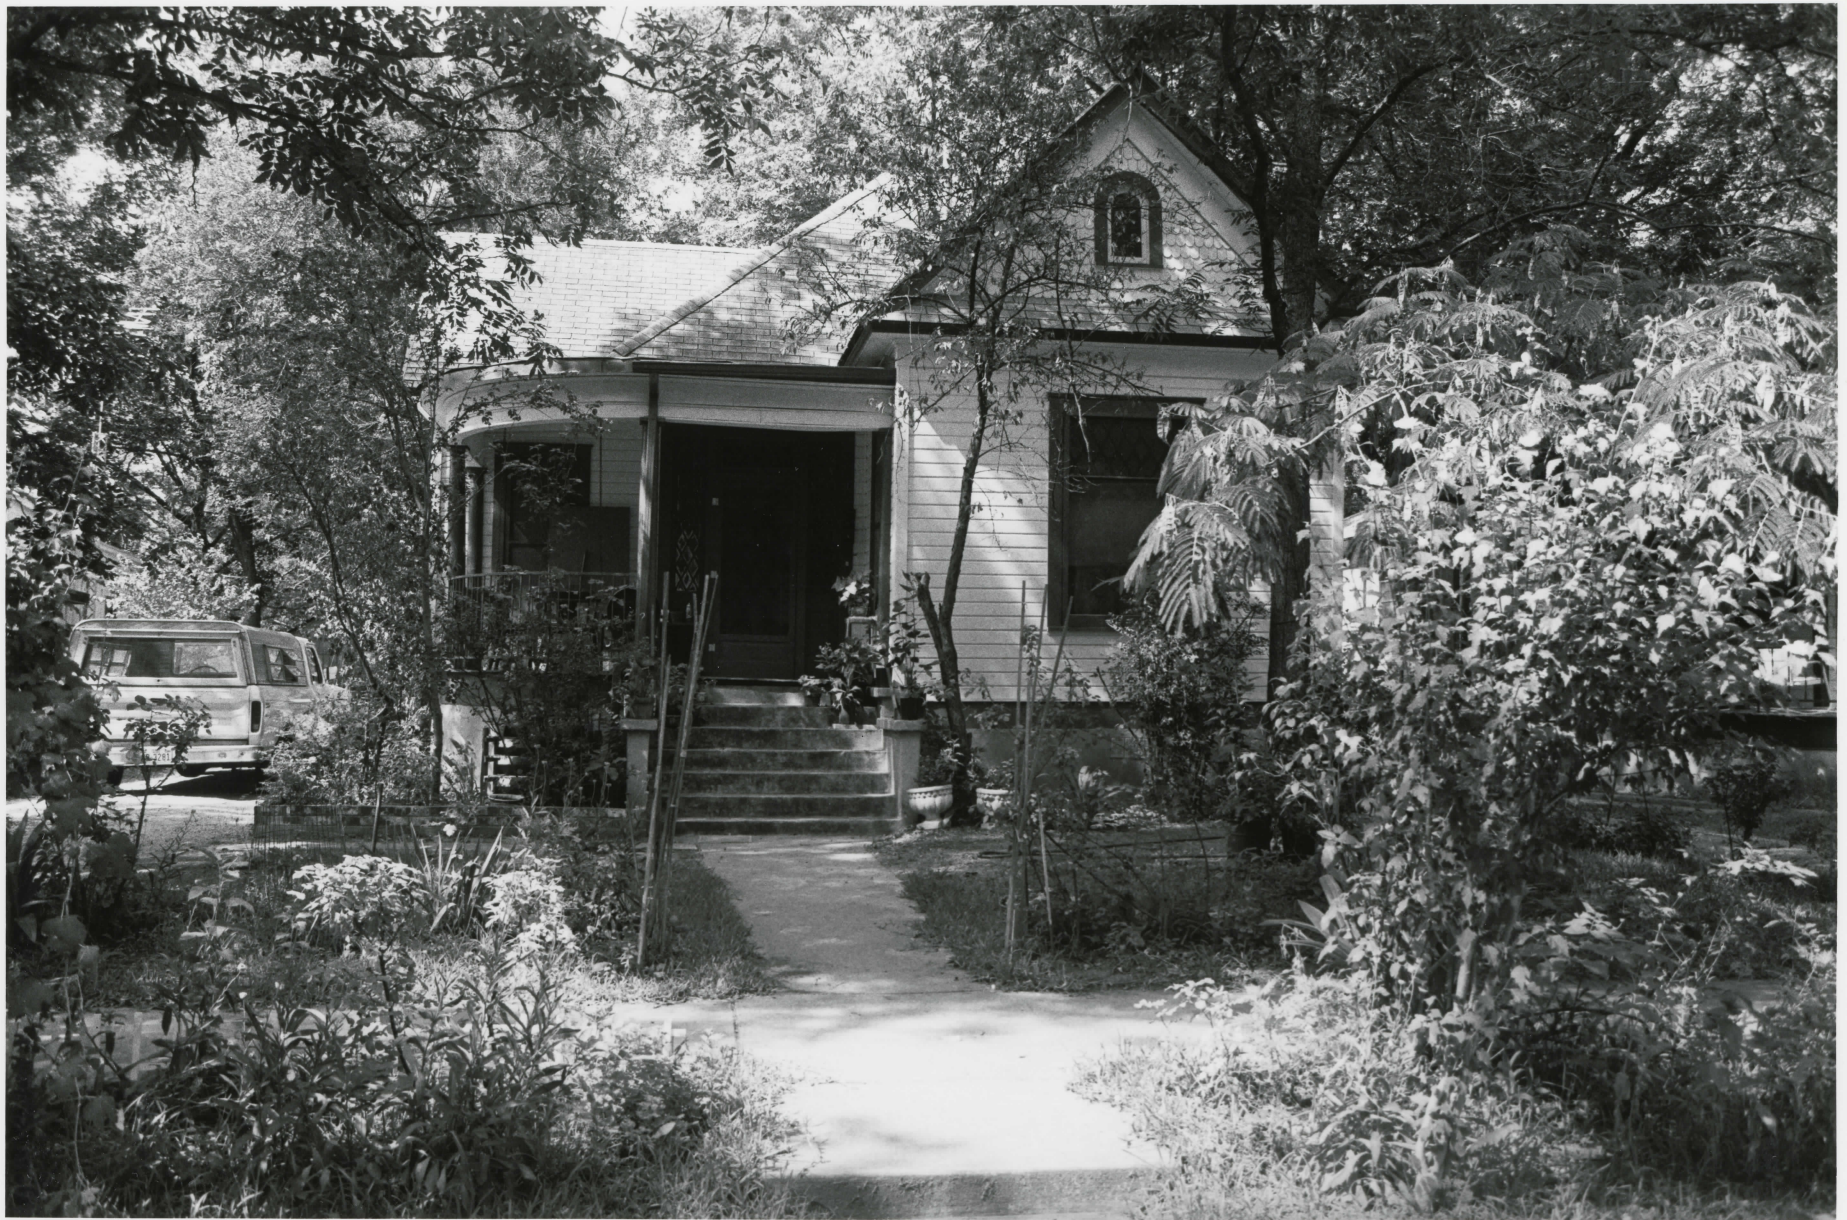
Site 81
Photo 43

Description and Significance: One-story, late Victorian, wood-frame house. The building configuration appears to be identical to that of Site No. 77 (1005 Willow Street) and Site No. 79 (1007 Willow Street).

North view
camera facing south

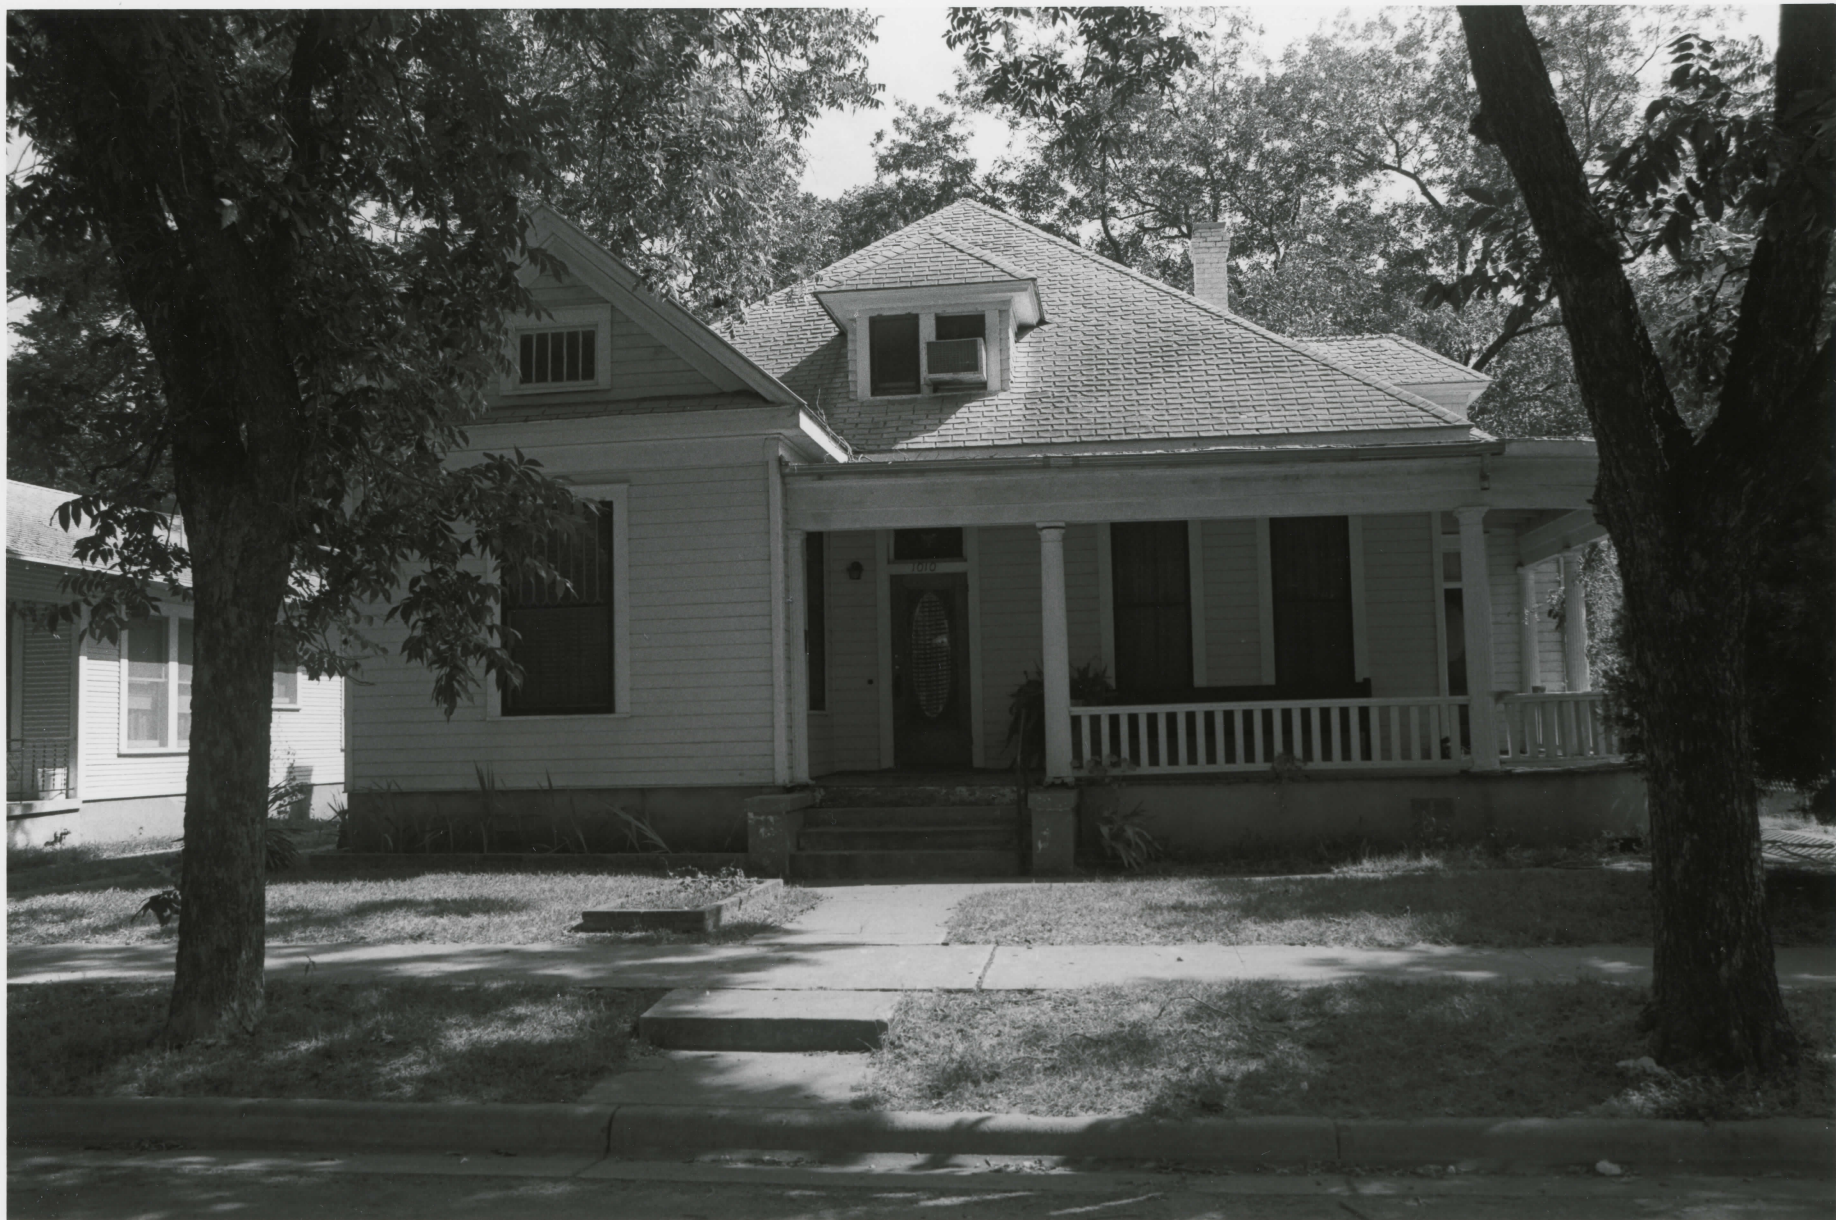
Site (82)
Photo (44)

Description and Significance: One-and-a-half-story, late Victorian, wood-frame house with a wraparound front porch and complex hipped roof. The porch is intact, but the roofline may have been altered to adapt attic space to living quarters by adding dormers. The porch railing has been replaced and front steps which formerly were wooden now are cement.

South view
camera facing north

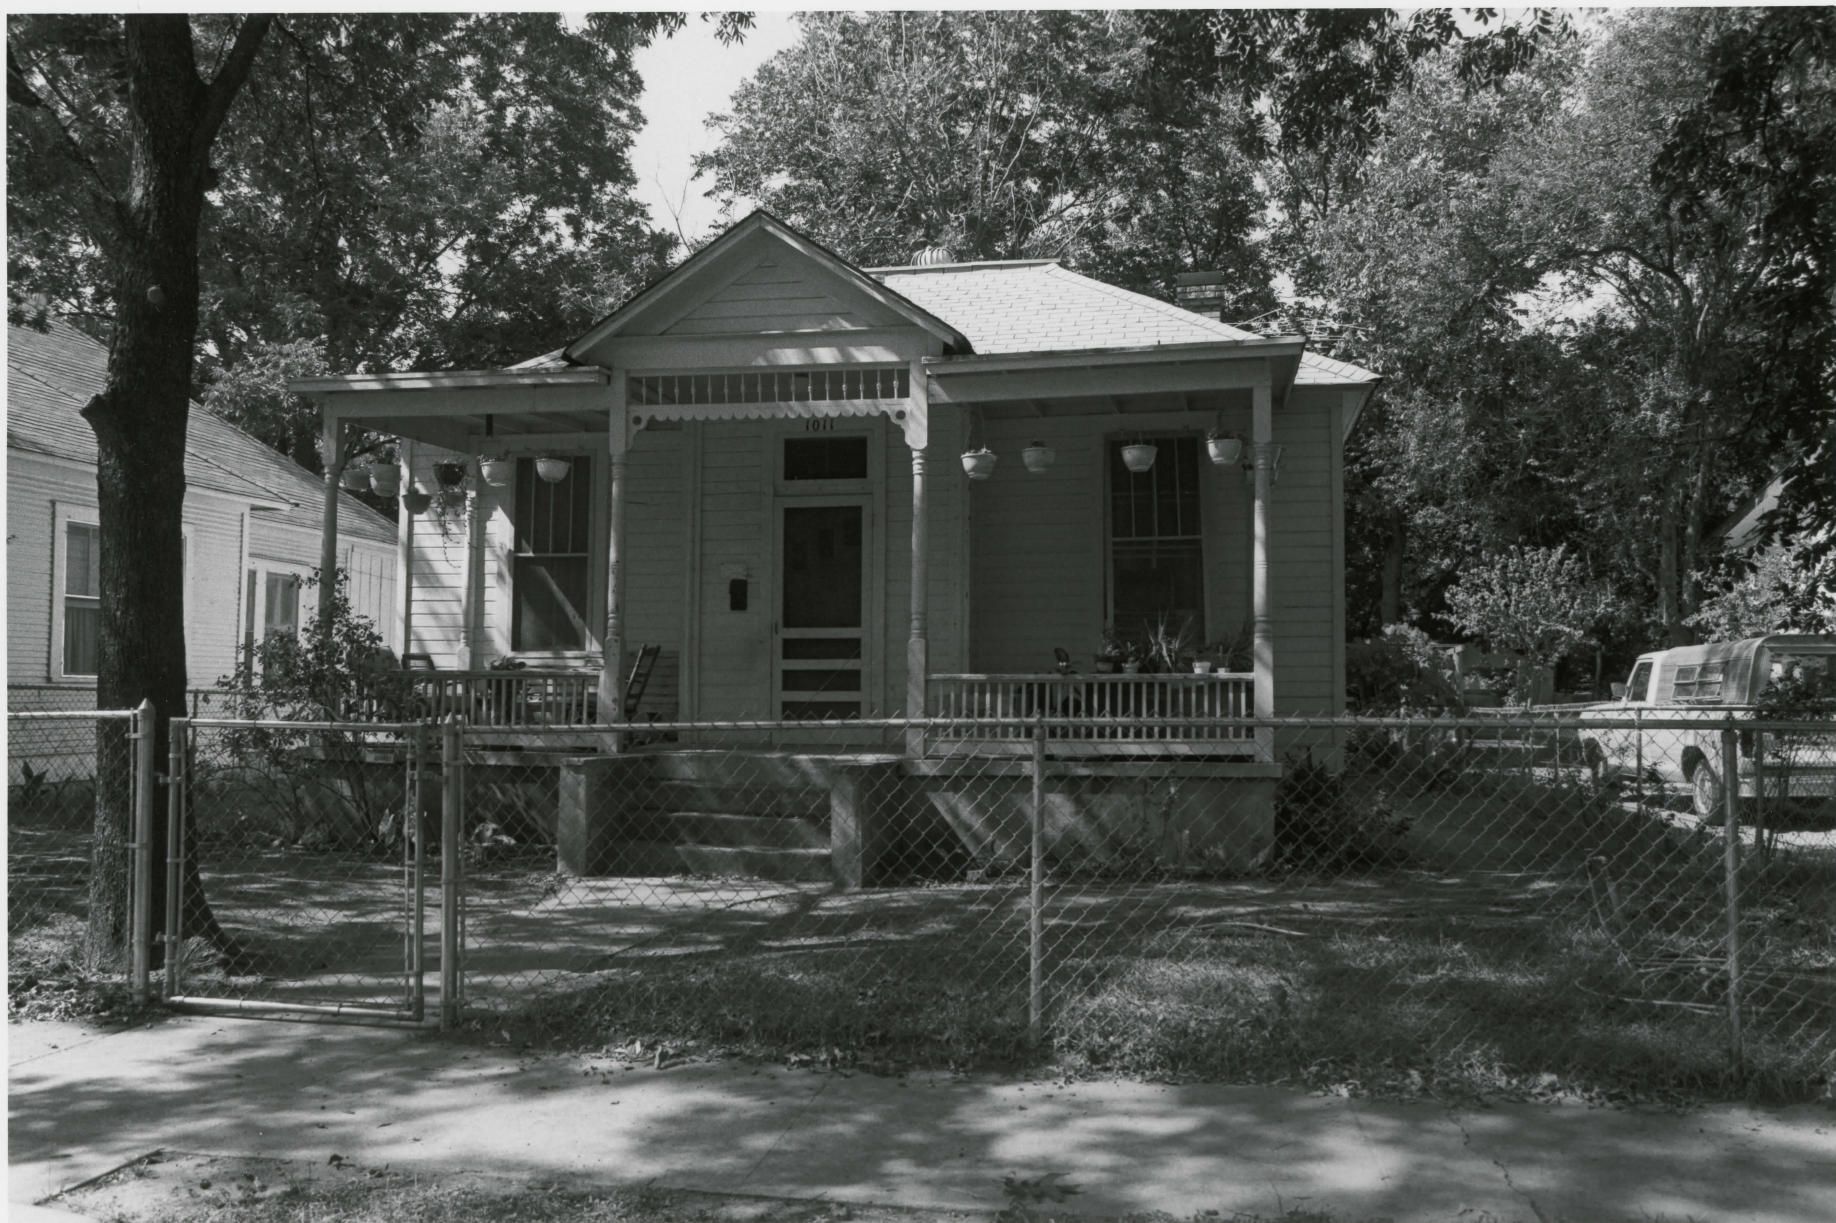
Site 83
Photo 45

Description and Significance: One-story, late Victorian, wood-frame cottage with a hipped, asphalt-shingle roof. A central entrance projects slightly from the plan of the front facade, which is covered by a finely detailed porch. Alterations include an addition to the rear of the building, a new porch railing, and the replacement of wooden front steps and porch deck with concrete.

Site No. 83, 1011 Willow Street
Photo by Joe Freeman, 1984, neg. with Texas
Historical Commission, Austin

North view
camera facing south
photo 45 of 60

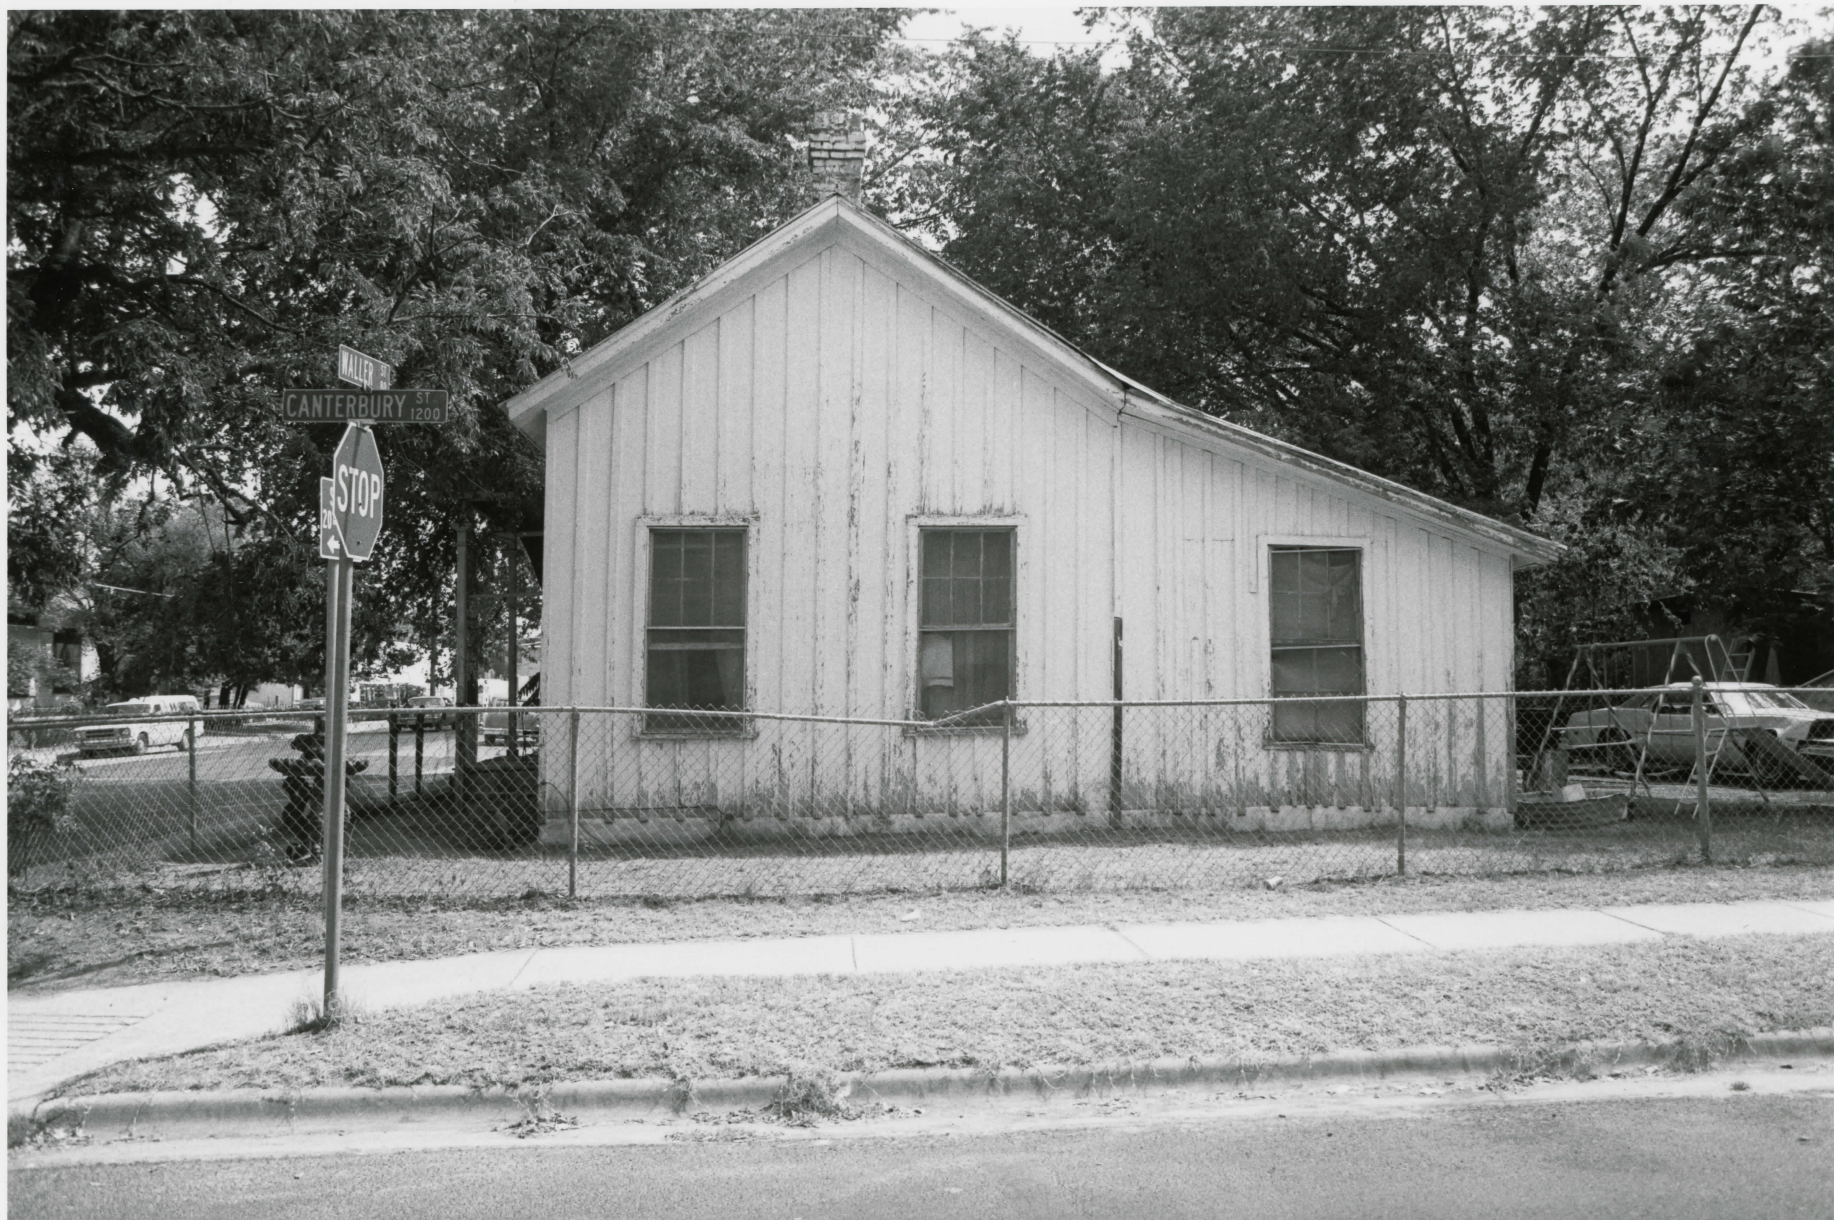
Site (127)
Photo (55)

Although one house, Site No. 127 located at 81 Waller Street (Photo No. 55), may have been constructed as early as 1882, most of the structures were erected between 1910 and the early 1930s. There is a considerable range of architectural styles, including T-plan, L-plan, Pyramidal, Bungalow, and wraparound-porch types; the specific attributes of each contributing structure appear in individual site descriptions. All structures are constructed of wood and have a uniform relationship to the street. Almost all the buildings

South view
camera facing north
