**National Register of Historic Places  
Inventory—Nomination Form**

Swedish Hill Distoric District

Name: Swedish Hill Historic District, Austin, Travis County, Texas

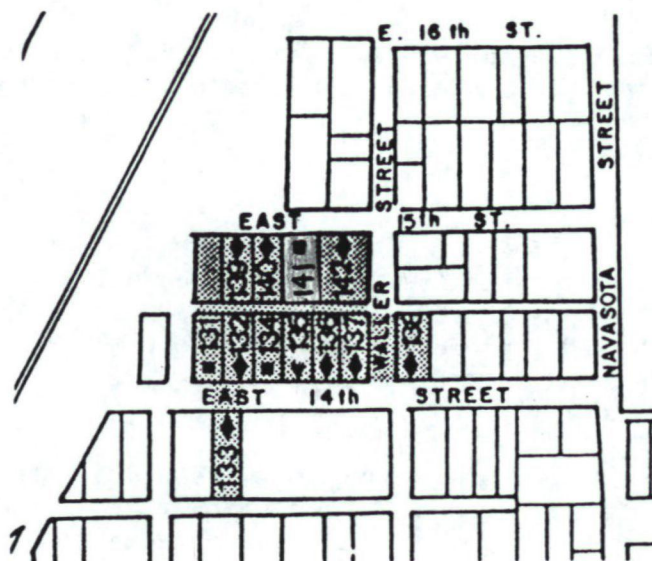
SWEEDISH HILL HISTORIC DISTRICT

■ - noncontributing

◆ - contributing

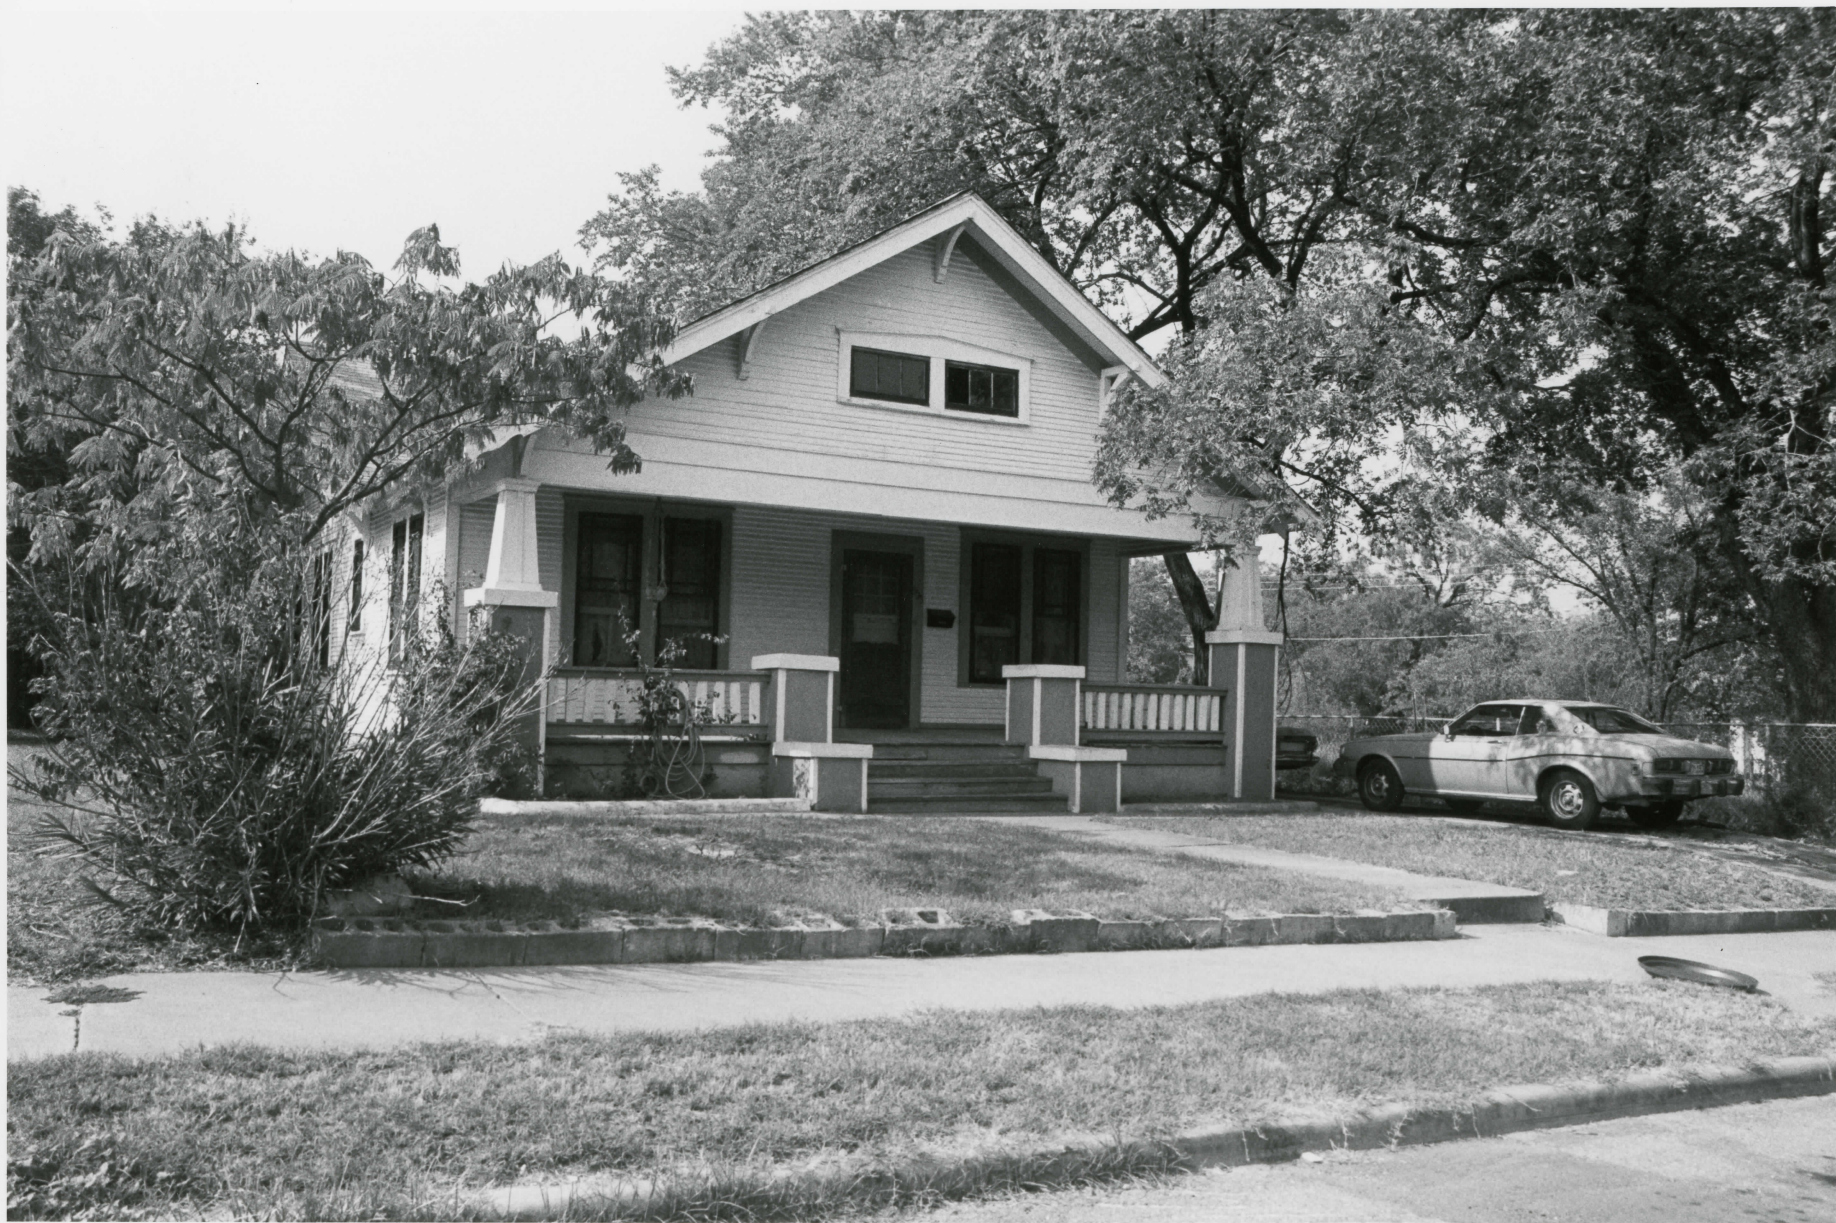
Photo (56)

Description and Significance: One-story bungalow with a broad front porch supported by short pyramidal wooden columns which rest on stuccoed columns. The structure is covered by a gabled roof; the off-center front entrance has been altered from its originally centered configuration.

Northeast view  
camera facing southwest

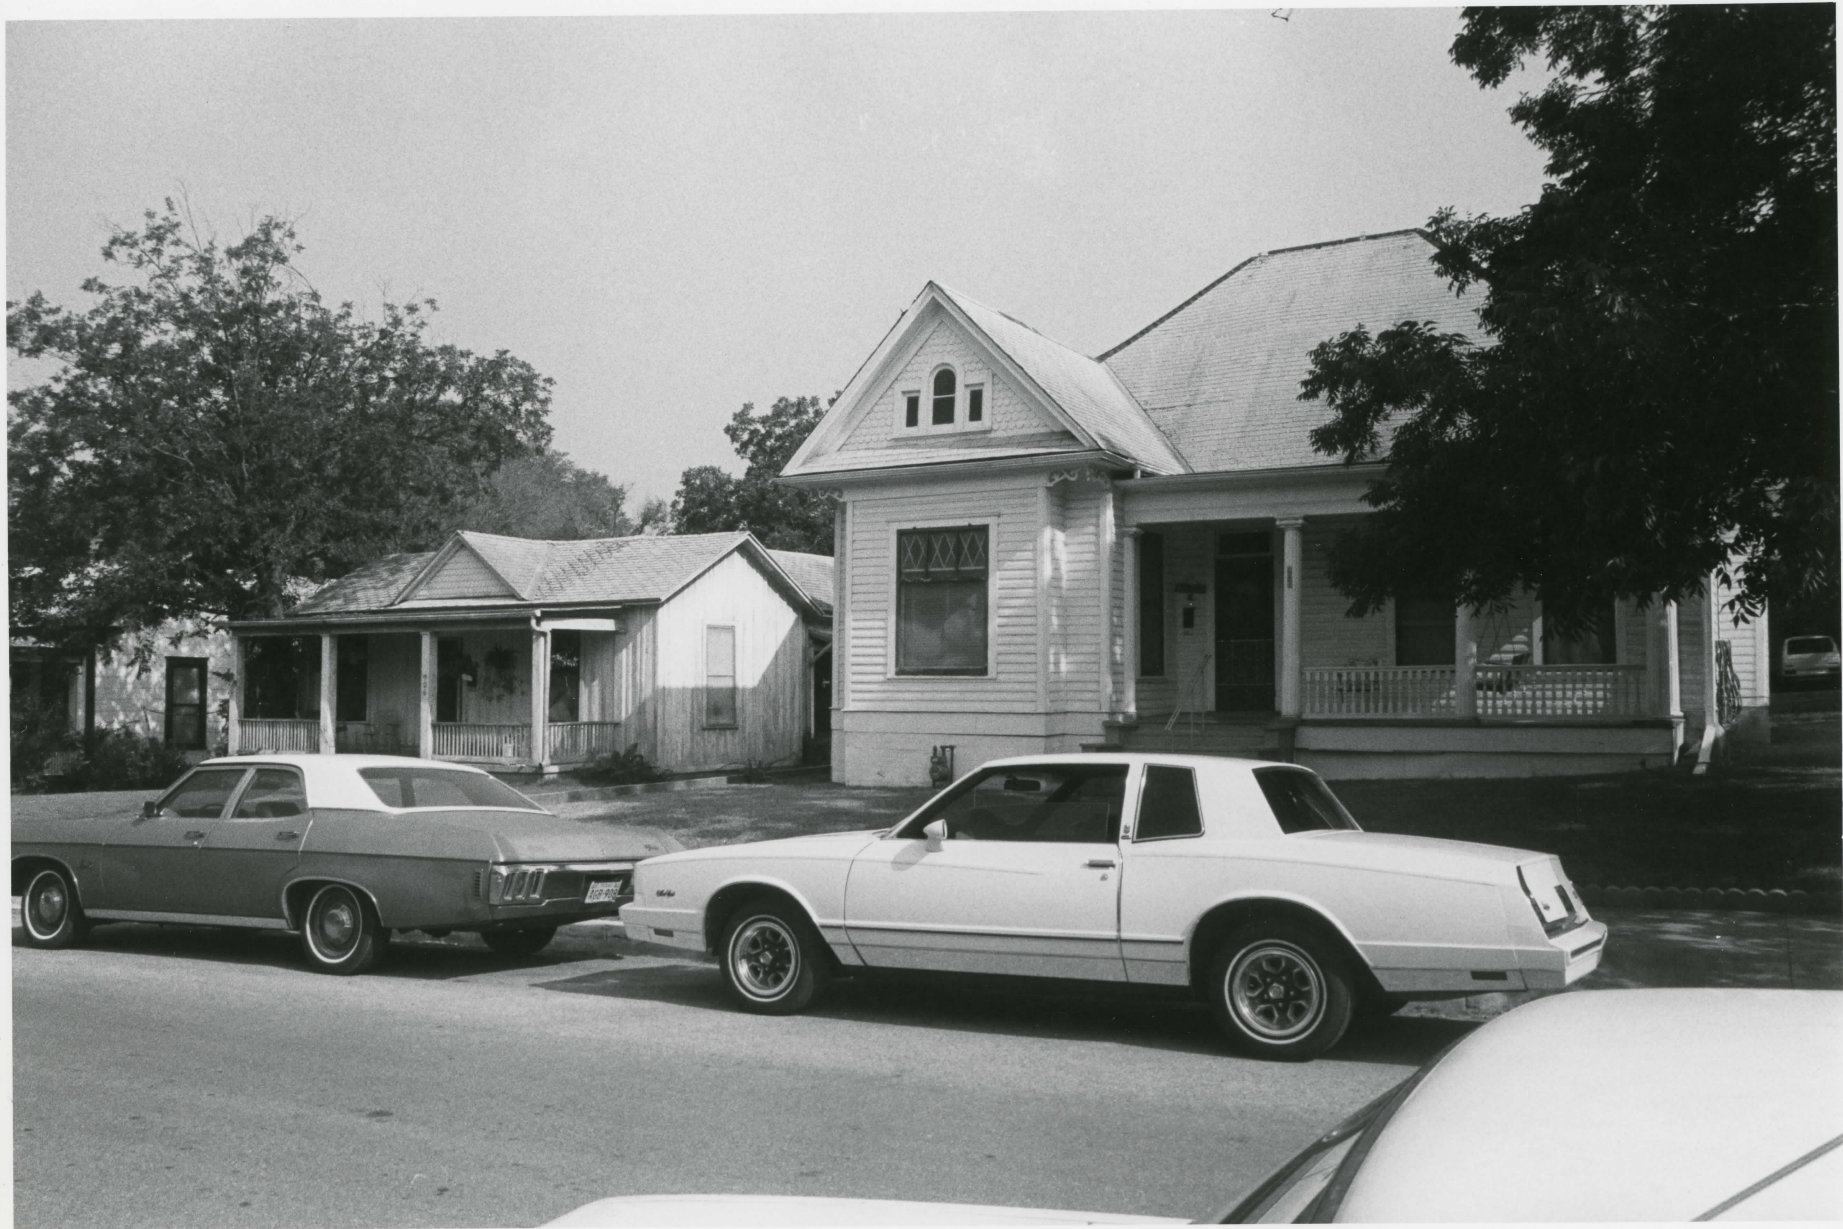
Photo No. (57)

Description and Significance: One story, late Victorian, board-and-batten structure with additions to the rear constructed by 1935. A porch spans the front facade. The location of the front door appears to have been slightly altered.

Description and Significance: One-story, late Victorian, wood-frame house with original front porch, projecting gabled wing, and hipped roof.

Southeast view  
camera facing northwest

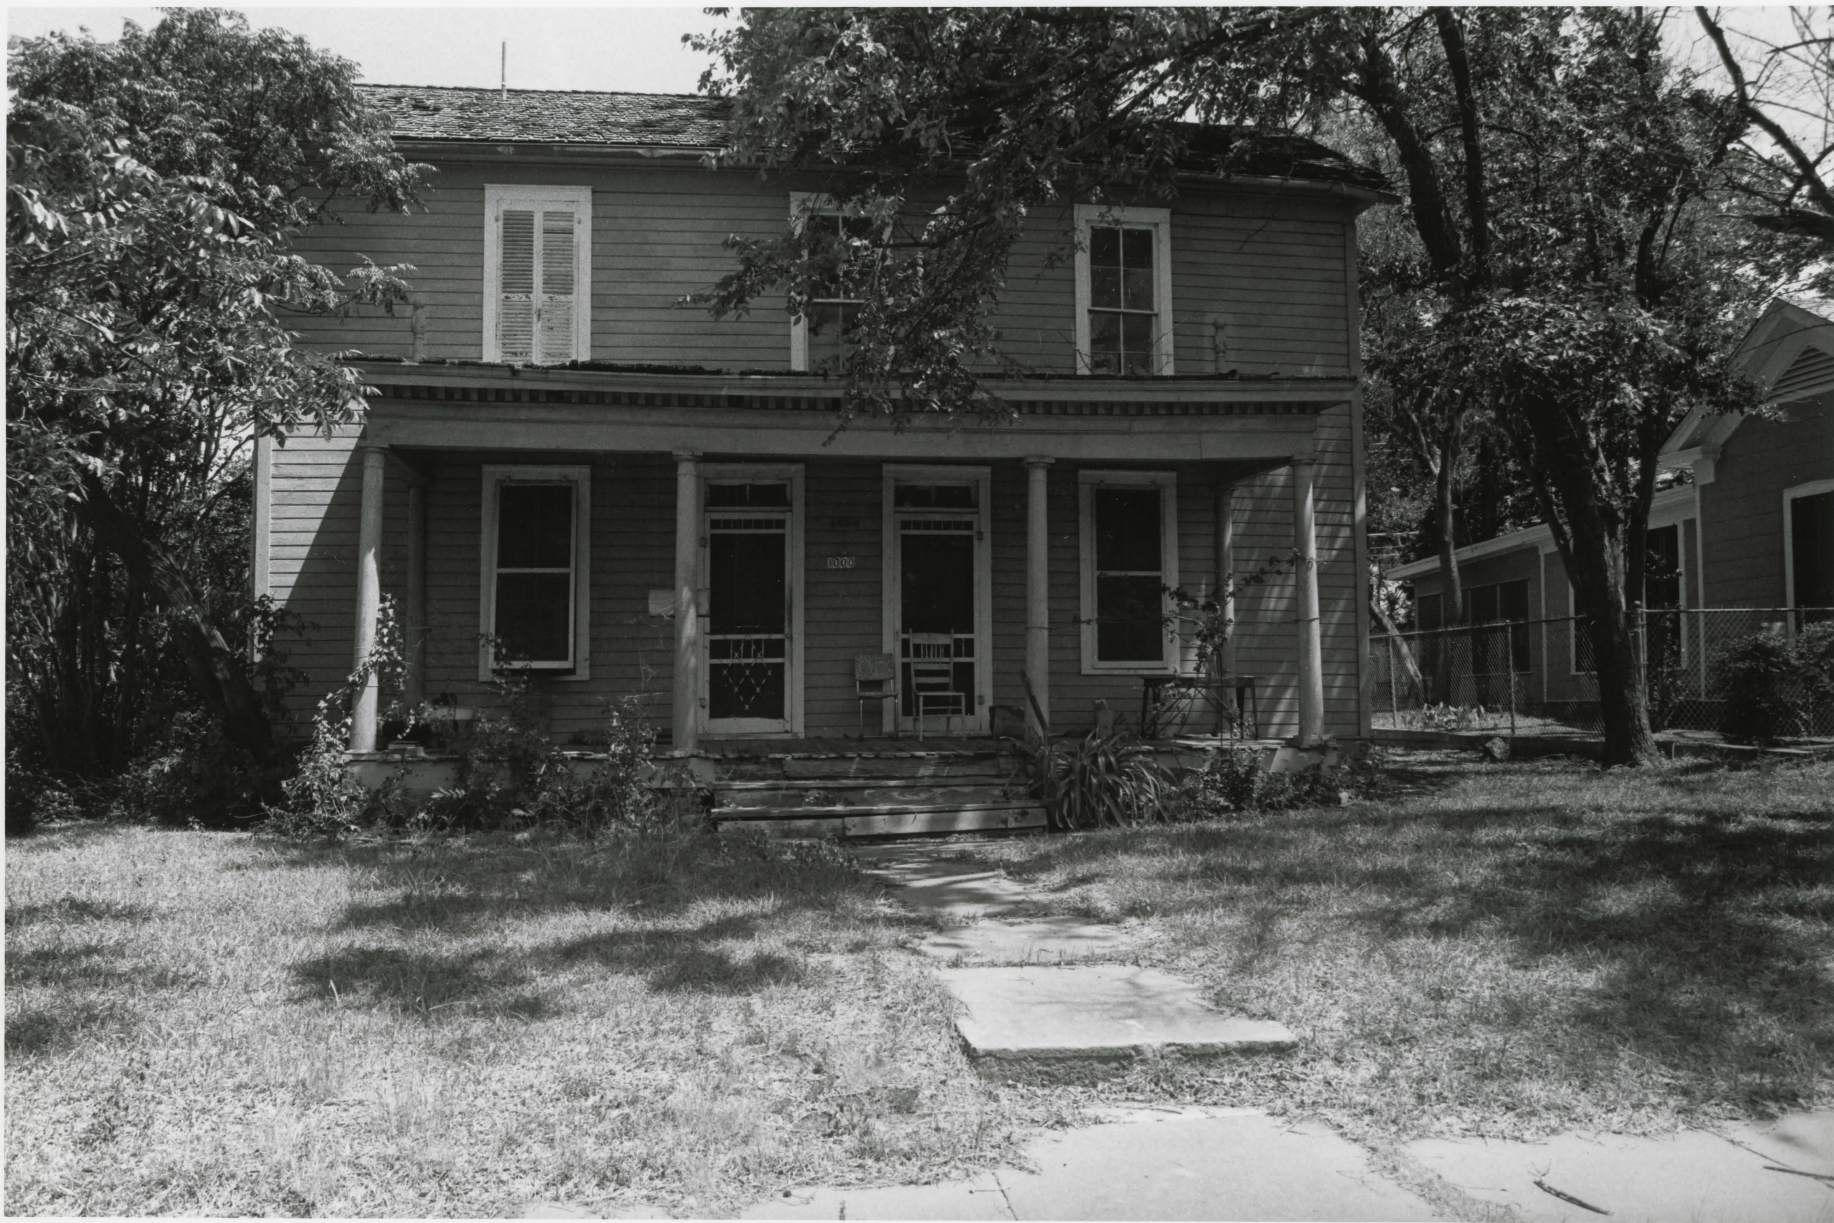
Site (138)  
Photo (58)

Description and Significance: Distinctive two-story, Cumberland-plan, wood-frame residence with an early board-and-batten, one-story addition on the rear of the building. Intact original or early features include a wood-shingle roof, simple but fine carpentry details, and a one-story porch supported by four columns which spans most of the width of the front facade.

Site No. 138, 1000 East 14th Street  
Photo by Joe Freeman, 1984, neg. with Texas  
Historical Commission, Austin

South view  
camera facing north  
photo 58 of 60

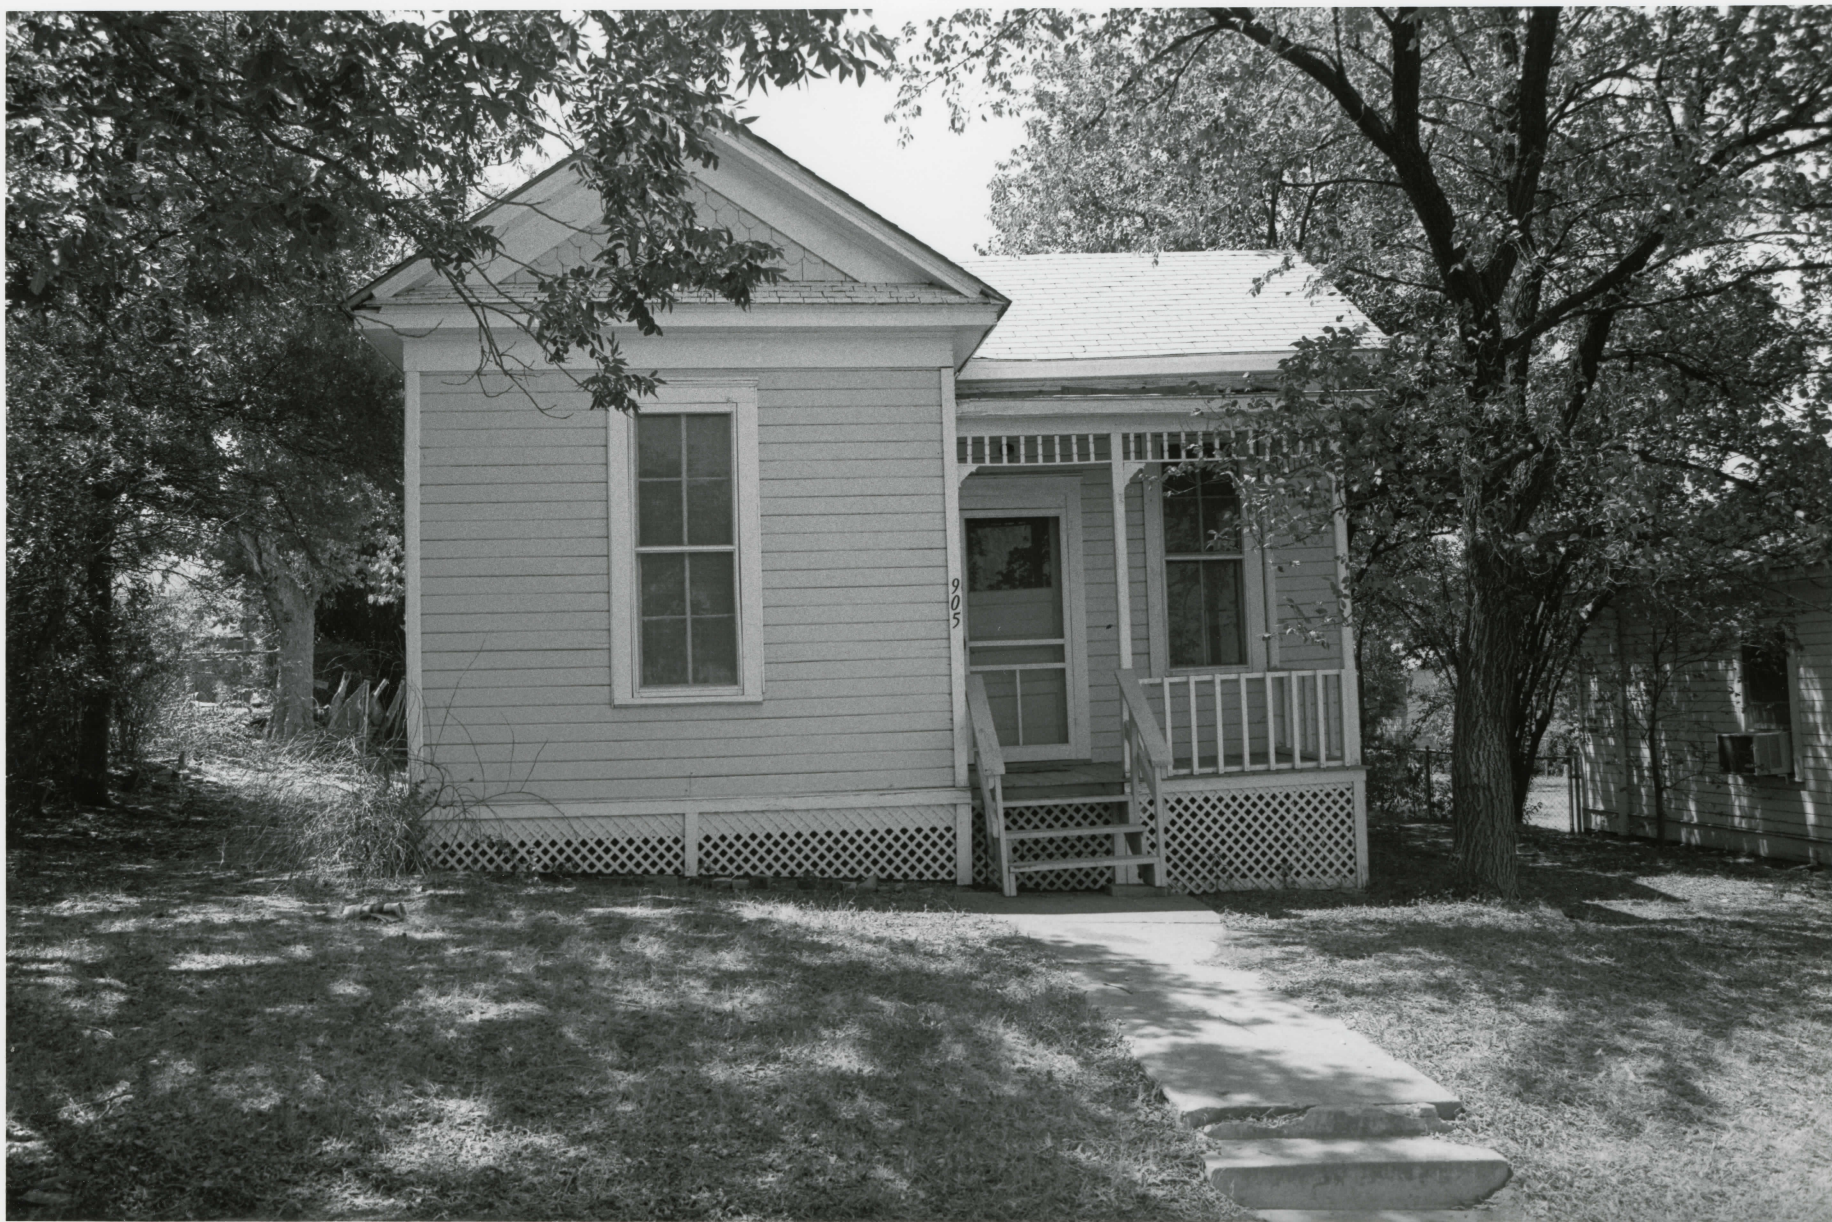
Site (140)  
Photo (59)

Description and Significance: Good example of a small, one-story, frame cottage with a gabled roof and front porch.

North view  
camera facing south

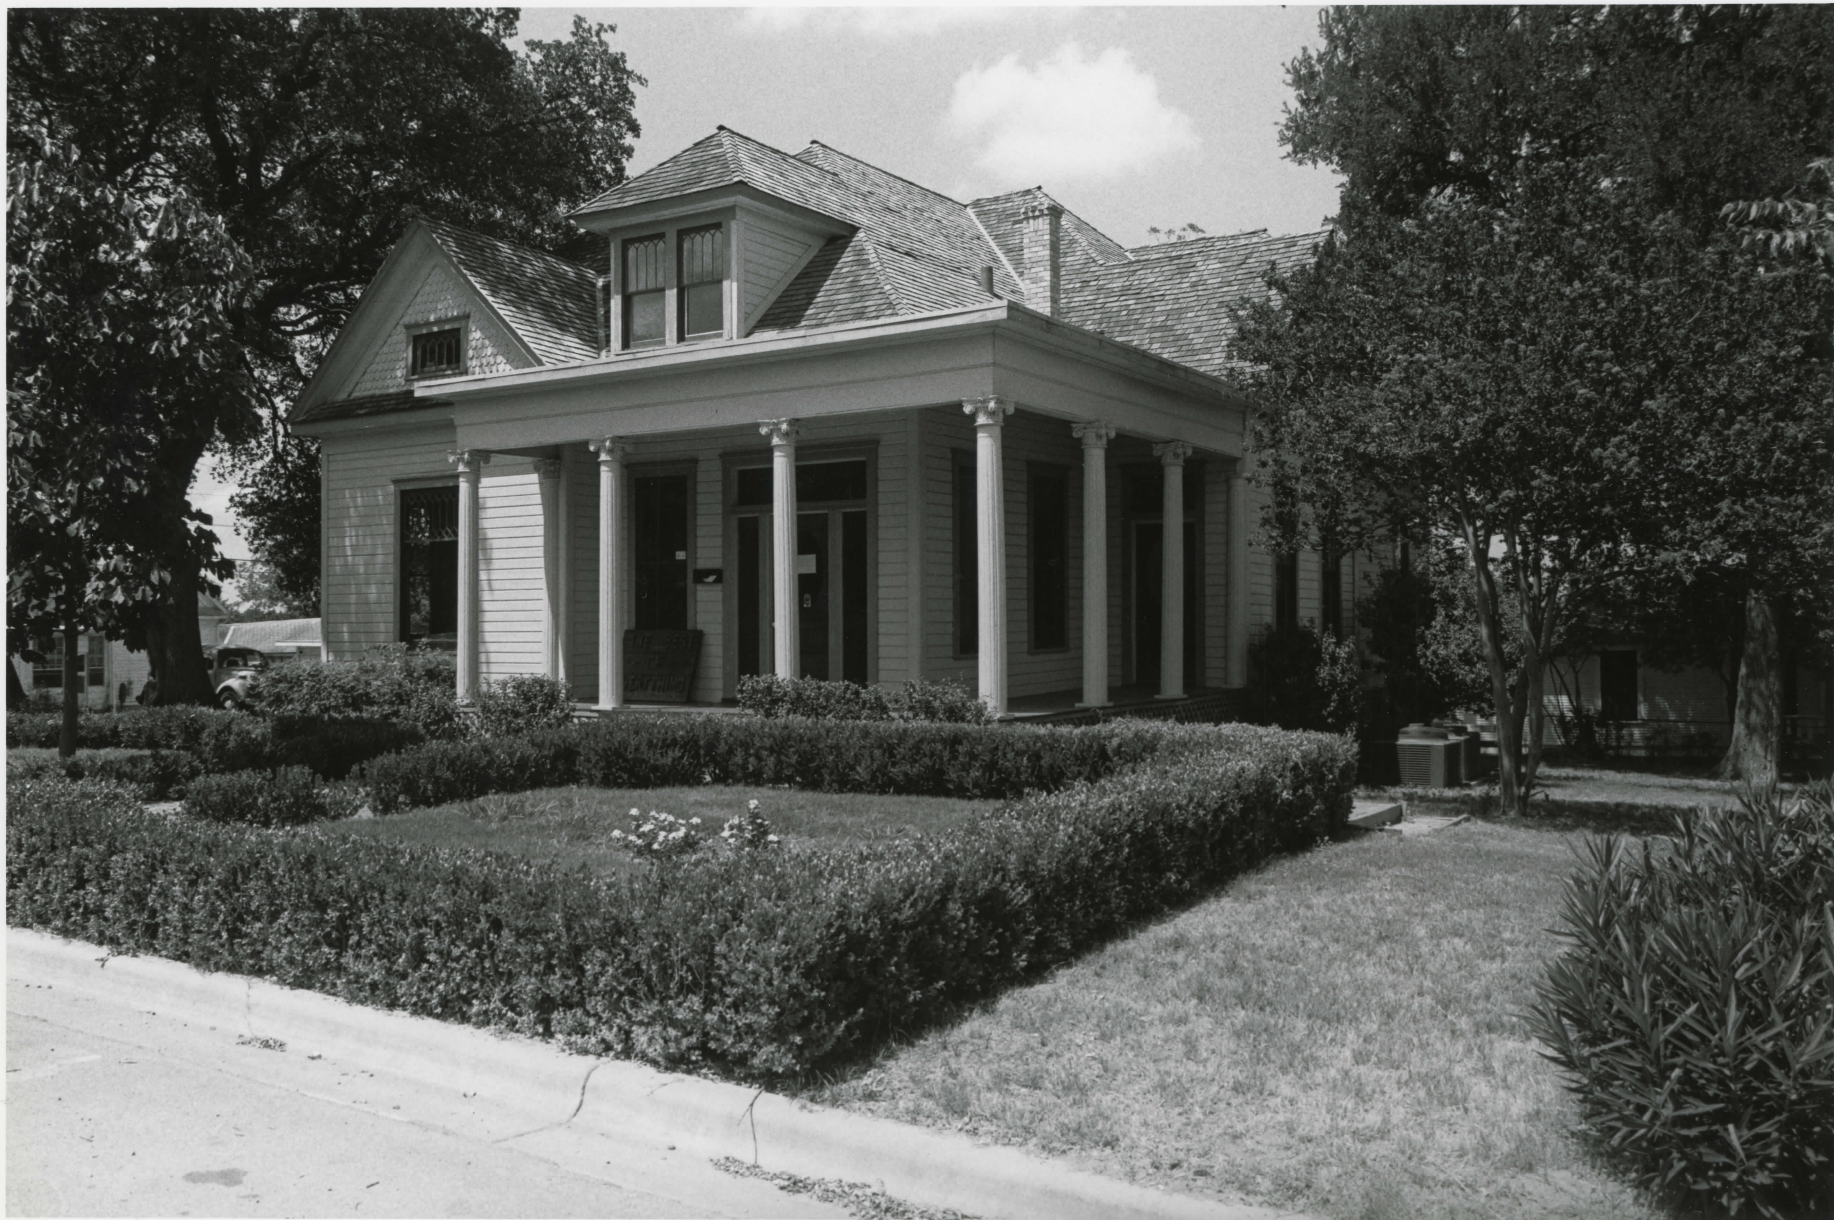
Photo (60)

Description and Significance: One-and-a-half, late Victorian, wood-frame  
house with a complex gabled and hipped roof. Columns are equally  
spaced along a porch which wraps around a portion of the structure.

Northeast view  
camera facing southwest
