**National Register of Historic Places
Inventory—Nomination Form**

historic Old Continental State Bank

street & number 312 Oak Street N/A not for publication

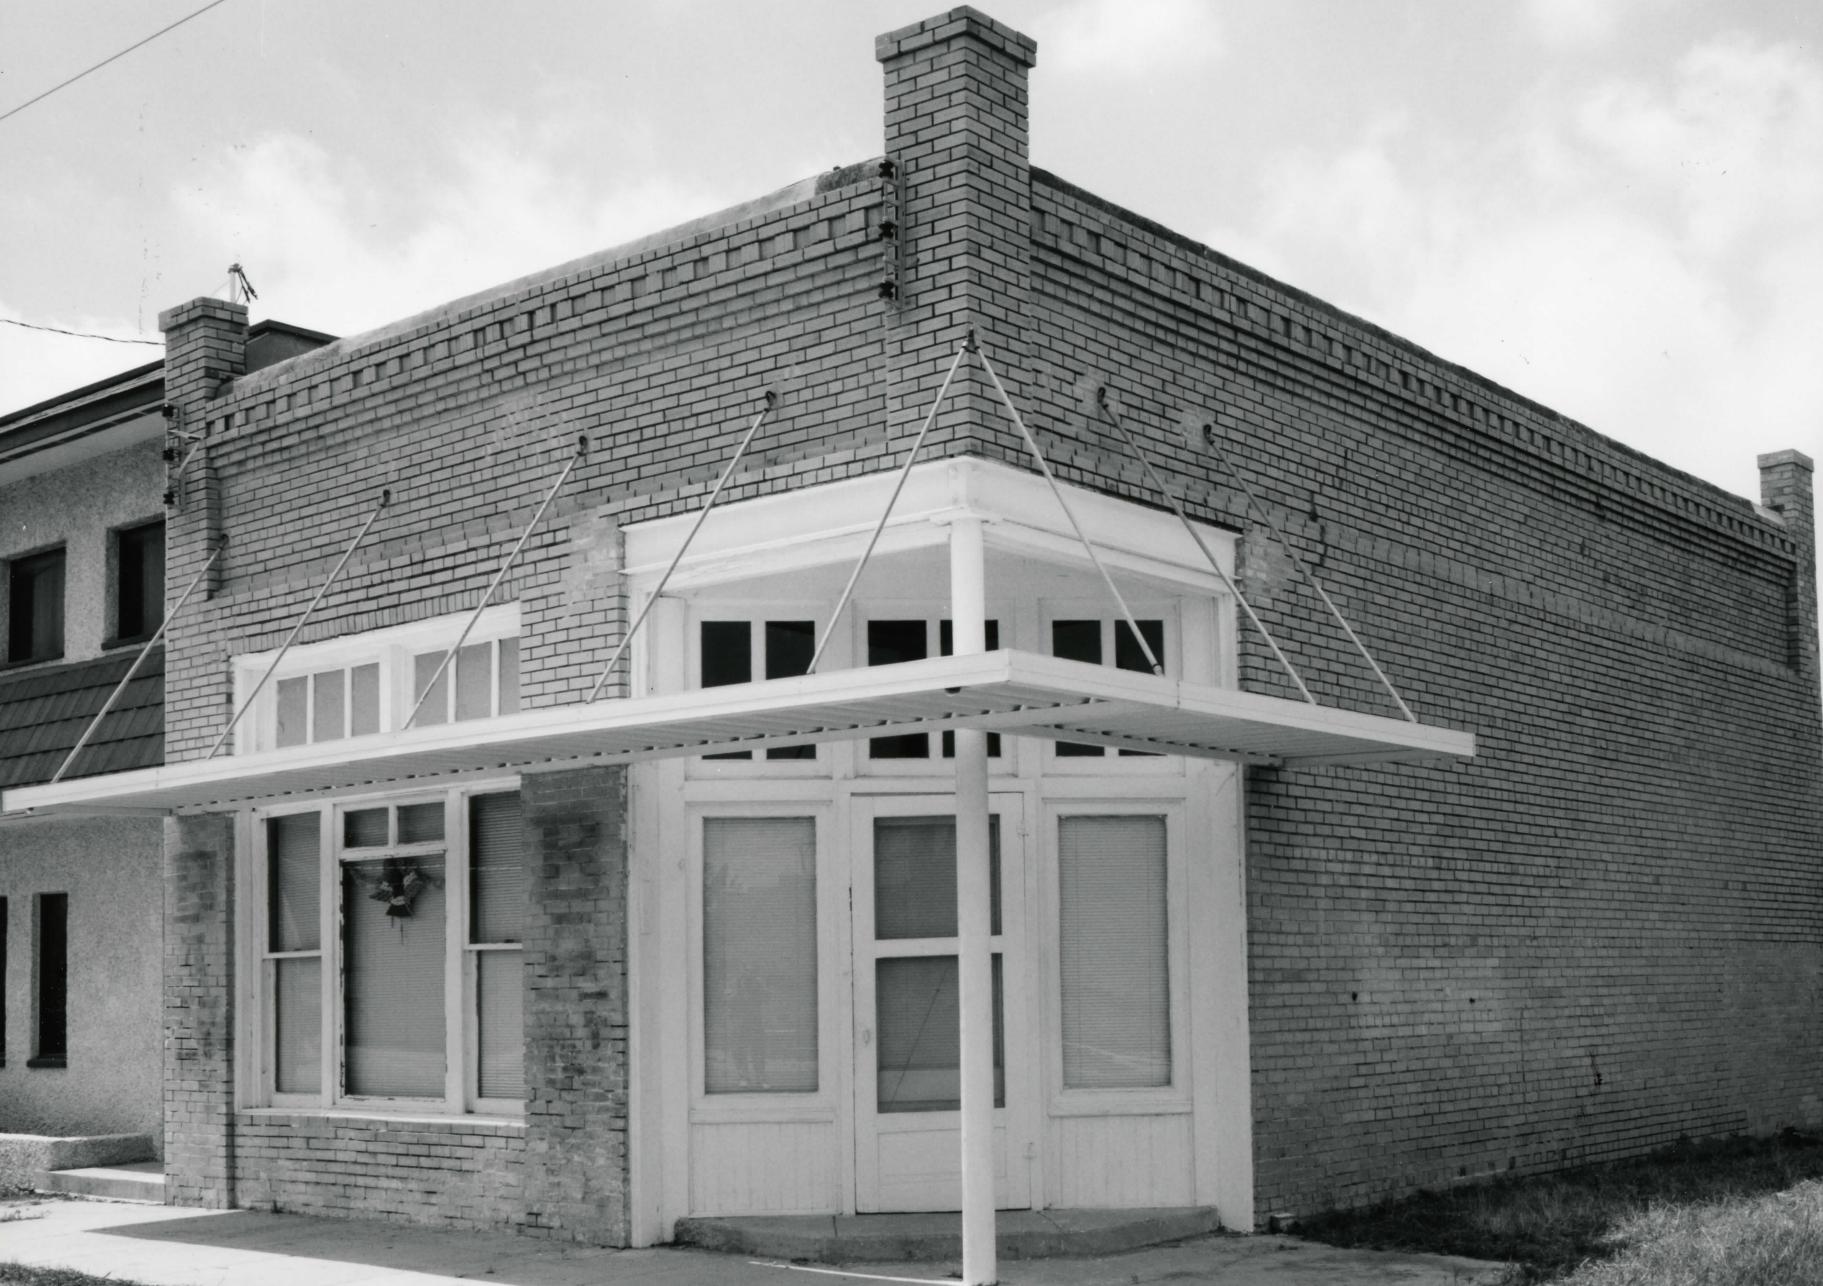
photo 1 of 5

View of the east front and north side taken from
Oak Street to the northeast of the building.

Constructed in 1906, the Continental Bank Building is a vernacular, early twentieth-century commercial structure built of light-tan brick. The flat-roofed building--with its simple corbeled brick parapet and decorative, false chimneys at the four corners--faces east on Oak Street, the main commercial avenue of the town. Designed as a corner building (although a vacant lot, rather than a street, is adjacent to the north), the one-story, single-bay structure is characterized by a three-section storefront window. Double-hung, 1 x 1 windows flank the large and fixed center pane, while a pair of transoms each marked by three vertical panes surmounts the storefront window.

The single-entry door, flanked by single-pane sidelights and surmounted by a three-part transom, is recessed beneath the building mass in a forty-five degree cut into the northeast corner at the lintel line. The projecting building corner above the recessed entry is supported by a slender, painted iron column. A simple metal canopy, suspended by iron bars from the paneled brick spandrel beneath the cornice, projects over the sidewalk at the level of the transom sills, turning the corner in order to shelter the entire recessed entry.

The corbeled brick cornice and panel beneath are the only detailed features of the solid-brick, north elevation.

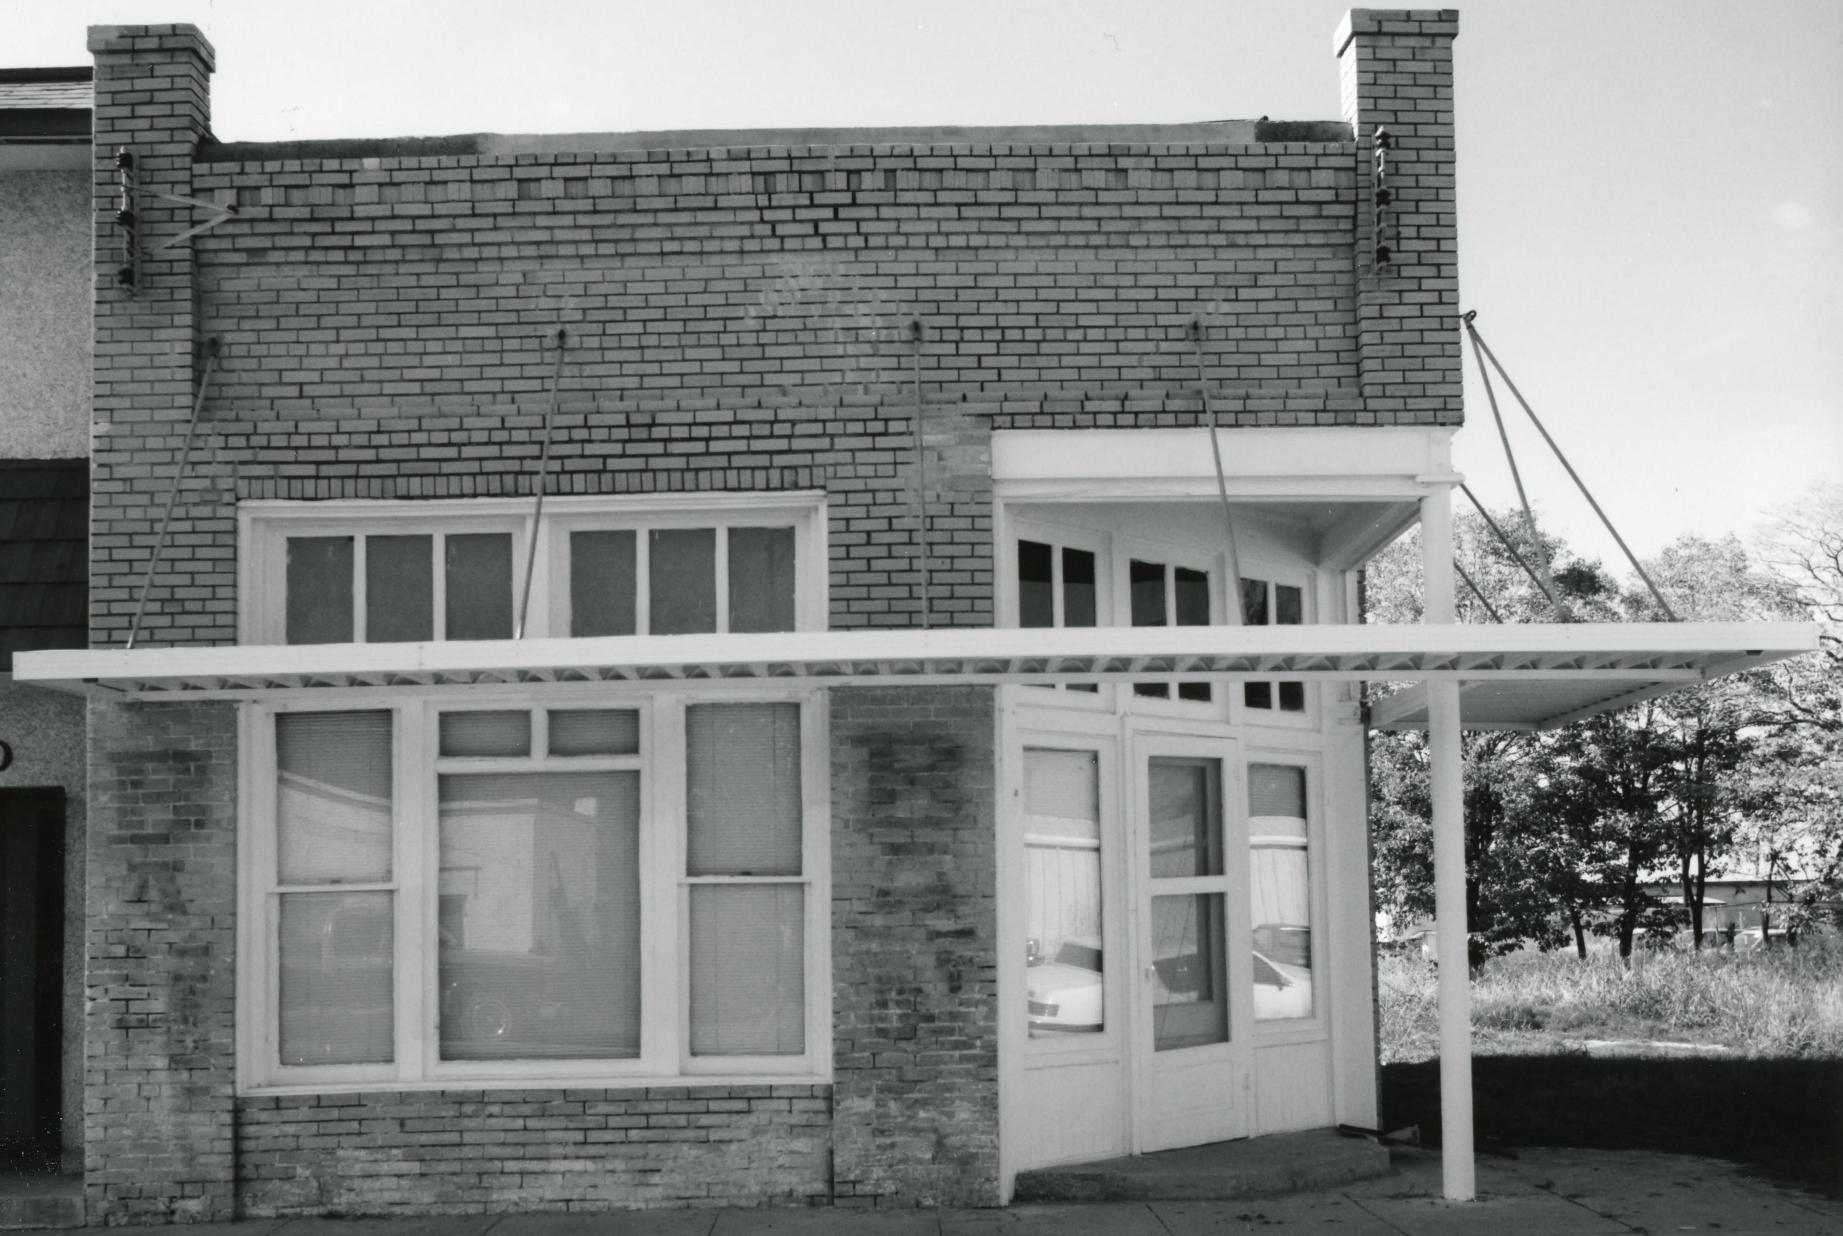
Old Continental State Bank
312 Oak Street, Roanoke, Denton County, Texas
photo by Ron Emrich, May 1986, negative with the
Texas Historical Commission, Austin
View of the east front taken from Oak Street facing
west.
Date: May 1986
Photo 2 of 5
HOUSE OF THE
CONTINENTAL STATE BANK OF
ROANOKE, TEXAS
View of the east front taken from Oak
Street facing west.

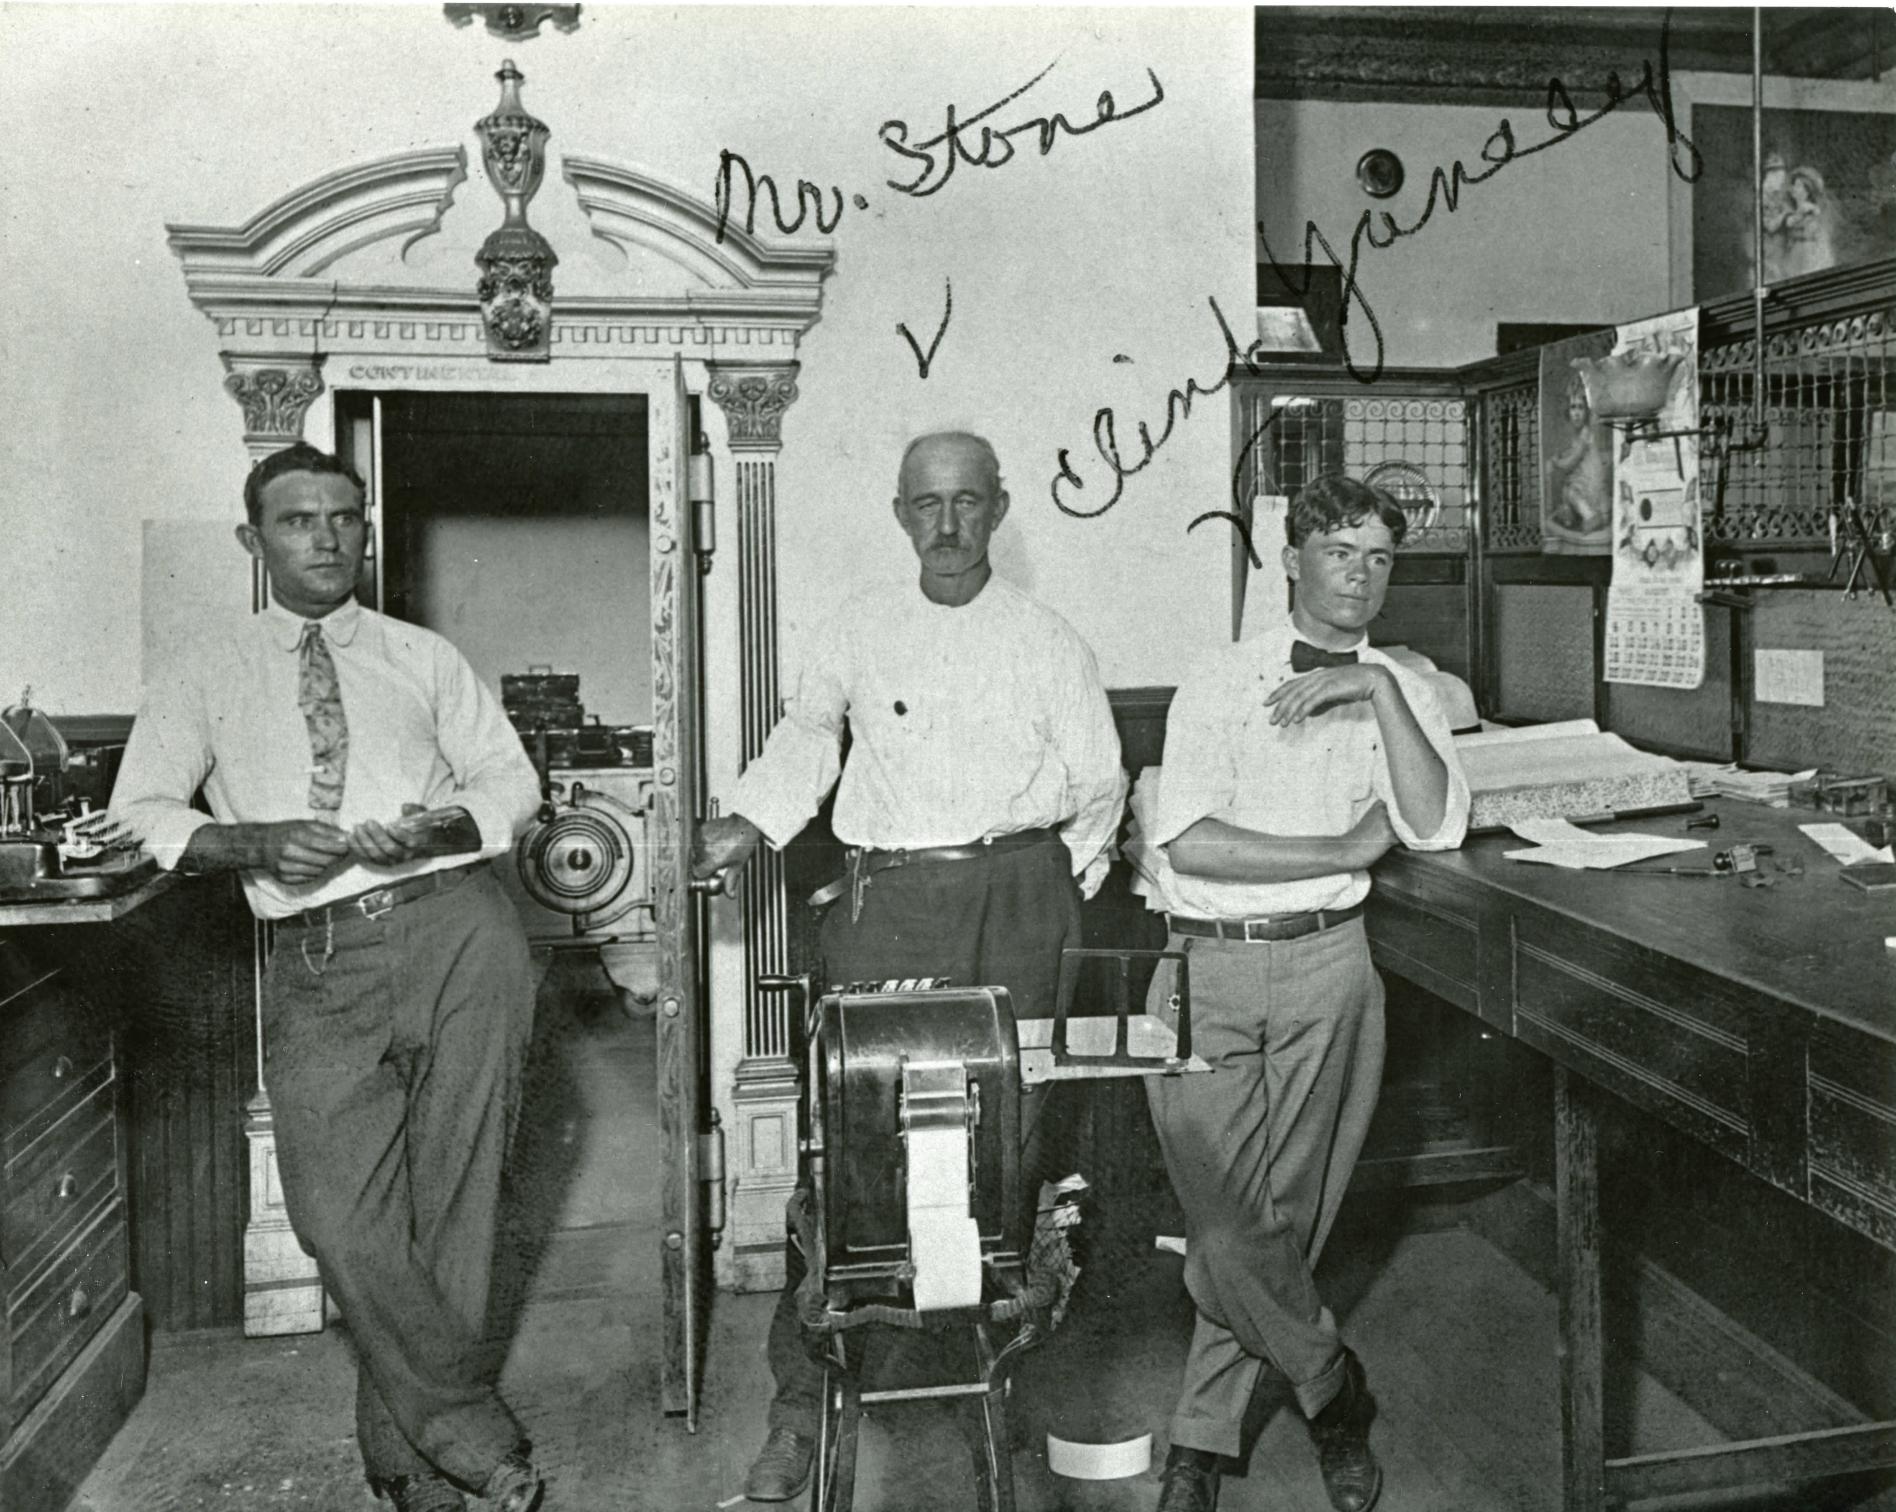
photo 3 of 5

print with the Texas Historical Commission, Austin
View of the vault entrance; photographer facing west.

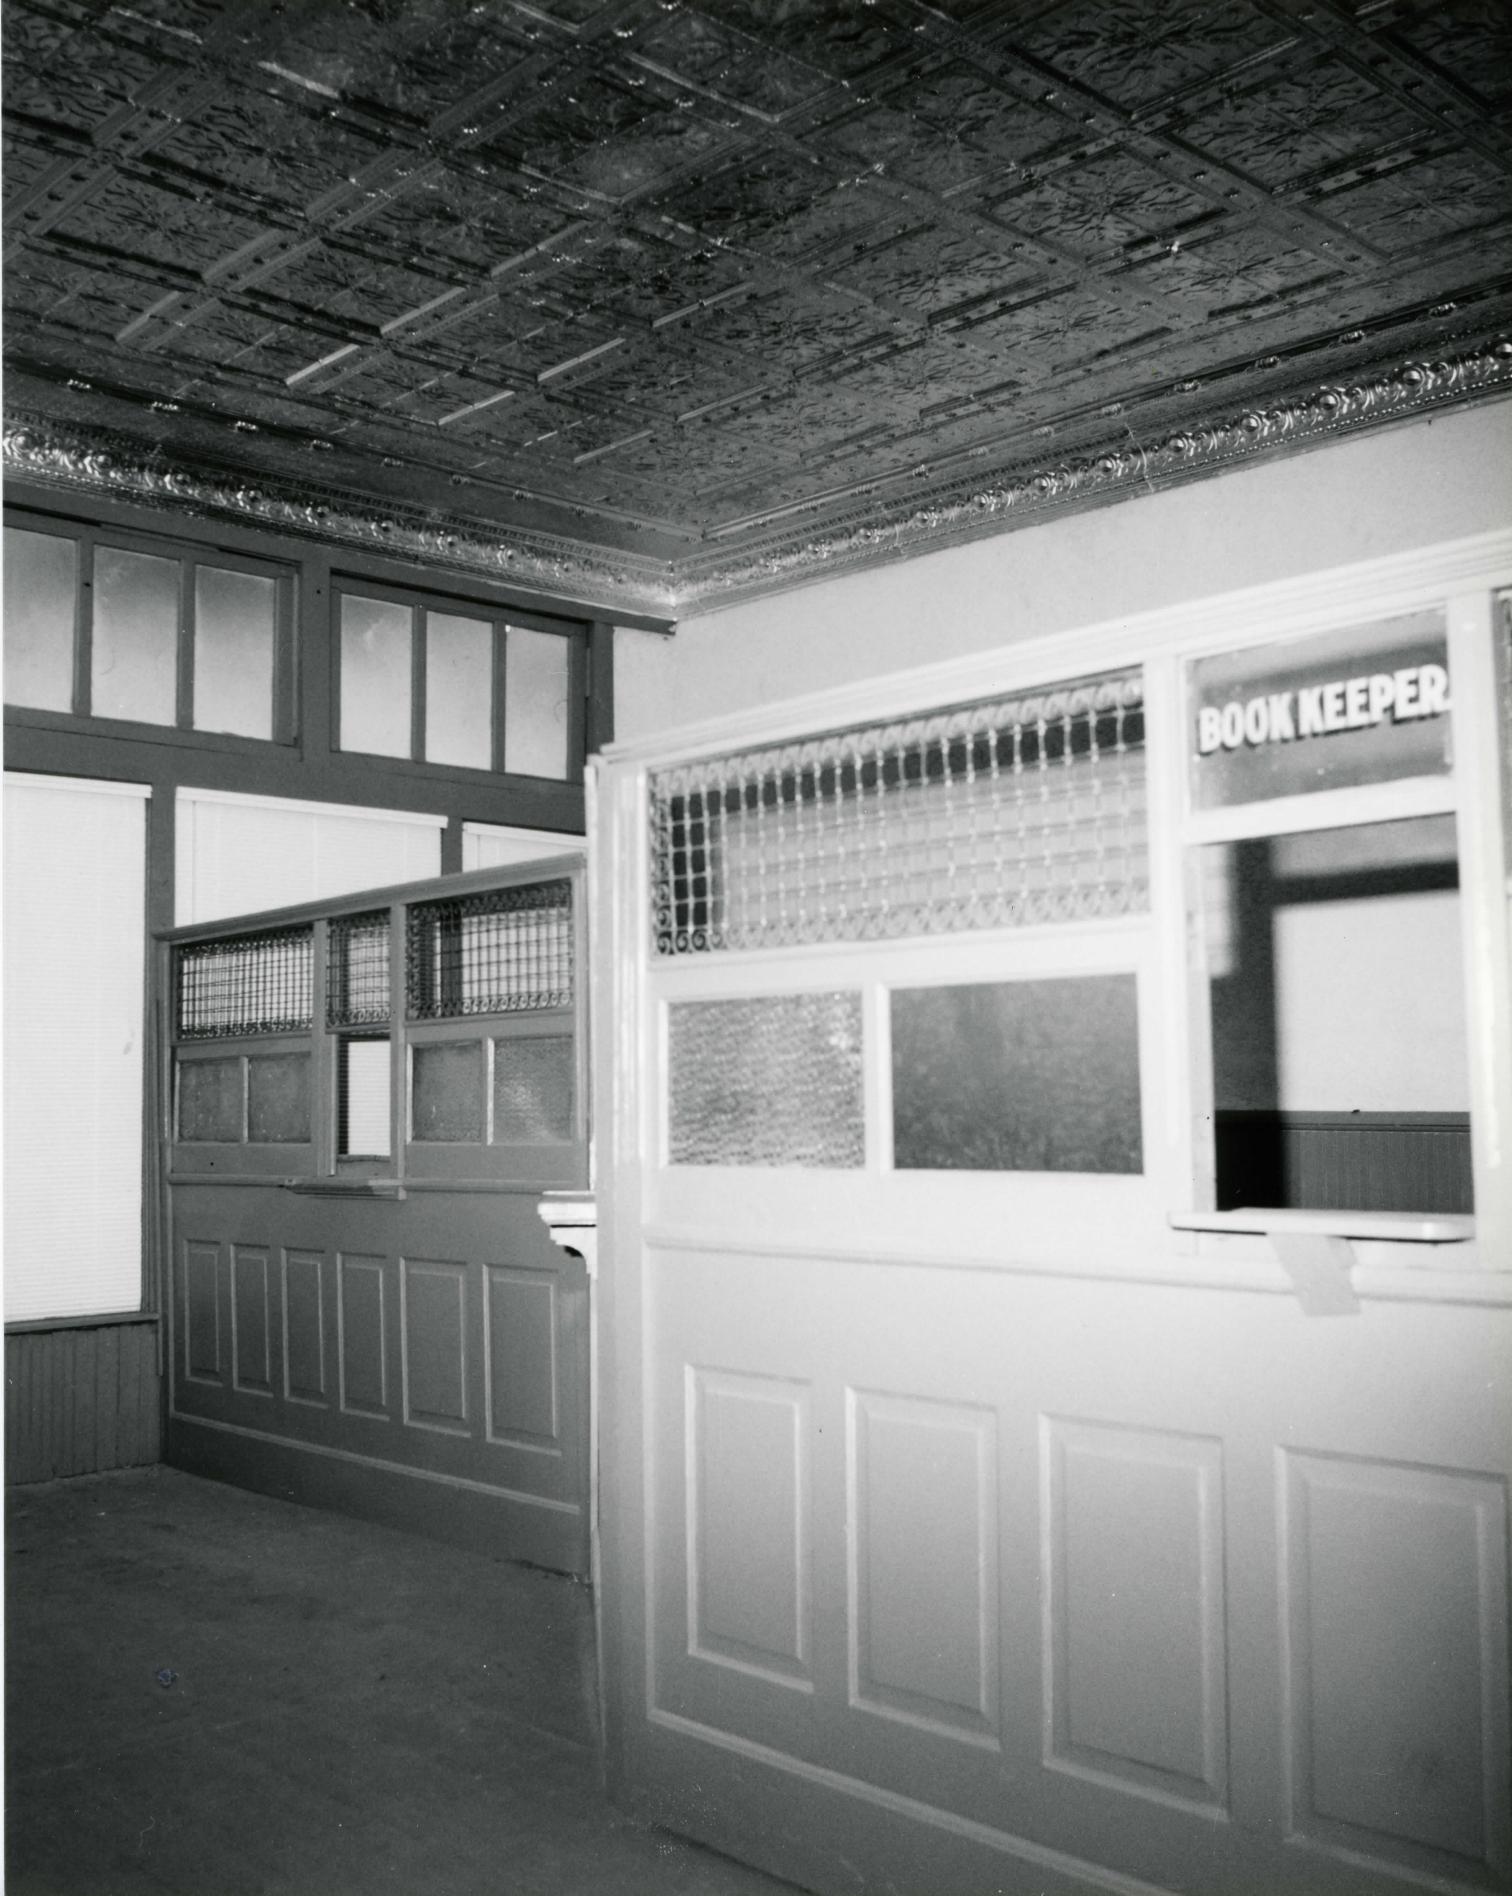
photo 4 of 5

No Looking east, inside building

The original, decorative, pressed-metal ceiling survives in the single large banking room, as does the massive-walled vault with its classically detailed, broken pediment door. Wooden and wrought-iron partitions that served as teller cages and work areas also survive.

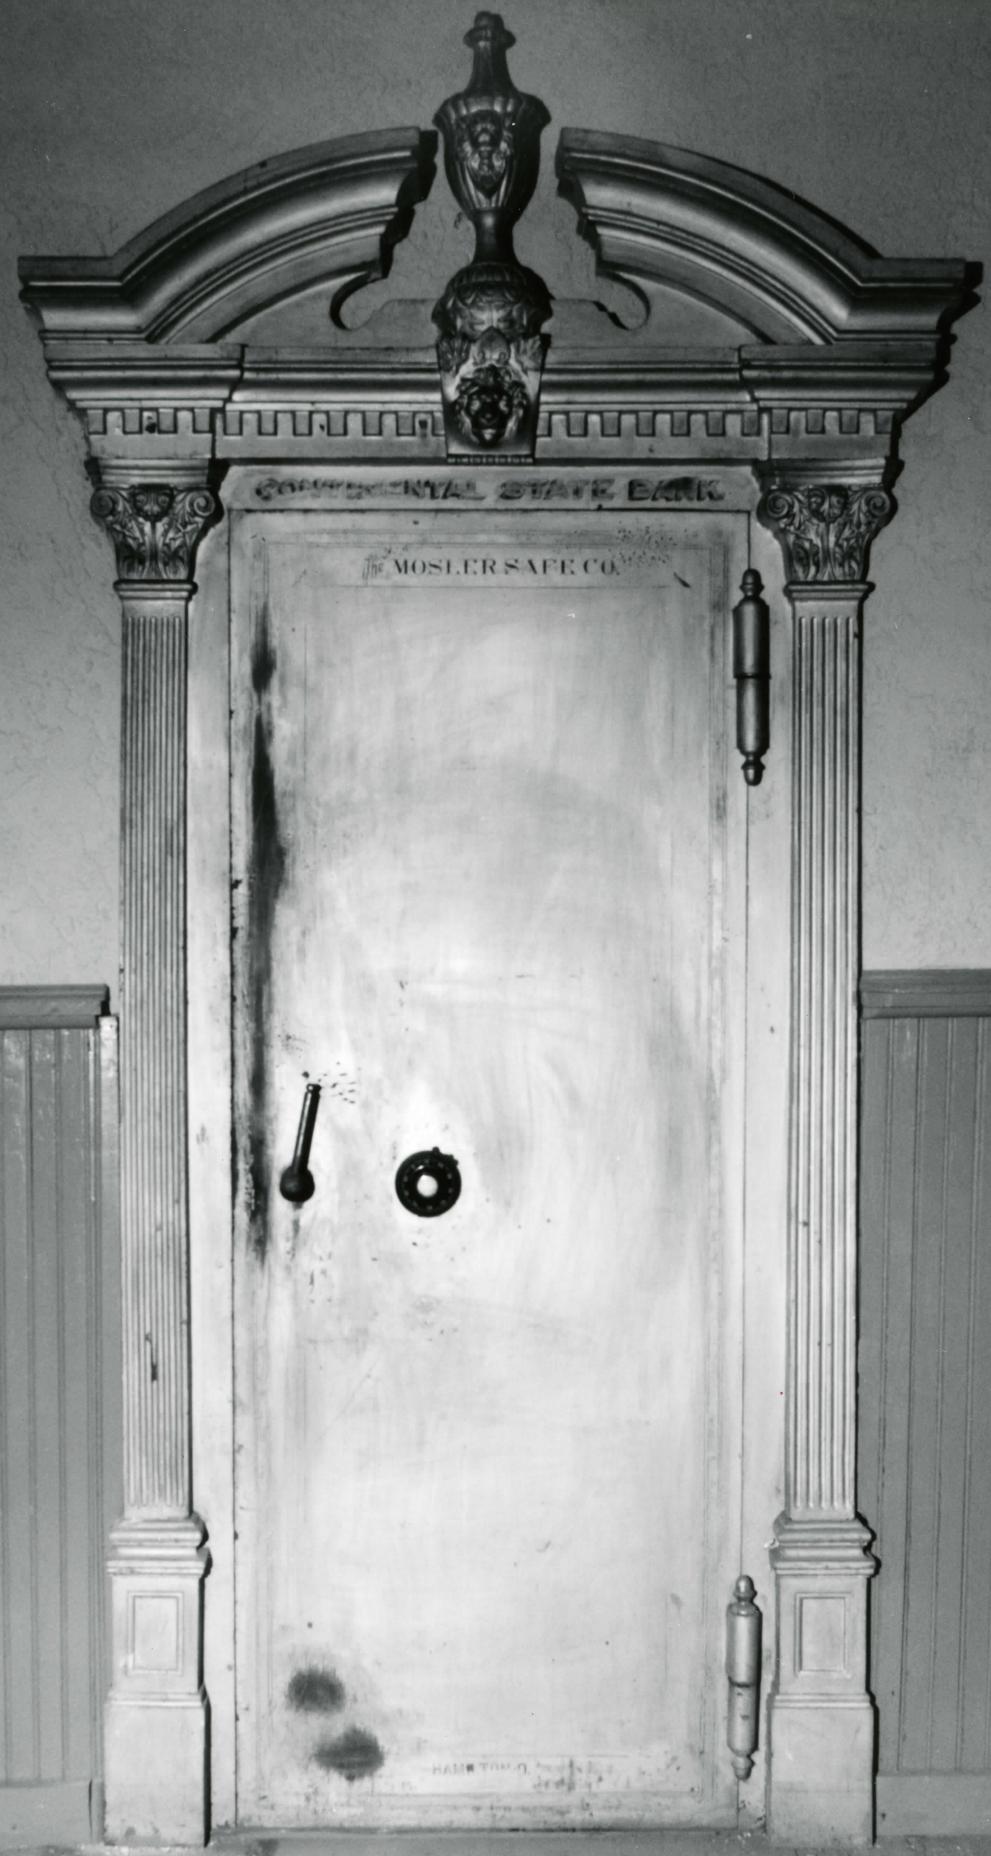
View of the vault door, middle section of the bank,
photographer looking west.

photo 5 of 5
Vault door 75 years after
photograph #1. Door operates well.
