National Register of Historic Places Inventory—Nomination Form

Historic Resources of Stamford

Stamford Historic Structures Survey Identification number, STA-008

Name of property- Old West Texas Utilities Co./Gail's Hallmark Shop

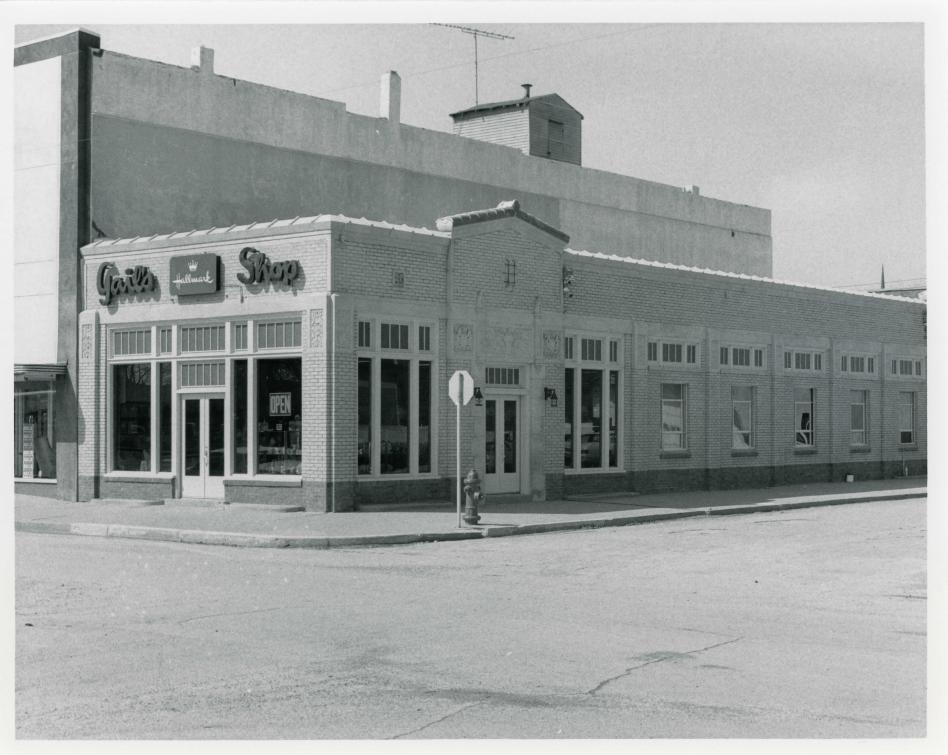
Photo 3 of 41.

Property No. 2 (STA-008), Old West Texas Utilities Co./Gail's Hallmark Shop 127 E. McHarg, looking NW

The Spanish Colonial Revival commercial building at 127 E. McHarg is one of Stamford's outstanding rehabilitation projects. The long and narrow, buff-brick building has a concrete frame which is articulated on the outside of the building in the brick-veneered piers with ornamental cast-stone panels and the concrete course above the transom windows.

The front portion of the building was built to house a retail function, and has large wood-framed plate-glass windows. The transom lights here, as elsewhere on the building, have been filled with wood panelling to match the original glass. Glass-paneled wooden doors, with multi-light transoms, allow entry to the interior. An elaborate copper awning shades the McHarg street entrance.

The two east side entrances are the architectural focal points of the building. Detailed cast-stone panels at the transom level repeat and elaborate the detailing found on the piers. Wrought-iron grilles cover small niches above each entrance. The tiled parapet above each door is gabled and slightly higher than the main parapet.

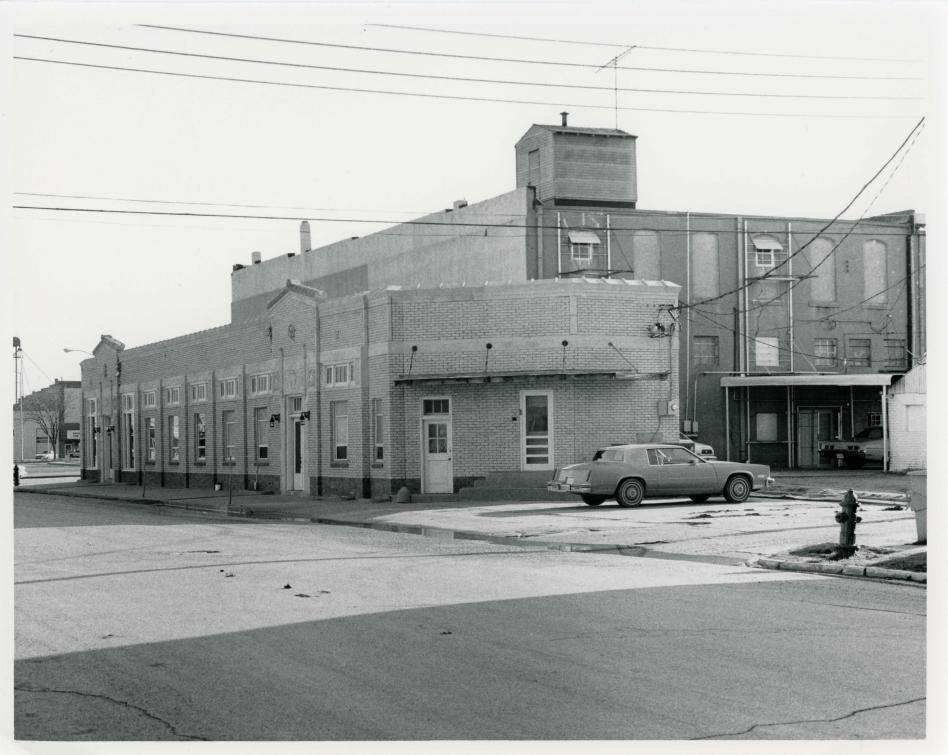
Photo 4 of 41.

Property No. 2 (STA-008), Old West Texas Utilities Co./Gail's Hallmark Shop 127 E. McHarg, looking SW to rear of building

The middle and rear portions of the building have metal fixed and awning windows. A wooden awning shades the irregularly shaped rear portion and loading dock.

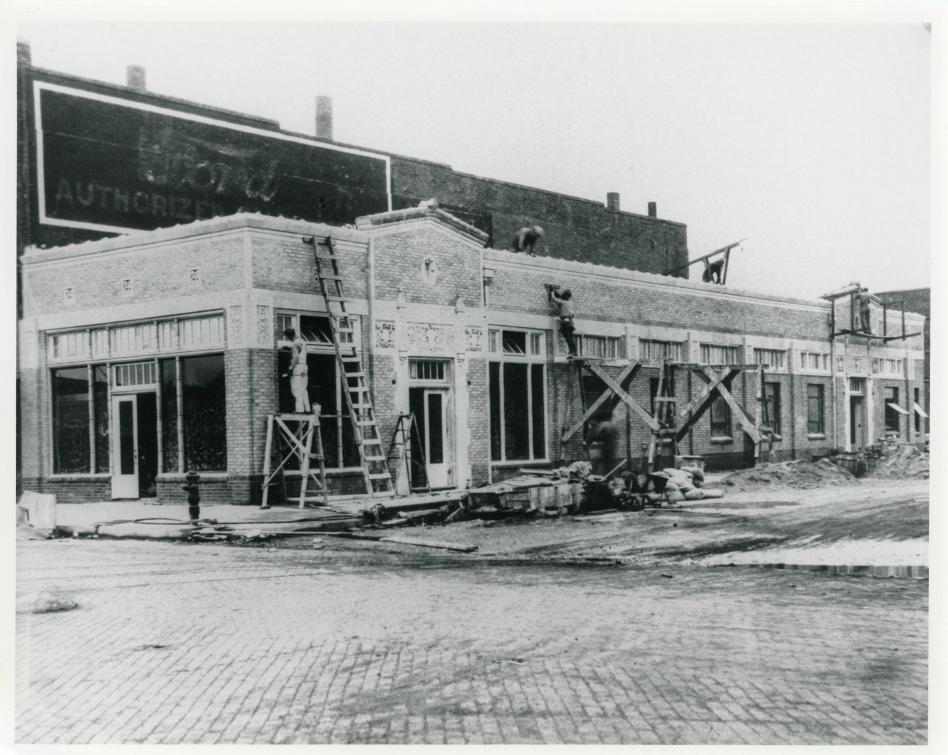
Photo 5 of 41.

Property No. 2 (STA-008), Old West Texas Utilities Co./Gail's Hallmark Shop 127 E. McHarg, under construction in 1927-28

This structure was built in 1928 by the West Texas Utilities Company. The Spanish Colonial Revival style was common across the Southwest during the 1920s, although not in Stamford. The building is an excellent example of the style as used on a smaller building; it survives today as one of the city's more handsome commercial buildings.

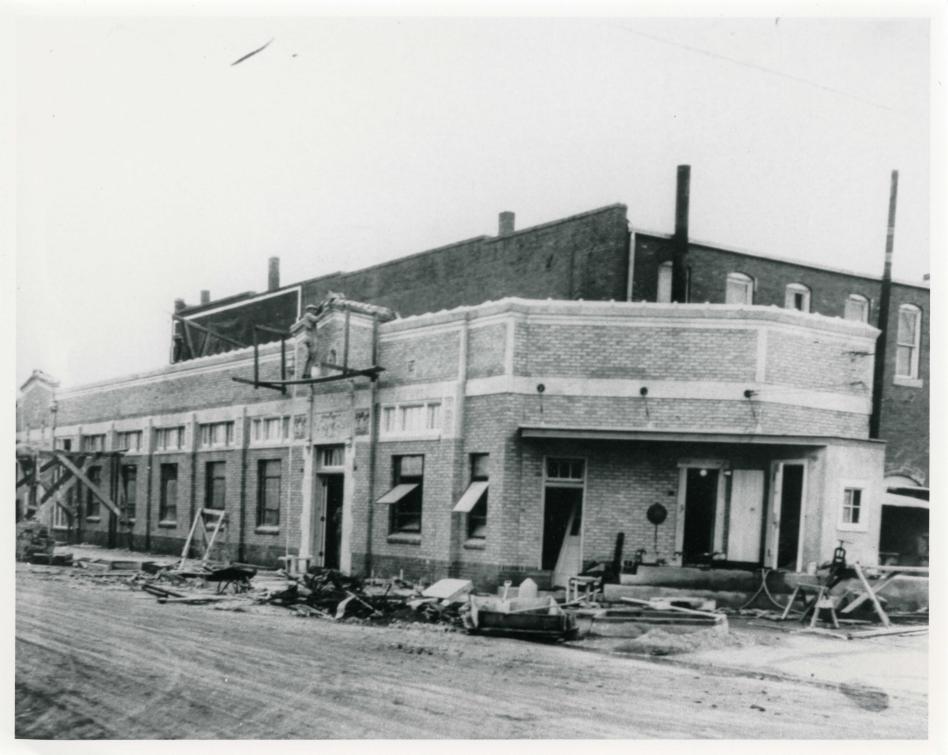
Photo 6 of 41.

Property No. 2 (STA-008), Old West Texas Utilities Co./Gail's Hallmark Shop 127 E. McHarg, under construction in 1927-28
