National Register of Historic Places Inventory—Nomination Form

Historic Resources of Stamford

Name of property- St. John's Methodist Church

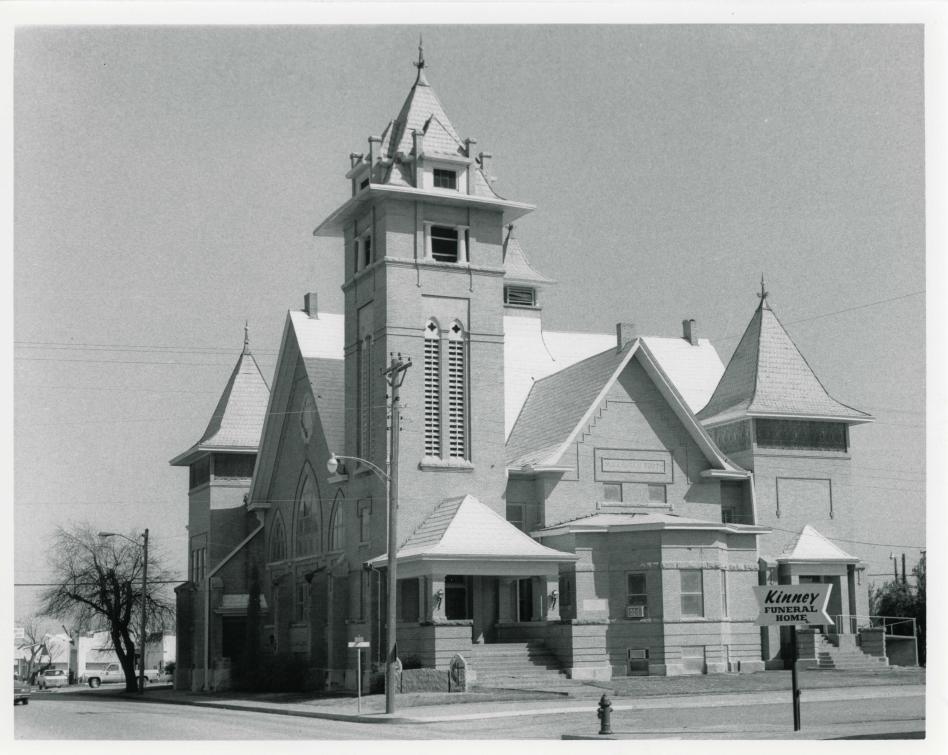
Photo 12 of 41.

Property No. 5 (Sta-015), St. John's Methodist Church, St. John's Street, looking SE

St. John's is a large, buff-brick, gable-roofed church built on a cruciform plan. The largest and tallest roof is on a north-south axis, with slightly lower gables pushing out to the east and west from the center of the building to form the basic cross plan. A small, square cupola with a pavilion roof is located on the ridge of the main north-south roof, marking the center of the plan.

Square towers rise from the empty space on each corner of the building, somewhat obscuring the basic plan and making the structure appear to be square and monolithic. Three of the towers are no taller than the main roof line, but the northwest tower, over the main entry, is much taller. The three lesser towers are capped by pavilion roofs, while terra-cotta freizes are found on all four sides of each tower. The taller tower is also capped by a pavilion roof, but it resides over an open belfry with two small wooden columns set in each opening. Verticality is stressed by the long, narrow louvers on each side of this tower.

A bell hip-roofed portico at the base of the taller northwest tower covers the main entrance to the church, while lesser entrances are found on the other three towers as well. The roofs of the main structure, the towers, and all porches were originally covered with metal shingles which are currently being replaced with composition units.

The verticality of the structure is relieved somewhat by string courses which enrich the building. Gothic-style stained-glass windows are set in the ends of the main gables on the north and south sides of the building, while lesser one-over-one or fixed-pane stained-glass units are used elsewhere.

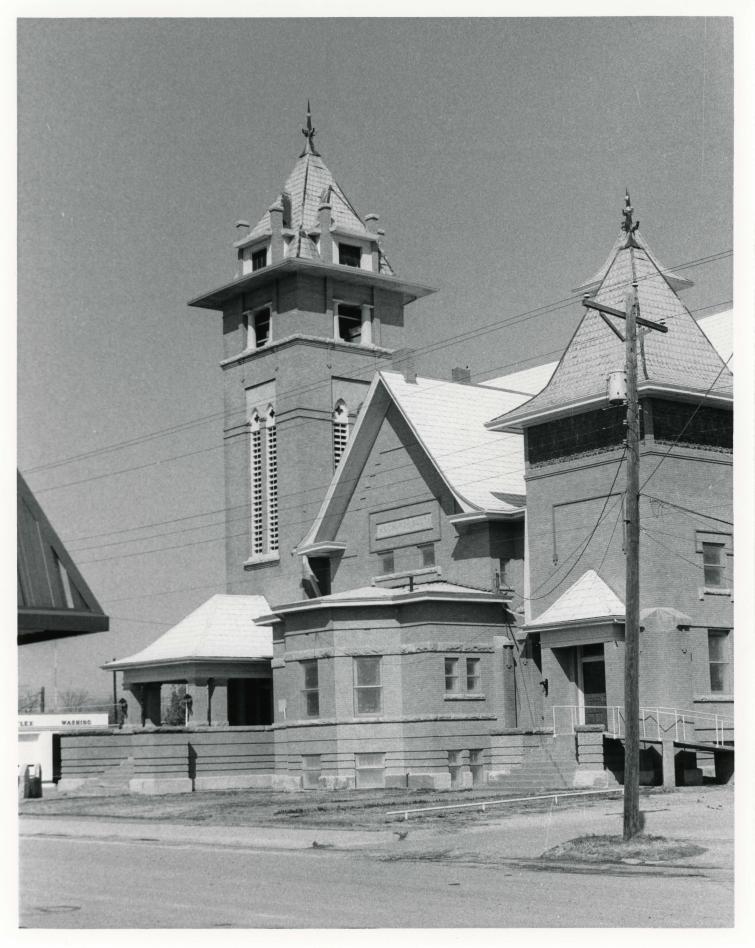
Photo 13 of 41.

Property No. 5 (Sta-015), St. John's Methodist Church, St. John's Street, looking NE
