**National Register of Historic Places
Inventory—Nomination Form**

Historic Resources of Stamford

Name of property- Residence, 709 E. Reynolds

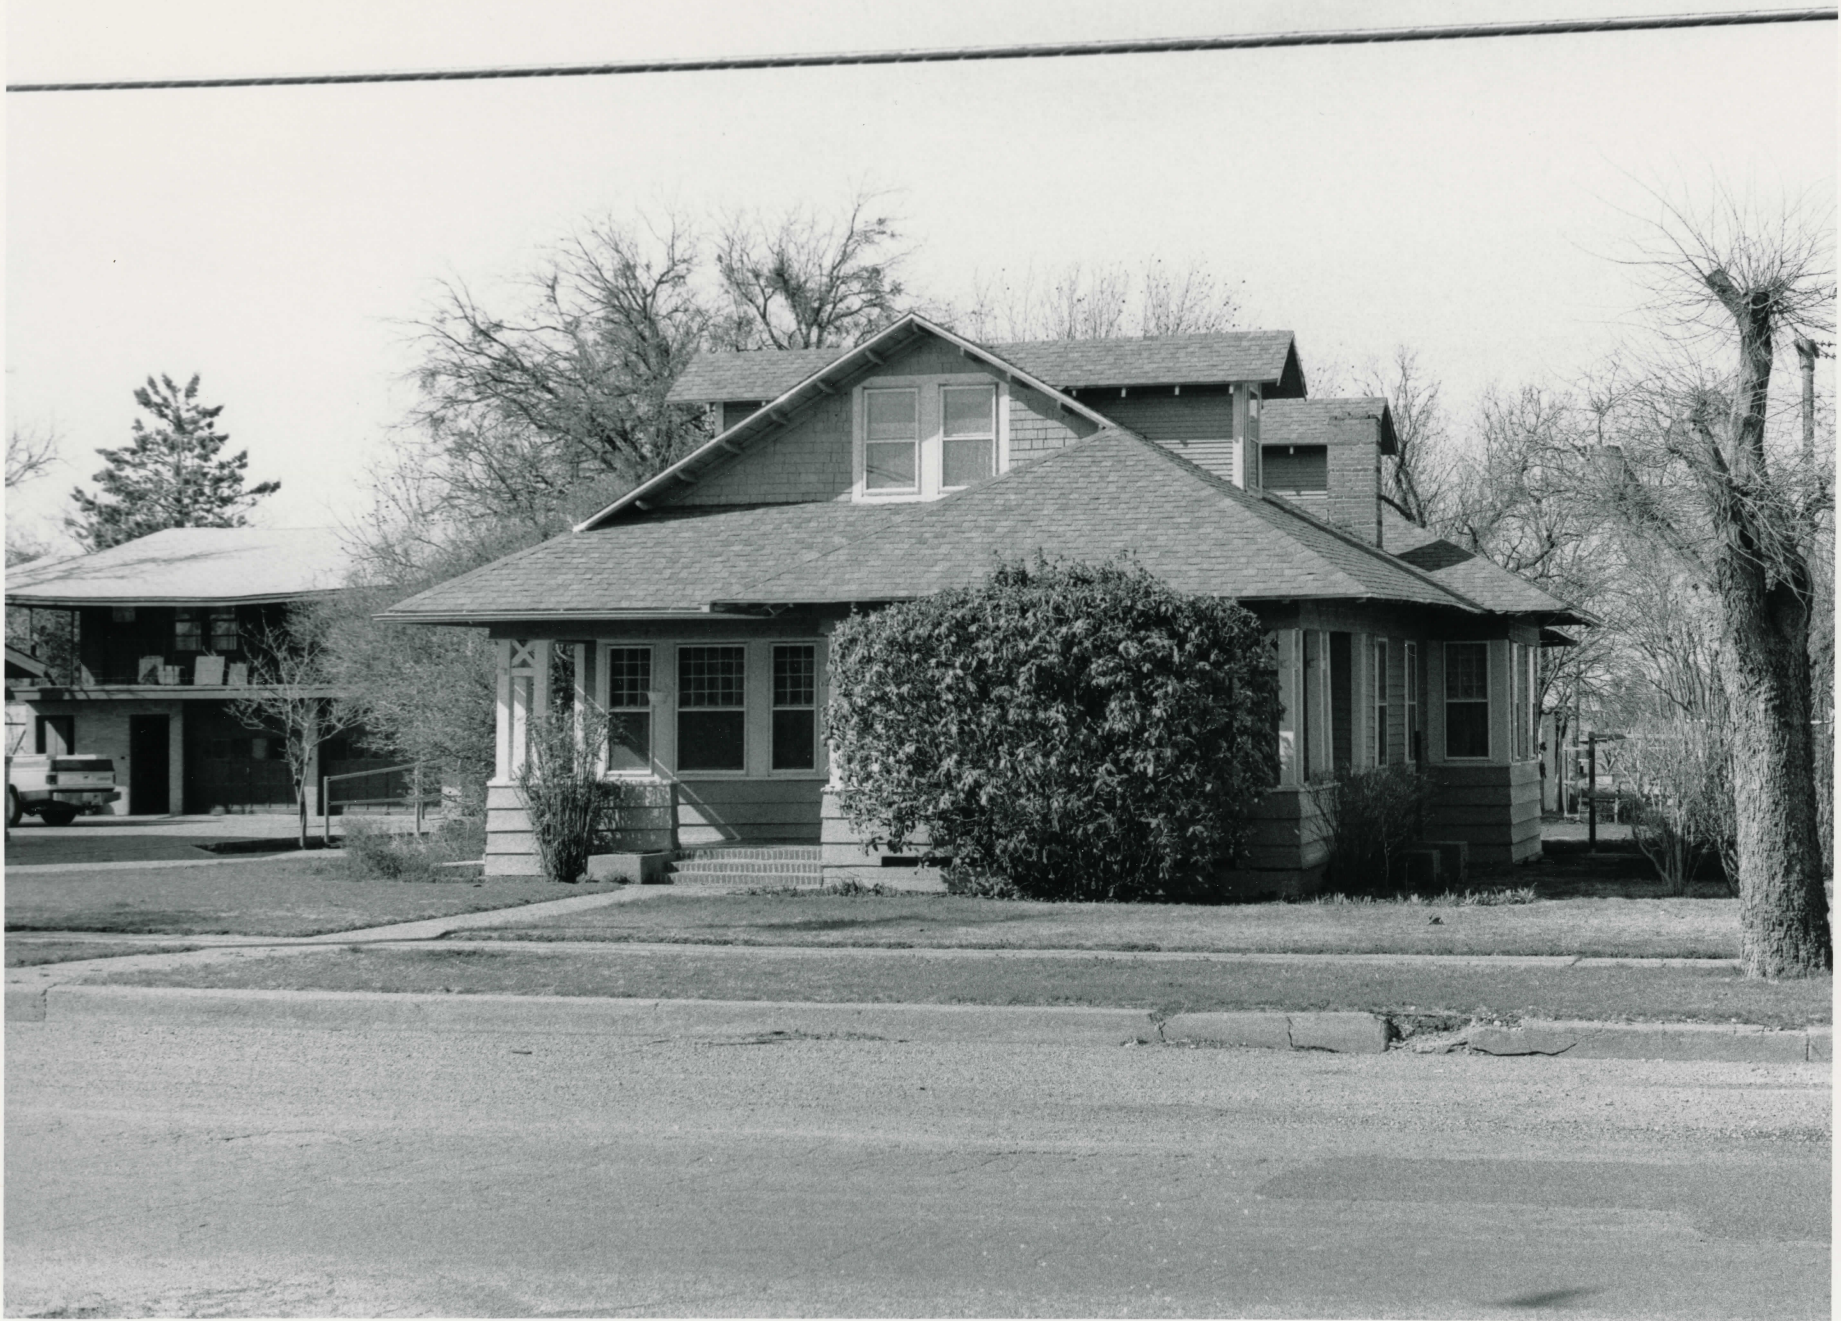
Photo 28 of 41.

Property No. 15 (Sta-113), Residence at
709 E. Reynolds, looking NW

The frame house has wood siding ranging from a narrow width near the eaves to a much wider board near the ground, creating the effect of slightly battered walls. The hipped roof has gablets at each end, four gabled dormers, and hipped extensions over the front porch and the two square bays. Exposed purlins and rafters further enhance the Bungalow effect.

The asymmetrical porch stretches across the front of the house. A solid wall continues the wide siding found on all walls below the window sill, and several sets of columns support the roof. The square columns are joined with decorative stickwork.

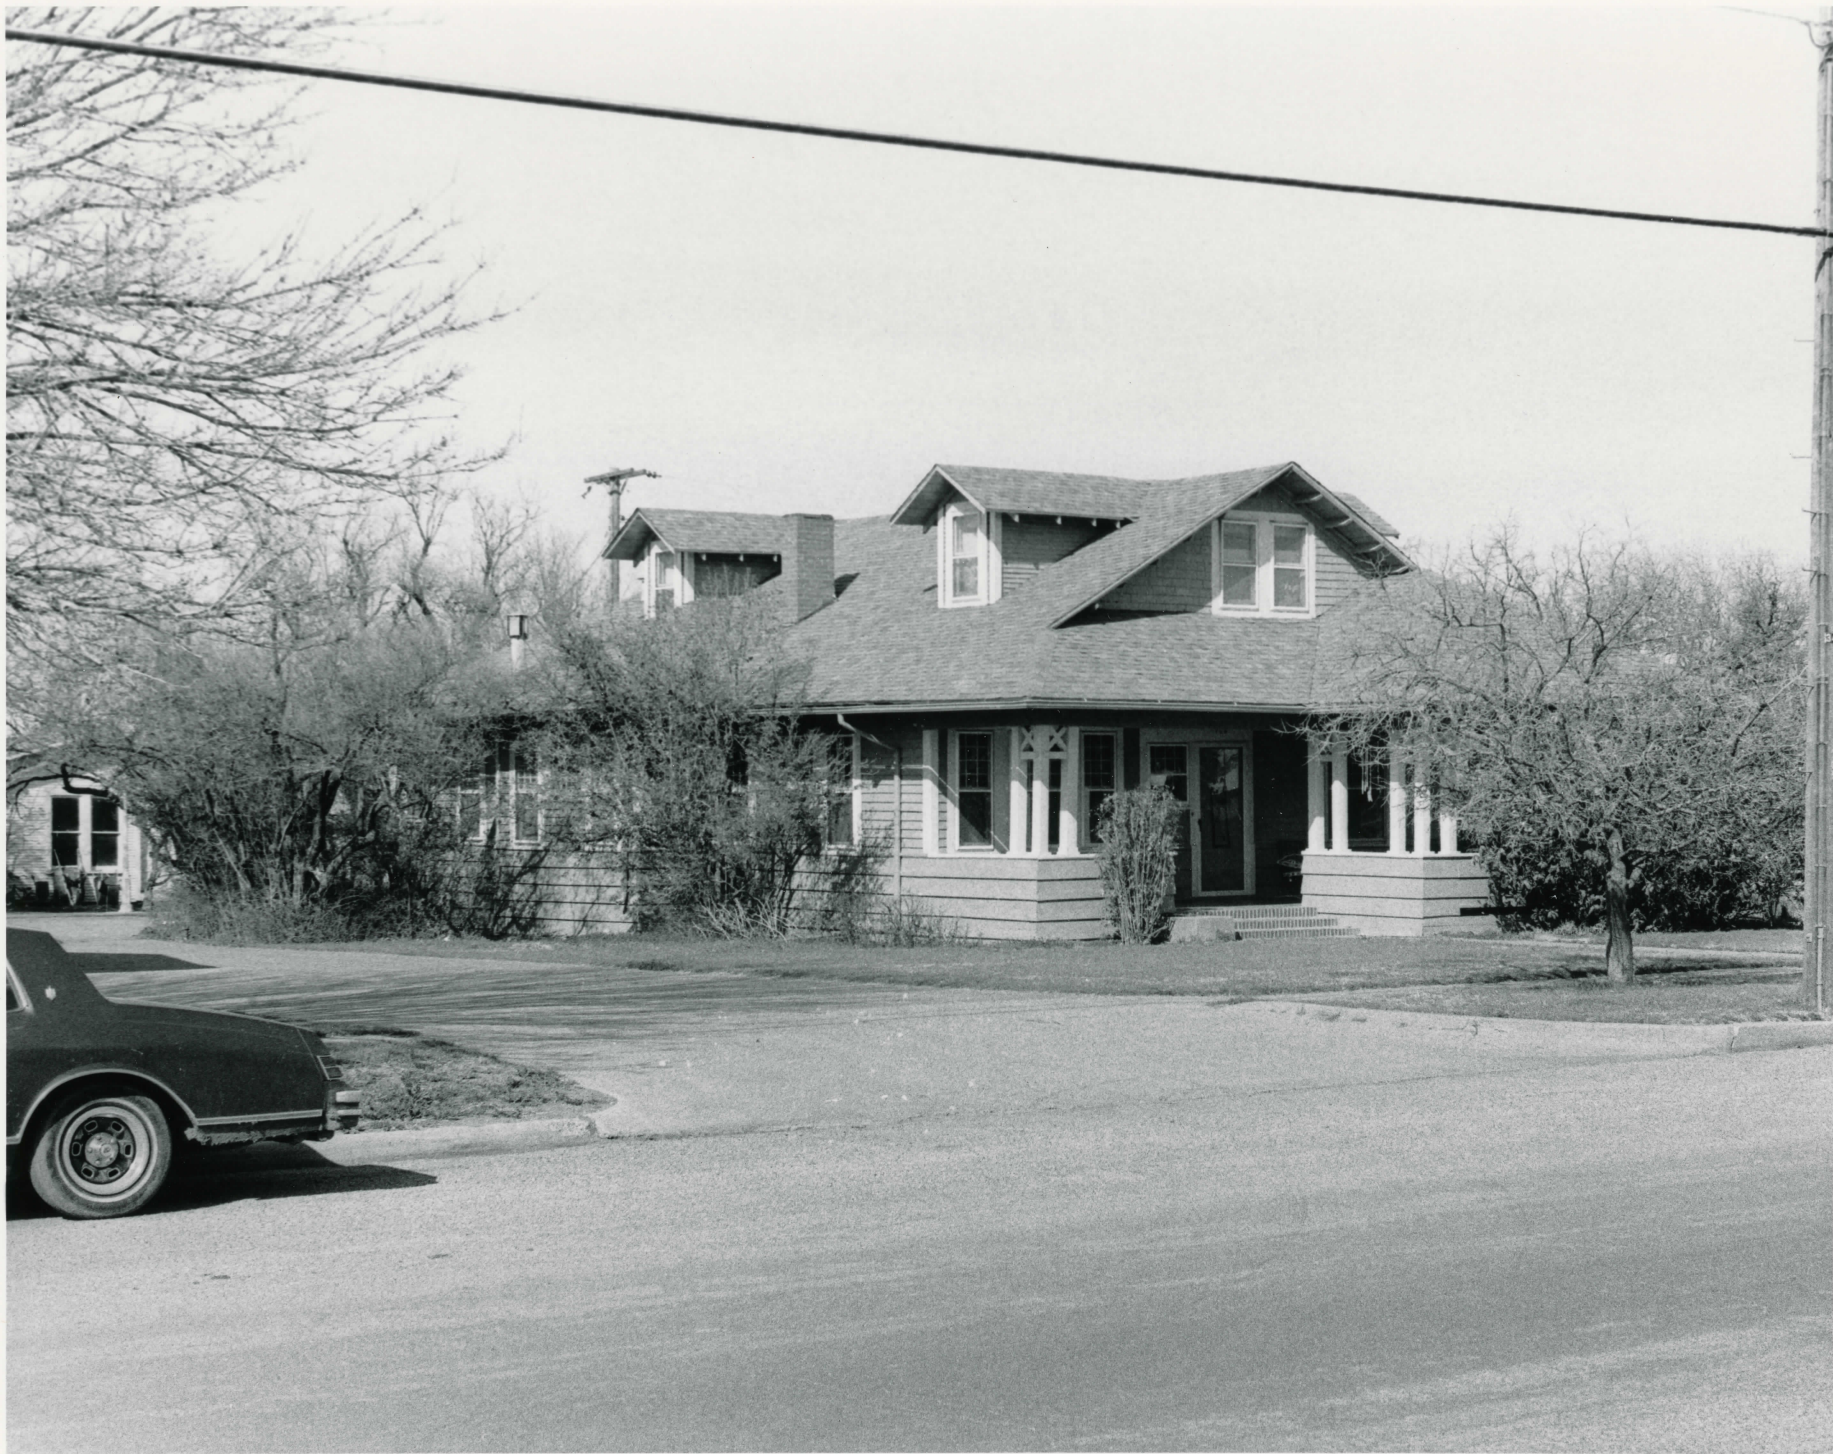
Photo 29 of 41.

Property No. 15 (Sta-113), Residence at
709 E. Reynolds, looking NE
