**National Register of Historic Places
Inventory—Nomination Form**

Historic Resources of Stamford

Name of property- Residence, 719 E. Reynolds

Significance: local level, architecture, c. 1908

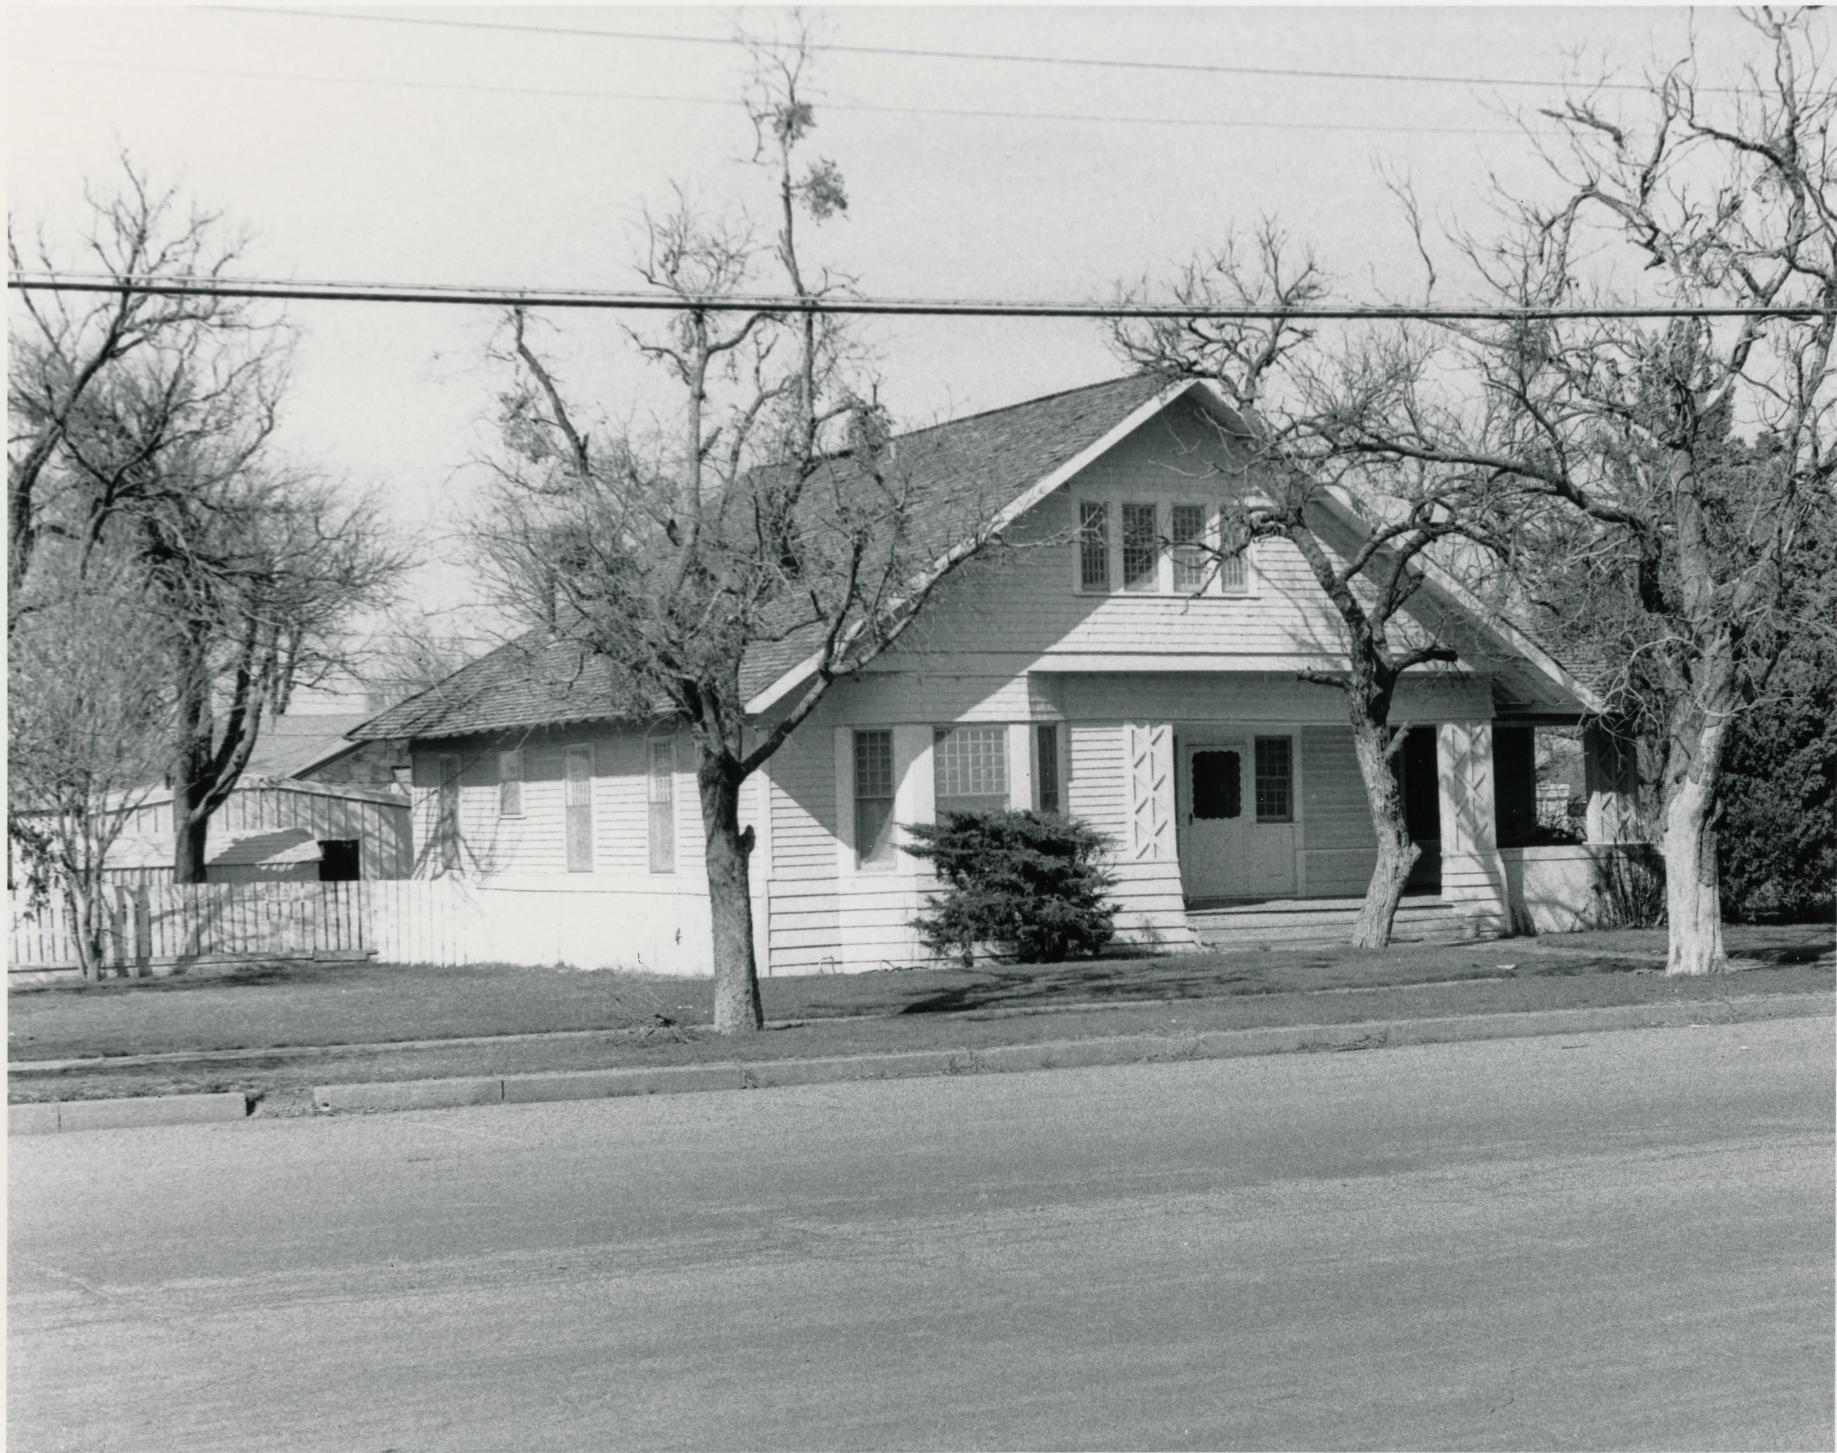
Photo 30 of 41.

Property No. 16 (Sta-115), Residence at
719 E. Reynolds, looking N

The house at 719 E. Reynolds is one variation of the typical bungalow built in Stamford early in its history. The one and one-half story, wood-frame house is built on a cross-gable plan with broad, steeply pitched, wood-shingle roofs to allow use of the attic story. Exposed rafters are evident around the roof edge.

The textual variation so popular in the Craftsman-type house is provided in a simple manner by the use of siding that varies in width from narrow at the roof line to very wide at the ground. As the width of the weatherboard increases, the wall flares slightly. This treatment is used around the house, including the bay windows and porch posts. It was possibly used along the now-stuccoed porch wall as well.

The L-shaped porch is contained under the main roof line. Geometric patterns adorn the porch posts. Multilight and single-light windows are used in a variety of sizes and configurations. An aluminum storm door has been added to the large paneled door with sidelights.

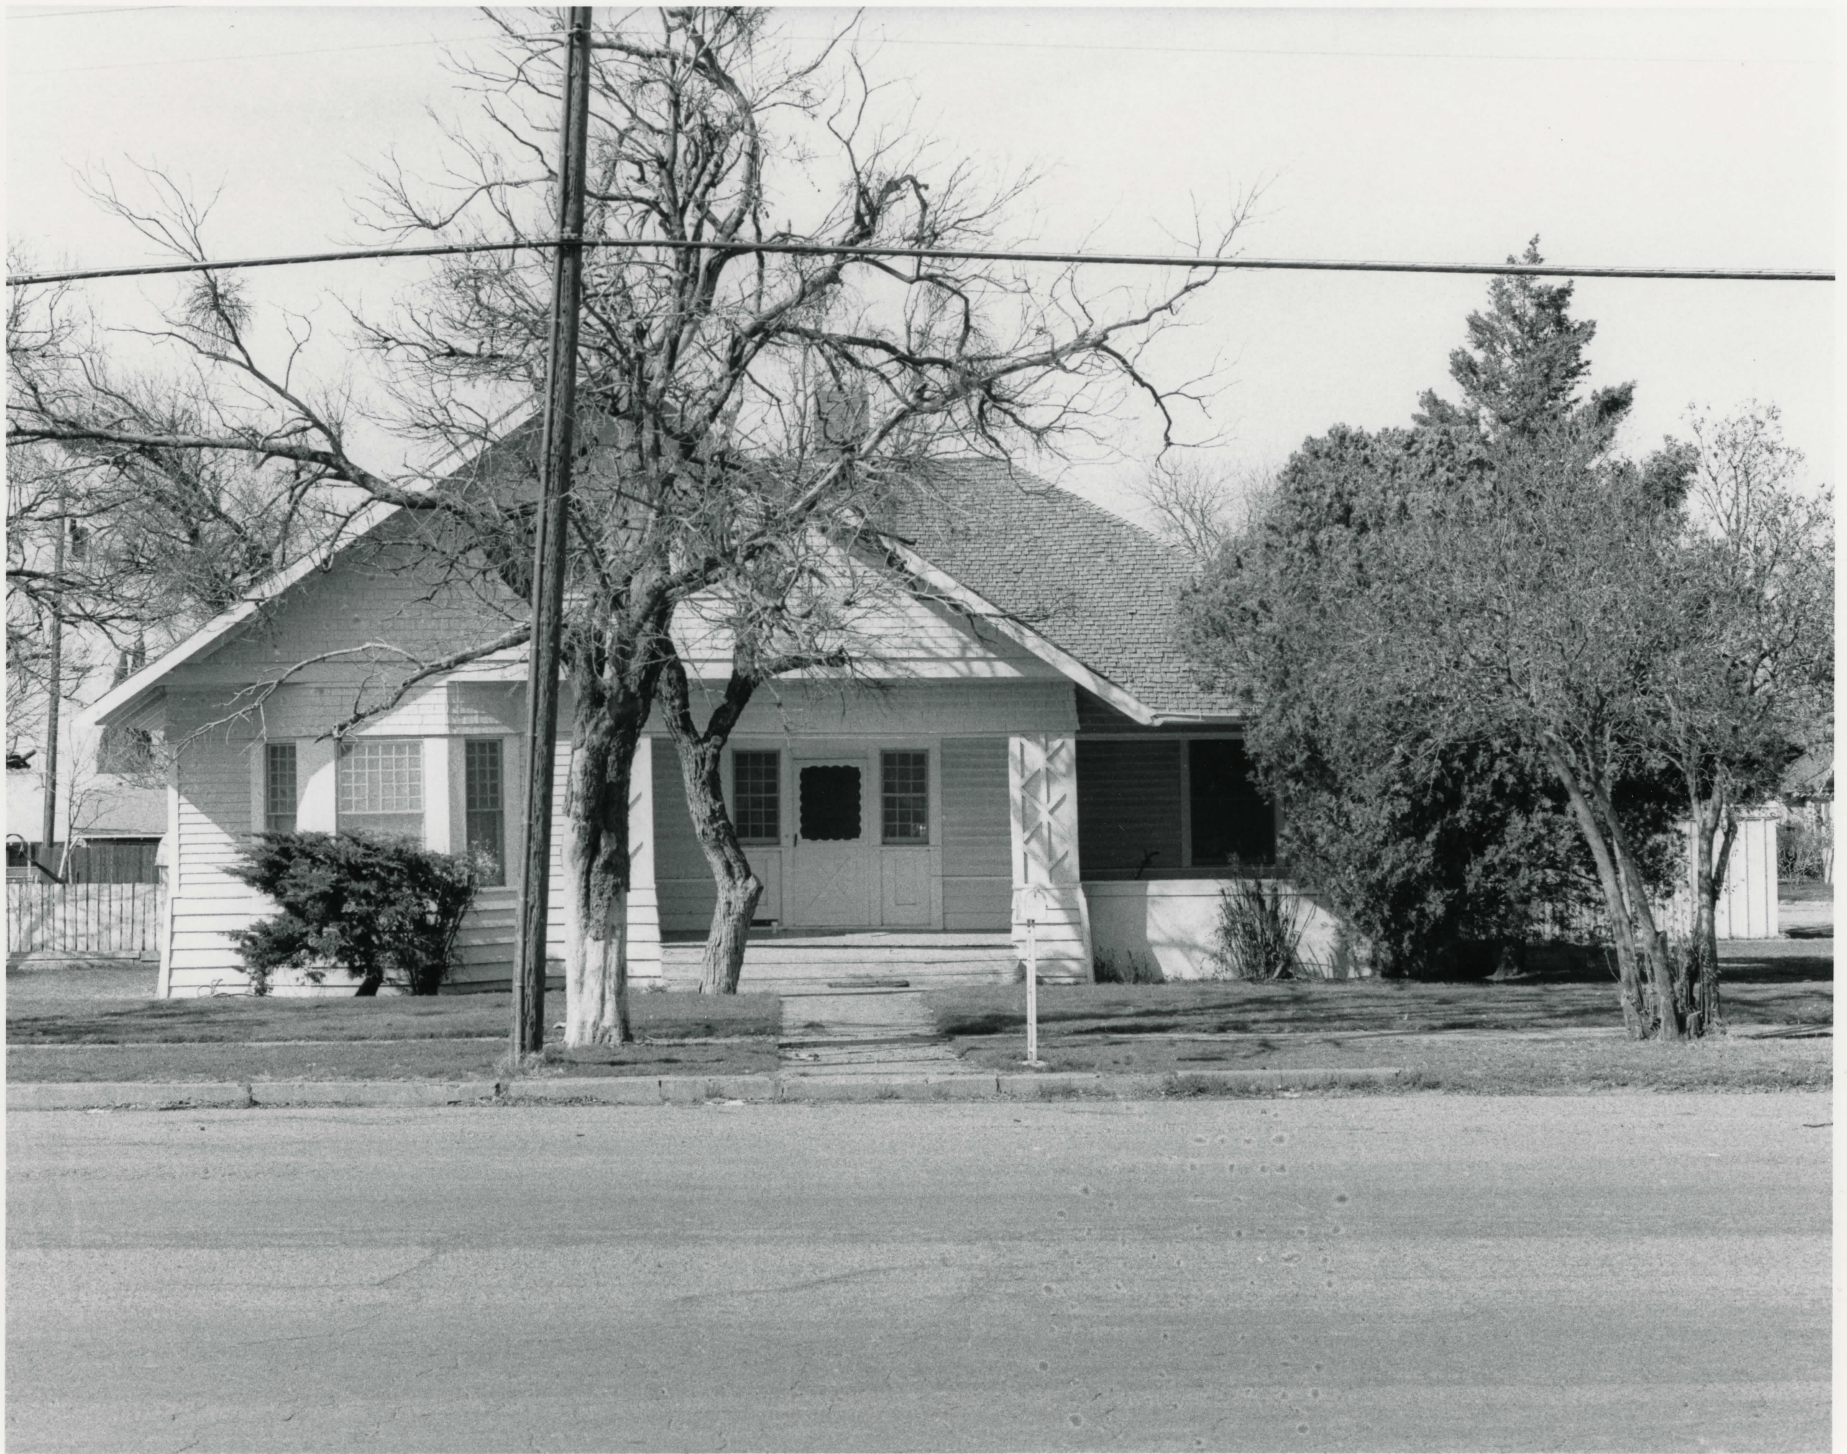
Photo 31 of 41.

Property No. 16 (Sta-115), Residence at
719 E. Reynolds, looking NE
